Profile/Photo Observation Report

Date:	09/29/2018	Weather:		Coding:	PACP 6.0
Pipe Length (ft):	302.1	Owner:	NA	Pre Clean:	Not Known
P.O.#:		Surveyor:	Selasie Honu	PSR:	P-503-029-030
Customer:		Clean Date:	01/01/1900	Shape:	C

Street:	Delaware St.	Flow Control:	Not Controlled
City:	Hobart, IN	Year Renewed:	
Location:	Light Highway	Tape/Media #:	
Purpose:	Routine Assessment	Dia/Height:	10"
Use:	Sanitary	Material:	VCP
Drain Area:	NA	Lining:	
Category:	NA		
Comment:

Location Details:		Direction of Survey:	Downstream
US MH:	M-503-030	DS MH:	M-503-029
		Total Length Surveyed (ft):	154.0

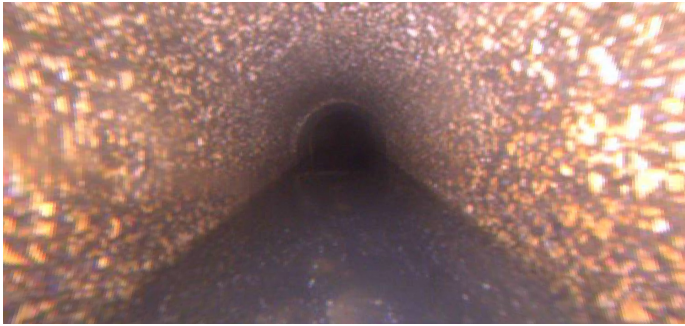
Code: **AMH**
Description: **Manhole**

Distance (ft): **.0**
Structural Grade: **0**
O&M Grade: **0**
Clock Start/From:
Clock To:
1st Value:
2nd Value:
Value Percent:
Continuous Index:
Within 8" of Joint: **NO**
Remarks: **M-503-030**

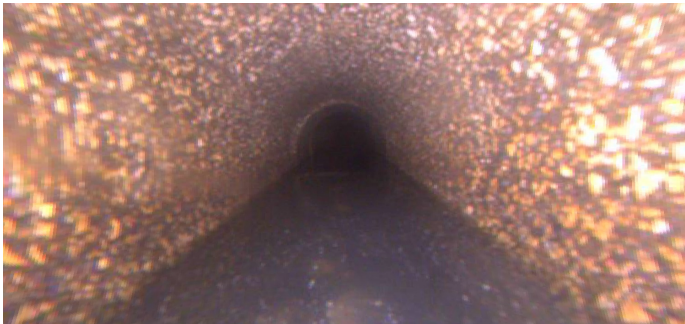
Code: **MWL**
Description: **Water Level**

Distance (ft): **.0**
Structural Grade: **0**
O&M Grade: **0**
Clock Start/From:
Clock To:
1st Value:
2nd Value:
Value Percent: **5.000**
Continuous Index:
Within 8" of Joint: **NO**
Remarks:

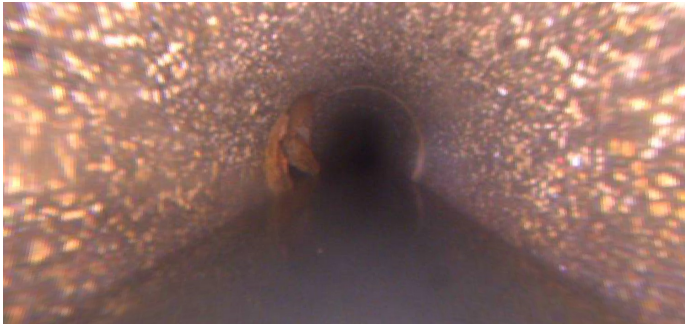
Code: **TF**
Description: **Tap Factory**

Distance (ft): **9.8**
Structural Grade: **0**
O&M Grade: **0**
Clock Start/From: **9**
Clock To:
1st Value: **4.000**
2nd Value:
Value Percent:
Continuous Index:
Within 8" of Joint:
Remarks:

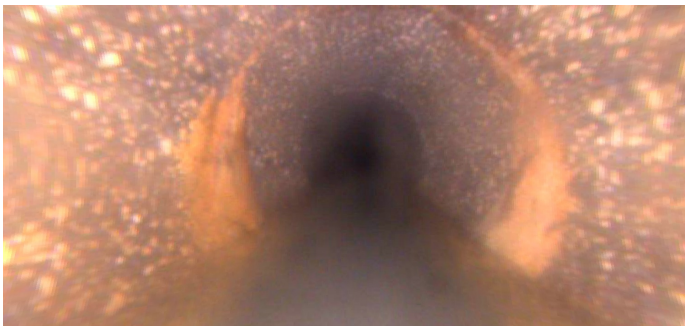
Code: **IS**
Description: **Infil Stain**

Distance (ft): **19.6**
Structural Grade: **0**
O&M Grade: **0**
Clock Start/From: **8**
Clock To: **4**
1st Value:
2nd Value:
Value Percent:
Continuous Index:
Within 8" of Joint: **YES**
Remarks:

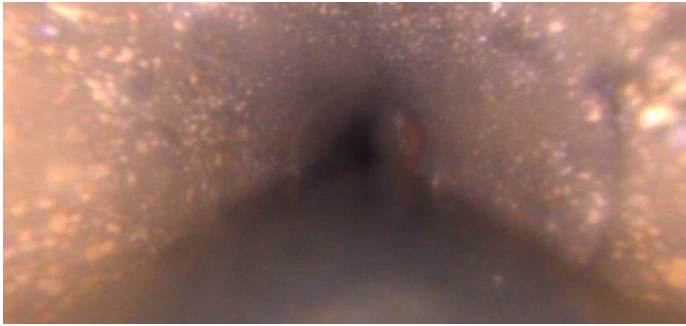
Code: **TF**
Description: **Tap Factory**

Distance (ft): **32.6**
Structural Grade: **0**
O&M Grade: **0**
Clock Start/From: **3**
Clock To:
1st Value: **4.000**
2nd Value:
Value Percent:
Continuous Index:
Within 8" of Joint:
Remarks:

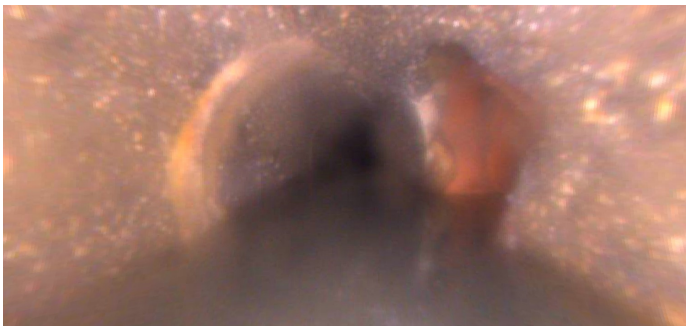
Code: **IS**
Description: **Infil Stain**

Distance (ft): **33.5**
Structural Grade: **0**
O&M Grade: **0**
Clock Start/From: **8**
Clock To: **12**
1st Value:
2nd Value:
Value Percent:
Continuous Index:
Within 8" of Joint: **YES**
Remarks:

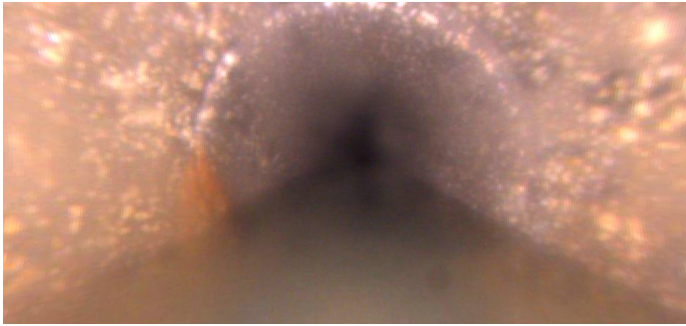
Code: **IS**
Description: **Infil Stain**

Distance (ft): **47.6**
Structural Grade: **0**
O&M Grade: **0**
Clock Start/From: **8**
Clock To: **9**
1st Value:
2nd Value:
Value Percent:
Continuous Index:
Within 8" of Joint: **YES**
Remarks:

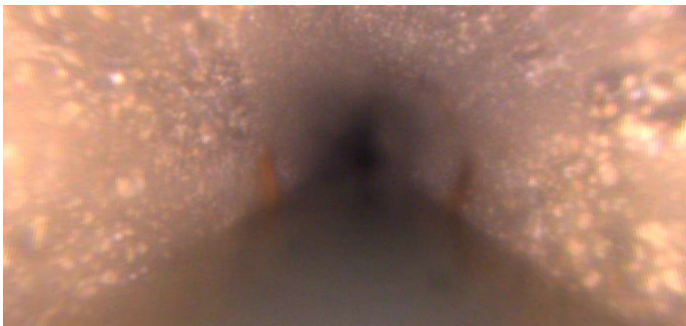
Code: **IS**
Description: **Infil Stain**

Distance (ft): **54.2**
Structural Grade: **0**
O&M Grade: **0**
Clock Start/From: **8**
Clock To: **4**
1st Value:
2nd Value:
Value Percent:
Continuous Index:
Within 8" of Joint: **YES**
Remarks:

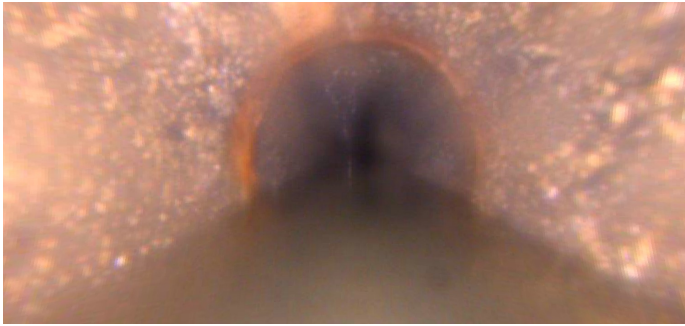
Code: **IS**
Description: **Infil Stain**

Distance (ft): **59.4**
Structural Grade: **0**
O&M Grade: **0**
Clock Start/From: **8**
Clock To: **4**
1st Value:
2nd Value:
Value Percent:
Continuous Index:
Within 8" of Joint: **YES**
Remarks:

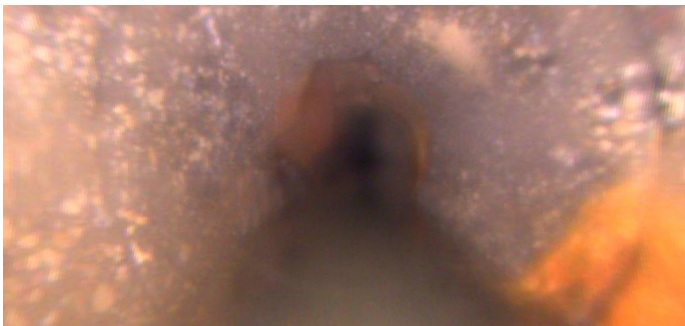
Code: **TF**
Description: **Tap Factory**

Distance (ft): **62.8**
Structural Grade: **0**
O&M Grade: **0**
Clock Start/From: **10**
Clock To:
1st Value: **4.000**
2nd Value:
Value Percent:
Continuous Index:
Within 8" of Joint:
Remarks:

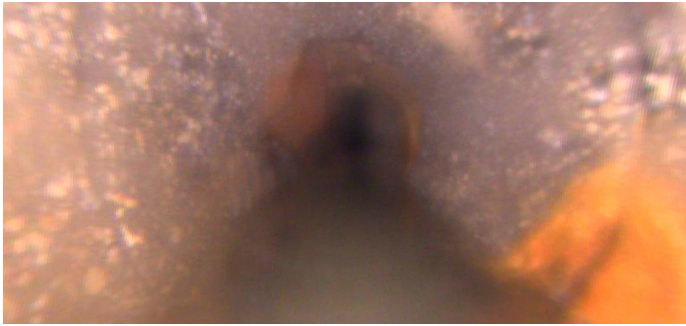
Code: **IS**
Description: **Infil Stain**

Distance (ft): **62.9**
Structural Grade: **0**
O&M Grade: **0**
Clock Start/From: **8**
Clock To: **4**
1st Value:
2nd Value:
Value Percent:
Continuous Index:
Within 8" of Joint: **YES**
Remarks:

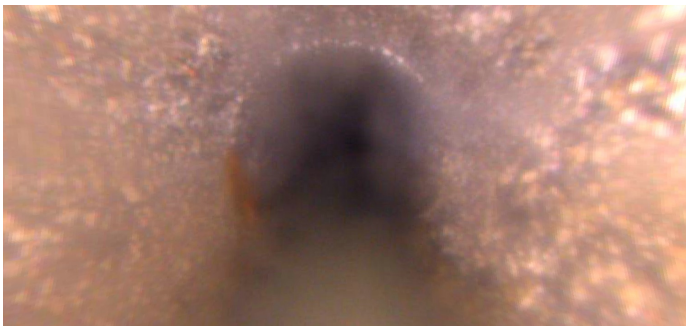
Code: **IS**
Description: **Infil Stain**

Distance (ft): **65.3**
Structural Grade: **0**
O&M Grade: **0**
Clock Start/From: **8**
Clock To: **9**
1st Value:
2nd Value:
Value Percent:
Continuous Index:
Within 8" of Joint: **YES**
Remarks:

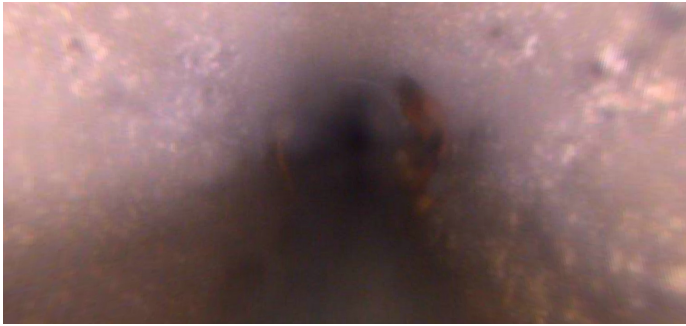
Code: **TF**
Description: **Tap Factory**

Distance (ft): **75.5**
Structural Grade: **0**
O&M Grade: **0**
Clock Start/From: **2**
Clock To:
1st Value: **4.000**
2nd Value:
Value Percent:
Continuous Index:
Within 8" of Joint:
Remarks:

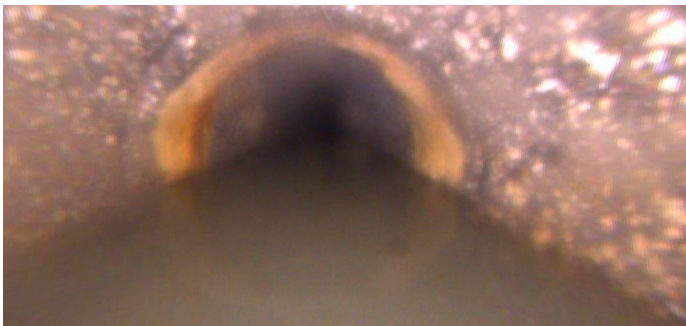
Code: **IS**
Description: **Infil Stain**

Distance (ft): **101.8**
Structural Grade: **0**
O&M Grade: **0**
Clock Start/From: **8**
Clock To: **4**
1st Value:
2nd Value:
Value Percent:
Continuous Index:
Within 8" of Joint: **YES**
Remarks:

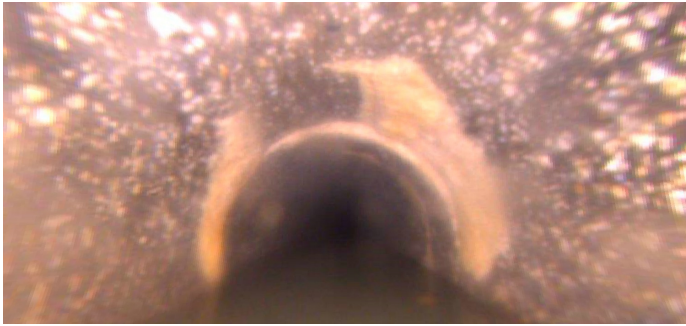
Code: **FL**
Description: **Fracture Longitudinal**

Distance (ft): **104.6**
Structural Grade: **3**
O&M Grade: **0**
Clock Start/From: **12**
Clock To:
1st Value:
2nd Value:
Value Percent:
Continuous Index:
Within 8" of Joint: **YES**
Remarks:

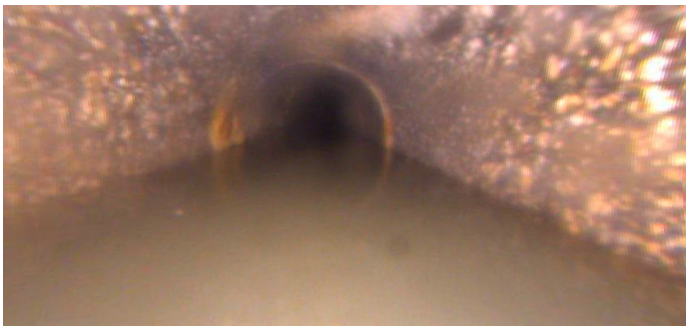
Code: **DAE**
Description: **Deposits Attached Encrustation**

Distance (ft): **107.2**
Structural Grade: **0**
O&M Grade: **2**
Clock Start/From: **8**
Clock To: **4**
1st Value:
2nd Value:
Value Percent: **10.000**
Continuous Index:
Within 8" of Joint: **YES**
Remarks:

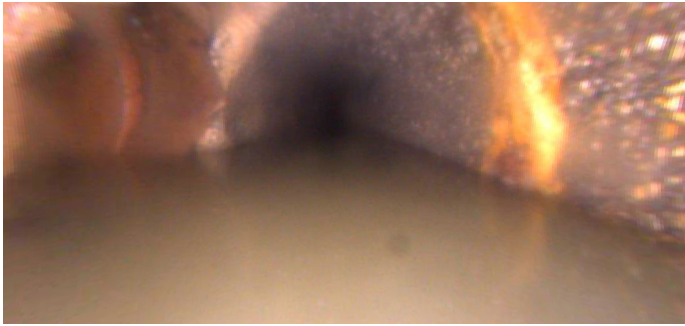
Code: **TF**
Description: **Tap Factory**

Distance (ft): **108.8**
Structural Grade: **0**
O&M Grade: **0**
Clock Start/From: **9**
Clock To:
1st Value: **4.000**
2nd Value:
Value Percent:
Continuous Index:
Within 8" of Joint:
Remarks:

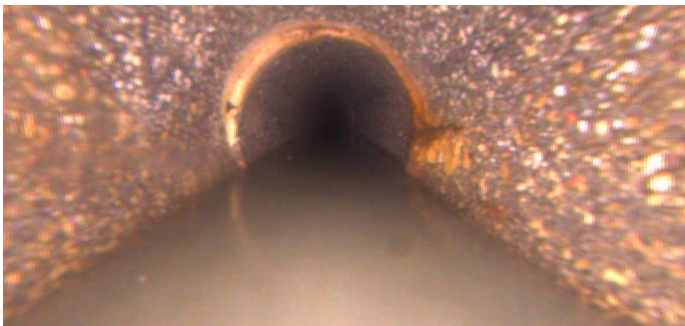
Code: **FL**
Description: **Fracture Longitudinal**

Distance (ft): **113.2**
Structural Grade: **3**
O&M Grade: **0**
Clock Start/From: **3**
Clock To:
1st Value:
2nd Value:
Value Percent:
Continuous Index:
Within 8" of Joint: **YES**
Remarks:

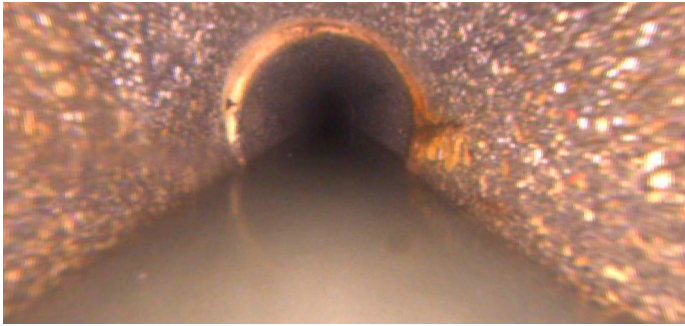
Code: **IS**
Description: **Infil Stain**

Distance (ft): **113.2**
Structural Grade: **0**
O&M Grade: **0**
Clock Start/From: **8**
Clock To: **4**
1st Value:
2nd Value:
Value Percent:
Continuous Index:
Within 8" of Joint: **YES**
Remarks:

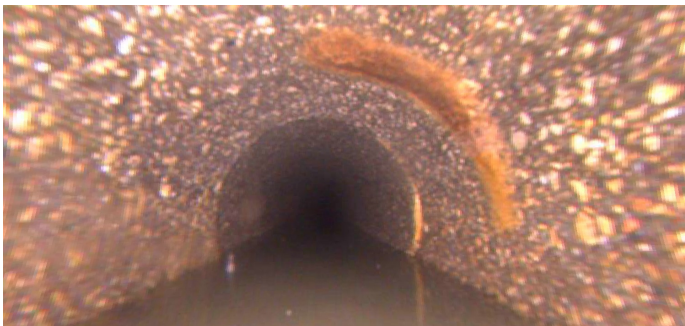
Code: **IS**
Description: **Infil Stain**

Distance (ft): **119.4**
Structural Grade: **0**
O&M Grade: **0**
Clock Start/From: **12**
Clock To: **3**
1st Value:
2nd Value:
Value Percent:
Continuous Index:
Within 8" of Joint: **NO**
Remarks:

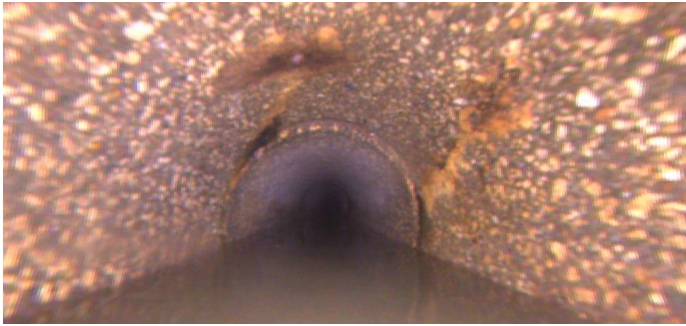
Code: **IS**
Description: **Infil Stain**

Distance (ft): **125.4**
Structural Grade: **0**
O&M Grade: **0**
Clock Start/From: **8**
Clock To: **4**
1st Value:
2nd Value:
Value Percent:
Continuous Index:
Within 8" of Joint: **YES**
Remarks:

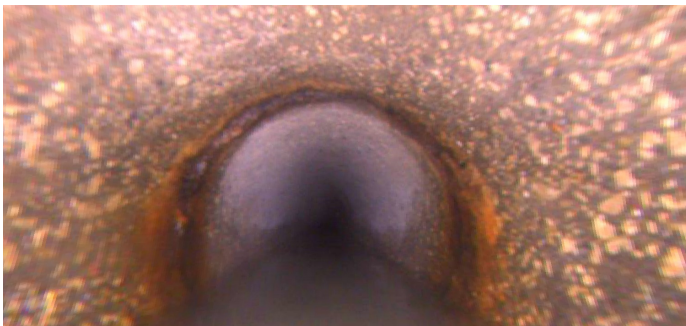
Code: **IS**
Description: **Infil Stain**

Distance (ft): **128.9**
Structural Grade: **0**
O&M Grade: **0**
Clock Start/From: **8**
Clock To: **4**
1st Value:
2nd Value:
Value Percent:
Continuous Index:
Within 8" of Joint: **YES**
Remarks:

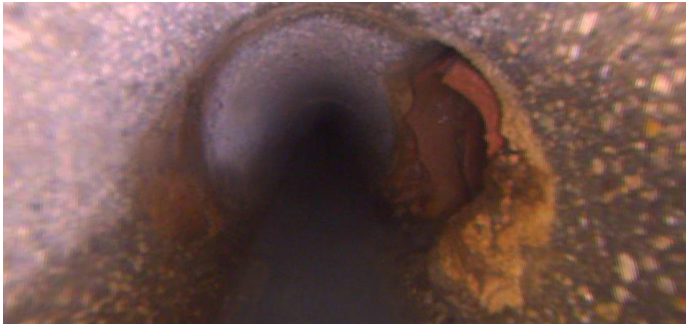
Code: **TF**
Description: **Tap Factory**

Distance (ft): **133.2**
Structural Grade: **0**
O&M Grade: **0**
Clock Start/From: **3**
Clock To:
1st Value: **4.000**
2nd Value:
Value Percent:
Continuous Index:
Within 8" of Joint:
Remarks:

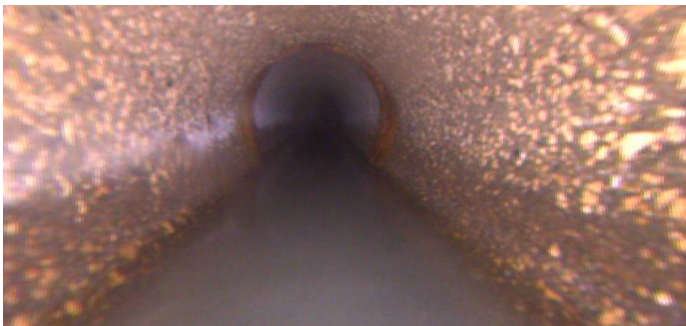
Code: **IS**
Description: **Infil Stain**

Distance (ft): **137.2**
Structural Grade: **0**
O&M Grade: **0**
Clock Start/From: **8**
Clock To: **4**
1st Value:
2nd Value:
Value Percent:
Continuous Index:
Within 8" of Joint: **YES**
Remarks:

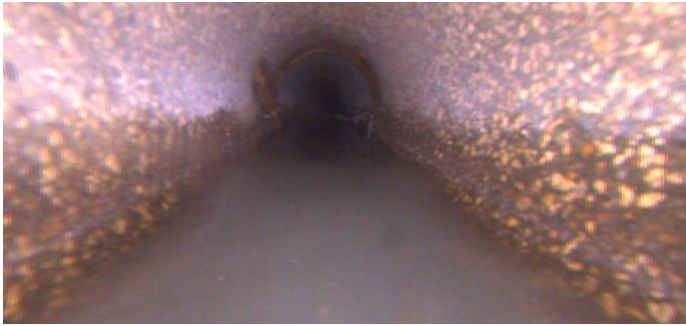
Code: **IS**
Description: **Infil Stain**

Distance (ft): **139.7**
Structural Grade: **0**
O&M Grade: **0**
Clock Start/From: **8**
Clock To: **4**
1st Value:
2nd Value:
Value Percent:
Continuous Index:
Within 8" of Joint: **YES**
Remarks:

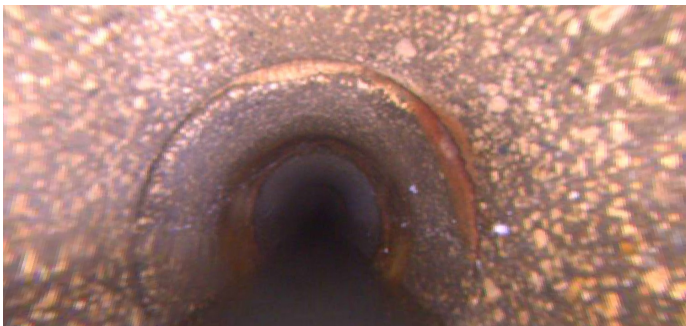
Code: **IS**
Description: **Infil Stain**

Distance (ft): **144.0**
Structural Grade: **0**
O&M Grade: **0**
Clock Start/From: **1**
Clock To: **3**
1st Value:
2nd Value:
Value Percent:
Continuous Index:
Within 8" of Joint: **YES**
Remarks:

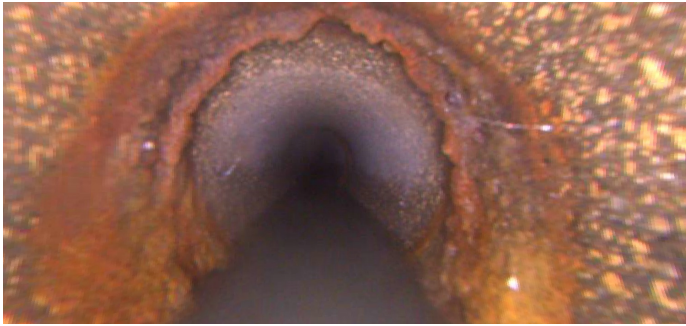
Code: **DAE**
Description: **Deposits Attached Encrustation**

Distance (ft): **144.7**
Structural Grade: **0**
O&M Grade: **3**
Clock Start/From: **8**
Clock To: **4**
1st Value:
2nd Value:
Value Percent: **20.000**
Continuous Index:
Within 8" of Joint: **YES**
Remarks:

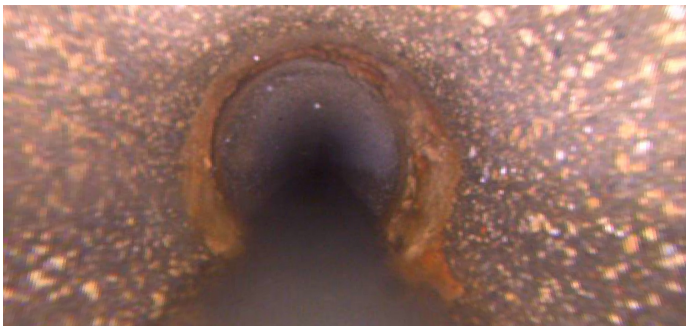
Code: **DAE**
Description: **Deposits Attached Encrustation**

Distance (ft): **146.8**
Structural Grade: **0**
O&M Grade: **2**
Clock Start/From: **8**
Clock To: **4**
1st Value:
2nd Value:
Value Percent: **10.000**
Continuous Index:
Within 8" of Joint: **YES**
Remarks:

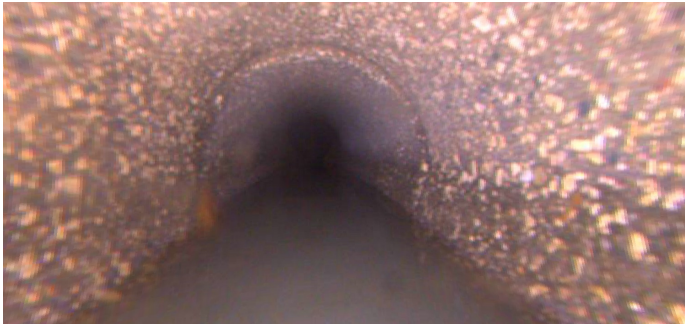
Code: **IS**
Description: **Infil Stain**

Distance (ft): **149.9**
Structural Grade: **0**
O&M Grade: **0**
Clock Start/From: **8**
Clock To:
1st Value:
2nd Value:
Value Percent:
Continuous Index:
Within 8" of Joint: **YES**
Remarks:

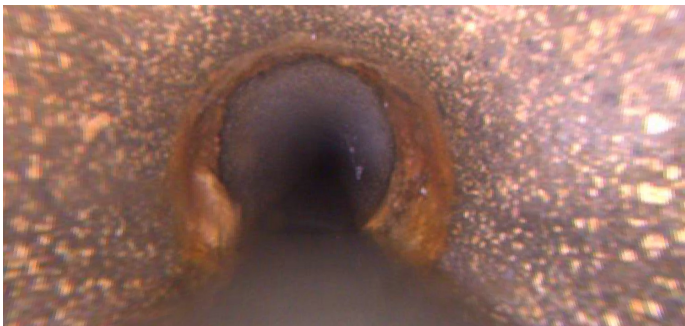
Code: **DAE**
Description: **Deposits Attached Encrustation**

Distance (ft): **152.8**
Structural Grade: **0**
O&M Grade: **3**
Clock Start/From: **8**
Clock To: **4**
1st Value:
2nd Value:
Value Percent: **20.000**
Continuous Index:
Within 8" of Joint: **YES**
Remarks:

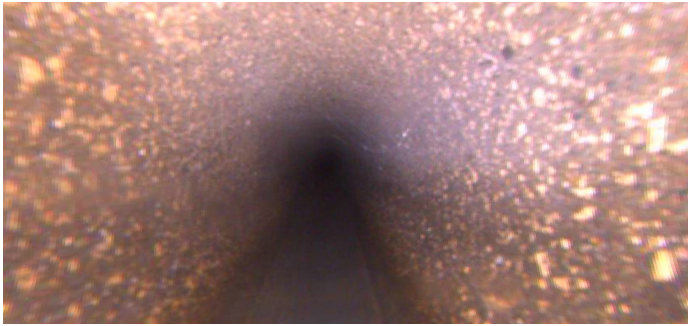
Code:	MSA
Description:	Abandoned Survey
Distance (ft):	154.0
Structural Grade:	0
O&M Grade:	0
Clock Start/From:	
Clock To:	
1st Value:	
2nd Value:	
Value Percent:	
Continuous Index:	
Within 8" of Joint:	NO
Remarks:	camera stopped
