RedZone
ROBOTICS

Street:	N DELAWARE ST		Flow Control:	Not Controlled	
City:	Hobart, IN		Year Renewed:		
Location:	Light Highway		Tape/Media #:		
Purpose:	Routine Assessment		Dia/Height:	10"	
Use:	Sanitary		Material:	CP	
Drain Area:	NA		Lining:	Other	
Category:	NA				
Comment:					
Location Details:			Direction of Survey:	Upstream	
US MH:	M-503-030	DS MH:	M-503-029	Total Length Surveyed (ft):	144.6

O&M Index:	<u>2.00</u>	O&M Quick:	312D	O&M Rating:	<u>54.00</u>
Structural Index:	<u>3.03</u>	Structural Quick:	5241	Structural Rating:	<u>109.00</u>
Overall Index:	<u>2.59</u>	Overall Quick:	5241	Overall Rating:	<u>163.00</u>

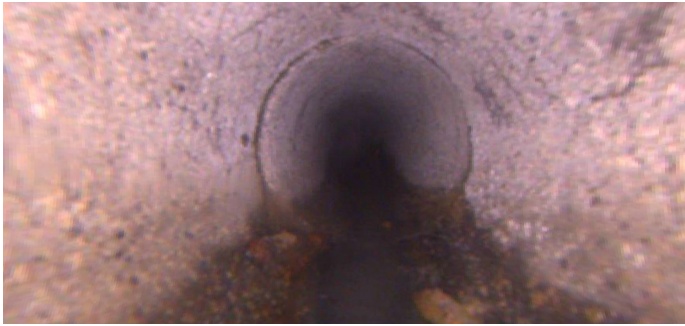
Code: **IS**
Description: **Infil Stain**

Distance (ft): **1.7**
Structural Grade: **0**
O&M Grade: **0**
Clock Start/From: **7**
Clock To: **5**
1st Value:
2nd Value:
Value Percent:
Continuous Index: **S01**
Within 8" of Joint: **YES**
Remarks:

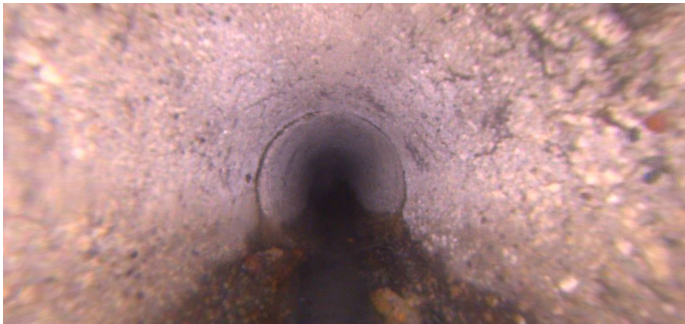
Code: **SAV**
Description: **Surface Aggregate Visible**

Distance (ft): **1.7**
Structural Grade: **3**
O&M Grade: **0**
Clock Start/From: **7**
Clock To: **5**
1st Value:
2nd Value:
Value Percent:
Continuous Index: **S02**
Within 8" of Joint:
Remarks:

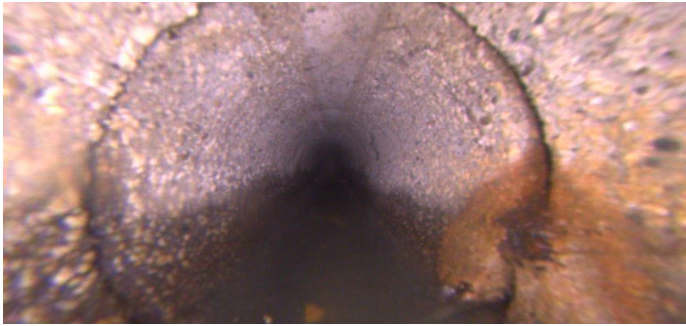
Code: **DSZ**
Description: **Deposits Settled Other**

Distance (ft): **5.3**
Structural Grade: **0**
O&M Grade: **2**
Clock Start/From: **5**
Clock To: **7**
1st Value:
2nd Value:
Value Percent: **5.000**
Continuous Index: **S03**
Within 8" of Joint: **NO**
Remarks: **debris evident below water level**

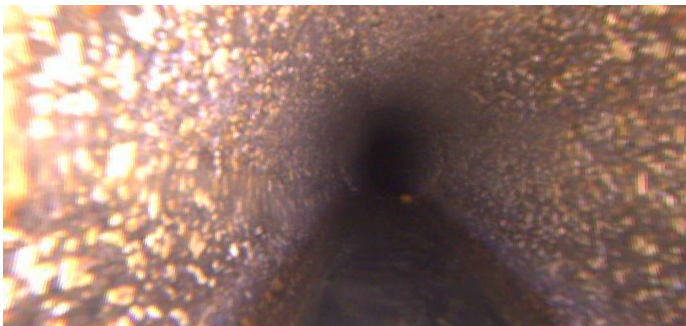
Code: **IS**
Description: **Infil Stain**

Distance (ft): **18.6**
Structural Grade: **0**
O&M Grade: **0**
Clock Start/From: **7**
Clock To: **5**
1st Value:
2nd Value:
Value Percent:
Continuous Index: **F01**
Within 8" of Joint: **YES**
Remarks:

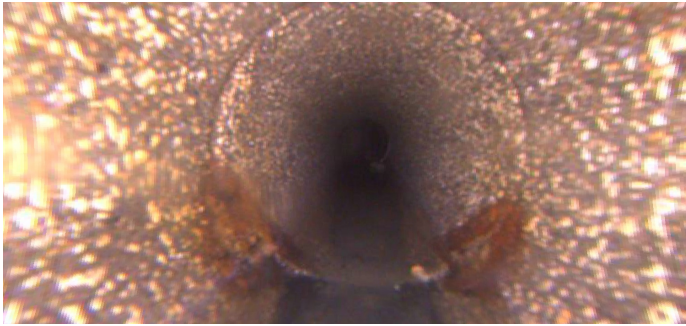
Code: **IS**
Description: **Infil Stain**

Distance (ft): **22.9**
Structural Grade: **0**
O&M Grade: **0**
Clock Start/From: **7**
Clock To: **5**
1st Value:
2nd Value:
Value Percent:
Continuous Index:
Within 8" of Joint: **YES**
Remarks:

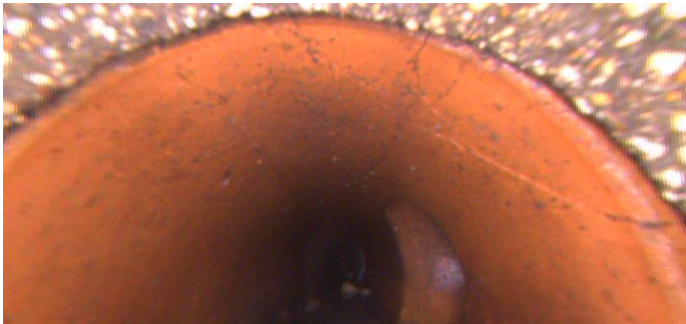
Code: **FS**
Description: **Fracture Spiral**

Distance (ft): **26.3**
Structural Grade: **3**
O&M Grade: **0**
Clock Start/From: **12**
Clock To: **2**
1st Value:
2nd Value:
Value Percent:
Continuous Index:
Within 8" of Joint: **YES**
Remarks:

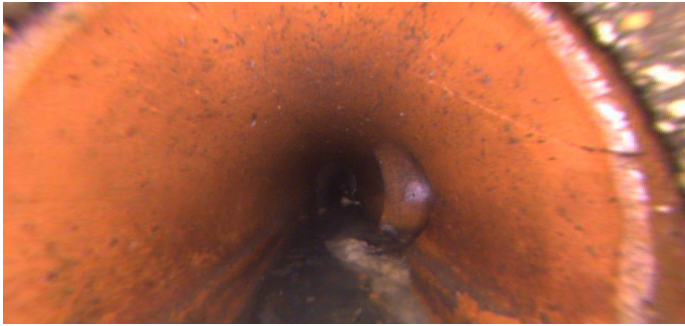
Code: **SAV**
Description: **Surface Aggregate Visible**

Distance (ft): **26.3**
Structural Grade: **3**
O&M Grade: **0**
Clock Start/From: **7**
Clock To: **5**
1st Value:
2nd Value:
Value Percent:
Continuous Index: **F02**
Within 8" of Joint:
Remarks:

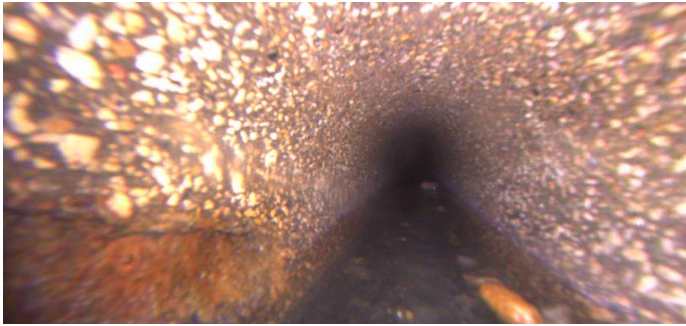
Code: **FL**
Description: **Fracture Longitudinal**

Distance (ft): **29.4**
Structural Grade: **3**
O&M Grade: **0**
Clock Start/From: **9**
Clock To:
1st Value:
2nd Value:
Value Percent:
Continuous Index:
Within 8" of Joint: **YES**
Remarks:

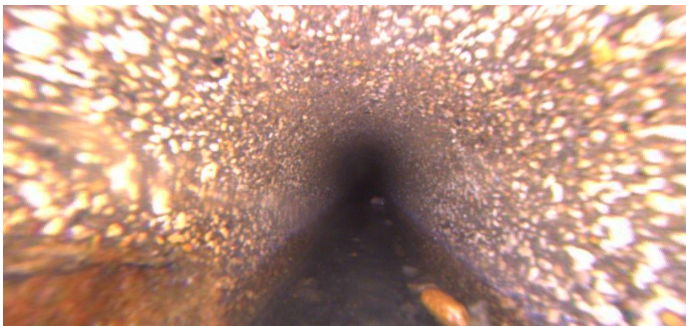
Code: **SAV**
Description: **Surface Aggregate Visible**

Distance (ft): **29.4**
Structural Grade: **3**
O&M Grade: **0**
Clock Start/From: **7**
Clock To: **5**
1st Value:
2nd Value:
Value Percent:
Continuous Index: **S04**
Within 8" of Joint:
Remarks:

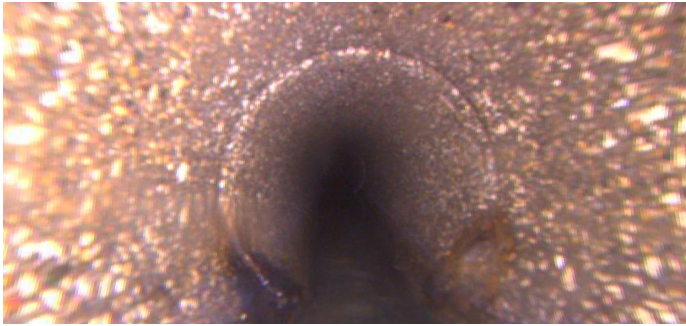
Code: **IS**
Description: **Infil Stain**

Distance (ft): **31.8**
Structural Grade: **0**
O&M Grade: **0**
Clock Start/From: **7**
Clock To: **5**
1st Value:
2nd Value:
Value Percent:
Continuous Index:
Within 8" of Joint: **YES**
Remarks:

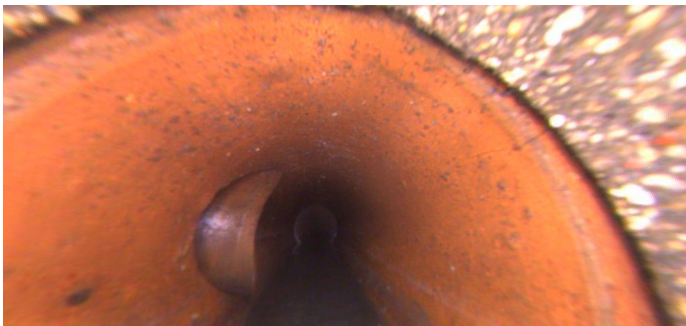
Code: **CL**
Description: **Crack Longitudinal**

Distance (ft): **44.4**
Structural Grade: **2**
O&M Grade: **0**
Clock Start/From: **2**
Clock To:
1st Value:
2nd Value:
Value Percent:
Continuous Index:
Within 8" of Joint: **YES**
Remarks:

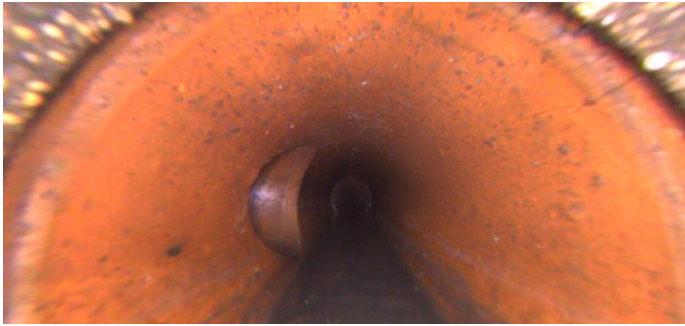
Code: **SAV**
Description: **Surface Aggregate Visible**

Distance (ft): **44.4**
Structural Grade: **3**
O&M Grade: **0**
Clock Start/From: **7**
Clock To: **5**
1st Value:
2nd Value:
Value Percent:
Continuous Index: **F04**
Within 8" of Joint:
Remarks:

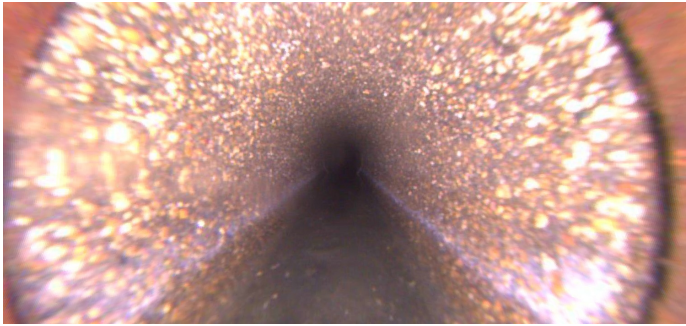
Code: **SAV**
Description: **Surface Aggregate Visible**

Distance (ft): **47.4**
Structural Grade: **3**
O&M Grade: **0**
Clock Start/From: **7**
Clock To: **5**
1st Value:
2nd Value:
Value Percent:
Continuous Index: **S05**
Within 8" of Joint:
Remarks:

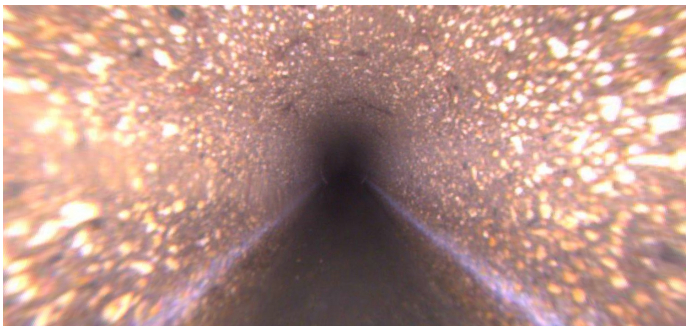
Code: **DSZ**
Description: **Deposits Settled Other**

Distance (ft): **54.0**
Structural Grade: **0**
O&M Grade: **2**
Clock Start/From: **5**
Clock To: **7**
1st Value:
2nd Value:
Value Percent: **5.000**
Continuous Index: **F03**
Within 8" of Joint: **NO**
Remarks: **debris evident below water level**

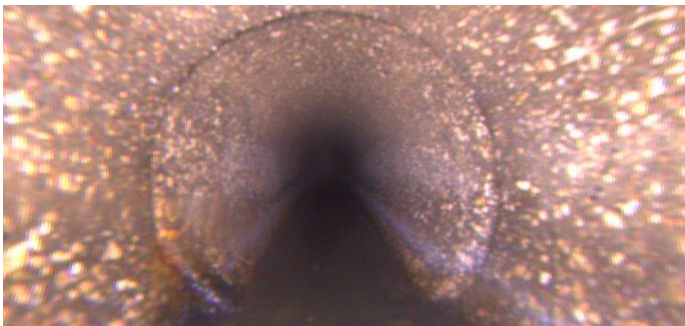
Code: **IS**
Description: **Infil Stain**

Distance (ft): **62.1**
Structural Grade: **0**
O&M Grade: **0**
Clock Start/From: **7**
Clock To: **8**
1st Value:
2nd Value:
Value Percent:
Continuous Index:
Within 8" of Joint: **YES**
Remarks:

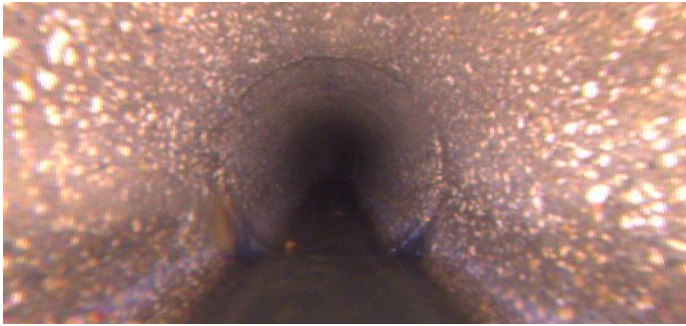
Code: **IS**
Description: **Infil Stain**

Distance (ft): **64.9**
Structural Grade: **0**
O&M Grade: **0**
Clock Start/From: **7**
Clock To: **5**
1st Value:
2nd Value:
Value Percent:
Continuous Index:
Within 8" of Joint: **YES**
Remarks:

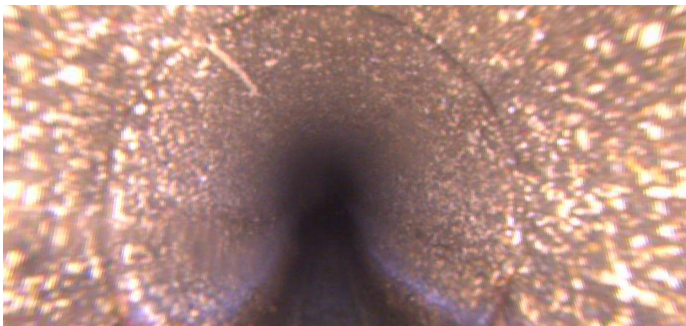
Code: **RFJ**
Description: **Roots Fine Joint**

Distance (ft): **71.2**
Structural Grade: **0**
O&M Grade: **1**
Clock Start/From: **11**
Clock To:
1st Value:
2nd Value:
Value Percent:
Continuous Index:
Within 8" of Joint: **YES**
Remarks:

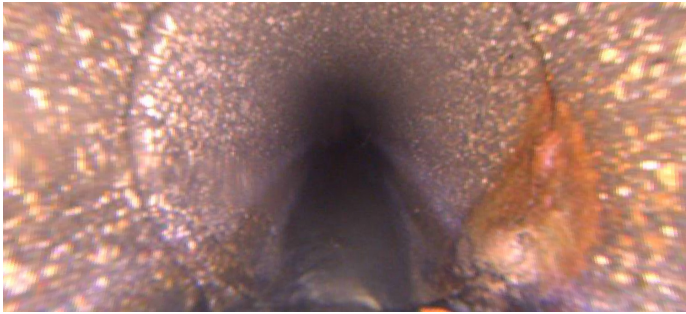
Code: **DAE**
Description: **Deposits Attached Encrustation**

Distance (ft): **74.3**
Structural Grade: **0**
O&M Grade: **2**
Clock Start/From: **3**
Clock To: **5**
1st Value:
2nd Value:
Value Percent: **10.000**
Continuous Index:
Within 8" of Joint: **YES**
Remarks:

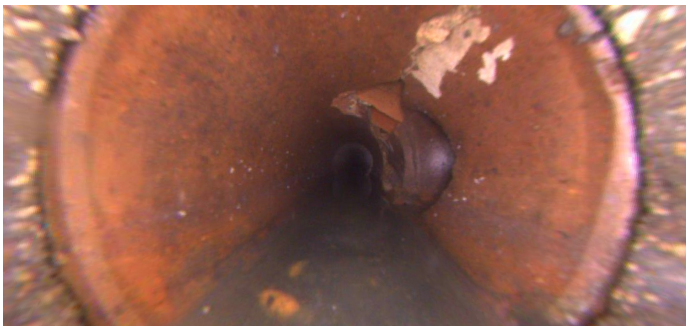
Code: **SAV**
Description: **Surface Aggregate Visible**

Distance (ft): **80.6**
Structural Grade: **3**
O&M Grade: **0**
Clock Start/From: **7**
Clock To: **5**
1st Value:
2nd Value:
Value Percent:
Continuous Index: **F05**
Within 8" of Joint:
Remarks:

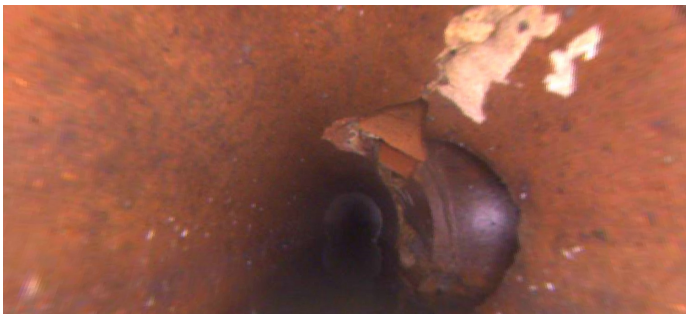
Code: **TFD**
Description: **Tap Factory Defective**

Distance (ft): **80.7**
Structural Grade: **0**
O&M Grade: **2**
Clock Start/From: **3**
Clock To:
1st Value: **4.000**
2nd Value:
Value Percent:
Continuous Index:
Within 8" of Joint:
Remarks: **HVV**

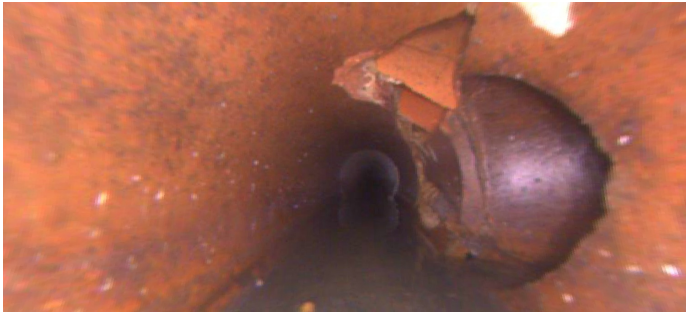
Code: **B**
Description: **Broken**

Distance (ft): **80.9**
Structural Grade: **5**
O&M Grade: **0**
Clock Start/From: **12**
Clock To: **5**
1st Value:
2nd Value:
Value Percent:
Continuous Index:
Within 8" of Joint:
Remarks:

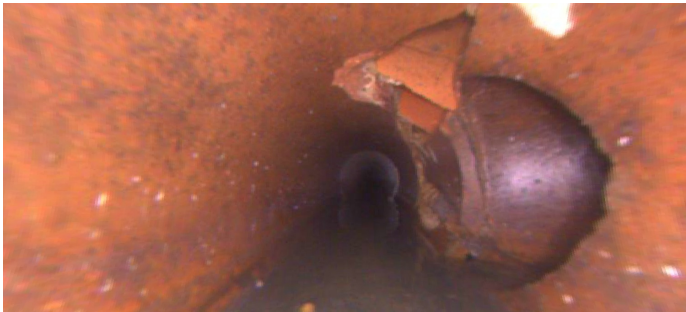
Code: **HVV**
Description: **Hole Void Visible**

Distance (ft): **80.9**
Structural Grade: **5**
O&M Grade: **0**
Clock Start/From: **12**
Clock To: **2**
1st Value:
2nd Value:
Value Percent:
Continuous Index:
Within 8" of Joint:
Remarks:

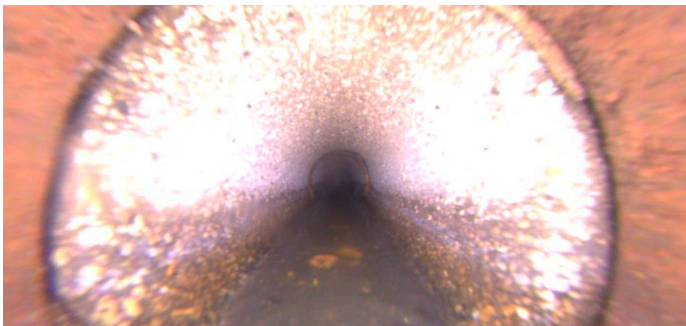
Code: **SAV**
Description: **Surface Aggregate Visible**

Distance (ft): **83.5**
Structural Grade: **3**
O&M Grade: **0**
Clock Start/From: **7**
Clock To: **5**
1st Value:
2nd Value:
Value Percent:
Continuous Index: **S06**
Within 8" of Joint:
Remarks:

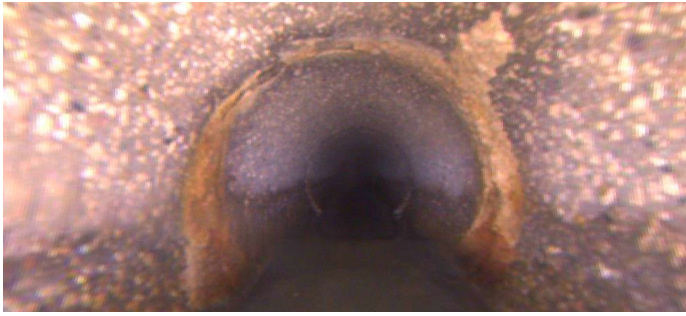
Code: **DAE**
Description: **Deposits Attached Encrustation**

Distance (ft): **85.1**
Structural Grade: **0**
O&M Grade: **2**
Clock Start/From: **7**
Clock To: **5**
1st Value:
2nd Value:
Value Percent: **5.000**
Continuous Index:
Within 8" of Joint: **NO**
Remarks:

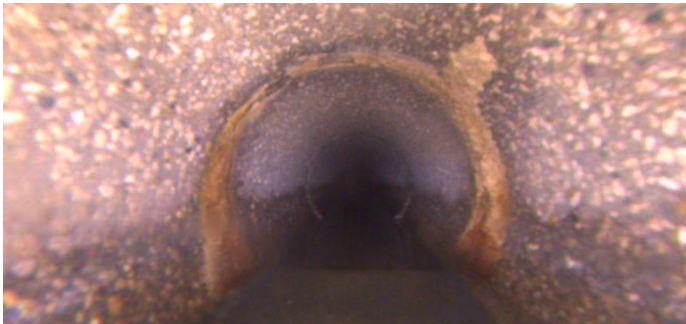
Code: **FC**
Description: **Fracture Circumferential**

Distance (ft): **85.1**
Structural Grade: **2**
O&M Grade: **0**
Clock Start/From: **7**
Clock To: **5**
1st Value:
2nd Value:
Value Percent:
Continuous Index:
Within 8" of Joint:
Remarks:

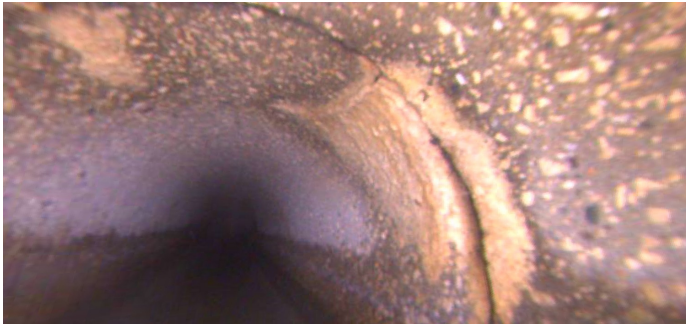
Code: **DAE**
Description: **Deposits Attached Encrustation**

Distance (ft): **89.6**
Structural Grade: **0**
O&M Grade: **2**
Clock Start/From: **1**
Clock To: **3**
1st Value:
2nd Value:
Value Percent: **5.000**
Continuous Index:
Within 8" of Joint: **YES**
Remarks:

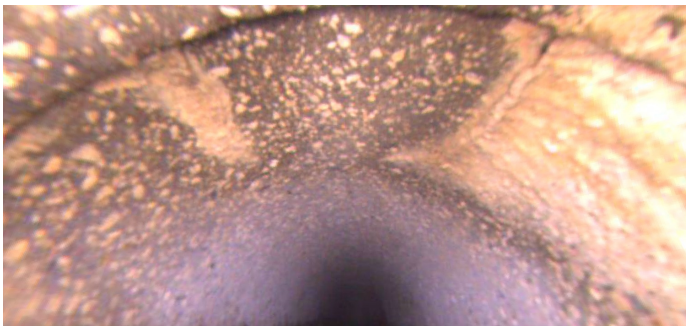
Code: **FM**
Description: **Fracture Multiple**

Distance (ft): **89.7**
Structural Grade: **4**
O&M Grade: **0**
Clock Start/From: **11**
Clock To: **1**
1st Value:
2nd Value:
Value Percent:
Continuous Index:
Within 8" of Joint: **YES**
Remarks:

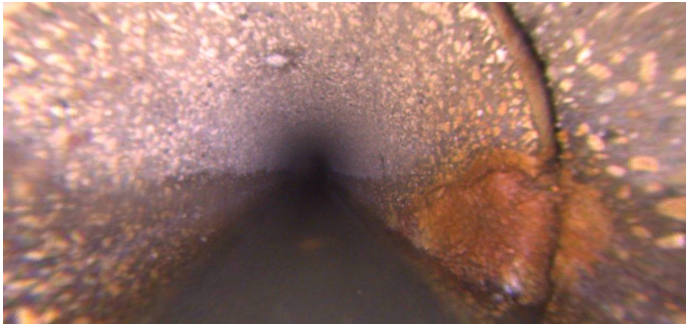
Code: **FL**
Description: **Fracture Longitudinal**

Distance (ft): **92.7**
Structural Grade: **3**
O&M Grade: **0**
Clock Start/From: **3**
Clock To:
1st Value:
2nd Value:
Value Percent:
Continuous Index:
Within 8" of Joint: **YES**
Remarks:

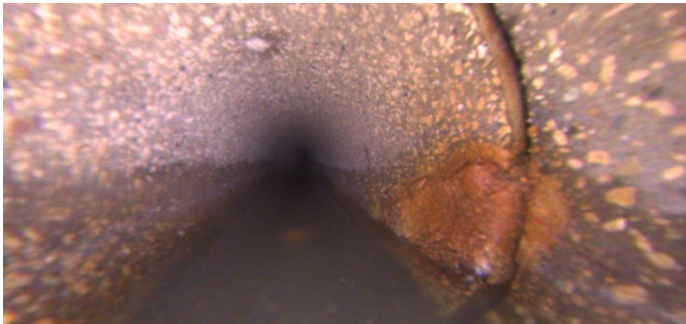
Code: **DAE**
Description: **Deposits Attached Encrustation**

Distance (ft): **92.7**
Structural Grade: **0**
O&M Grade: **2**
Clock Start/From: **3**
Clock To: **4**
1st Value:
2nd Value:
Value Percent: **5.000**
Continuous Index:
Within 8" of Joint: **YES**
Remarks:

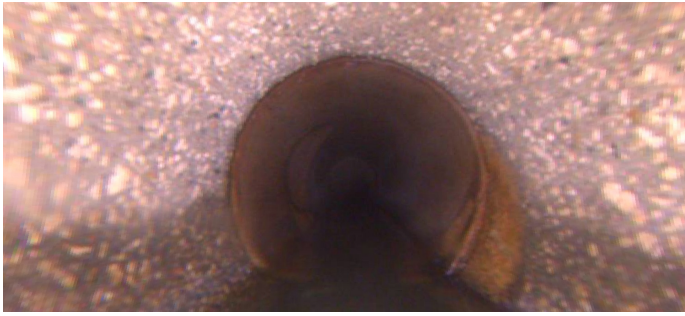
Code: **IS**
Description: **Infil Stain**

Distance (ft): **98.2**
Structural Grade: **0**
O&M Grade: **0**
Clock Start/From: **7**
Clock To: **5**
1st Value:
2nd Value:
Value Percent:
Continuous Index:
Within 8" of Joint: **YES**
Remarks:

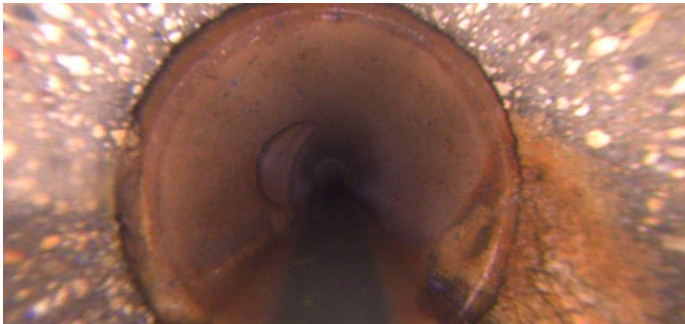
Code: **SAV**
Description: **Surface Aggregate Visible**

Distance (ft): **98.7**
Structural Grade: **3**
O&M Grade: **0**
Clock Start/From: **7**
Clock To: **5**
1st Value:
2nd Value:
Value Percent:
Continuous Index: **F06**
Within 8" of Joint:
Remarks:

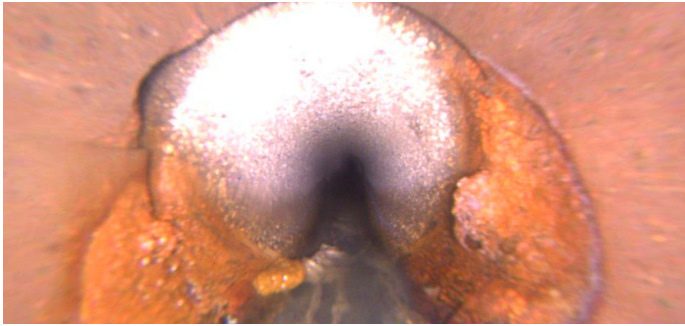
Code: **DAE**
Description: **Deposits Attached Encrustation**

Distance (ft): **101.5**
Structural Grade: **0**
O&M Grade: **3**
Clock Start/From: **7**
Clock To: **5**
1st Value:
2nd Value:
Value Percent: **15.000**
Continuous Index:
Within 8" of Joint: **YES**
Remarks:

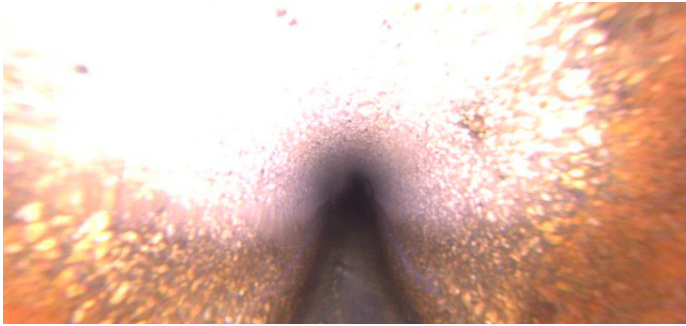
Code: **SAV**
Description: **Surface Aggregate Visible**

Distance (ft): **101.9**
Structural Grade: **3**
O&M Grade: **0**
Clock Start/From: **7**
Clock To: **5**
1st Value:
2nd Value:
Value Percent:
Continuous Index: **S07**
Within 8" of Joint:
Remarks:

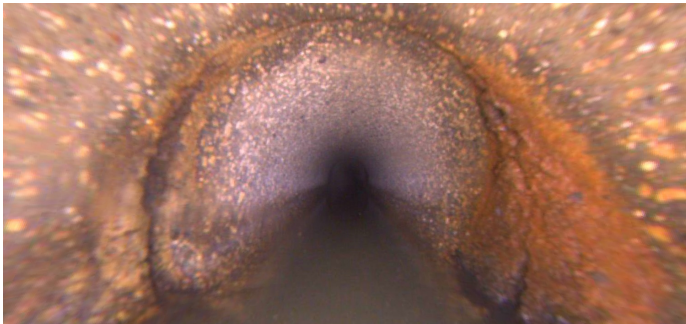
Code: **DAE**
Description: **Deposits Attached Encrustation**

Distance (ft): **104.6**
Structural Grade: **0**
O&M Grade: **2**
Clock Start/From: **7**
Clock To: **5**
1st Value:
2nd Value:
Value Percent: **10.000**
Continuous Index: **S08**
Within 8" of Joint: **YES**
Remarks:

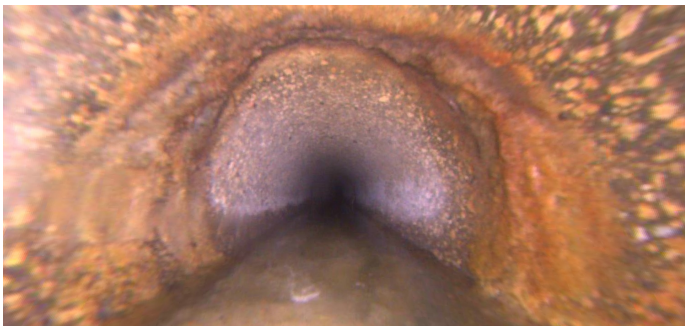
Code: **DAE**
Description: **Deposits Attached Encrustation**

Distance (ft): **123.2**
Structural Grade: **0**
O&M Grade: **2**
Clock Start/From: **7**
Clock To: **5**
1st Value:
2nd Value:
Value Percent: **10.000**
Continuous Index:
Within 8" of Joint: **NO**
Remarks:

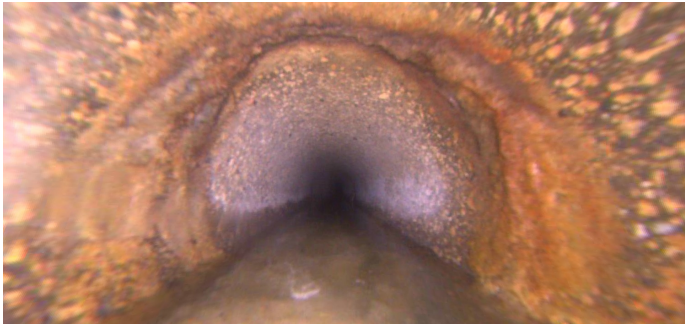
Code: **FC**
Description: **Fracture Circumferential**

Distance (ft): **123.2**
Structural Grade: **2**
O&M Grade: **0**
Clock Start/From: **7**
Clock To: **5**
1st Value:
2nd Value:
Value Percent:
Continuous Index:
Within 8" of Joint:
Remarks:

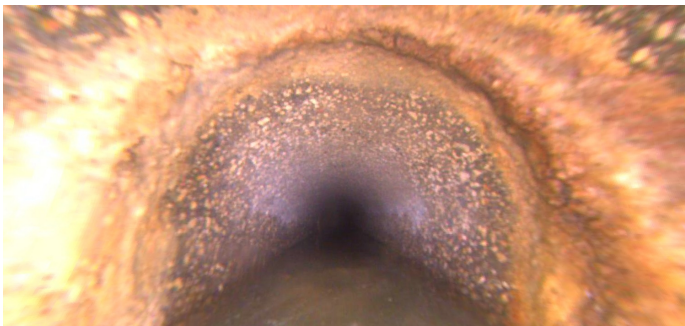
Code: **DAE**
Description: **Deposits Attached Encrustation**

Distance (ft): **129.3**
Structural Grade: **0**
O&M Grade: **2**
Clock Start/From: **8**
Clock To: **4**
1st Value:
2nd Value:
Value Percent: **10.000**
Continuous Index:
Within 8" of Joint: **NO**
Remarks:

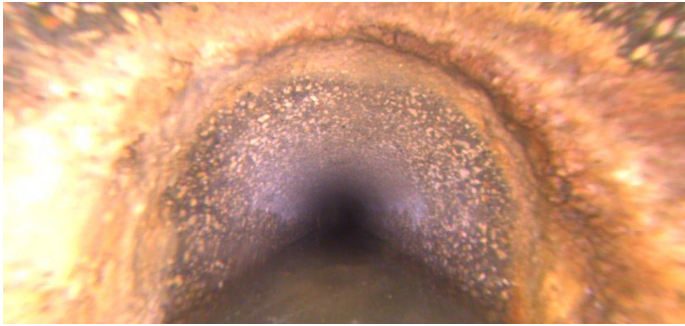
Code: **FC**
Description: **Fracture Circumferential**

Distance (ft): **129.3**
Structural Grade: **2**
O&M Grade: **0**
Clock Start/From: **8**
Clock To: **4**
1st Value:
2nd Value:
Value Percent:
Continuous Index:
Within 8" of Joint:
Remarks:

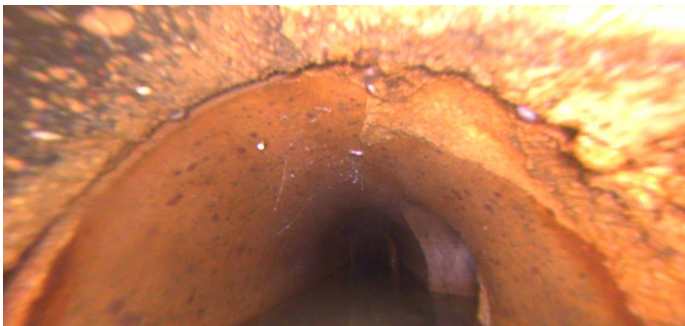
Code: **SAV**
Description: **Surface Aggregate Visible**

Distance (ft): **135.0**
Structural Grade: **3**
O&M Grade: **0**
Clock Start/From: **7**
Clock To: **5**
1st Value:
2nd Value:
Value Percent:
Continuous Index: **F07**
Within 8" of Joint:
Remarks:

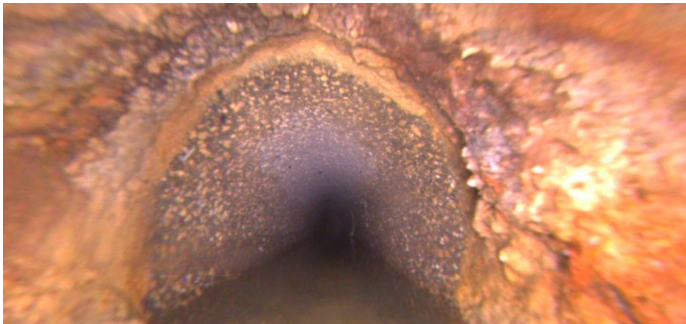
Code: **SAV**
Description: **Surface Aggregate Visible**

Distance (ft): **138.3**
Structural Grade: **3**
O&M Grade: **0**
Clock Start/From: **8**
Clock To: **4**
1st Value:
2nd Value:
Value Percent:
Continuous Index: **S09**
Within 8" of Joint:
Remarks:

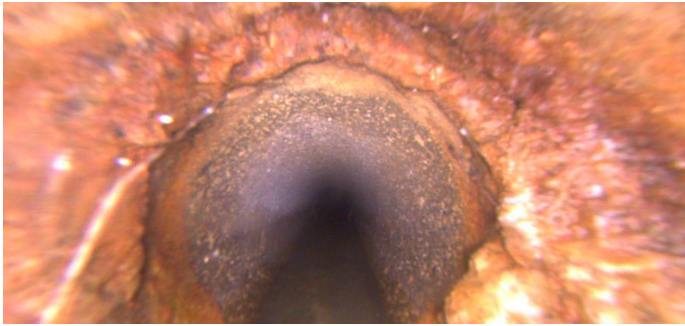
Code: **DAE**
Description: **Deposits Attached Encrustation**

Distance (ft): **144.0**
Structural Grade: **0**
O&M Grade: **2**
Clock Start/From: **7**
Clock To: **5**
1st Value:
2nd Value:
Value Percent: **10.000**
Continuous Index: **F08**
Within 8" of Joint: **YES**
Remarks:

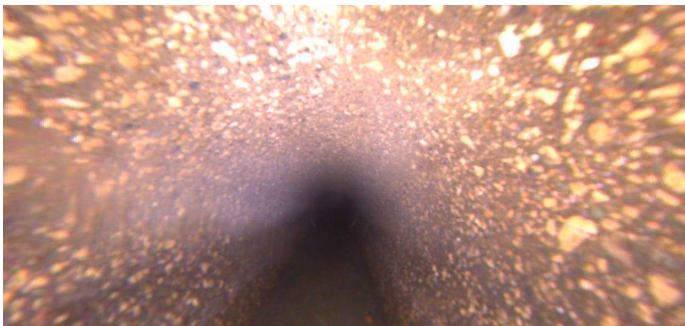
Code: **SAV**
Description: **Surface Aggregate Visible**

Distance (ft): **144.6**
Structural Grade: **3**
O&M Grade: **0**
Clock Start/From: **8**
Clock To: **4**
1st Value:
2nd Value:
Value Percent:
Continuous Index: **F09**
Within 8" of Joint:
Remarks:
