## Profile/Photo Observation Report

Date:	<b>04/07/2018</b>	Weather:		Coding:	<b>PACP 6.0</b>
Pipe Length (ft):	<b>296.1</b>	Owner:	<b>NA</b>	Pre Clean:	<b>Not Known</b>
P.O.#:		Surveyor:	<b>Mark Ruby</b>	PSR:	<b>P-503-030-031</b>
Customer:		Clean Date:	<b>01/01/1900</b>	Shape:	<b>C</b>

Street:	<b>N DELAWARE ST</b>	Flow Control:	<b>Not Controlled</b>
City:	<b>Hobart, IN</b>	Year Renewed:	
Location:	<b>Other</b>	Tape/Media #:	
Purpose:	<b>Not Known</b>	Dia/Height:	<b>10"</b>
Use:	<b>Sanitary</b>	Material:	<b>VCP</b>
Drain Area:	<b>NA</b>	Lining:	
Category:	<b>NA</b>		
Comment:

Location Details:		Direction of Survey:	<b>Upstream</b>
US MH:	<b>M-503-031</b>	DS MH:	<b>M-503-030</b>
		Total Length Surveyed (ft):	<b>286.0</b>

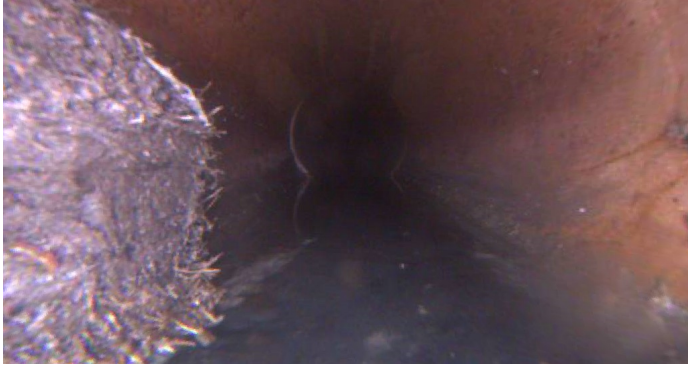
Code: **RMJ**  
Description: **Roots Medium Joint**

Distance (ft): **.0**  
Structural Grade: **0**  
O&M Grade: **3**  
Clock Start/From: **7**  
Clock To: **12**  
1st Value:  
2nd Value:  
Value Percent: **20.000**  
Continuous Index:  
Within 8" of Joint: **YES**  
Remarks:

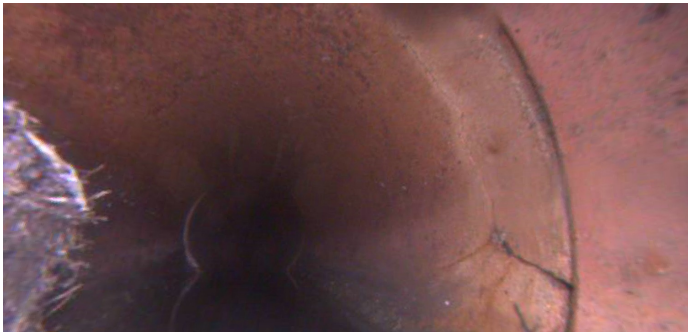
Code: **FM**  
Description: **Fracture Multiple**

Distance (ft): **.0**  
Structural Grade: **4**  
O&M Grade: **0**  
Clock Start/From: **1**  
Clock To: **4**  
1st Value:  
2nd Value:  
Value Percent:  
Continuous Index:  
Within 8" of Joint: **YES**  
Remarks:

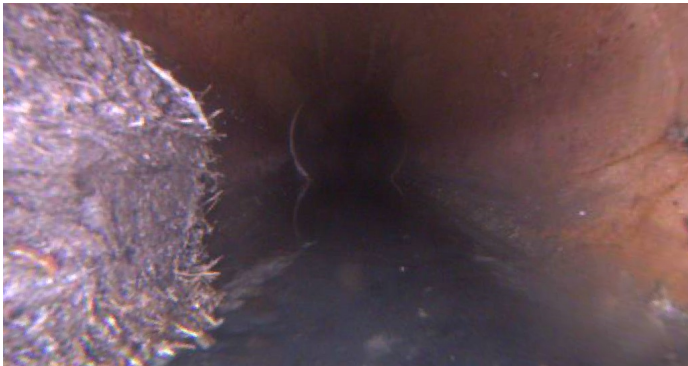
Code: **MWL**  
Description: **Water Level**

Distance (ft): **.0**  
Structural Grade: **0**  
O&M Grade: **0**  
Clock Start/From:  
Clock To:  
1st Value:  
2nd Value:  
Value Percent: **10.000**  
Continuous Index:  
Within 8" of Joint: **NO**  
Remarks:

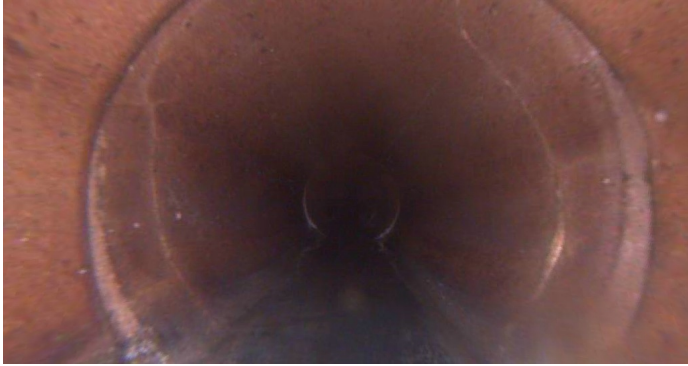
Code:	<b>CS</b>
Description:	<b>Crack Spiral</b>
Distance (ft):	<b>7.0</b>
Structural Grade:	<b>2</b>
O&M Grade:	<b>0</b>
Clock Start/From:	<b>7</b>
Clock To:	<b>5</b>
1st Value:	
2nd Value:	
Value Percent:	
Continuous Index:	
Within 8" of Joint:	<b>YES</b>
Remarks:

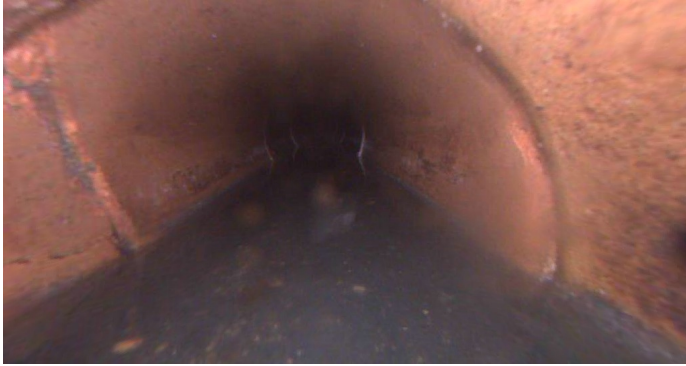
Code: **FS**  
Description: **Fracture Spiral**

Distance (ft): **31.7**  
Structural Grade: **3**  
O&M Grade: **0**  
Clock Start/From: **8**  
Clock To: **10**  
1st Value:  
2nd Value:  
Value Percent:  
Continuous Index:  
Within 8" of Joint: **YES**  
Remarks:

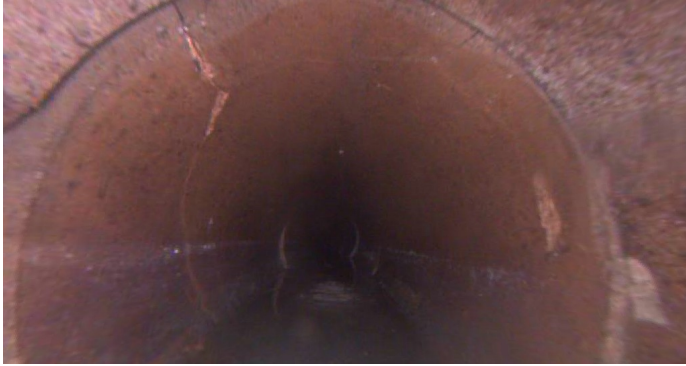
Code: **FM**  
Description: **Fracture Multiple**

Distance (ft): **53.1**  
Structural Grade: **4**  
O&M Grade: **0**  
Clock Start/From: **7**  
Clock To: **5**  
1st Value:  
2nd Value:  
Value Percent:  
Continuous Index:  
Within 8" of Joint: **YES**  
Remarks:

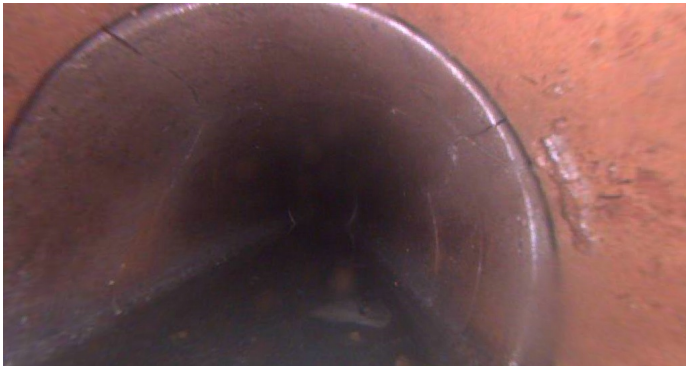
Code: **FM**  
Description: **Fracture Multiple**

Distance (ft): **62.5**  
Structural Grade: **4**  
O&M Grade: **0**  
Clock Start/From: **7**  
Clock To: **5**  
1st Value:  
2nd Value:  
Value Percent:  
Continuous Index:  
Within 8" of Joint: **YES**  
Remarks:

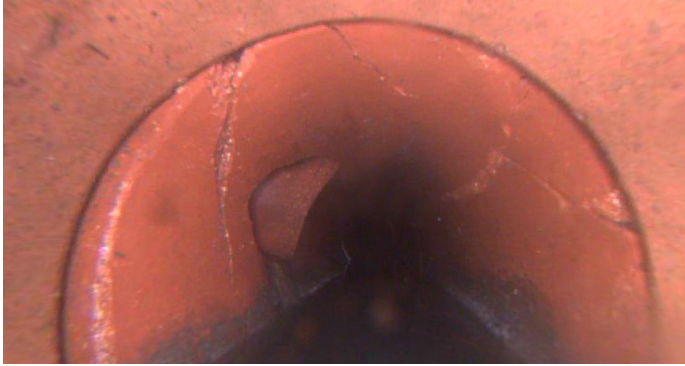
Code: **FM**  
Description: **Fracture Multiple**

Distance (ft): **77.9**  
Structural Grade: **4**  
O&M Grade: **0**  
Clock Start/From: **7**  
Clock To: **5**  
1st Value:  
2nd Value:  
Value Percent:  
Continuous Index:  
Within 8" of Joint:  
Remarks:

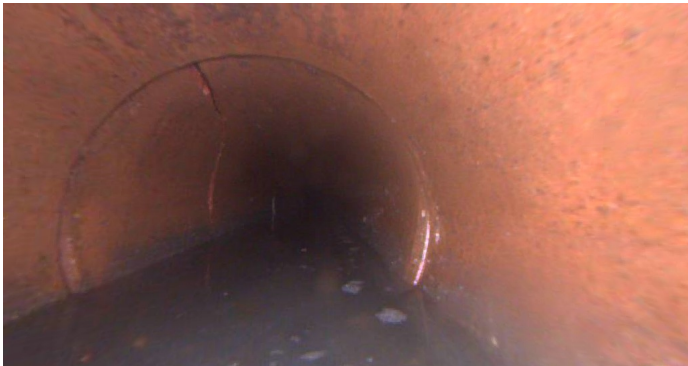
Code: **FS**  
Description: **Fracture Spiral**

Distance (ft): **87.0**  
Structural Grade: **3**  
O&M Grade: **0**  
Clock Start/From: **7**  
Clock To: **11**  
1st Value:  
2nd Value:  
Value Percent:  
Continuous Index:  
Within 8" of Joint: **YES**  
Remarks:

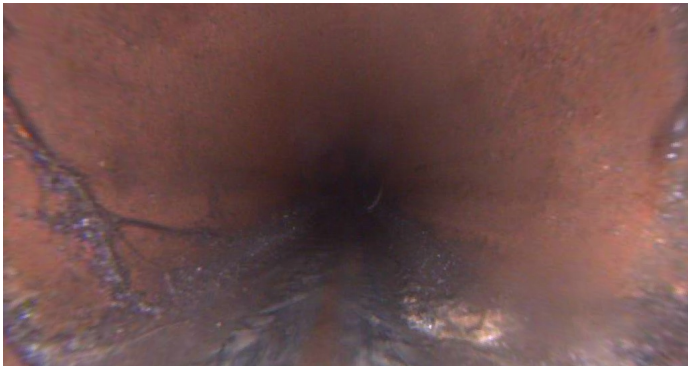
Code: **RFJ**  
Description: **Roots Fine Joint**

Distance (ft): **131.1**  
Structural Grade: **0**  
O&M Grade: **1**  
Clock Start/From: **7**  
Clock To: **5**  
1st Value:  
2nd Value:  
Value Percent:  
Continuous Index:  
Within 8" of Joint: **YES**  
Remarks:

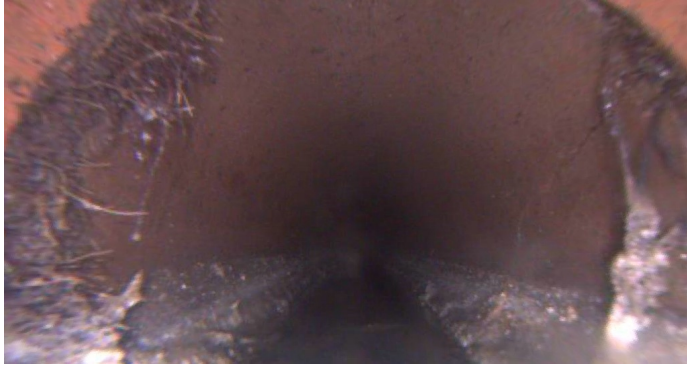
Code: **RMJ**  
Description: **Roots Medium Joint**

Distance (ft): **137.4**  
Structural Grade: **0**  
O&M Grade: **3**  
Clock Start/From: **7**  
Clock To: **5**  
1st Value:  
2nd Value:  
Value Percent: **5.000**  
Continuous Index:  
Within 8" of Joint: **YES**  
Remarks:

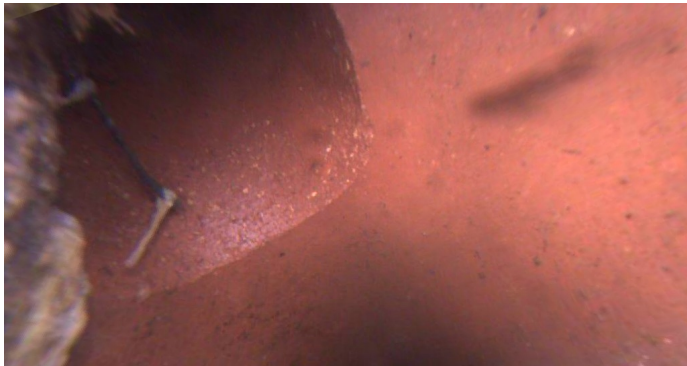
Code: **TFD**  
Description: **Tap Factory Defective**

Distance (ft): **141.3**  
Structural Grade: **0**  
O&M Grade: **2**  
Clock Start/From: **10**  
Clock To:  
1st Value: **4.000**  
2nd Value:  
Value Percent:  
Continuous Index:  
Within 8" of Joint:  
Remarks: **Roots**

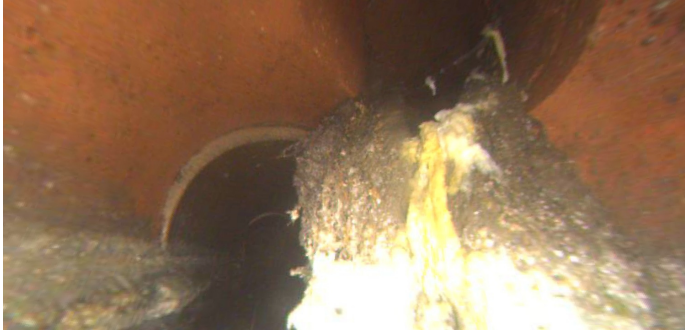
Code: **RML**  
Description: **Roots Medium Lateral**

Distance (ft): **142.0**  
Structural Grade: **0**  
O&M Grade: **3**  
Clock Start/From: **6**  
Clock To: **10**  
1st Value:  
2nd Value:  
Value Percent: **30.000**  
Continuous Index:  
Within 8" of Joint: **NO**  
Remarks:

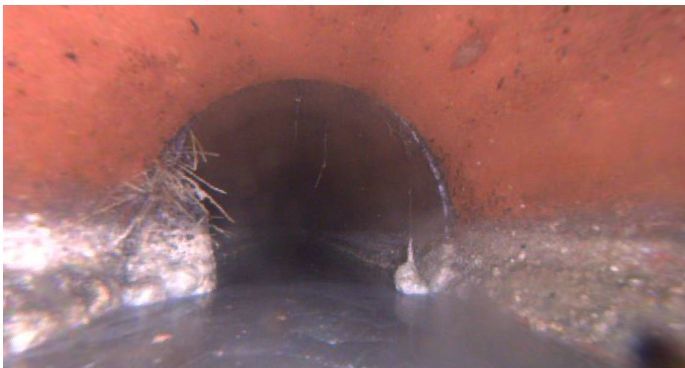
Code: **RFJ**  
Description: **Roots Fine Joint**

Distance (ft): **143.1**  
Structural Grade: **0**  
O&M Grade: **1**  
Clock Start/From: **7**  
Clock To: **9**  
1st Value:  
2nd Value:  
Value Percent:  
Continuous Index:  
Within 8" of Joint: **YES**  
Remarks:

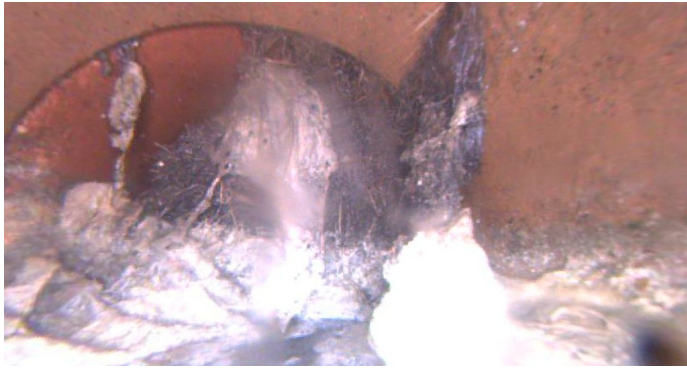
Code: **RBJ**  
Description: **Roots Ball Joint**

Distance (ft): **149.6**  
Structural Grade: **0**  
O&M Grade: **4**  
Clock Start/From: **7**  
Clock To: **5**  
1st Value:  
2nd Value:  
Value Percent: **70.000**  
Continuous Index:  
Within 8" of Joint: **YES**  
Remarks:

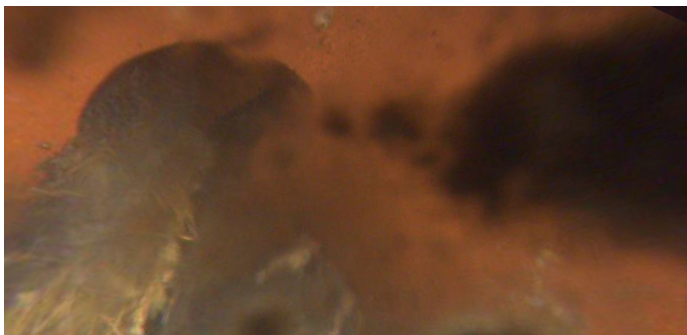
Code: **TFD**  
Description: **Tap Factory Defective**

Distance (ft): **151.7**  
Structural Grade: **0**  
O&M Grade: **2**  
Clock Start/From: **1**  
Clock To:  
1st Value: **4.000**  
2nd Value:  
Value Percent:  
Continuous Index:  
Within 8" of Joint:  
Remarks: **roots**

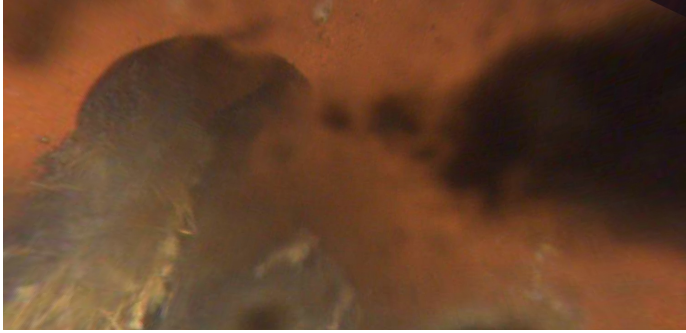
Code: **RML**  
Description: **Roots Medium Lateral**

Distance (ft): **151.7**  
Structural Grade: **0**  
O&M Grade: **3**  
Clock Start/From: **1**  
Clock To: **4**  
1st Value:  
2nd Value:  
Value Percent: **20.000**  
Continuous Index:  
Within 8" of Joint: **NO**  
Remarks:

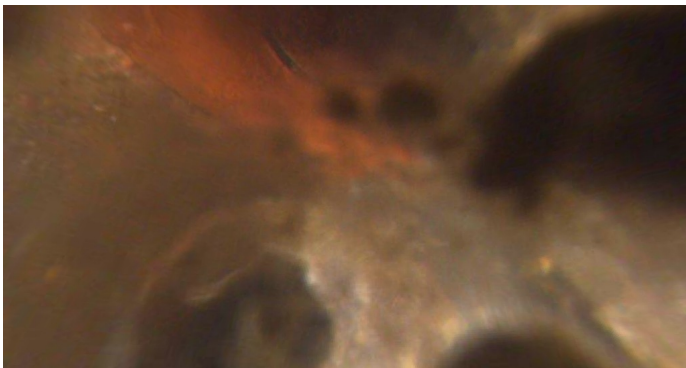
Code: **TBD**  
Description: **Tap Break-in Defective**

Distance (ft): **179.2**  
Structural Grade: **0**  
O&M Grade: **3**  
Clock Start/From: **2**  
Clock To:  
1st Value: **4.000**  
2nd Value:  
Value Percent:  
Continuous Index:  
Within 8" of Joint:  
Remarks: **Roots**

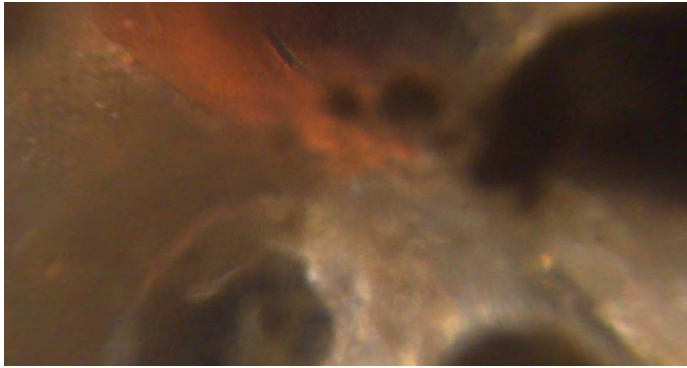
Code: **RML**  
Description: **Roots Medium Lateral**

Distance (ft): **179.2**  
Structural Grade: **0**  
O&M Grade: **3**  
Clock Start/From: **11**  
Clock To:  
1st Value:  
2nd Value:  
Value Percent: **15.000**  
Continuous Index:  
Within 8" of Joint: **NO**  
Remarks:

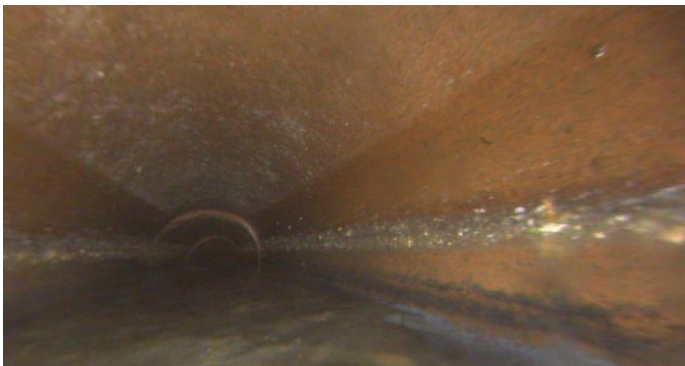
Code: **MCU**  
Description: **Camera Underwater**

Distance (ft): **270.9**  
Structural Grade: **0**  
O&M Grade: **4**  
Clock Start/From:  
Clock To:  
1st Value:  
2nd Value:  
Value Percent:  
Continuous Index: **F01**  
Within 8" of Joint: **NO**  
Remarks:

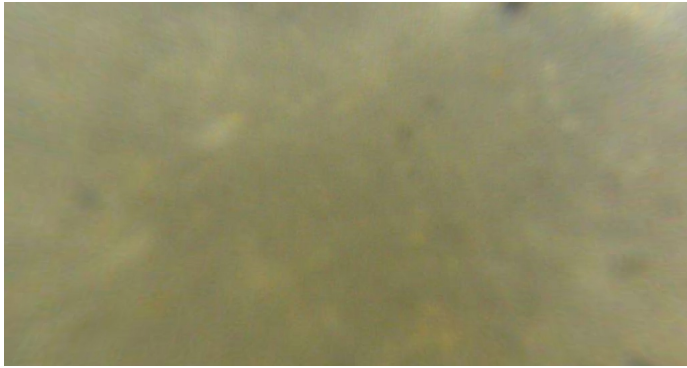
Code: **MCU**  
Description: **Camera Underwater**

Distance (ft): **280.7**  
Structural Grade: **0**  
O&M Grade: **4**  
Clock Start/From:  
Clock To:  
1st Value:  
2nd Value:  
Value Percent:  
Continuous Index:  
Within 8" of Joint: **NO**  
Remarks:
