Profile/Photo Observation Report

Date:	04/07/2018	Weather:		Coding:	PACP 6.0
Pipe Length (ft):	296.1	Owner:	NA	Pre Clean:	Not Known
P.O.#:		Surveyor:	Mark Ruby	PSR:	P-503-030-031
Customer:		Clean Date:	01/01/1900	Shape:	C

Street:	delaware st	Flow Control:	Not Controlled
City:	Hobart, IN	Year Renewed:	
Location:	Other	Tape/Media #:	
Purpose:	Not Known	Dia/Height:	10"
Use:	Sanitary	Material:	VCP
Drain Area:	NA	Lining:	
Category:	NA		
Comment:

Location Details:		Direction of Survey:	Upstream
US MH:	M-503-031	DS MH:	M-503-030
		Total Length Surveyed (ft):	286.0

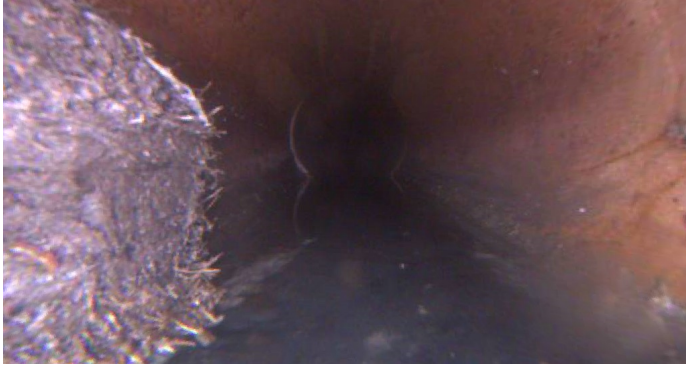
Code:	RMJ
Description:	Roots Medium Joint
Distance (ft):	.0
Structural Grade:	0
O&M Grade:	3
Clock Start/From:	7
Clock To:	12
1st Value:	
2nd Value:	
Value Percent:	20.000
Continuous Index:	
Within 8" of Joint:	YES
Remarks:

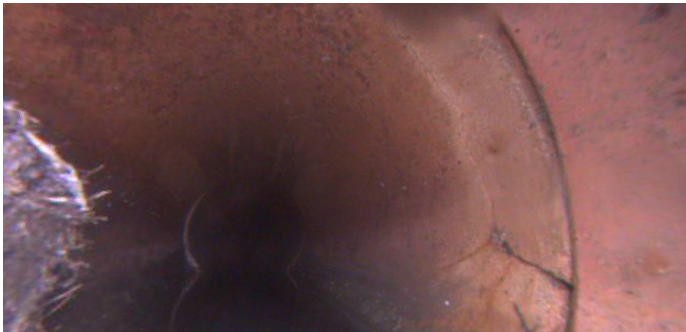
Code:	FM
Description:	Fracture Multiple
Distance (ft):	.0
Structural Grade:	4
O&M Grade:	0
Clock Start/From:	1
Clock To:	4
1st Value:	
2nd Value:	
Value Percent:	
Continuous Index:	
Within 8" of Joint:	YES
Remarks:

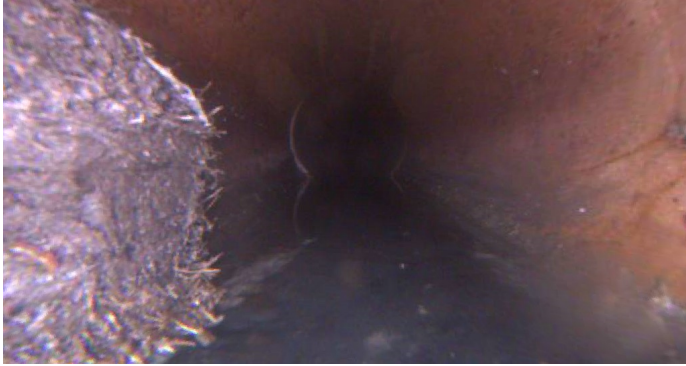
Code: **AMH**
Description: **Manhole**

Distance (ft): **.0**
Structural Grade: **0**
O&M Grade: **0**
Clock Start/From:
Clock To:
1st Value:
2nd Value:
Value Percent:
Continuous Index:
Within 8" of Joint: **NO**
Remarks: **M-503-030**

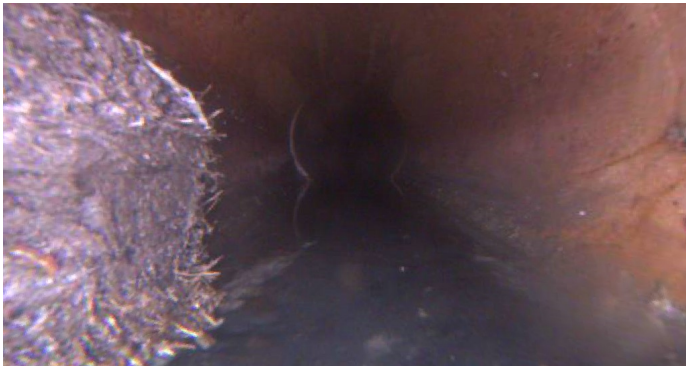
Code: **MWL**
Description: **Water Level**

Distance (ft): **.0**
Structural Grade: **0**
O&M Grade: **0**
Clock Start/From:
Clock To:
1st Value:
2nd Value:
Value Percent: **10.000**
Continuous Index:
Within 8" of Joint: **NO**
Remarks:

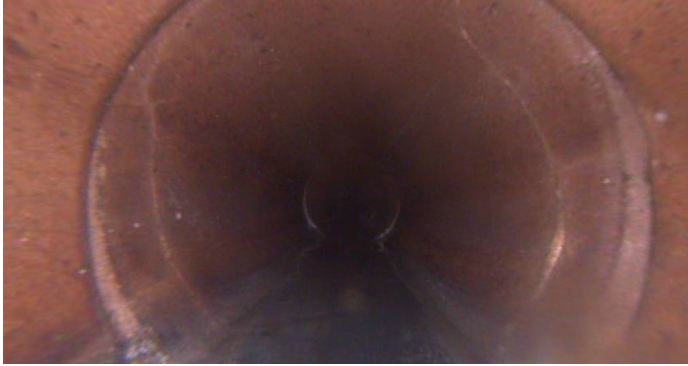
Code: **CS**
Description: **Crack Spiral**

Distance (ft): **7.0**
Structural Grade: **2**
O&M Grade: **0**
Clock Start/From: **7**
Clock To: **5**
1st Value:
2nd Value:
Value Percent:
Continuous Index:
Within 8" of Joint: **YES**
Remarks:

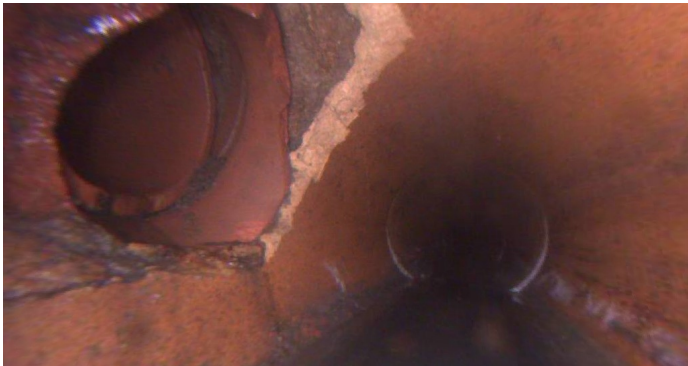
Code: **TB**
Description: **Tap Break-in**

Distance (ft): **18.0**
Structural Grade: **0**
O&M Grade: **0**
Clock Start/From: **9**
Clock To:
1st Value: **4.000**
2nd Value:
Value Percent:
Continuous Index:
Within 8" of Joint:
Remarks:

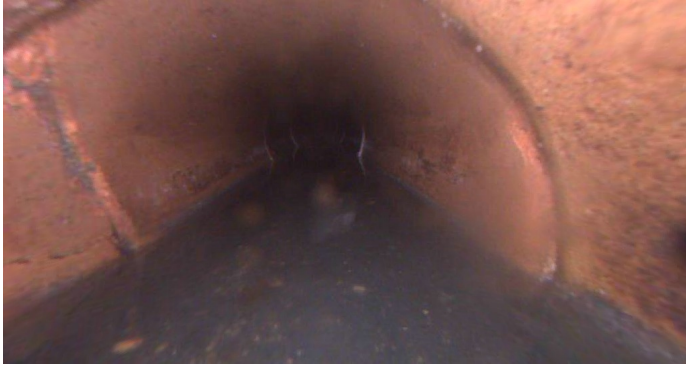
Code: **FS**
Description: **Fracture Spiral**

Distance (ft): **31.7**
Structural Grade: **3**
O&M Grade: **0**
Clock Start/From: **8**
Clock To: **10**
1st Value:
2nd Value:
Value Percent:
Continuous Index:
Within 8" of Joint: **YES**
Remarks:

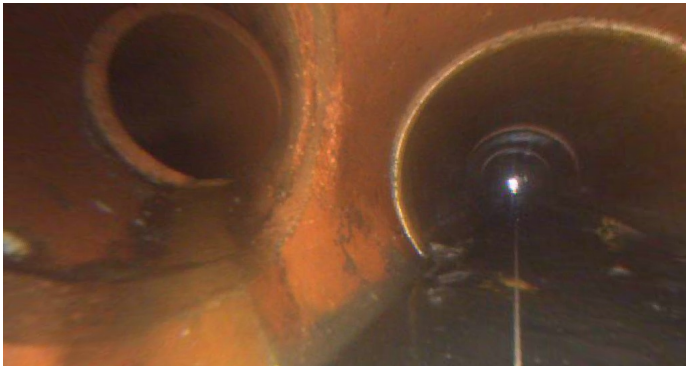
Code: **TF**
Description: **Tap Factory**

Distance (ft): **47.6**
Structural Grade: **0**
O&M Grade: **0**
Clock Start/From: **3**
Clock To:
1st Value: **4.000**
2nd Value:
Value Percent:
Continuous Index:
Within 8" of Joint:
Remarks: **Photo taken from rear camera.**

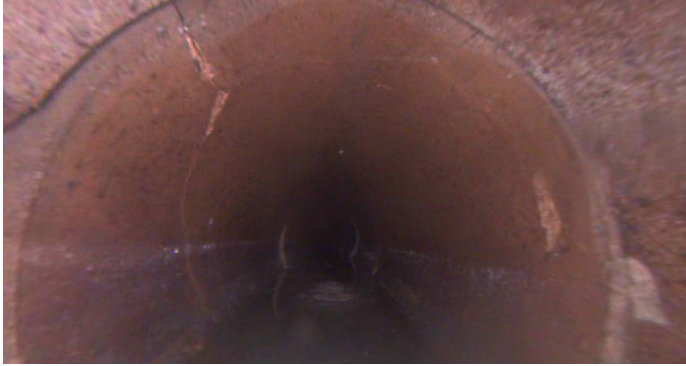
Code: **FM**
Description: **Fracture Multiple**

Distance (ft): **53.1**
Structural Grade: **4**
O&M Grade: **0**
Clock Start/From: **7**
Clock To: **5**
1st Value:
2nd Value:
Value Percent:
Continuous Index:
Within 8" of Joint: **YES**
Remarks:

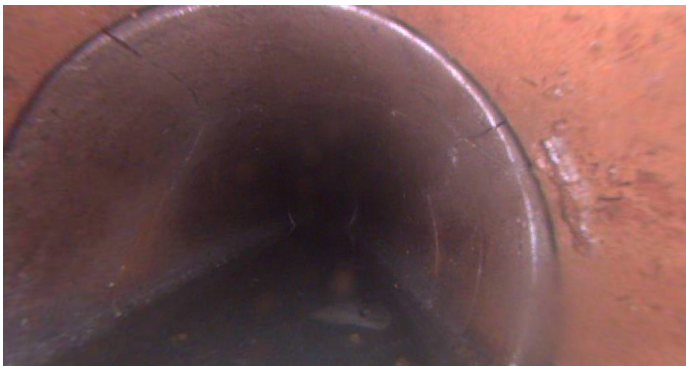
Code: **FM**
Description: **Fracture Multiple**

Distance (ft): **62.5**
Structural Grade: **4**
O&M Grade: **0**
Clock Start/From: **7**
Clock To: **5**
1st Value:
2nd Value:
Value Percent:
Continuous Index:
Within 8" of Joint: **YES**
Remarks:

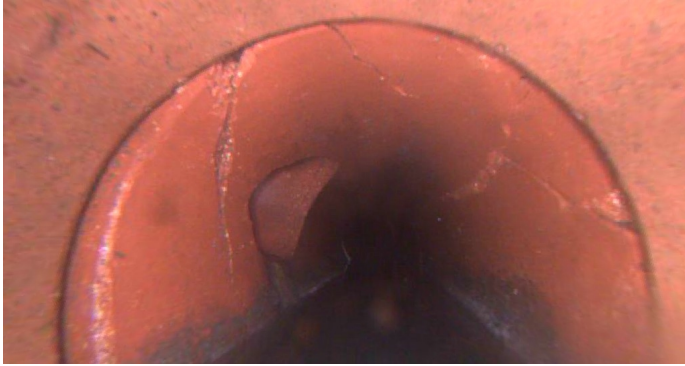
Code: **FM**
Description: **Fracture Multiple**

Distance (ft): **77.9**
Structural Grade: **4**
O&M Grade: **0**
Clock Start/From: **7**
Clock To: **5**
1st Value:
2nd Value:
Value Percent:
Continuous Index:
Within 8" of Joint:
Remarks:

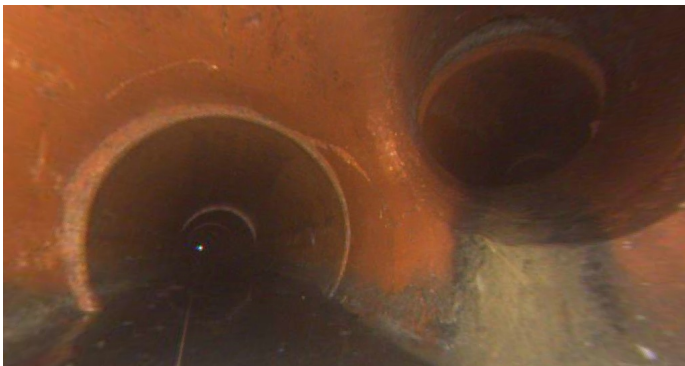
Code: **TF**
Description: **Tap Factory**

Distance (ft): **79.5**
Structural Grade: **0**
O&M Grade: **0**
Clock Start/From: **9**
Clock To:
1st Value: **4.000**
2nd Value:
Value Percent:
Continuous Index:
Within 8" of Joint:
Remarks: **Photo taken from rear camera.**

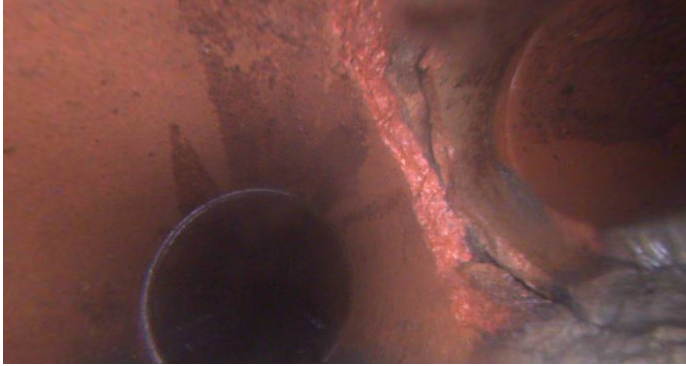
Code: **TF**
Description: **Tap Factory**

Distance (ft): **83.2**
Structural Grade: **0**
O&M Grade: **0**
Clock Start/From: **9**
Clock To:
1st Value: **4.000**
2nd Value:
Value Percent:
Continuous Index:
Within 8" of Joint:
Remarks:

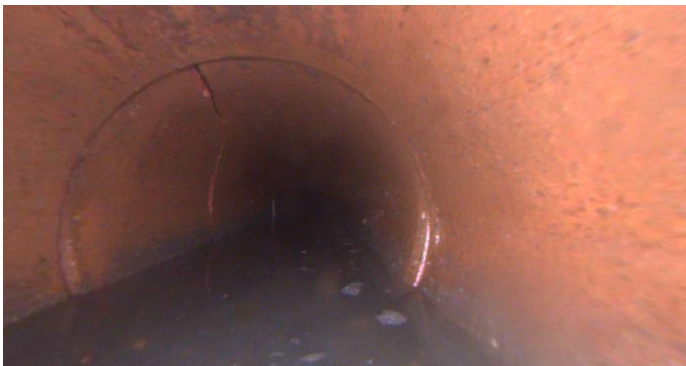
Code: **FS**
Description: **Fracture Spiral**

Distance (ft): **87.0**
Structural Grade: **3**
O&M Grade: **0**
Clock Start/From: **7**
Clock To: **11**
1st Value:
2nd Value:
Value Percent:
Continuous Index:
Within 8" of Joint: **YES**
Remarks:

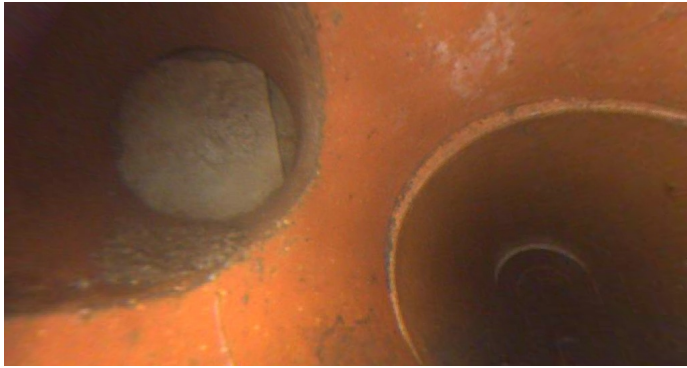
Code: **TFC**
Description: **Tap Factory Capped**

Distance (ft): **101.2**
Structural Grade: **0**
O&M Grade: **0**
Clock Start/From: **3**
Clock To:
1st Value: **4.000**
2nd Value:
Value Percent:
Continuous Index:
Within 8" of Joint:
Remarks: **Photo taken from rear camera.**

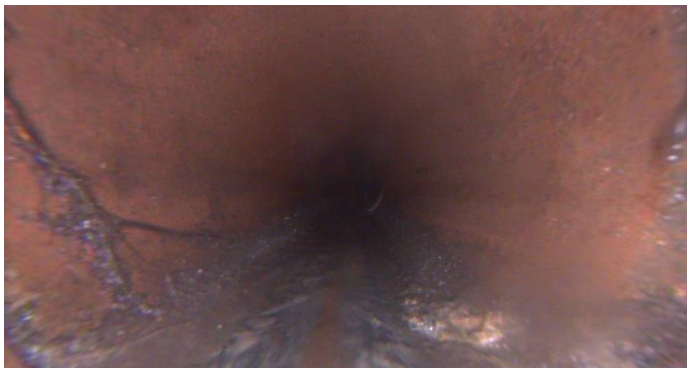
Code: **RFJ**
Description: **Roots Fine Joint**

Distance (ft): **131.1**
Structural Grade: **0**
O&M Grade: **1**
Clock Start/From: **7**
Clock To: **5**
1st Value:
2nd Value:
Value Percent:
Continuous Index:
Within 8" of Joint: **YES**
Remarks:

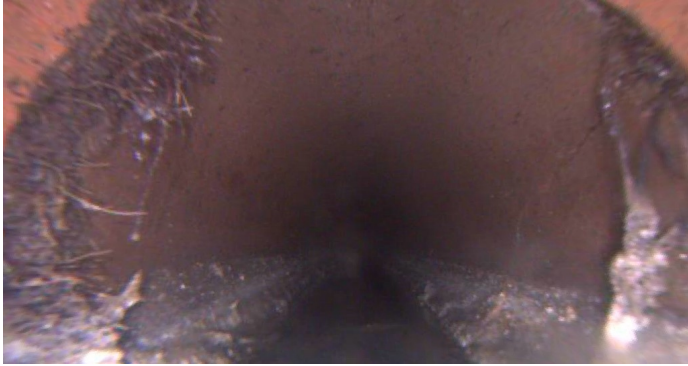
Code: **RMJ**
Description: **Roots Medium Joint**

Distance (ft): **137.4**
Structural Grade: **0**
O&M Grade: **3**
Clock Start/From: **7**
Clock To: **5**
1st Value:
2nd Value:
Value Percent: **5.000**
Continuous Index:
Within 8" of Joint: **YES**
Remarks:

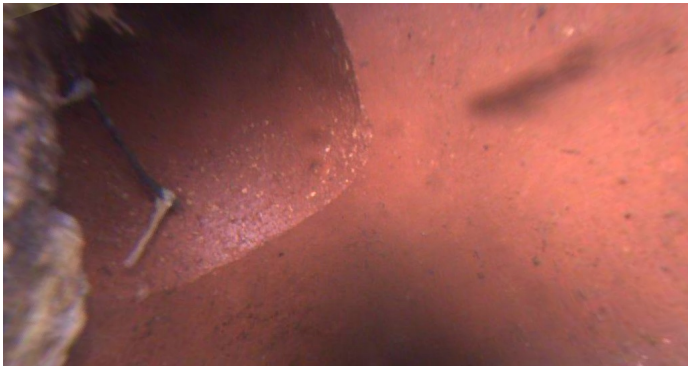
Code: **TFD**
Description: **Tap Factory Defective**

Distance (ft): **141.3**
Structural Grade: **0**
O&M Grade: **2**
Clock Start/From: **10**
Clock To:
1st Value: **4.000**
2nd Value:
Value Percent:
Continuous Index:
Within 8" of Joint:
Remarks: **Roots**

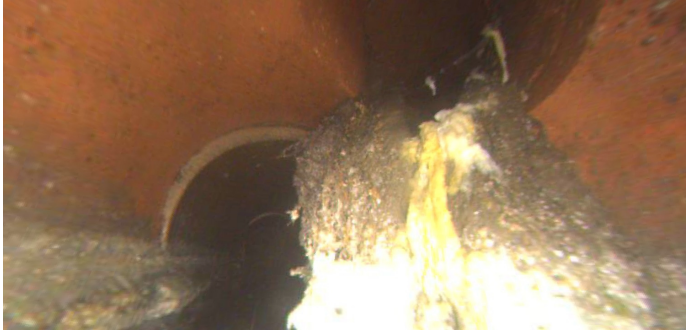
Code: **RML**
Description: **Roots Medium Lateral**

Distance (ft): **142.0**
Structural Grade: **0**
O&M Grade: **3**
Clock Start/From: **6**
Clock To: **10**
1st Value:
2nd Value:
Value Percent: **30.000**
Continuous Index:
Within 8" of Joint: **NO**
Remarks:

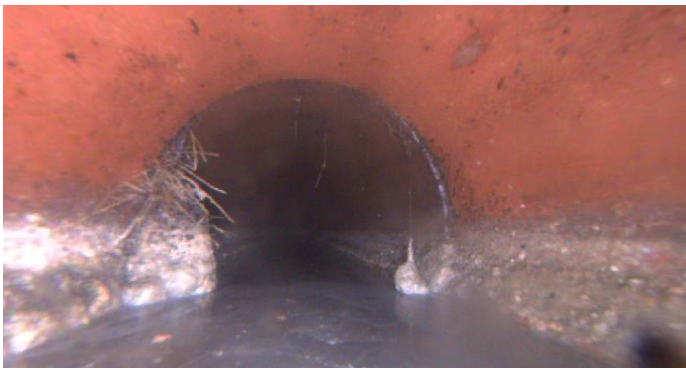
Code: **RFJ**
Description: **Roots Fine Joint**

Distance (ft): **143.1**
Structural Grade: **0**
O&M Grade: **1**
Clock Start/From: **7**
Clock To: **9**
1st Value:
2nd Value:
Value Percent:
Continuous Index:
Within 8" of Joint: **YES**
Remarks:

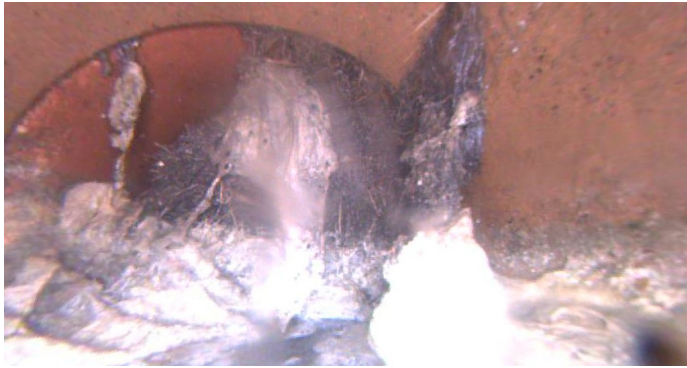
Code: **RBJ**
Description: **Roots Ball Joint**

Distance (ft): **149.6**
Structural Grade: **0**
O&M Grade: **4**
Clock Start/From: **7**
Clock To: **5**
1st Value:
2nd Value:
Value Percent: **70.000**
Continuous Index:
Within 8" of Joint: **YES**
Remarks:

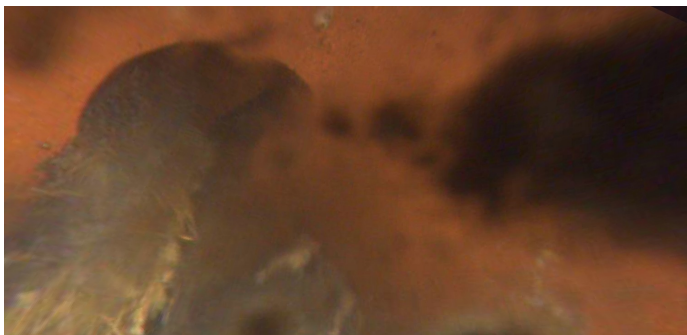
Code: **TFD**
Description: **Tap Factory Defective**

Distance (ft): **151.7**
Structural Grade: **0**
O&M Grade: **2**
Clock Start/From: **1**
Clock To:
1st Value: **4.000**
2nd Value:
Value Percent:
Continuous Index:
Within 8" of Joint:
Remarks: **roots**

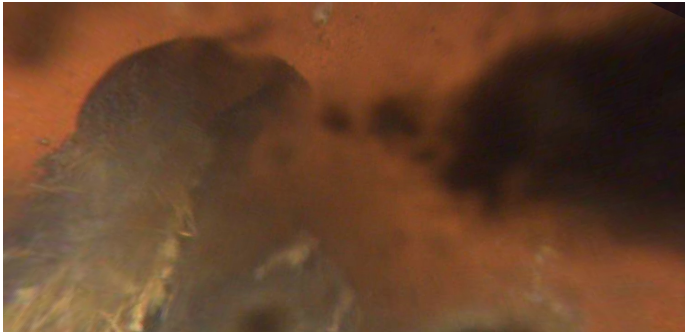
Code: **RML**
Description: **Roots Medium Lateral**

Distance (ft): **151.7**
Structural Grade: **0**
O&M Grade: **3**
Clock Start/From: **1**
Clock To: **4**
1st Value:
2nd Value:
Value Percent: **20.000**
Continuous Index:
Within 8" of Joint: **NO**
Remarks:

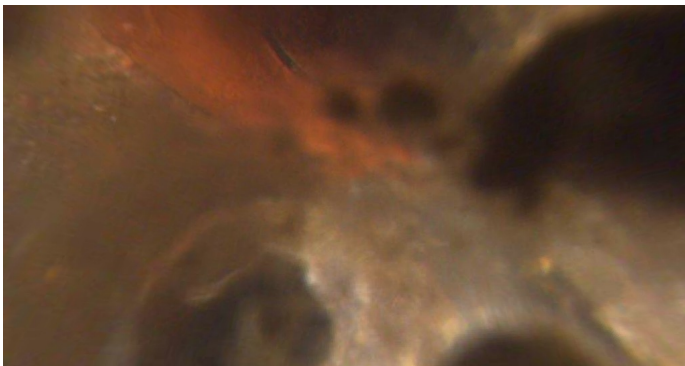
Code: **TBD**
Description: **Tap Break-in Defective**

Distance (ft): **179.2**
Structural Grade: **0**
O&M Grade: **3**
Clock Start/From: **2**
Clock To:
1st Value: **4.000**
2nd Value:
Value Percent:
Continuous Index:
Within 8" of Joint:
Remarks: **Roots**

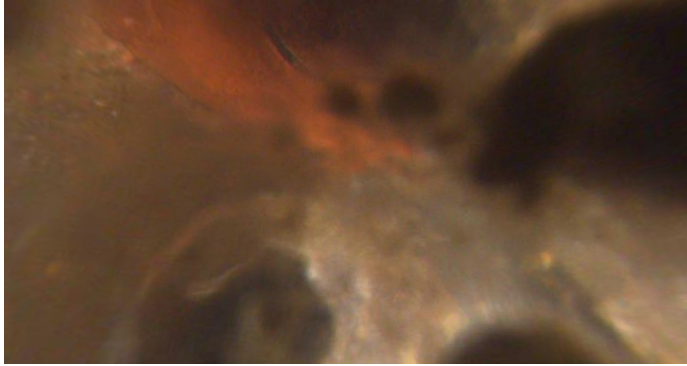
Code: **RML**
Description: **Roots Medium Lateral**

Distance (ft): **179.2**
Structural Grade: **0**
O&M Grade: **3**
Clock Start/From: **11**
Clock To:
1st Value:
2nd Value:
Value Percent: **15.000**
Continuous Index:
Within 8" of Joint: **NO**
Remarks:

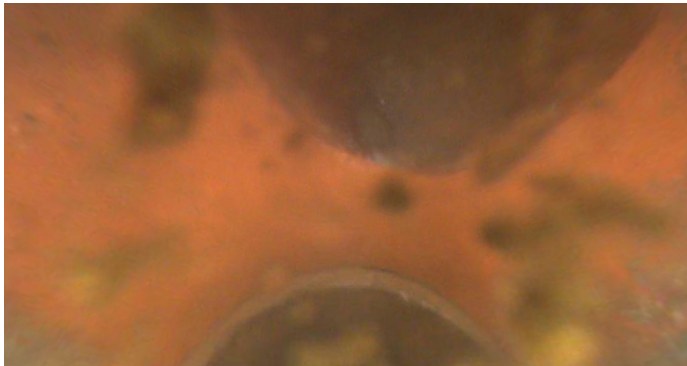
Code: **TFC**
Description: **Tap Factory Capped**

Distance (ft): **203.5**
Structural Grade: **0**
O&M Grade: **0**
Clock Start/From: **11**
Clock To:
1st Value: **4.000**
2nd Value:
Value Percent:
Continuous Index:
Within 8" of Joint:
Remarks:

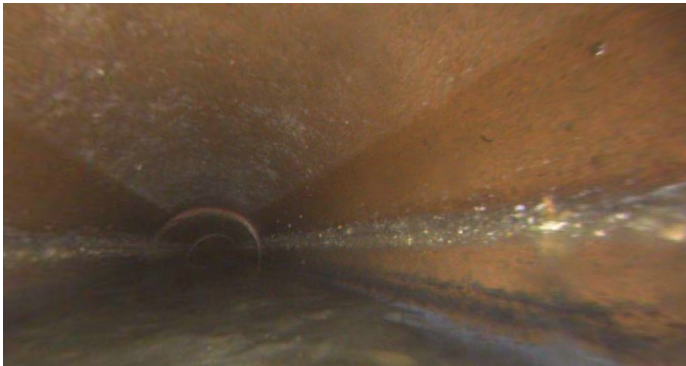
Code: **MCU**
Description: **Camera Underwater**

Distance (ft): **270.9**
Structural Grade: **0**
O&M Grade: **4**
Clock Start/From:
Clock To:
1st Value:
2nd Value:
Value Percent:
Continuous Index: **F01**
Within 8" of Joint: **NO**
Remarks:
