Profile/Photo Observation Report

Date:	09/09/2021	Weather:		Coding:	PACP 7.0
Pipe Length (ft):	160.0	Owner:	City of Hobart	Pre Clean:	Light Cleaning
P.O.#:	YES502259	Surveyor:	S. Bucklin	PSR:	P-503-031-032
Customer:	City of Hobart	Clean Date:	08/27/2021	Shape:	C

Street:	West 41st Avenue	Flow Control:	Not Controlled
City:	Hobart, IN	Year Renewed:	
Location:	Local rural streets with light traffic, t	Tape/Media #:	
Purpose:	Routine Assessment	Dia/Height:	10"
Use:	Sanitary Sewage Pipe	Material:	VCP
Drain Area:		Lining:	None
Category:	NA		
Comment:			
Location Details:		Direction of Survey:	Upstream
US MH:	M-503-032	DS MH:	M-503-031
		Total Length Surveyed (ft):	160.0

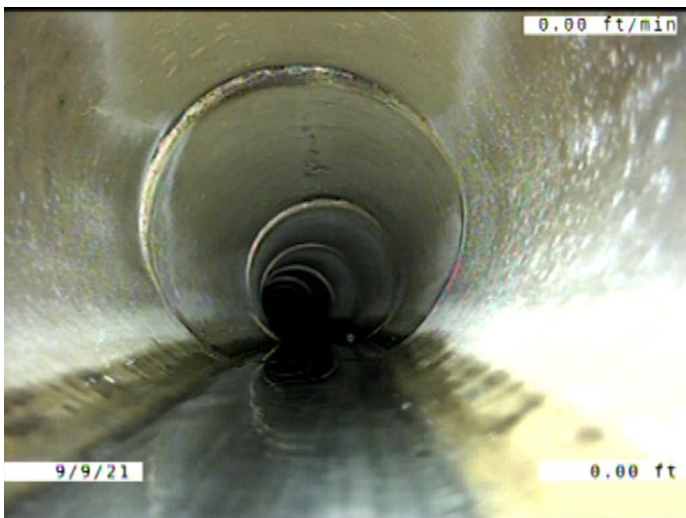
Code: **MWL**
Description: **Miscellaneous Water Level**

Distance (ft): **.0**
Structural Grade: **0**
O&M Grade: **0**
Clock Start/From:
Clock To:
1st Value:
2nd Value:
Value Percent: **5.000**
Continuous Index:
Within 8" of Joint: **NO**
Remarks:

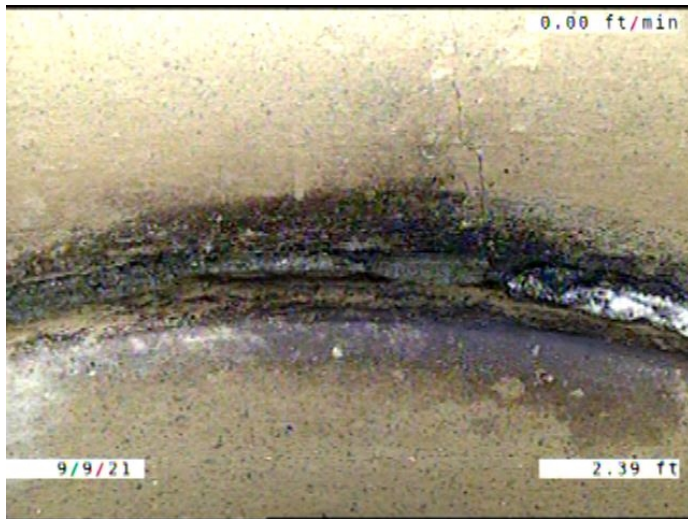
Code: **ISJ**
 Description: **Infiltration Stain Joint**

Distance (ft): **2.4**
 Structural Grade: **0**
 O&M Grade: **1**
 Clock Start/From: **10**
 Clock To: **2**
 1st Value:
 2nd Value:
 Value Percent:
 Continuous Index:
 Within 8" of Joint: **YES**
 Remarks:

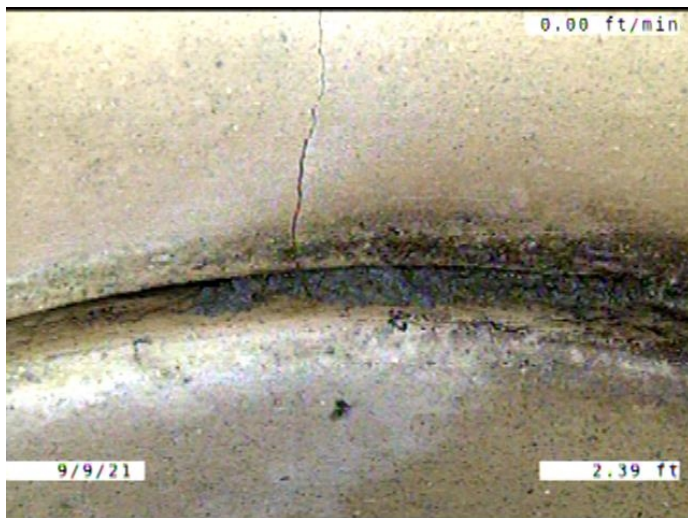
Code: **CM**
 Description: **Crack Multiple**

Distance (ft): **2.4**
 Structural Grade: **3**
 O&M Grade: **0**
 Clock Start/From: **10**
 Clock To: **12**
 1st Value:
 2nd Value:
 Value Percent:
 Continuous Index:
 Within 8" of Joint: **YES**
 Remarks:

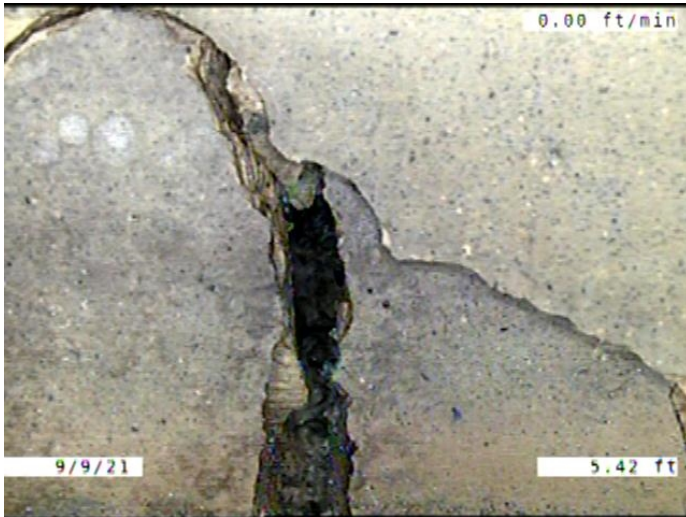
Code: **BSV**
Description: **Broken Soil Visible**

Distance (ft): **5.4**
Structural Grade: **5**
O&M Grade: **0**
Clock Start/From: **10**
Clock To: **2**
1st Value:
2nd Value:
Value Percent:
Continuous Index:
Within 8" of Joint: **YES**
Remarks:

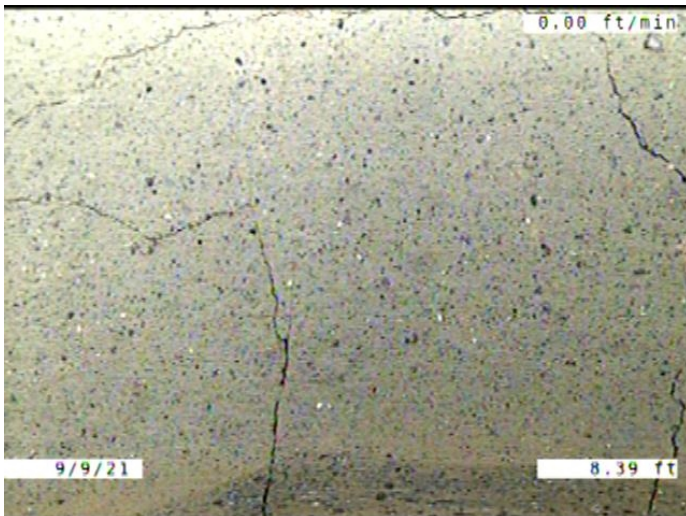
Code: **CM**
Description: **Crack Multiple**

Distance (ft): **8.4**
Structural Grade: **3**
O&M Grade: **0**
Clock Start/From: **8**
Clock To: **12**
1st Value:
2nd Value:
Value Percent:
Continuous Index:
Within 8" of Joint: **YES**
Remarks:

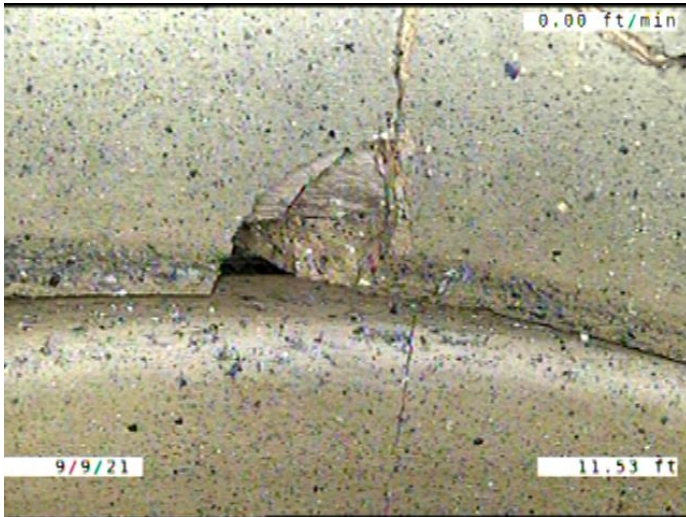
Code: **BVV**
Description: **Broken Void Visible**

Distance (ft): **11.5**
Structural Grade: **5**
O&M Grade: **0**
Clock Start/From: **2**
Clock To: **4**
1st Value:
2nd Value:
Value Percent:
Continuous Index:
Within 8" of Joint: **YES**
Remarks:

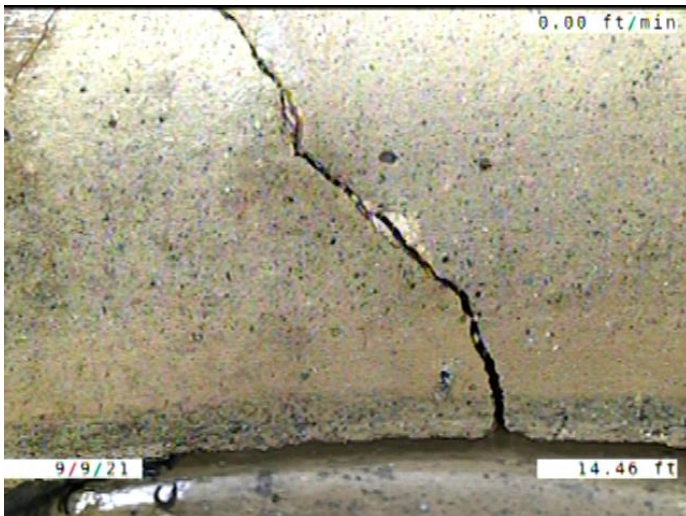
Code: **FM**
Description: **Fracture Multiple**

Distance (ft): **14.5**
Structural Grade: **4**
O&M Grade: **0**
Clock Start/From: **7**
Clock To: **9**
1st Value:
2nd Value:
Value Percent:
Continuous Index:
Within 8" of Joint: **YES**
Remarks:

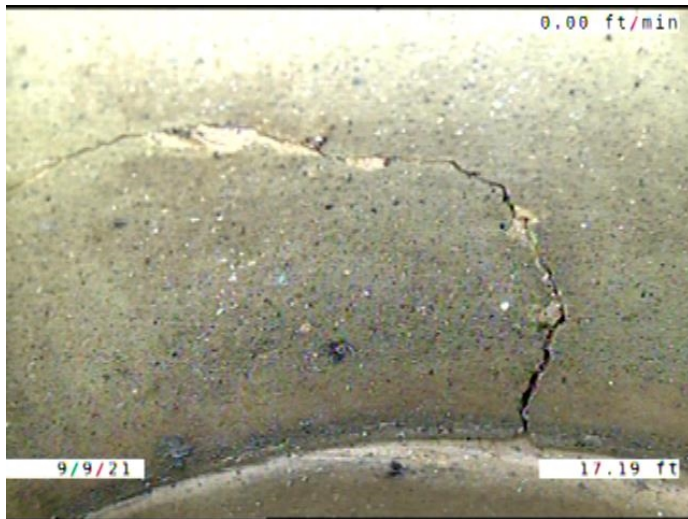
Code: **FM**
Description: **Fracture Multiple**

Distance (ft): **17.2**
Structural Grade: **4**
O&M Grade: **0**
Clock Start/From: **7**
Clock To: **5**
1st Value:
2nd Value:
Value Percent:
Continuous Index:
Within 8" of Joint: **YES**
Remarks:

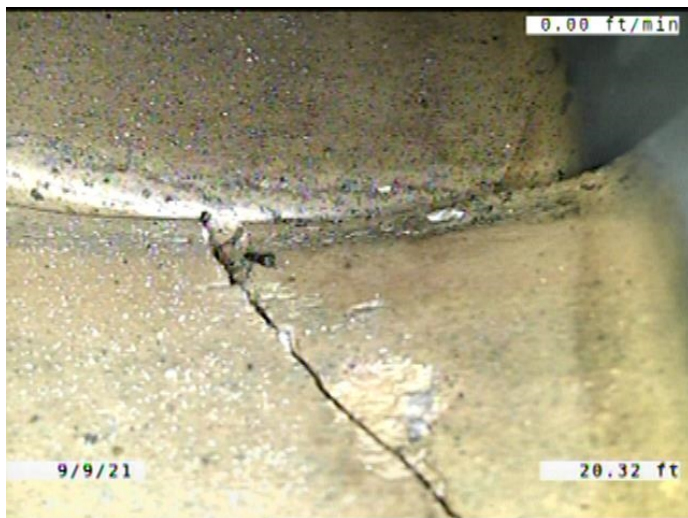
Code: **FM**
Description: **Fracture Multiple**

Distance (ft): **20.3**
Structural Grade: **4**
O&M Grade: **0**
Clock Start/From: **7**
Clock To: **5**
1st Value:
2nd Value:
Value Percent:
Continuous Index:
Within 8" of Joint: **YES**
Remarks:

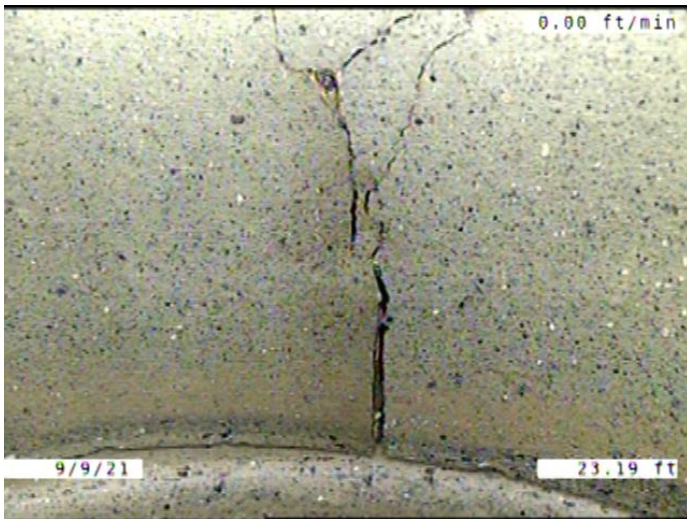
Code: **FM**
 Description: **Fracture Multiple**

Distance (ft): **23.2**
 Structural Grade: **4**
 O&M Grade: **0**
 Clock Start/From: **10**
 Clock To: **5**
 1st Value:
 2nd Value:
 Value Percent:
 Continuous Index:
 Within 8" of Joint: **YES**
 Remarks:

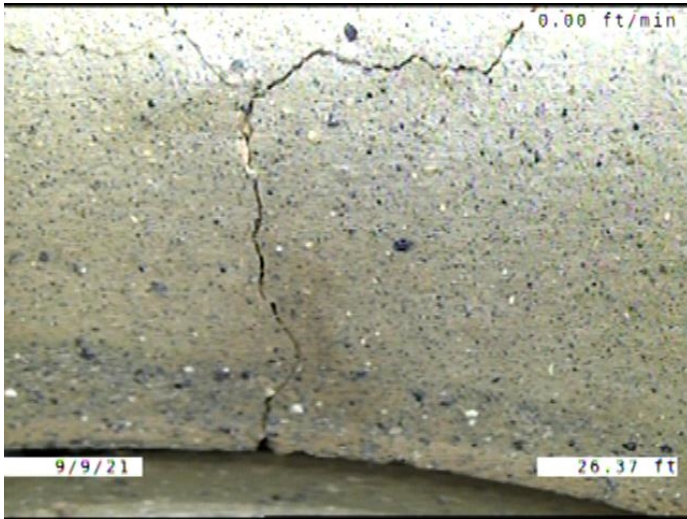
Code: **FM**
Description: **Fracture Multiple**

Distance (ft): **26.4**
Structural Grade: **4**
O&M Grade: **0**
Clock Start/From: **2**
Clock To: **4**
1st Value:
2nd Value:
Value Percent:
Continuous Index:
Within 8" of Joint: **YES**
Remarks:

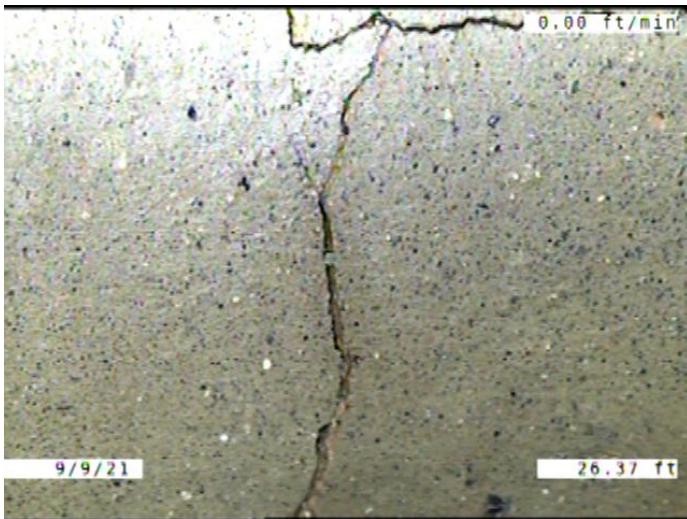
Code: **FM**
Description: **Fracture Multiple**

Distance (ft): **26.4**
Structural Grade: **4**
O&M Grade: **0**
Clock Start/From: **8**
Clock To: **12**
1st Value:
2nd Value:
Value Percent:
Continuous Index:
Within 8" of Joint: **YES**
Remarks:

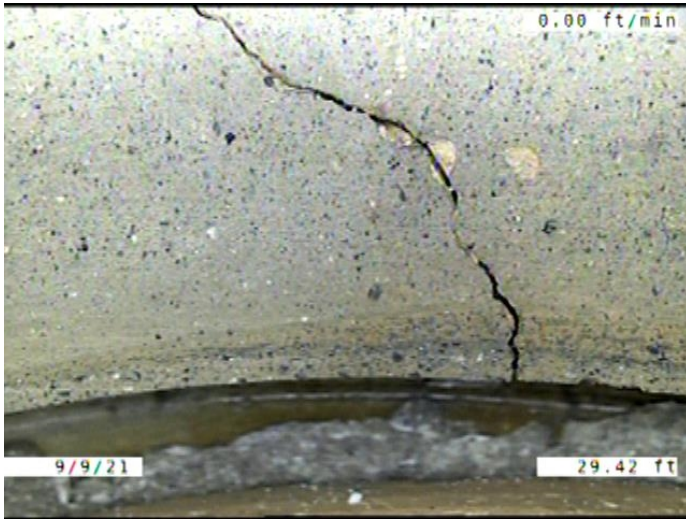
Code: **FM**
Description: **Fracture Multiple**

Distance (ft): **29.4**
Structural Grade: **4**
O&M Grade: **0**
Clock Start/From: **1**
Clock To: **11**
1st Value:
2nd Value:
Value Percent:
Continuous Index:
Within 8" of Joint: **YES**
Remarks:

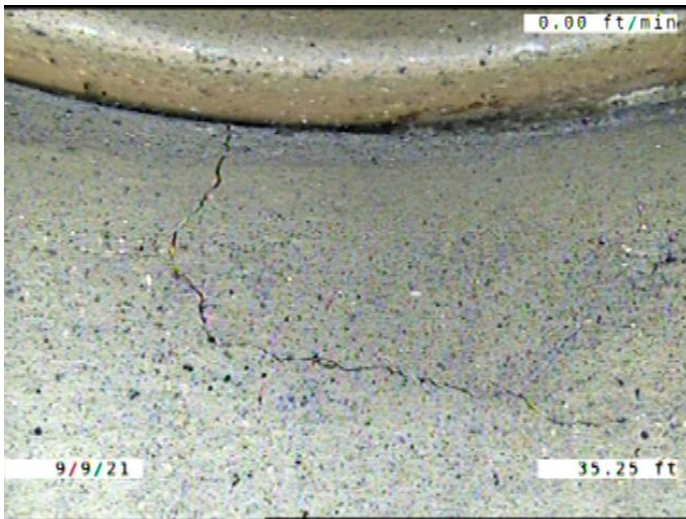
Code: **CM**
Description: **Crack Multiple**

Distance (ft): **35.2**
Structural Grade: **3**
O&M Grade: **0**
Clock Start/From: **12**
Clock To: **12**
1st Value:
2nd Value:
Value Percent:
Continuous Index:
Within 8" of Joint: **YES**
Remarks:

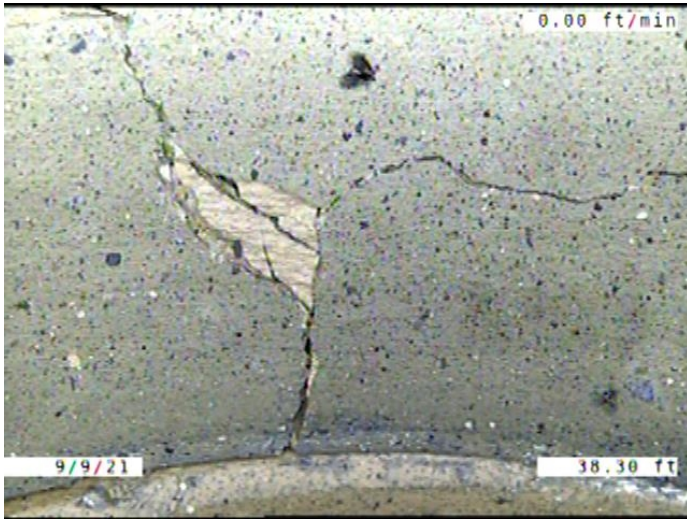
Code: **FM**
Description: **Fracture Multiple**

Distance (ft): **38.3**
Structural Grade: **4**
O&M Grade: **0**
Clock Start/From: **7**
Clock To: **3**
1st Value:
2nd Value:
Value Percent:
Continuous Index:
Within 8" of Joint: **YES**
Remarks:

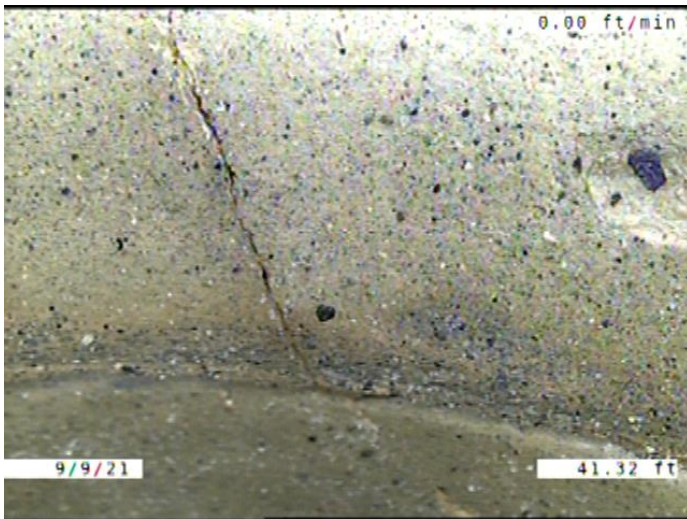
Code: **FM**
Description: **Fracture Multiple**

Distance (ft): **41.3**
Structural Grade: **4**
O&M Grade: **0**
Clock Start/From: **8**
Clock To: **3**
1st Value:
2nd Value:
Value Percent:
Continuous Index:
Within 8" of Joint: **YES**
Remarks:

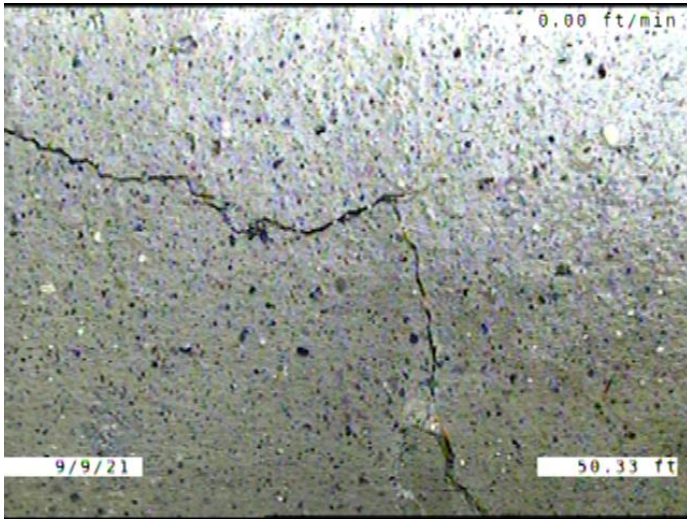
Code: **CM**
 Description: **Crack Multiple**

Distance (ft): **50.3**
 Structural Grade: **3**
 O&M Grade: **0**
 Clock Start/From: **2**
 Clock To: **4**
 1st Value:
 2nd Value:
 Value Percent:
 Continuous Index:
 Within 8" of Joint: **YES**
 Remarks:

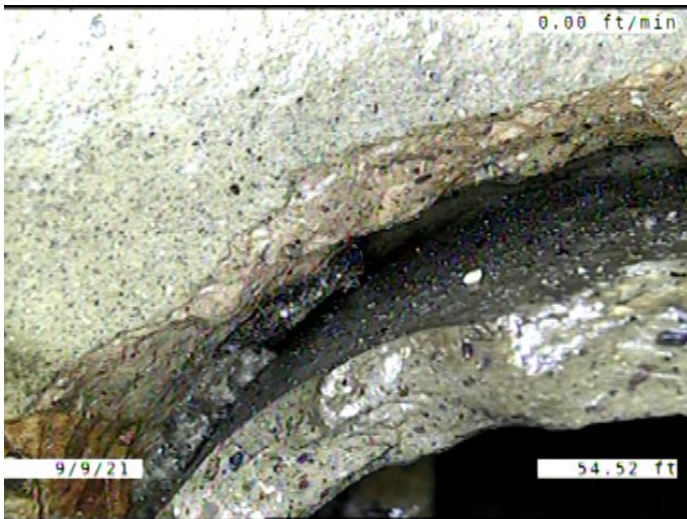
Code: **CL**
 Description: **Crack Longitudinal**

Distance (ft): **54.5**
 Structural Grade: **2**
 O&M Grade: **0**
 Clock Start/From: **11**
 Clock To:
 1st Value:
 2nd Value:
 Value Percent:
 Continuous Index:
 Within 8" of Joint: **YES**
 Remarks:

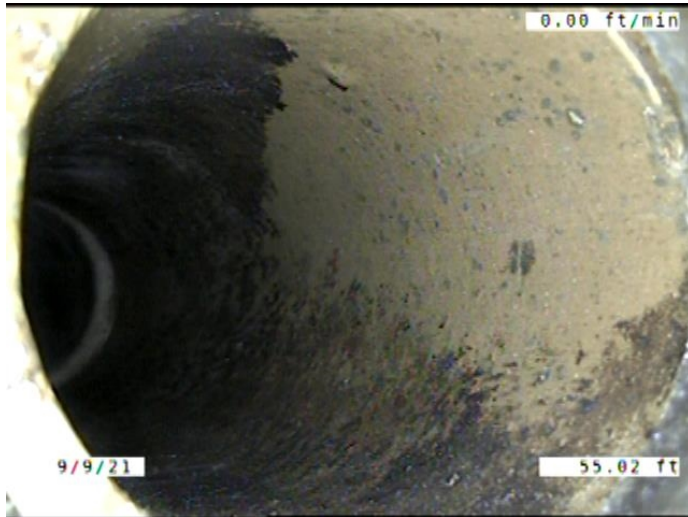
Code: **TBI**
 Description: **Tap Break-in Intruding**

Distance (ft): **55.0**
 Structural Grade: **0**
 O&M Grade: **2**
 Clock Start/From: **10**
 Clock To:
 1st Value: **4.000**
 2nd Value: **1.000**
 Value Percent:
 Continuous Index:
 Within 8" of Joint: **YES**
 Remarks:

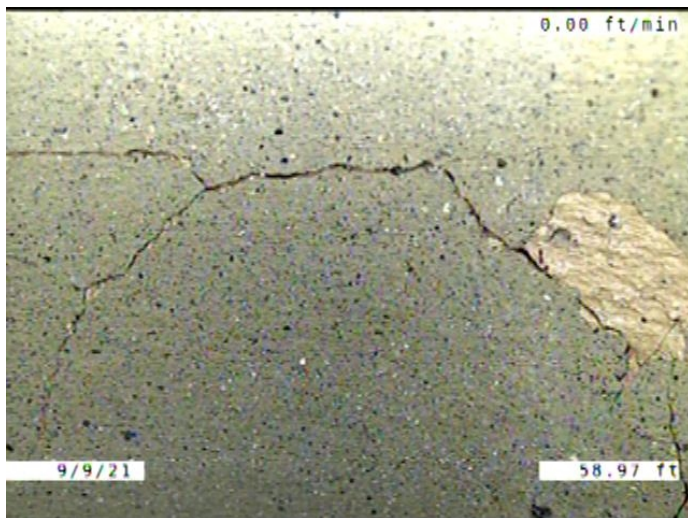
Code: **FM**
 Description: **Fracture Multiple**

Distance (ft): **59.0**
 Structural Grade: **4**
 O&M Grade: **0**
 Clock Start/From: **9**
 Clock To: **3**
 1st Value:
 2nd Value:
 Value Percent:
 Continuous Index:
 Within 8" of Joint: **YES**
 Remarks:

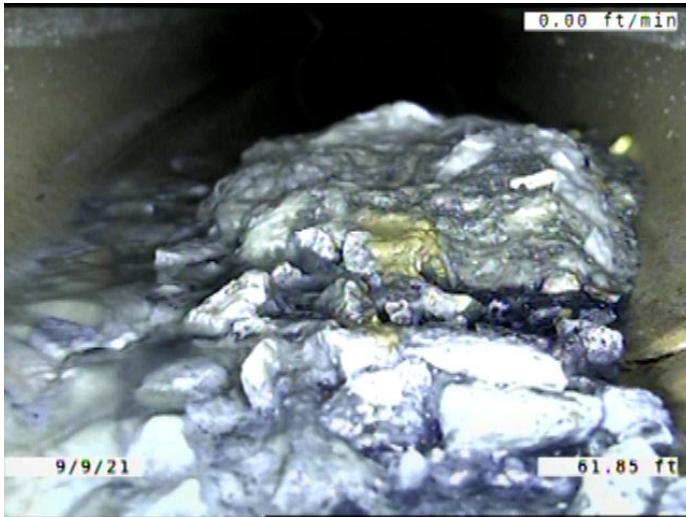
Code: **DSGV**
Description: **Deposits Settled Gravel**

Distance (ft): **61.9**
Structural Grade: **0**
O&M Grade: **2**
Clock Start/From: **5**
Clock To: **7**
1st Value:
2nd Value:
Value Percent: **5.000**
Continuous Index:
Within 8" of Joint: **YES**
Remarks:

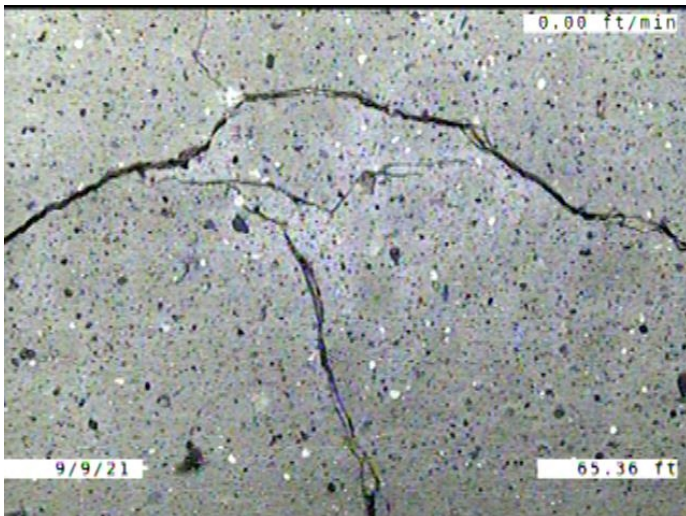
Code: **FM**
Description: **Fracture Multiple**

Distance (ft): **65.4**
Structural Grade: **4**
O&M Grade: **0**
Clock Start/From: **8**
Clock To: **4**
1st Value:
2nd Value:
Value Percent:
Continuous Index:
Within 8" of Joint: **YES**
Remarks:

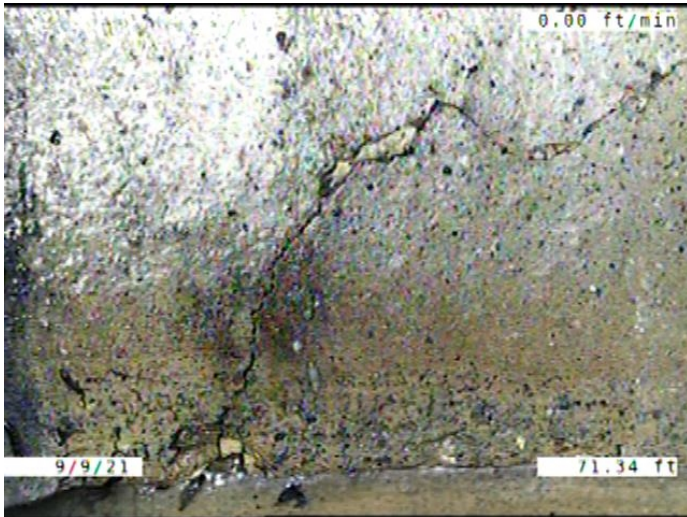
Code: **FM**
 Description: **Fracture Multiple**

Distance (ft): **71.3**
 Structural Grade: **4**
 O&M Grade: **0**
 Clock Start/From: **8**
 Clock To: **11**
 1st Value:
 2nd Value:
 Value Percent:
 Continuous Index:
 Within 8" of Joint: **YES**
 Remarks:

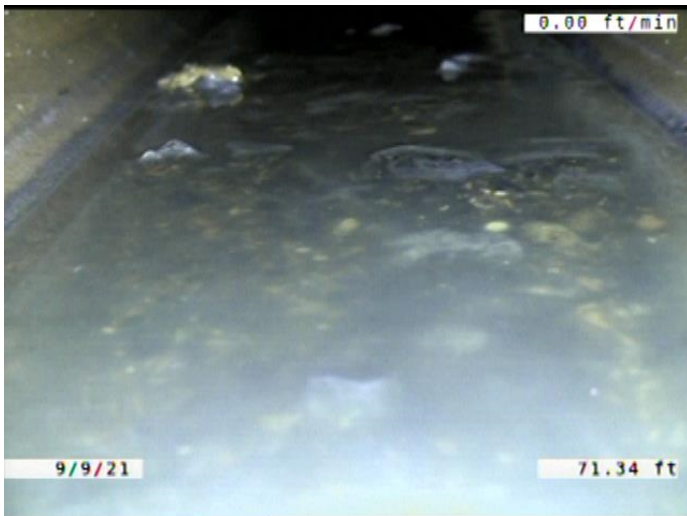
Code: **DSF**
 Description: **Deposits Settled Fine**

Distance (ft): **71.3**
 Structural Grade: **0**
 O&M Grade: **2**
 Clock Start/From: **5**
 Clock To: **7**
 1st Value:
 2nd Value:
 Value Percent: **5.000**
 Continuous Index: **S01**
 Within 8" of Joint: **YES**
 Remarks:

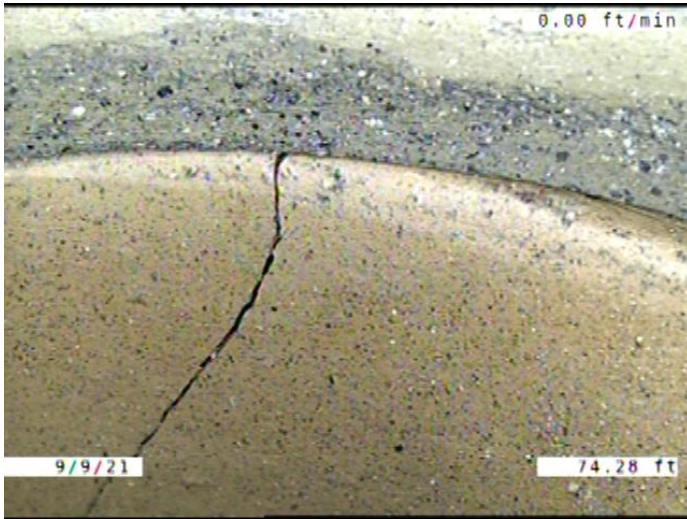
Code: **FS**
 Description: **Fracture Spiral**

Distance (ft): **74.3**
 Structural Grade: **3**
 O&M Grade: **0**
 Clock Start/From: **1**
 Clock To: **2**
 1st Value:
 2nd Value:
 Value Percent:
 Continuous Index:
 Within 8" of Joint: **YES**
 Remarks:

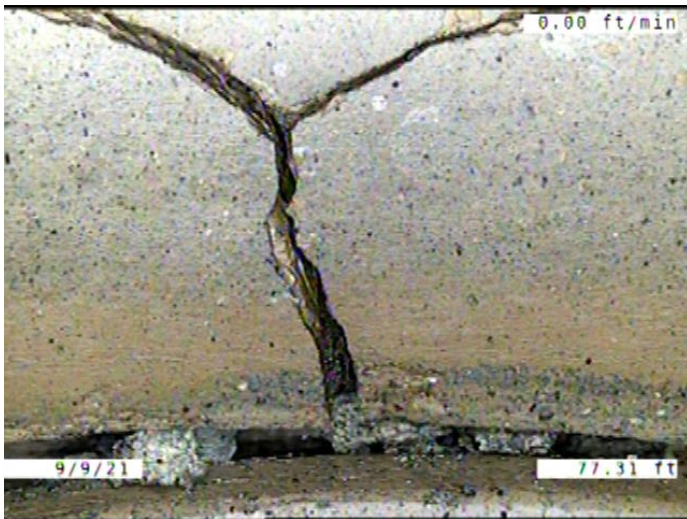
Code: **B**
 Description: **Broken**

Distance (ft): **77.3**
 Structural Grade: **4**
 O&M Grade: **0**
 Clock Start/From: **8**
 Clock To: **12**
 1st Value:
 2nd Value:
 Value Percent:
 Continuous Index:
 Within 8" of Joint: **YES**
 Remarks:

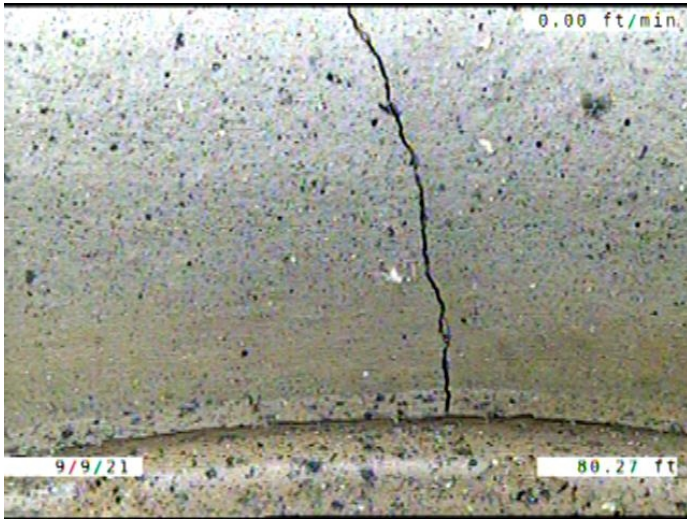
Code: **CM**
Description: **Crack Multiple**

Distance (ft): **80.3**
Structural Grade: **3**
O&M Grade: **0**
Clock Start/From: **12**
Clock To: **12**
1st Value:
2nd Value:
Value Percent:
Continuous Index:
Within 8" of Joint: **YES**
Remarks:

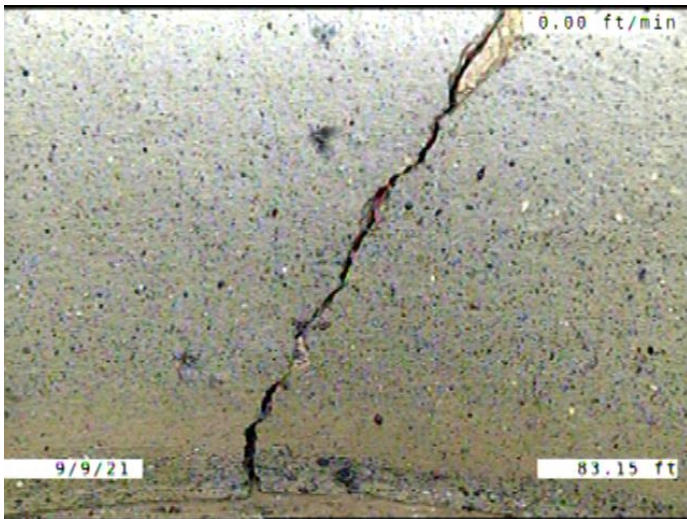
Code: **FM**
Description: **Fracture Multiple**

Distance (ft): **83.2**
Structural Grade: **4**
O&M Grade: **0**
Clock Start/From: **10**
Clock To: **4**
1st Value:
2nd Value:
Value Percent:
Continuous Index:
Within 8" of Joint: **YES**
Remarks:

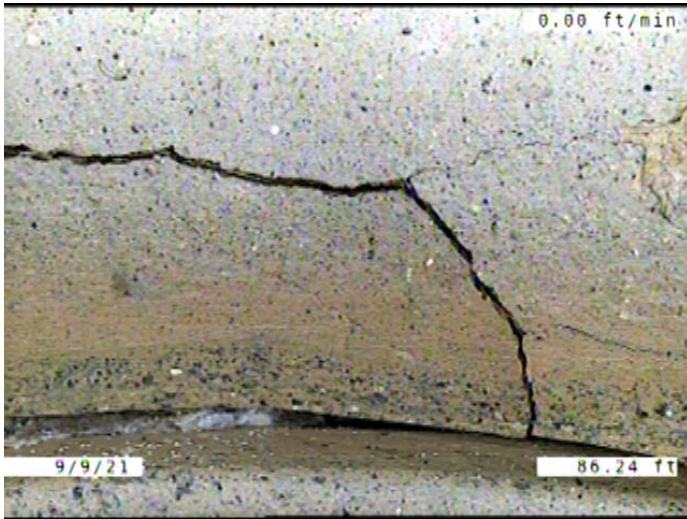
Code: **FM**
 Description: **Fracture Multiple**

Distance (ft): **86.2**
 Structural Grade: **4**
 O&M Grade: **0**
 Clock Start/From: **7**
 Clock To: **5**
 1st Value:
 2nd Value:
 Value Percent:
 Continuous Index:
 Within 8" of Joint: **YES**
 Remarks:

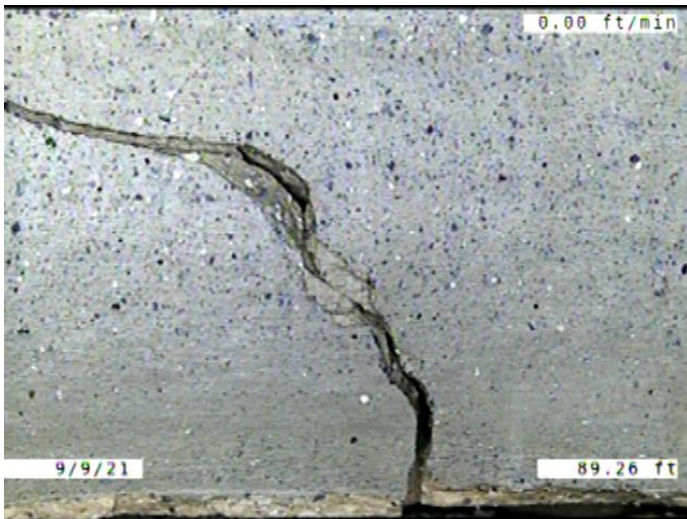
Code: **B**
 Description: **Broken**

Distance (ft): **89.3**
 Structural Grade: **4**
 O&M Grade: **0**
 Clock Start/From: **1**
 Clock To: **11**
 1st Value:
 2nd Value:
 Value Percent:
 Continuous Index:
 Within 8" of Joint: **YES**
 Remarks:

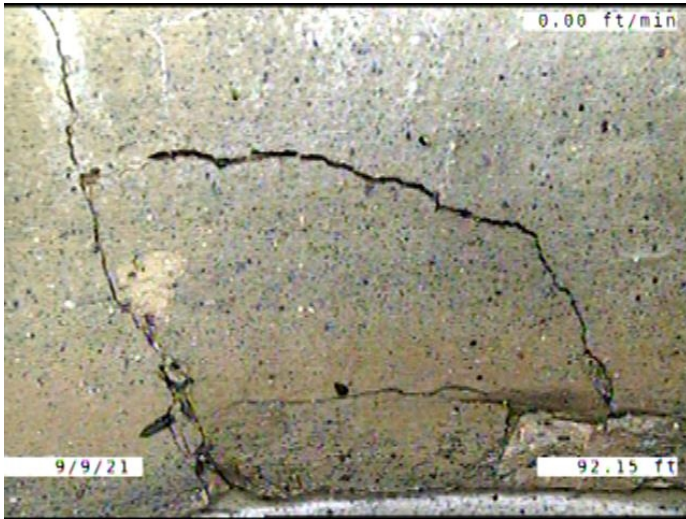
Code: **FM**
Description: **Fracture Multiple**

Distance (ft): **92.2**
Structural Grade: **4**
O&M Grade: **0**
Clock Start/From: **9**
Clock To: **12**
1st Value:
2nd Value:
Value Percent:
Continuous Index:
Within 8" of Joint: **YES**
Remarks:

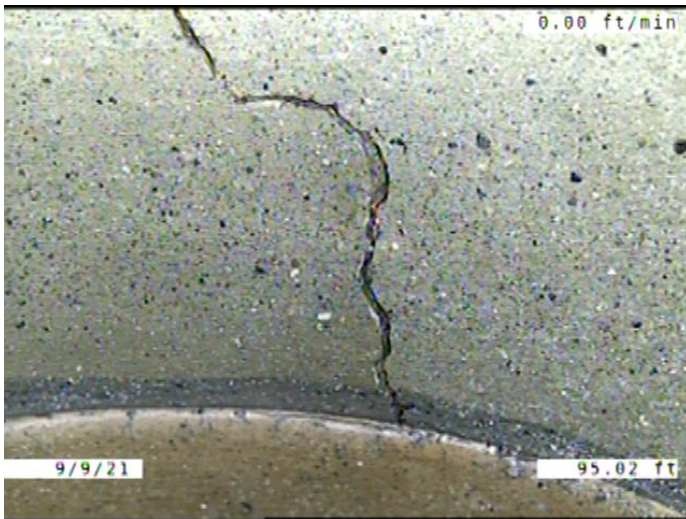
Code: **FM**
Description: **Fracture Multiple**

Distance (ft): **95.0**
Structural Grade: **4**
O&M Grade: **0**
Clock Start/From: **8**
Clock To: **2**
1st Value:
2nd Value:
Value Percent:
Continuous Index:
Within 8" of Joint: **YES**
Remarks:

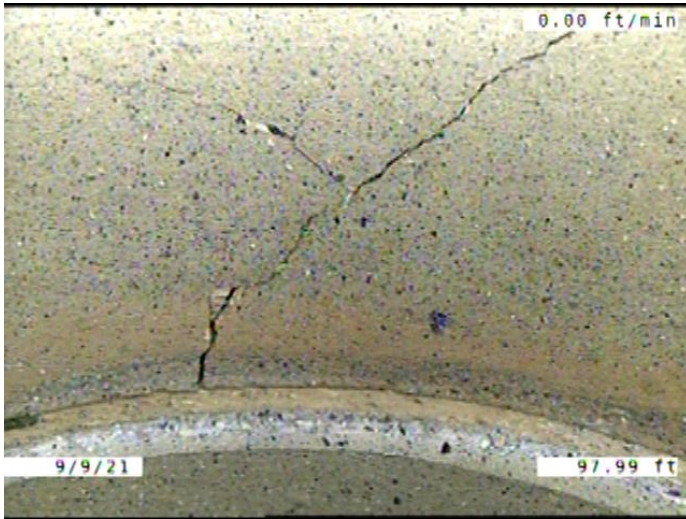
Code: **FM**
 Description: **Fracture Multiple**

Distance (ft): **98.0**
 Structural Grade: **4**
 O&M Grade: **0**
 Clock Start/From: **9**
 Clock To: **2**
 1st Value:
 2nd Value:
 Value Percent:
 Continuous Index:
 Within 8" of Joint: **YES**
 Remarks:

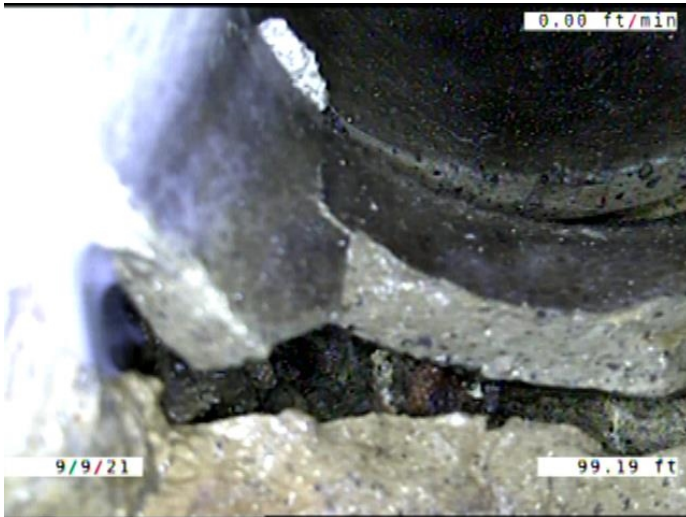
Code: **BSV**
 Description: **Broken Soil Visible**

Distance (ft): **99.2**
 Structural Grade: **5**
 O&M Grade: **0**
 Clock Start/From: **11**
 Clock To:
 1st Value:
 2nd Value:
 Value Percent:
 Continuous Index:
 Within 8" of Joint: **YES**
 Remarks:

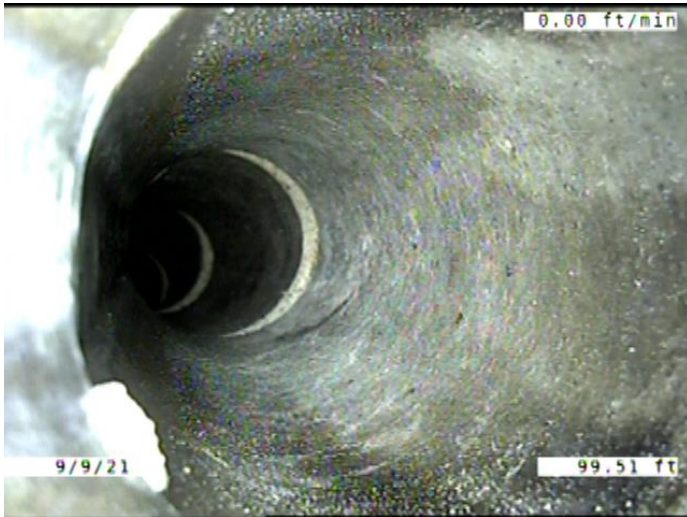
Code: **TBD**
 Description: **Tap Break-in/Hammer Defective**

Distance (ft): **99.5**
 Structural Grade: **0**
 O&M Grade: **3**
 Clock Start/From: **9**
 Clock To:
 1st Value: **4.000**
 2nd Value:
 Value Percent:
 Continuous Index:
 Within 8" of Joint: **YES**
 Remarks: **Defective**

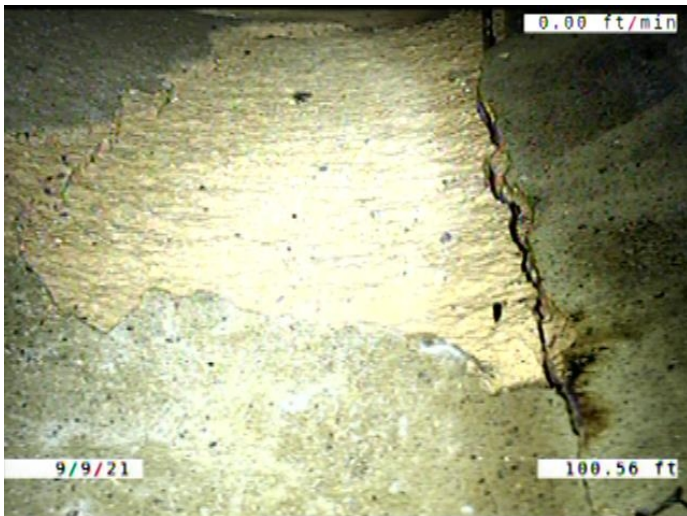
Code: **SSS**
 Description: **Surface Damage Surface Spalling**

Distance (ft): **100.6**
 Structural Grade: **2**
 O&M Grade: **0**
 Clock Start/From: **8**
 Clock To: **9**
 1st Value:
 2nd Value:
 Value Percent:
 Continuous Index:
 Within 8" of Joint: **YES**
 Remarks:

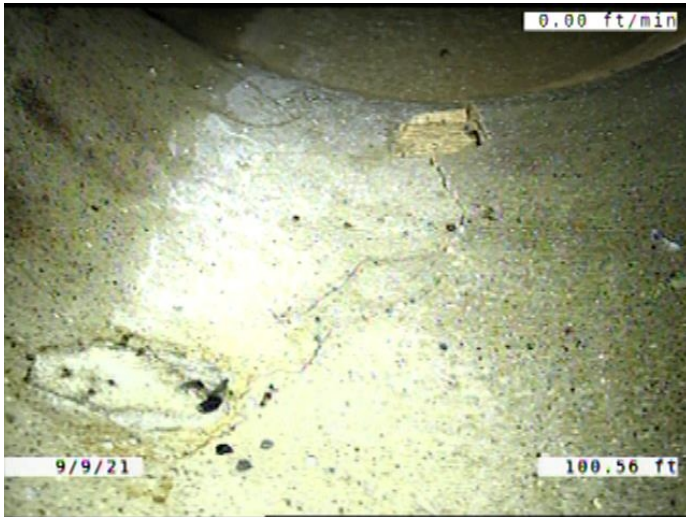
Code: **FM**
Description: **Fracture Multiple**

Distance (ft): **100.6**
Structural Grade: **4**
O&M Grade: **0**
Clock Start/From: **3**
Clock To: **9**
1st Value:
2nd Value:
Value Percent:
Continuous Index:
Within 8" of Joint: **YES**
Remarks:

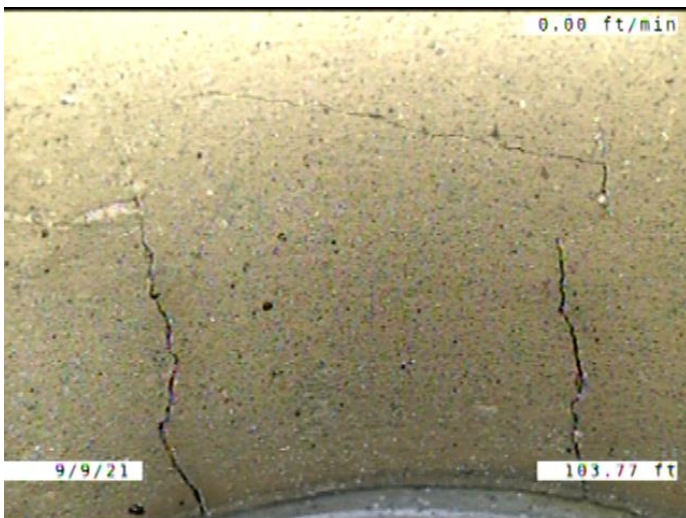
Code: **FM**
Description: **Fracture Multiple**

Distance (ft): **103.8**
Structural Grade: **4**
O&M Grade: **0**
Clock Start/From: **7**
Clock To: **5**
1st Value:
2nd Value:
Value Percent:
Continuous Index:
Within 8" of Joint: **YES**
Remarks:

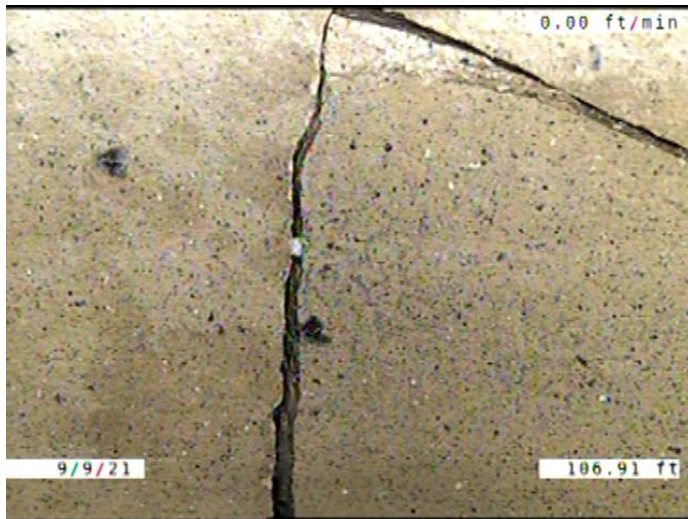
Code: **B**
 Description: **Broken**

Distance (ft): **106.9**
 Structural Grade: **4**
 O&M Grade: **0**
 Clock Start/From: **1**
 Clock To: **4**
 1st Value:
 2nd Value:
 Value Percent:
 Continuous Index:
 Within 8" of Joint: **YES**
 Remarks:

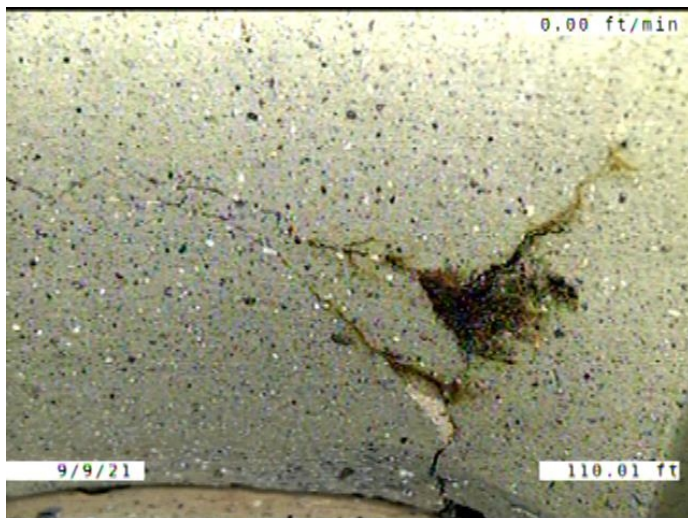
Code: **FM**
 Description: **Fracture Multiple**

Distance (ft): **110.0**
 Structural Grade: **4**
 O&M Grade: **0**
 Clock Start/From: **9**
 Clock To: **3**
 1st Value:
 2nd Value:
 Value Percent:
 Continuous Index:
 Within 8" of Joint: **YES**
 Remarks:

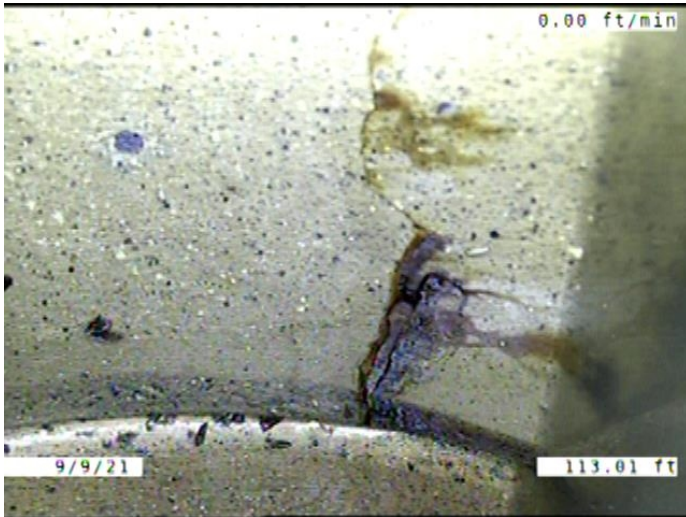
Code: **CM**
Description: **Crack Multiple**

Distance (ft): **113.0**
Structural Grade: **3**
O&M Grade: **0**
Clock Start/From: **3**
Clock To: **4**
1st Value:
2nd Value:
Value Percent:
Continuous Index:
Within 8" of Joint: **YES**
Remarks:

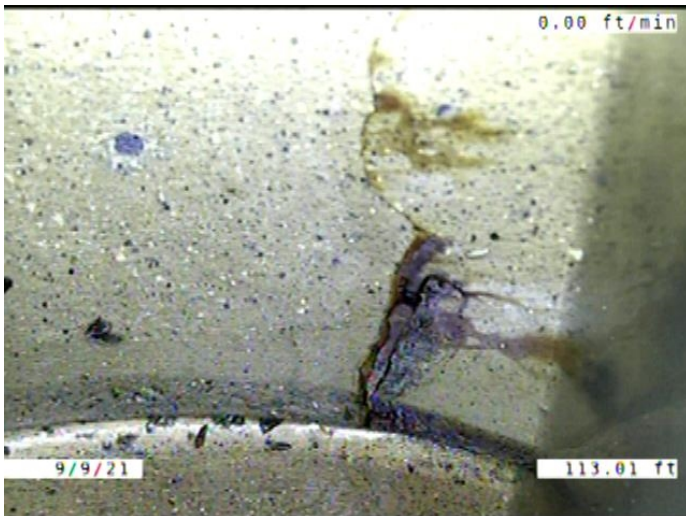
Code: **ISB**
Description: **Infiltration Stain Barrel**

Distance (ft): **113.0**
Structural Grade: **0**
O&M Grade: **1**
Clock Start/From: **3**
Clock To: **4**
1st Value:
2nd Value:
Value Percent:
Continuous Index:
Within 8" of Joint: **YES**
Remarks:

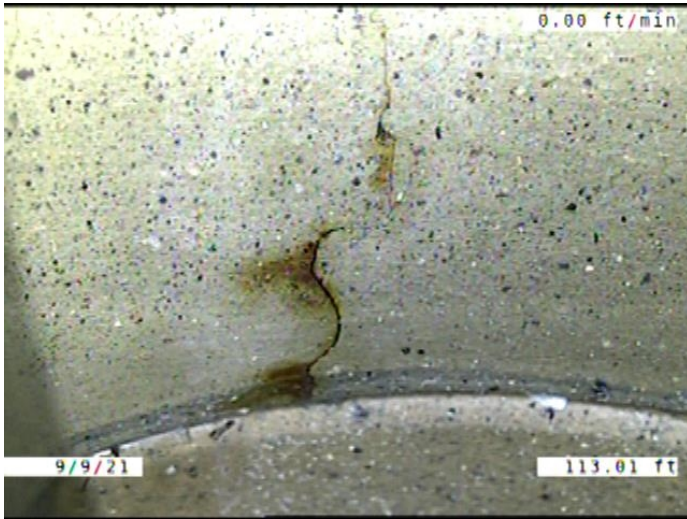
Code: **CM**
Description: **Crack Multiple**

Distance (ft): **113.0**
Structural Grade: **3**
O&M Grade: **0**
Clock Start/From: **8**
Clock To: **9**
1st Value:
2nd Value:
Value Percent:
Continuous Index:
Within 8" of Joint: **YES**
Remarks:

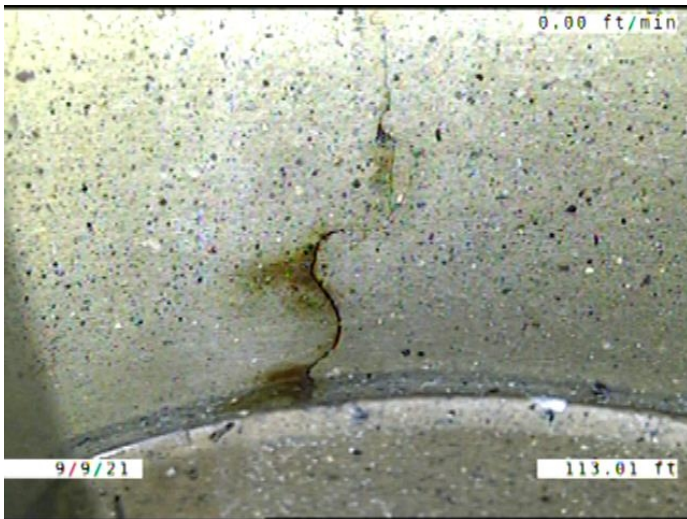
Code: **ISB**
Description: **Infiltration Stain Barrel**

Distance (ft): **113.0**
Structural Grade: **0**
O&M Grade: **1**
Clock Start/From: **9**
Clock To:
1st Value:
2nd Value:
Value Percent:
Continuous Index:
Within 8" of Joint: **YES**
Remarks:

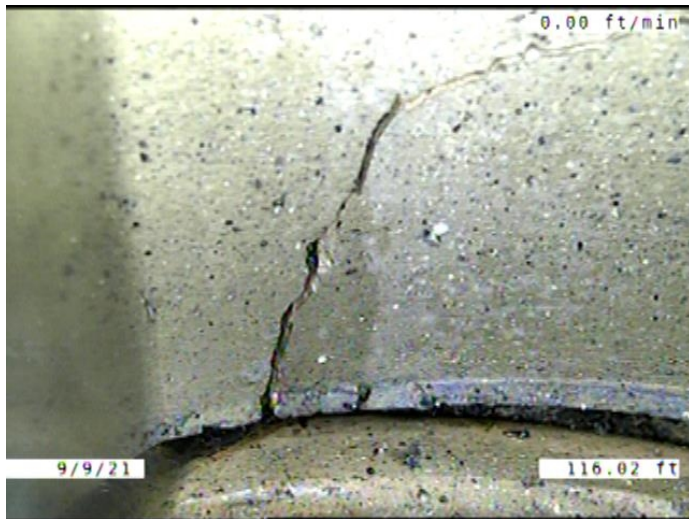
Code: **B**
Description: **Broken**

Distance (ft): **116.0**
Structural Grade: **4**
O&M Grade: **0**
Clock Start/From: **8**
Clock To: **4**
1st Value:
2nd Value:
Value Percent:
Continuous Index:
Within 8" of Joint: **YES**
Remarks:

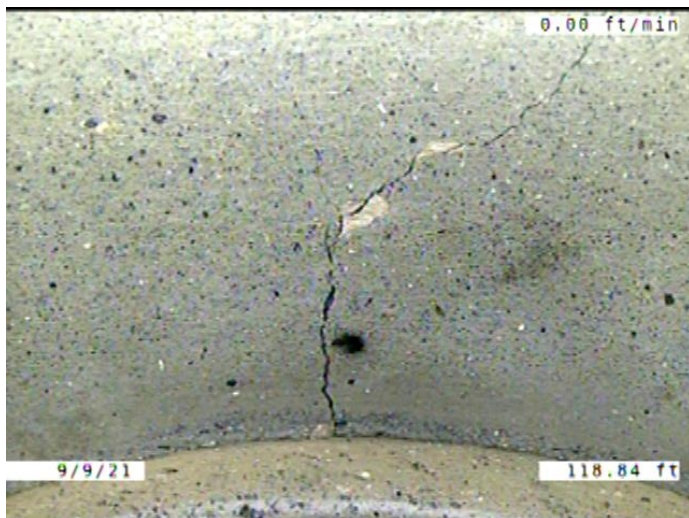
Code: **CM**
Description: **Crack Multiple**

Distance (ft): **118.8**
Structural Grade: **3**
O&M Grade: **0**
Clock Start/From: **9**
Clock To: **4**
1st Value:
2nd Value:
Value Percent:
Continuous Index:
Within 8" of Joint: **YES**
Remarks:

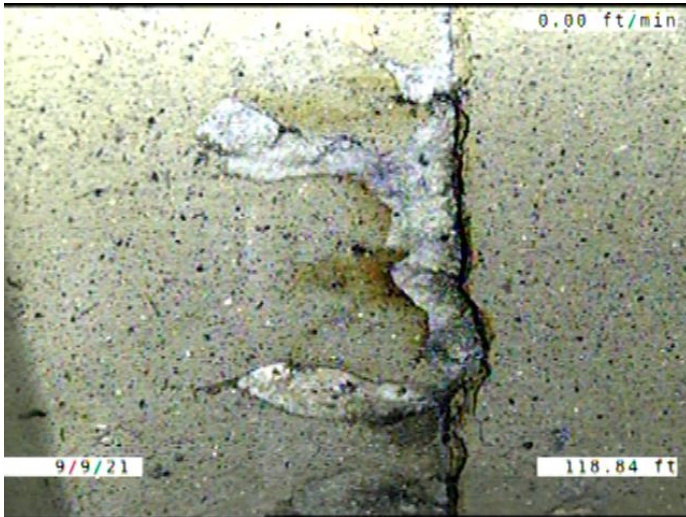
Code: **ISB**
Description: **Infiltration Stain Barrel**

Distance (ft): **118.8**
Structural Grade: **0**
O&M Grade: **1**
Clock Start/From: **9**
Clock To:
1st Value:
2nd Value:
Value Percent:
Continuous Index:
Within 8" of Joint: **YES**
Remarks:

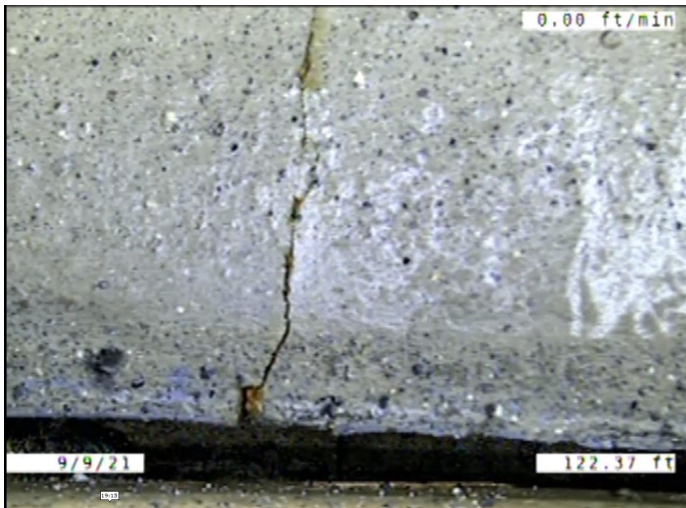
Code: **CM**
Description: **Crack Multiple**

Distance (ft): **122.4**
Structural Grade: **3**
O&M Grade: **0**
Clock Start/From: **12**
Clock To: **4**
1st Value:
2nd Value:
Value Percent:
Continuous Index:
Within 8" of Joint: **YES**
Remarks:

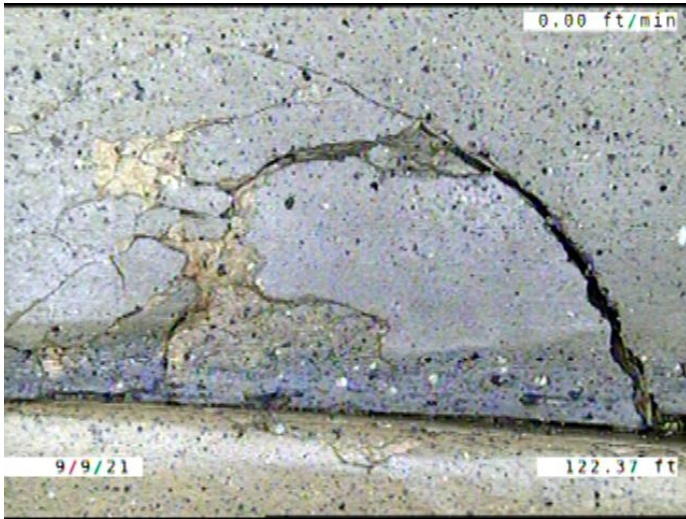
Code: **FM**
Description: **Fracture Multiple**

Distance (ft): **122.4**
Structural Grade: **4**
O&M Grade: **0**
Clock Start/From: **7**
Clock To: **11**
1st Value:
2nd Value:
Value Percent:
Continuous Index:
Within 8" of Joint: **YES**
Remarks:

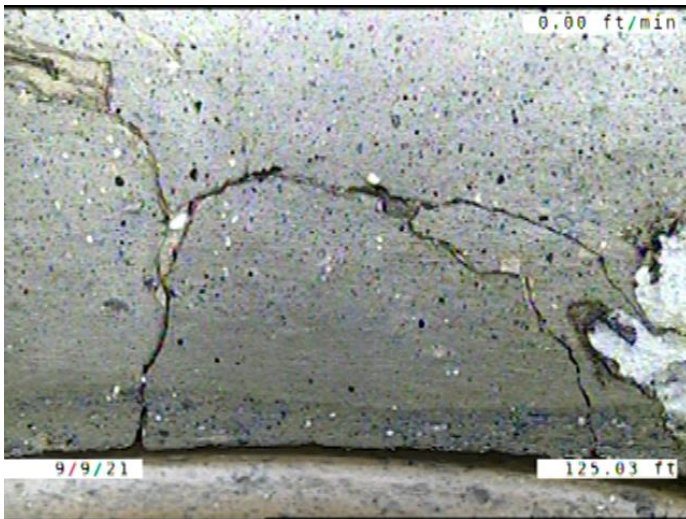
Code: **FM**
Description: **Fracture Multiple**

Distance (ft): **125.0**
Structural Grade: **4**
O&M Grade: **0**
Clock Start/From: **11**
Clock To: **2**
1st Value:
2nd Value:
Value Percent:
Continuous Index:
Within 8" of Joint: **NO**
Remarks:

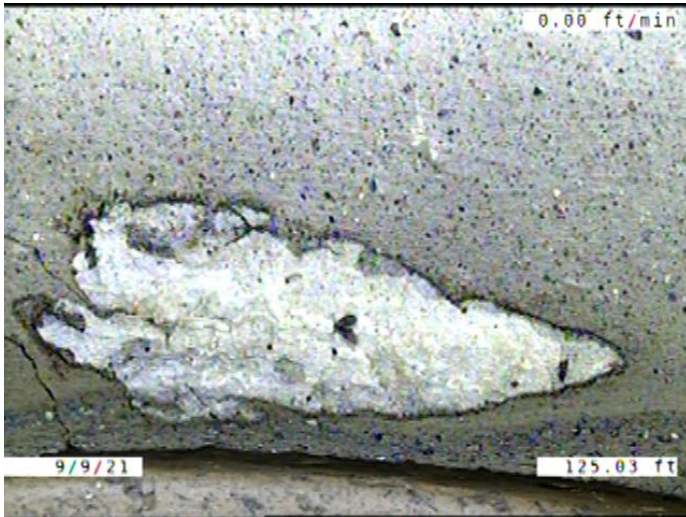
Code: **DAE**
Description: **Deposits Attached Encrustation**

Distance (ft): **125.0**
Structural Grade: **0**
O&M Grade: **2**
Clock Start/From: **1**
Clock To: **2**
1st Value:
2nd Value:
Value Percent: **5.000**
Continuous Index:
Within 8" of Joint: **YES**
Remarks:

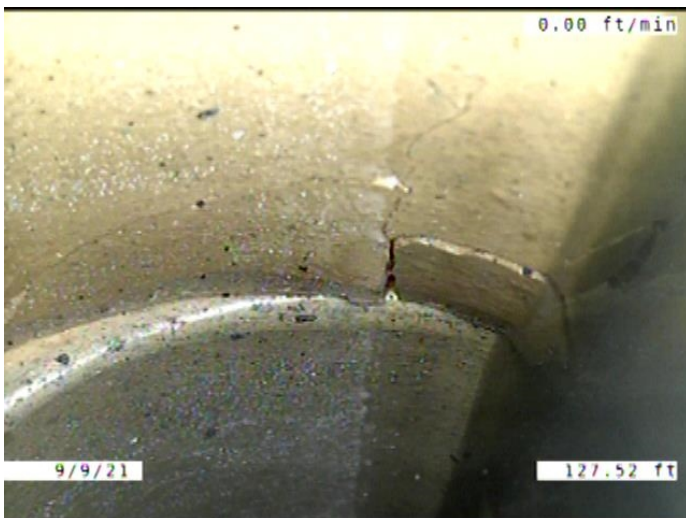
Code: **B**
Description: **Broken**

Distance (ft): **127.5**
Structural Grade: **4**
O&M Grade: **0**
Clock Start/From: **3**
Clock To: **4**
1st Value:
2nd Value:
Value Percent:
Continuous Index:
Within 8" of Joint: **YES**
Remarks:

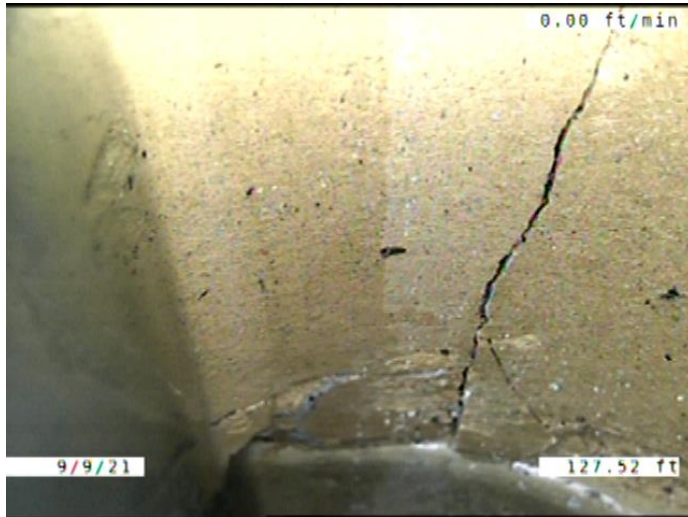
Code: **FM**
 Description: **Fracture Multiple**

Distance (ft): **127.5**
 Structural Grade: **4**
 O&M Grade: **0**
 Clock Start/From: **8**
 Clock To: **3**
 1st Value:
 2nd Value:
 Value Percent:
 Continuous Index:
 Within 8" of Joint: **YES**
 Remarks:
