Profile/Photo Observation Report

Date:	09/09/2021	Weather:		Coding:	PACP 7.0
Pipe Length (ft):	160.0	Owner:	City of Hobart	Pre Clean:	Light Cleaning
P.O.#:	YES502259	Surveyor:	S. Bucklin	PSR:	P-503-031-032
Customer:	City of Hobart	Clean Date:	08/27/2021	Shape:	C

Street:	West 41st Avenue	Flow Control:	Not Controlled
City:	Hobart, IN	Year Renewed:	
Location:	Local rural streets with light traffic, t	Tape/Media #:	
Purpose:	Routine Assessment	Dia/Height:	10"
Use:	Sanitary Sewage Pipe	Material:	VCP
Drain Area:		Lining:	None
Category:	NA		
Comment:			
Location Details:		Direction of Survey:	Upstream
US MH:	M-503-032	DS MH:	M-503-031
		Total Length Surveyed (ft):	160.0

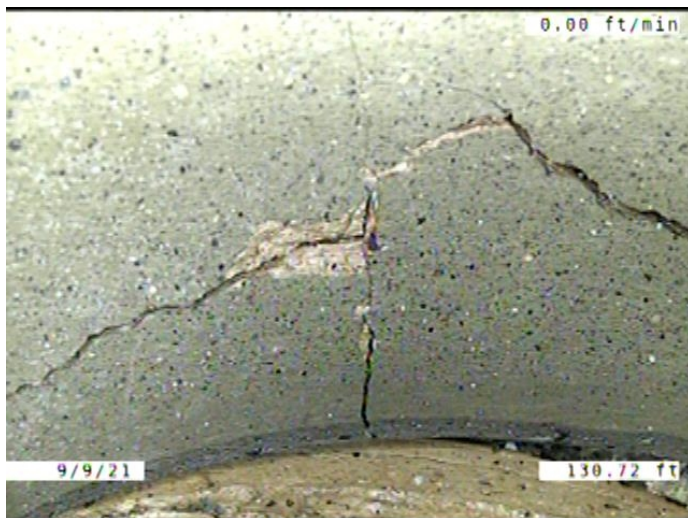
Code: **FM**
 Description: **Fracture Multiple**

Distance (ft): **130.7**
 Structural Grade: **4**
 O&M Grade: **0**
 Clock Start/From: **9**
 Clock To: **3**
 1st Value:
 2nd Value:
 Value Percent:
 Continuous Index:
 Within 8" of Joint: **YES**
 Remarks:

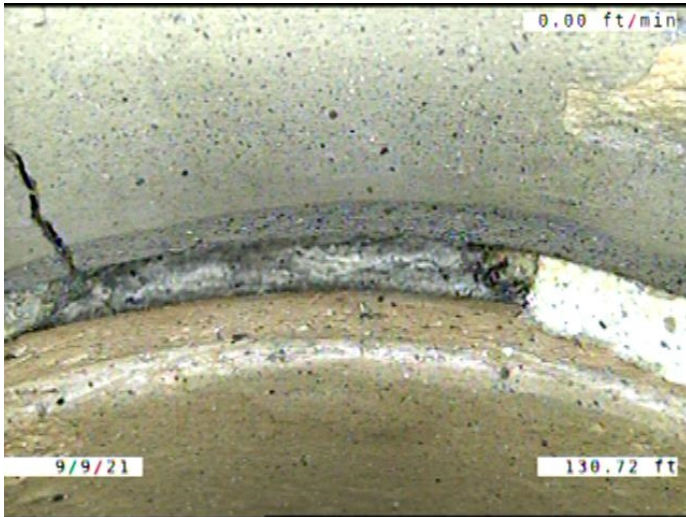
Code: **JOMD**
Description: **Joint Offset Medium Defective**

Distance (ft): **130.7**
Structural Grade: **3**
O&M Grade: **0**
Clock Start/From:
Clock To:
1st Value:
2nd Value:
Value Percent:
Continuous Index:
Within 8" of Joint: **NO**
Remarks:

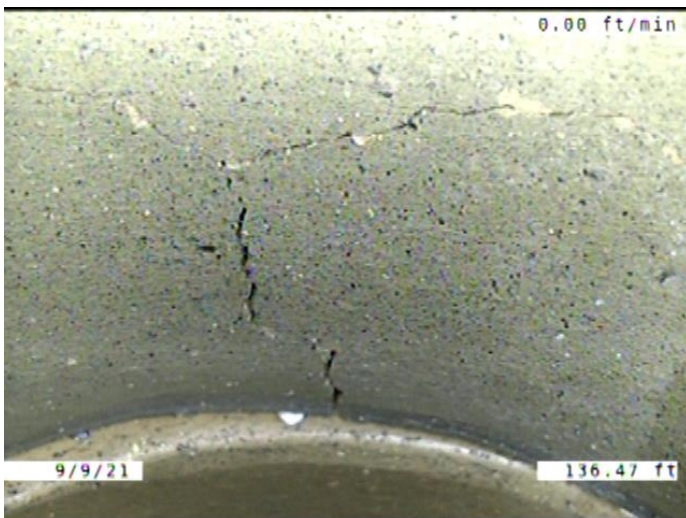
Code: **FM**
Description: **Fracture Multiple**

Distance (ft): **136.5**
Structural Grade: **4**
O&M Grade: **0**
Clock Start/From: **8**
Clock To: **4**
1st Value:
2nd Value:
Value Percent:
Continuous Index:
Within 8" of Joint: **YES**
Remarks:

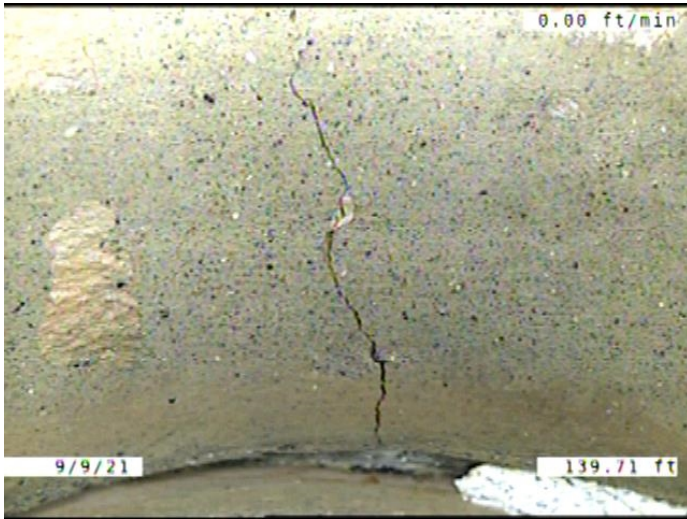
Code: **FM**
Description: **Fracture Multiple**

Distance (ft): **139.7**
Structural Grade: **4**
O&M Grade: **0**
Clock Start/From: **9**
Clock To: **3**
1st Value:
2nd Value:
Value Percent:
Continuous Index:
Within 8" of Joint: **NO**
Remarks:

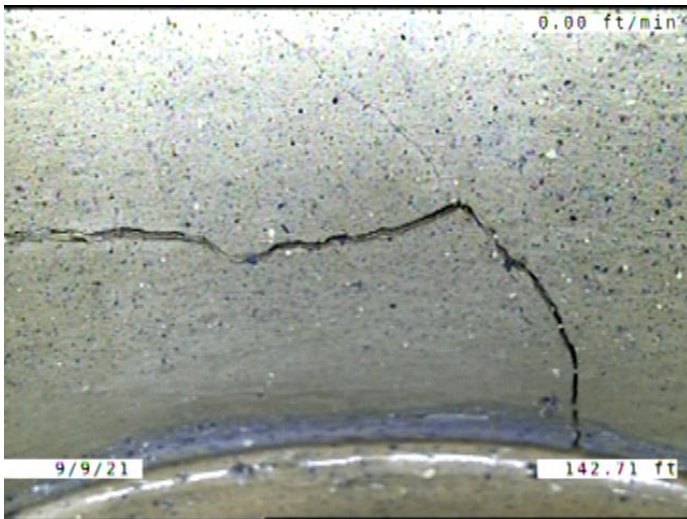
Code: **FM**
Description: **Fracture Multiple**

Distance (ft): **142.7**
Structural Grade: **4**
O&M Grade: **0**
Clock Start/From: **9**
Clock To: **12**
1st Value:
2nd Value:
Value Percent:
Continuous Index:
Within 8" of Joint: **YES**
Remarks:

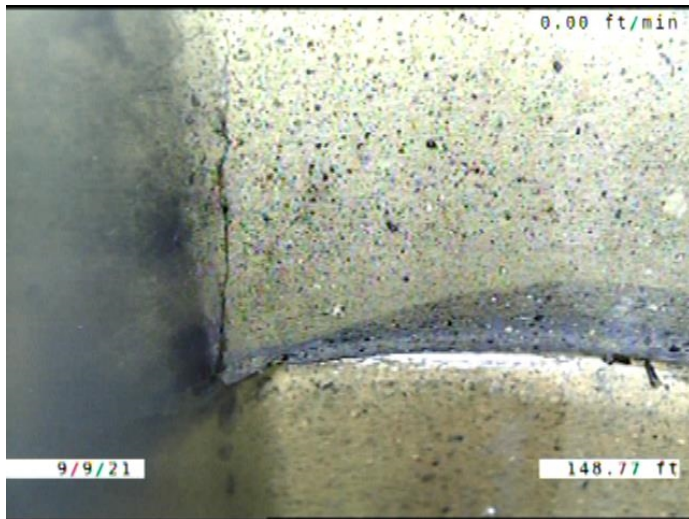
Code: **CM**
Description: **Crack Multiple**

Distance (ft): **148.8**
Structural Grade: **3**
O&M Grade: **0**
Clock Start/From: **8**
Clock To: **4**
1st Value:
2nd Value:
Value Percent:
Continuous Index:
Within 8" of Joint: **YES**
Remarks:

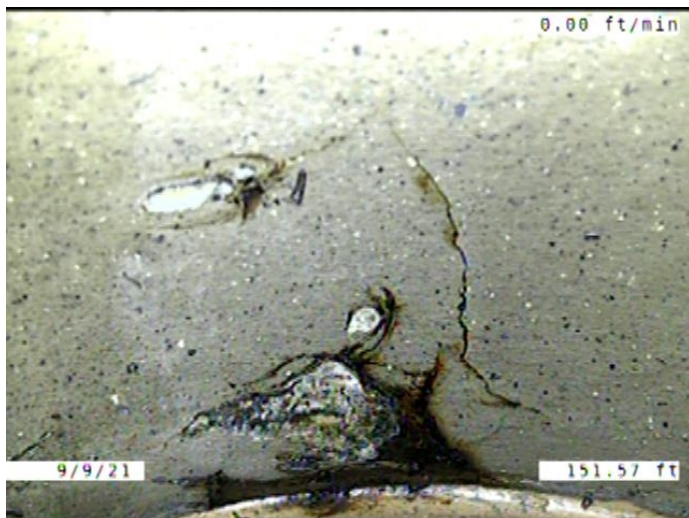
Code: **CM**
Description: **Crack Multiple**

Distance (ft): **151.6**
Structural Grade: **3**
O&M Grade: **0**
Clock Start/From: **8**
Clock To: **4**
1st Value:
2nd Value:
Value Percent:
Continuous Index:
Within 8" of Joint: **YES**
Remarks:

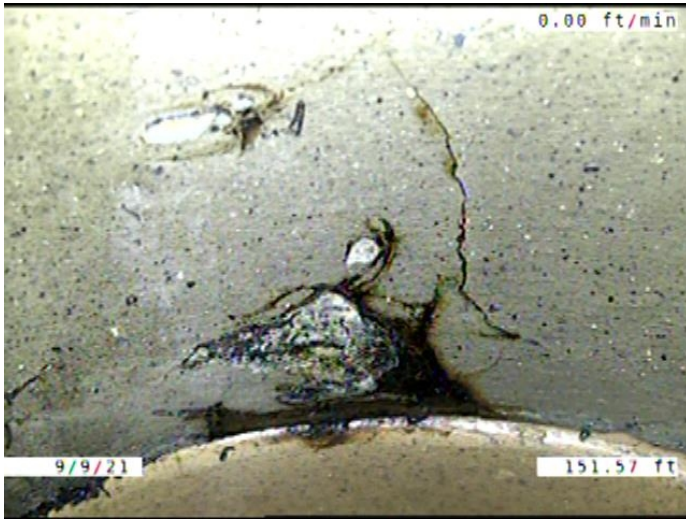
Code: **ISB**
Description: **Infiltration Stain Barrel**

Distance (ft): **151.6**
Structural Grade: **0**
O&M Grade: **1**
Clock Start/From: **9**
Clock To: **10**
1st Value:
2nd Value:
Value Percent:
Continuous Index:
Within 8" of Joint: **YES**
Remarks:

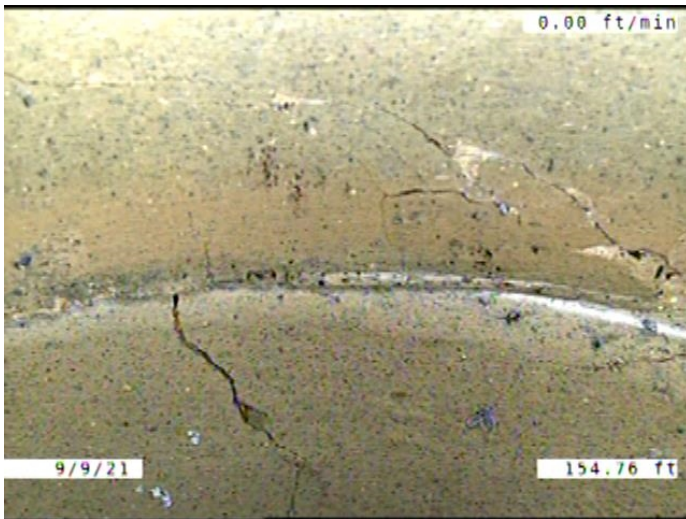
Code: **FM**
Description: **Fracture Multiple**

Distance (ft): **154.8**
Structural Grade: **4**
O&M Grade: **0**
Clock Start/From: **10**
Clock To: **4**
1st Value:
2nd Value:
Value Percent:
Continuous Index:
Within 8" of Joint: **YES**
Remarks:

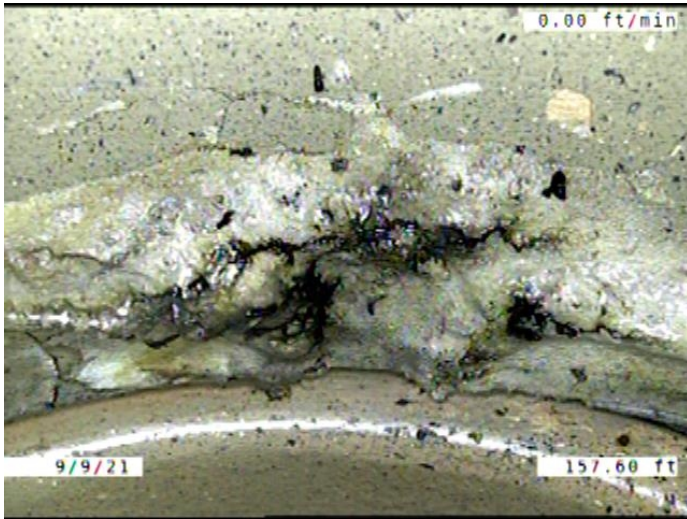
Code: **DAE**
Description: **Deposits Attached Encrustation**

Distance (ft): **157.6**
Structural Grade: **0**
O&M Grade: **2**
Clock Start/From: **9**
Clock To: **3**
1st Value:
2nd Value:
Value Percent: **5.000**
Continuous Index:
Within 8" of Joint: **YES**
Remarks:

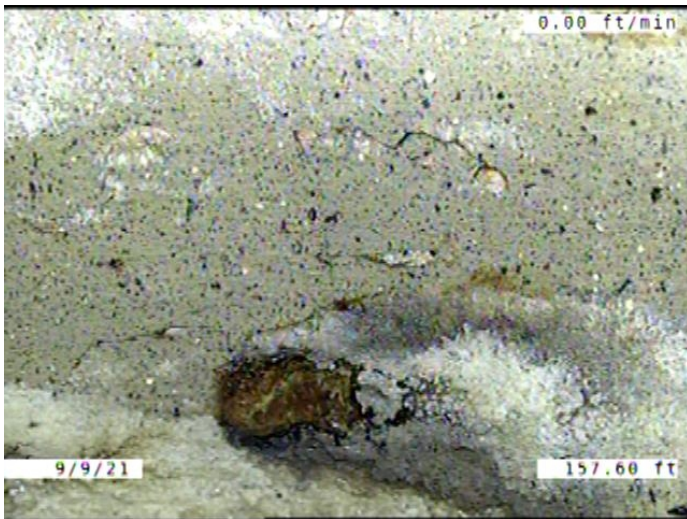
Code: **CM**
Description: **Crack Multiple**

Distance (ft): **157.6**
Structural Grade: **3**
O&M Grade: **0**
Clock Start/From: **10**
Clock To: **2**
1st Value:
2nd Value:
Value Percent:
Continuous Index:
Within 8" of Joint: **YES**
Remarks:

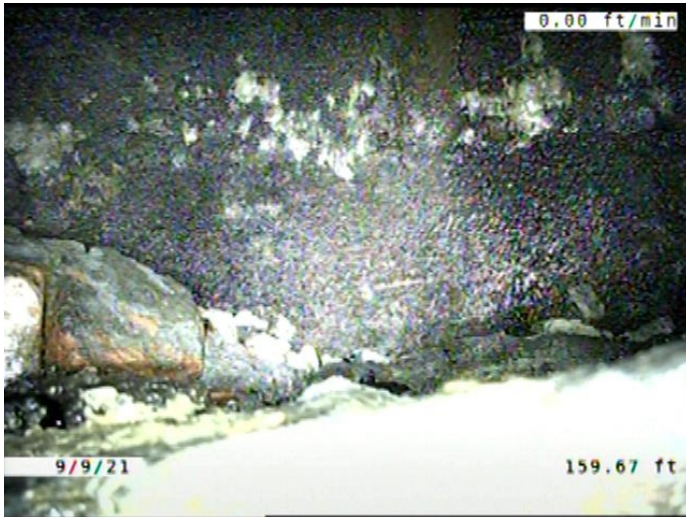
Code: **DSF**
 Description: **Deposits Settled Fine**

Distance (ft): **159.7**
 Structural Grade: **0**
 O&M Grade: **2**
 Clock Start/From: **5**
 Clock To: **7**
 1st Value:
 2nd Value:
 Value Percent: **5.000**
 Continuous Index: **F01**
 Within 8" of Joint: **YES**
 Remarks:
