# Profile/Photo Observation Report

Date:	<b>09/09/2021</b>	Weather:		Coding:	<b>PACP 7.0</b>
Pipe Length (ft):	<b>160.0</b>	Owner:	<b>City of Hobart</b>	Pre Clean:	<b>Light Cleaning</b>
P.O.#:	<b>YES502259</b>	Surveyor:	<b>S. Bucklin</b>	PSR:	<b>P-503-031-032</b>
Customer:	<b>City of Hobart</b>	Clean Date:	<b>08/27/2021</b>	Shape:	<b>C</b>

Street:	<b>West 41st Avenue</b>	Flow Control:	<b>Not Controlled</b>
City:	<b>Hobart, IN</b>	Year Renewed:	
Location:	<b>Local rural streets with light traffic, t</b>	Tape/Media #:	
Purpose:	<b>Routine Assessment</b>	Dia/Height:	<b>10"</b>
Use:	<b>Sanitary Sewage Pipe</b>	Material:	<b>VCP</b>
Drain Area:		Lining:	<b>None</b>
Category:	<b>NA</b>		
Comment:			
Location Details:		Direction of Survey:	<b>Upstream</b>
US MH:	<b>M-503-032</b>	DS MH:	<b>M-503-031</b>
		Total Length Surveyed (ft):	<b>160.0</b>

O&M Index:	<b>1.86</b>	O&M Quick:	<b>312C</b>	O&M Rating:	<b>54.00</b>
Structural Index:	<b>3.71</b>	Structural Quick:	<b>534E</b>	Structural Rating:	<b>193.00</b>
Overall Index:	<b>3.05</b>	Overall Quick:	<b>534E</b>	Overall Rating:	<b>247.00</b>

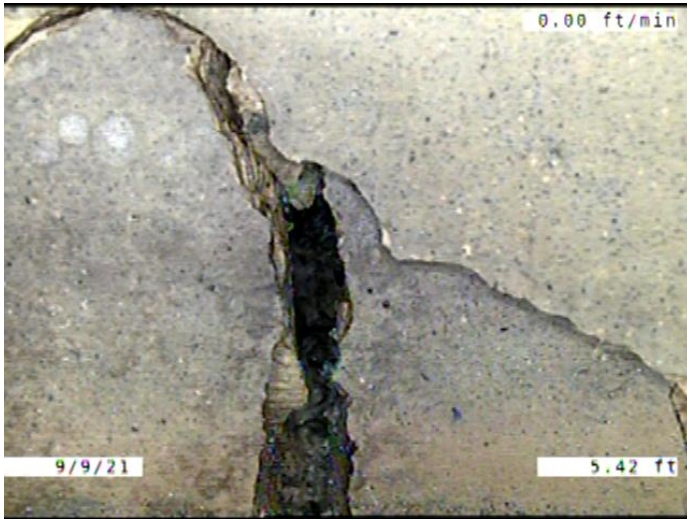
Code: **BSV**  
 Description: **Broken Soil Visible**

Distance (ft): **5.4**  
 Structural Grade: **5**  
 O&M Grade: **0**  
 Clock Start/From: **10**  
 Clock To: **2**  
 1st Value:  
 2nd Value:  
 Value Percent:  
 Continuous Index:  
 Within 8" of Joint: **YES**  
 Remarks:

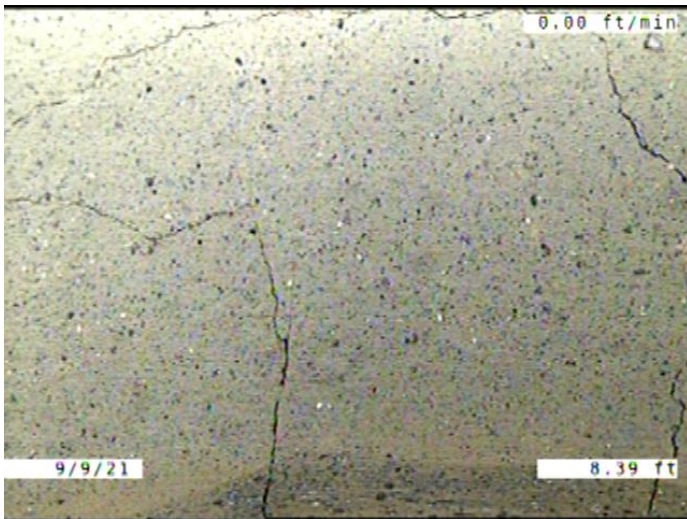
Code: **CM**  
 Description: **Crack Multiple**

Distance (ft): **8.4**  
 Structural Grade: **3**  
 O&M Grade: **0**  
 Clock Start/From: **8**  
 Clock To: **12**  
 1st Value:  
 2nd Value:  
 Value Percent:  
 Continuous Index:  
 Within 8" of Joint: **YES**  
 Remarks:

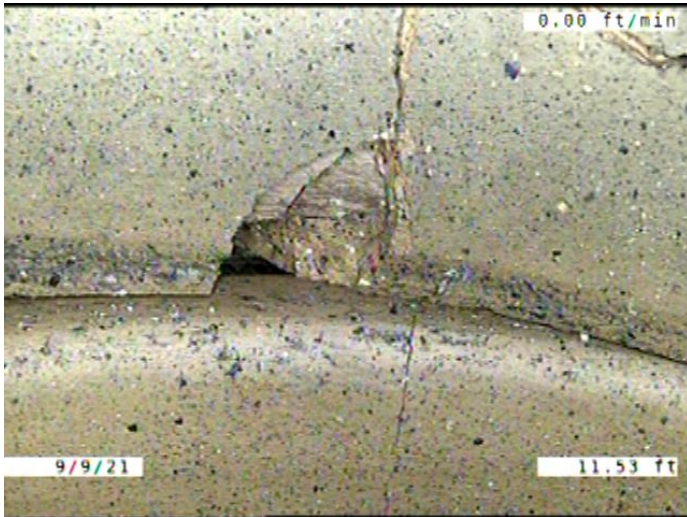
Code: **BVV**  
 Description: **Broken Void Visible**

Distance (ft): **11.5**  
 Structural Grade: **5**  
 O&M Grade: **0**  
 Clock Start/From: **2**  
 Clock To: **4**  
 1st Value:  
 2nd Value:  
 Value Percent:  
 Continuous Index:  
 Within 8" of Joint: **YES**  
 Remarks:

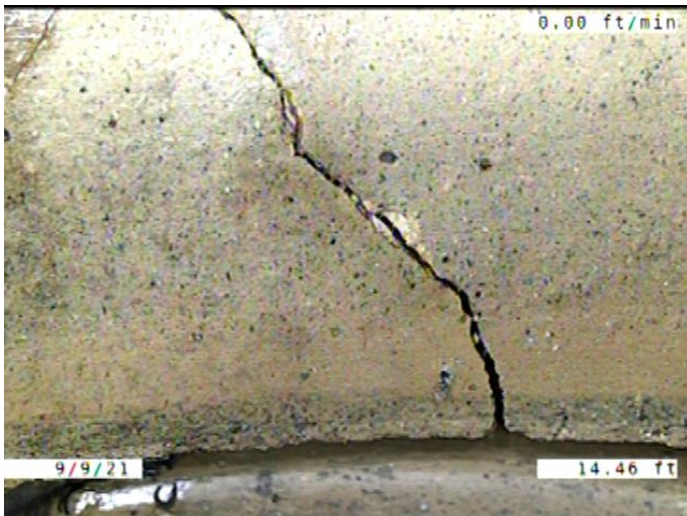
Code: **FM**  
 Description: **Fracture Multiple**

Distance (ft): **14.5**  
 Structural Grade: **4**  
 O&M Grade: **0**  
 Clock Start/From: **7**  
 Clock To: **9**  
 1st Value:  
 2nd Value:  
 Value Percent:  
 Continuous Index:  
 Within 8" of Joint: **YES**  
 Remarks:

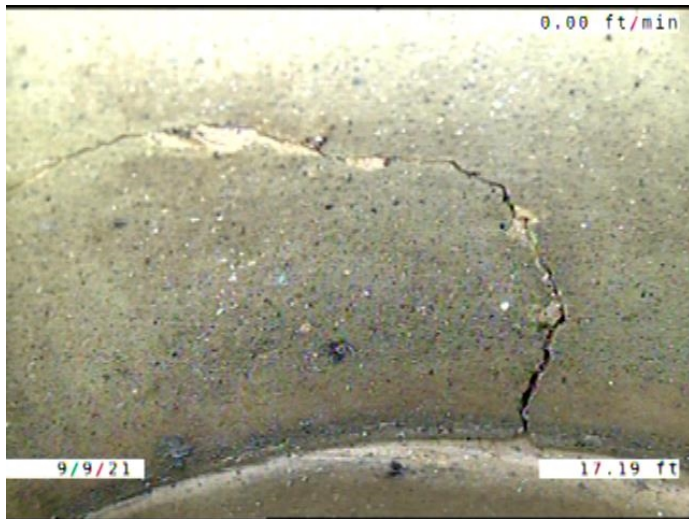
Code: **FM**  
 Description: **Fracture Multiple**

Distance (ft): **17.2**  
 Structural Grade: **4**  
 O&M Grade: **0**  
 Clock Start/From: **7**  
 Clock To: **5**  
 1st Value:  
 2nd Value:  
 Value Percent:  
 Continuous Index:  
 Within 8" of Joint: **YES**  
 Remarks:

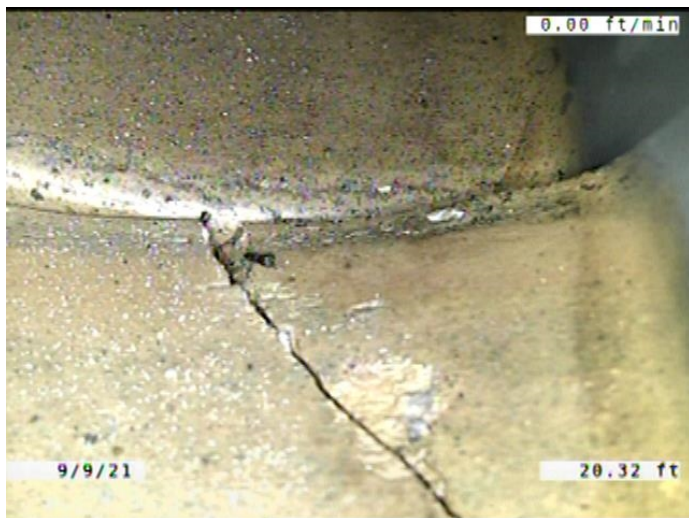
Code: **FM**  
 Description: **Fracture Multiple**

Distance (ft): **20.3**  
 Structural Grade: **4**  
 O&M Grade: **0**  
 Clock Start/From: **7**  
 Clock To: **5**  
 1st Value:  
 2nd Value:  
 Value Percent:  
 Continuous Index:  
 Within 8" of Joint: **YES**  
 Remarks:

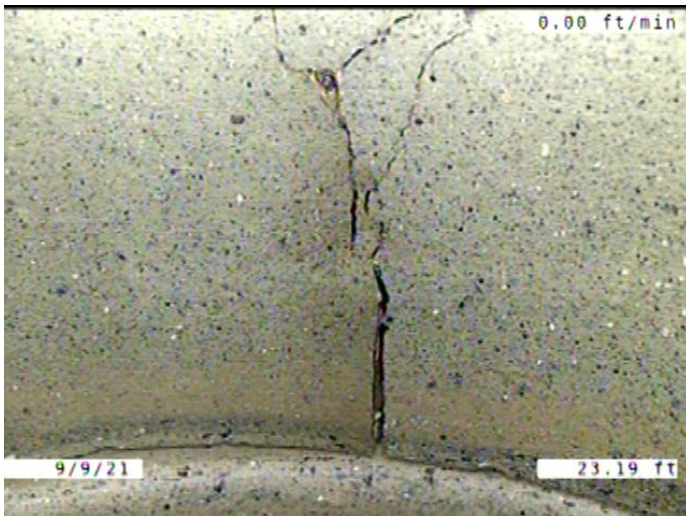
Code: **FM**  
 Description: **Fracture Multiple**

Distance (ft): **23.2**  
 Structural Grade: **4**  
 O&M Grade: **0**  
 Clock Start/From: **10**  
 Clock To: **5**  
 1st Value:  
 2nd Value:  
 Value Percent:  
 Continuous Index:  
 Within 8" of Joint: **YES**  
 Remarks:

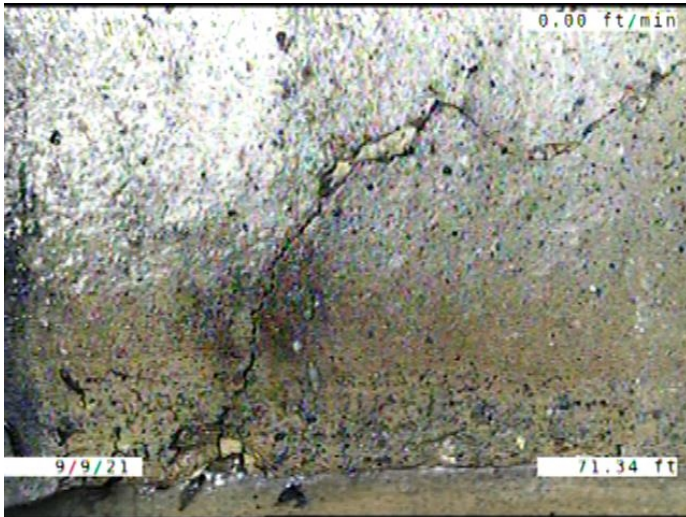
Code: **FM**  
 Description: **Fracture Multiple**

Distance (ft): **71.3**  
 Structural Grade: **4**  
 O&M Grade: **0**  
 Clock Start/From: **8**  
 Clock To: **11**  
 1st Value:  
 2nd Value:  
 Value Percent:  
 Continuous Index:  
 Within 8" of Joint: **YES**  
 Remarks:

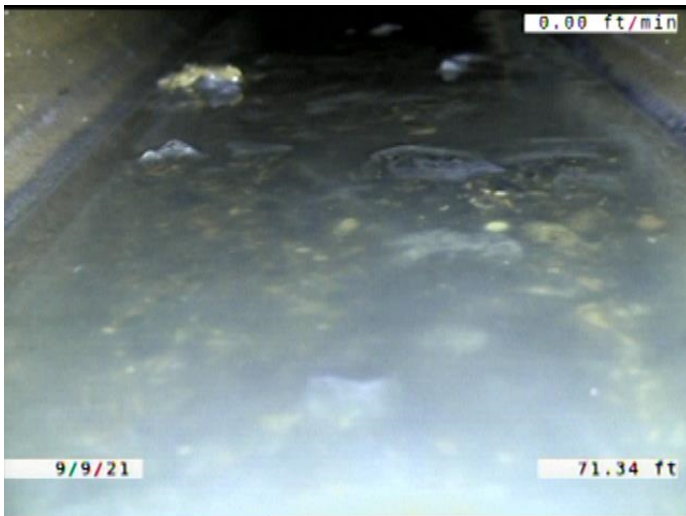
Code: **DSF**  
 Description: **Deposits Settled Fine**

Distance (ft): **71.3**  
 Structural Grade: **0**  
 O&M Grade: **2**  
 Clock Start/From: **5**  
 Clock To: **7**  
 1st Value:  
 2nd Value:  
 Value Percent: **5.000**  
 Continuous Index: **S01**  
 Within 8" of Joint: **YES**  
 Remarks:

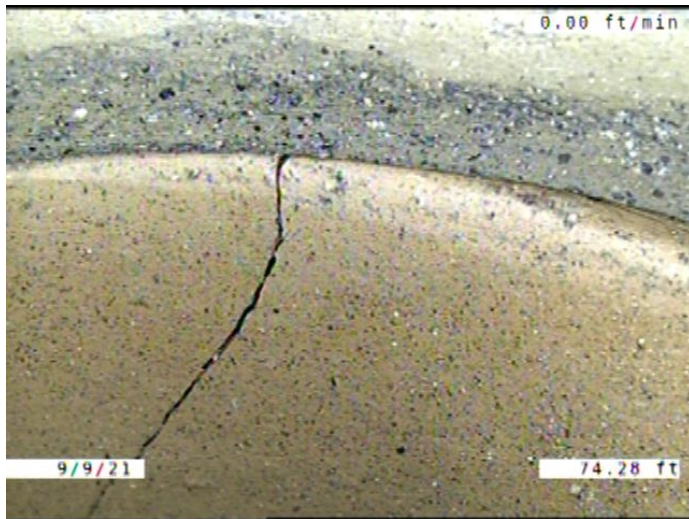
Code: **FS**  
 Description: **Fracture Spiral**

Distance (ft): **74.3**  
 Structural Grade: **3**  
 O&M Grade: **0**  
 Clock Start/From: **1**  
 Clock To: **2**  
 1st Value:  
 2nd Value:  
 Value Percent:  
 Continuous Index:  
 Within 8" of Joint: **YES**  
 Remarks:

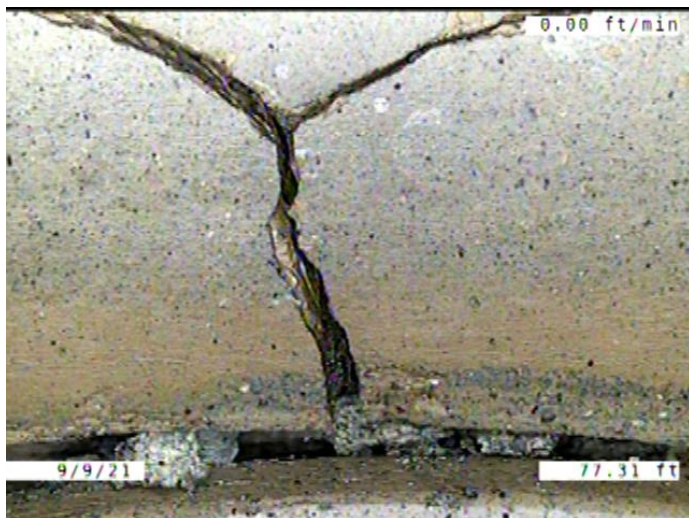
Code: **B**  
 Description: **Broken**

Distance (ft): **77.3**  
 Structural Grade: **4**  
 O&M Grade: **0**  
 Clock Start/From: **8**  
 Clock To: **12**  
 1st Value:  
 2nd Value:  
 Value Percent:  
 Continuous Index:  
 Within 8" of Joint: **YES**  
 Remarks:

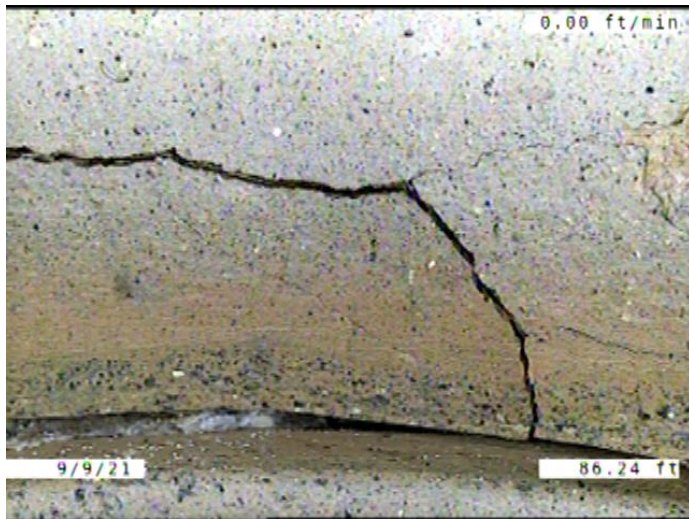
Code: **FM**  
 Description: **Fracture Multiple**

Distance (ft): **86.2**  
 Structural Grade: **4**  
 O&M Grade: **0**  
 Clock Start/From: **7**  
 Clock To: **5**  
 1st Value:  
 2nd Value:  
 Value Percent:  
 Continuous Index:  
 Within 8" of Joint: **YES**  
 Remarks:

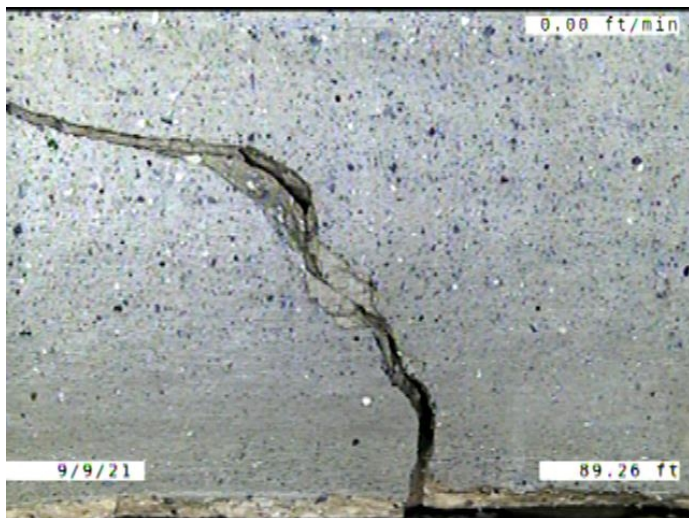
Code: **B**  
 Description: **Broken**

Distance (ft): **89.3**  
 Structural Grade: **4**  
 O&M Grade: **0**  
 Clock Start/From: **1**  
 Clock To: **11**  
 1st Value:  
 2nd Value:  
 Value Percent:  
 Continuous Index:  
 Within 8" of Joint: **YES**  
 Remarks:

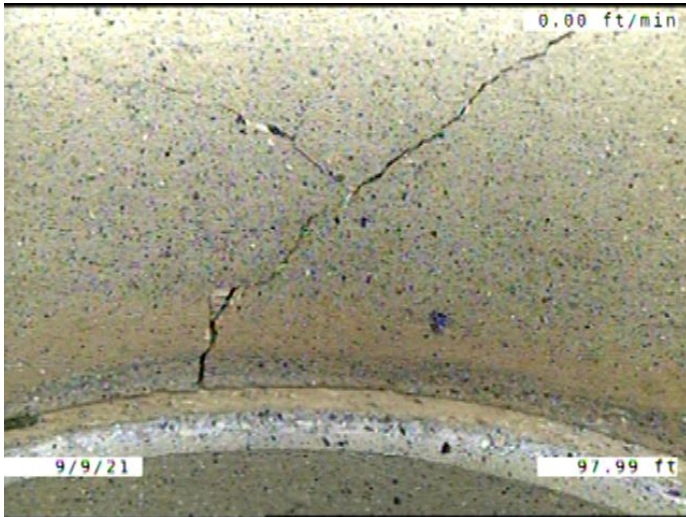
Code: **FM**  
 Description: **Fracture Multiple**

Distance (ft): **98.0**  
 Structural Grade: **4**  
 O&M Grade: **0**  
 Clock Start/From: **9**  
 Clock To: **2**  
 1st Value:  
 2nd Value:  
 Value Percent:  
 Continuous Index:  
 Within 8" of Joint: **YES**  
 Remarks:

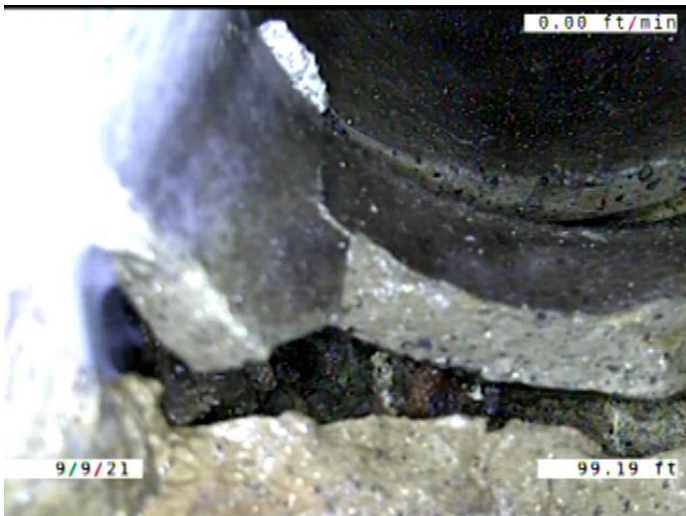
Code: **BSV**  
 Description: **Broken Soil Visible**

Distance (ft): **99.2**  
 Structural Grade: **5**  
 O&M Grade: **0**  
 Clock Start/From: **11**  
 Clock To:  
 1st Value:  
 2nd Value:  
 Value Percent:  
 Continuous Index:  
 Within 8" of Joint: **YES**  
 Remarks:

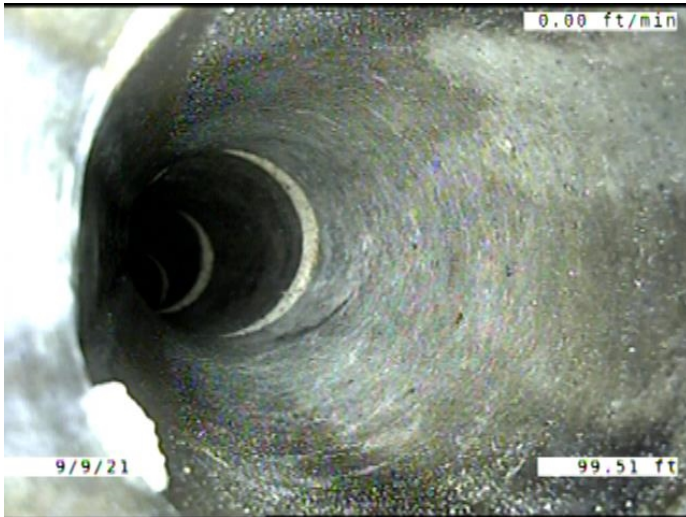
Code: **TBD**  
 Description: **Tap Break-in/Hammer Defective**

Distance (ft): **99.5**  
 Structural Grade: **0**  
 O&M Grade: **3**  
 Clock Start/From: **9**  
 Clock To:  
 1st Value: **4.000**  
 2nd Value:  
 Value Percent:  
 Continuous Index:  
 Within 8" of Joint: **YES**  
 Remarks: **Defective**

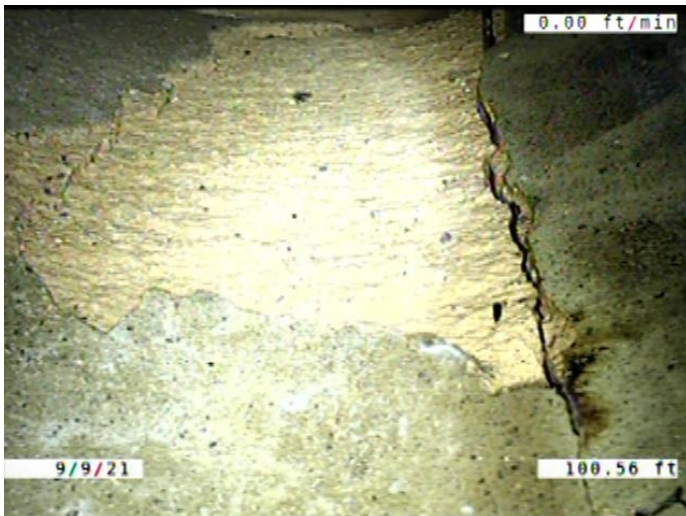
Code: **SSS**  
 Description: **Surface Damage Surface Spalling**

Distance (ft): **100.6**  
 Structural Grade: **2**  
 O&M Grade: **0**  
 Clock Start/From: **8**  
 Clock To: **9**  
 1st Value:  
 2nd Value:  
 Value Percent:  
 Continuous Index:  
 Within 8" of Joint: **YES**  
 Remarks:

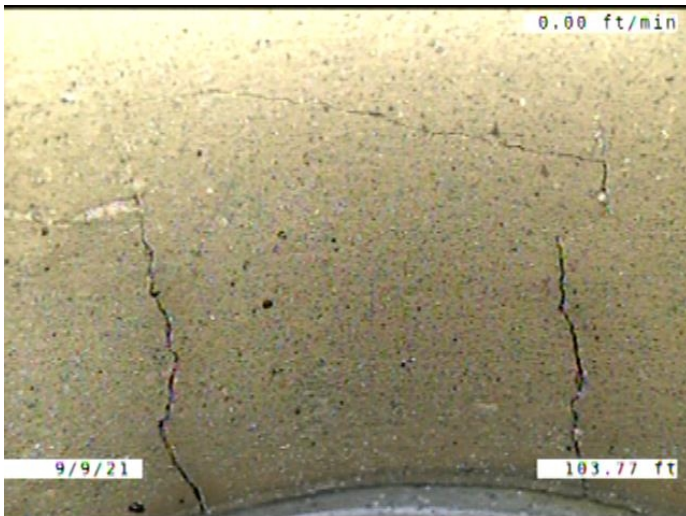
Code: **FM**  
Description: **Fracture Multiple**

Distance (ft): **103.8**  
Structural Grade: **4**  
O&M Grade: **0**  
Clock Start/From: **7**  
Clock To: **5**  
1st Value:  
2nd Value:  
Value Percent:  
Continuous Index:  
Within 8" of Joint: **YES**  
Remarks:

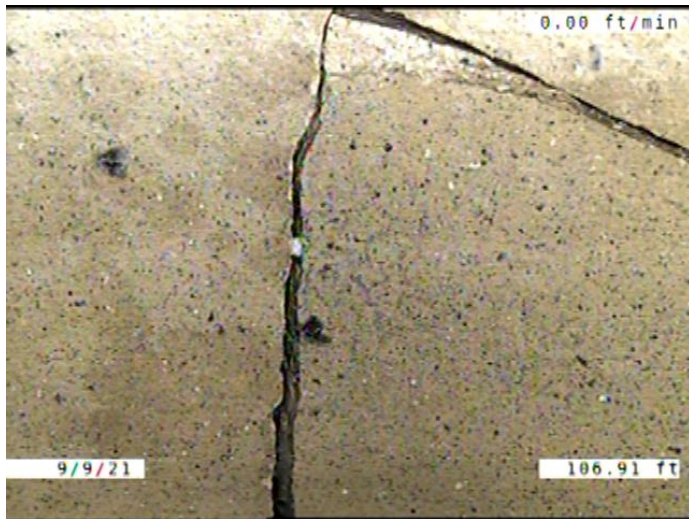
Code: **B**  
Description: **Broken**

Distance (ft): **106.9**  
Structural Grade: **4**  
O&M Grade: **0**  
Clock Start/From: **1**  
Clock To: **4**  
1st Value:  
2nd Value:  
Value Percent:  
Continuous Index:  
Within 8" of Joint: **YES**  
Remarks:

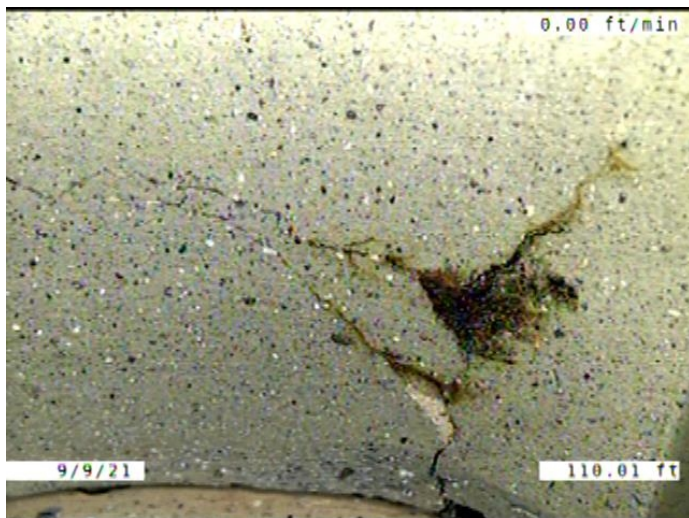
Code: **FM**  
Description: **Fracture Multiple**

Distance (ft): **110.0**  
Structural Grade: **4**  
O&M Grade: **0**  
Clock Start/From: **9**  
Clock To: **3**  
1st Value:  
2nd Value:  
Value Percent:  
Continuous Index:  
Within 8" of Joint: **YES**  
Remarks:

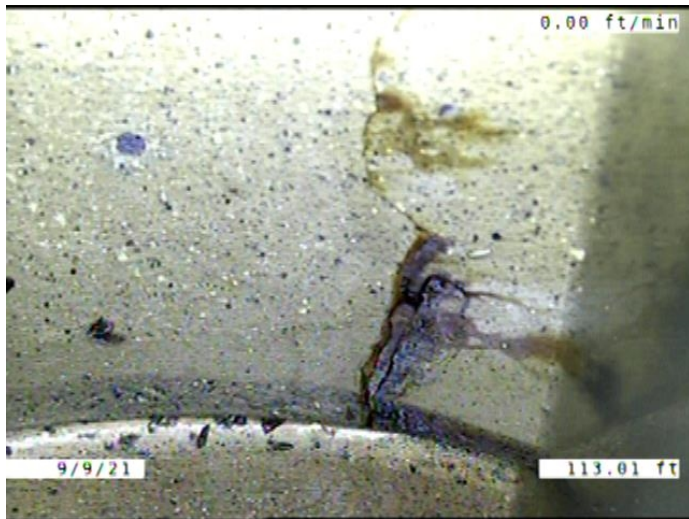
Code: **CM**  
 Description: **Crack Multiple**

Distance (ft): **113.0**  
 Structural Grade: **3**  
 O&M Grade: **0**  
 Clock Start/From: **3**  
 Clock To: **4**  
 1st Value:  
 2nd Value:  
 Value Percent:  
 Continuous Index:  
 Within 8" of Joint: **YES**  
 Remarks:

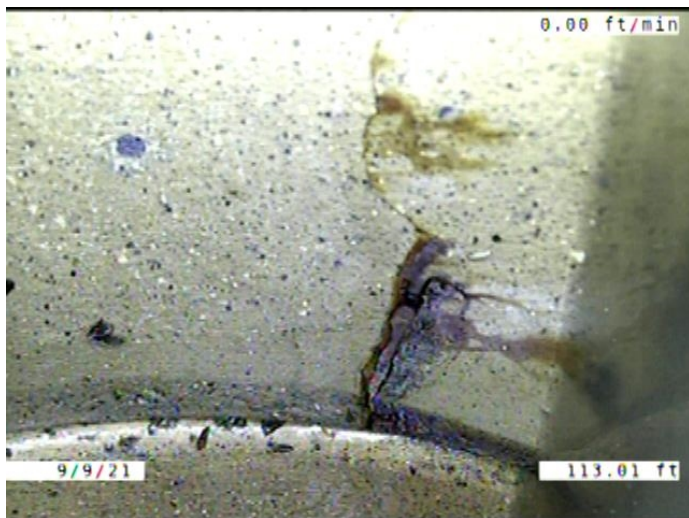
Code: **ISB**  
 Description: **Infiltration Stain Barrel**

Distance (ft): **113.0**  
 Structural Grade: **0**  
 O&M Grade: **1**  
 Clock Start/From: **3**  
 Clock To: **4**  
 1st Value:  
 2nd Value:  
 Value Percent:  
 Continuous Index:  
 Within 8" of Joint: **YES**  
 Remarks:

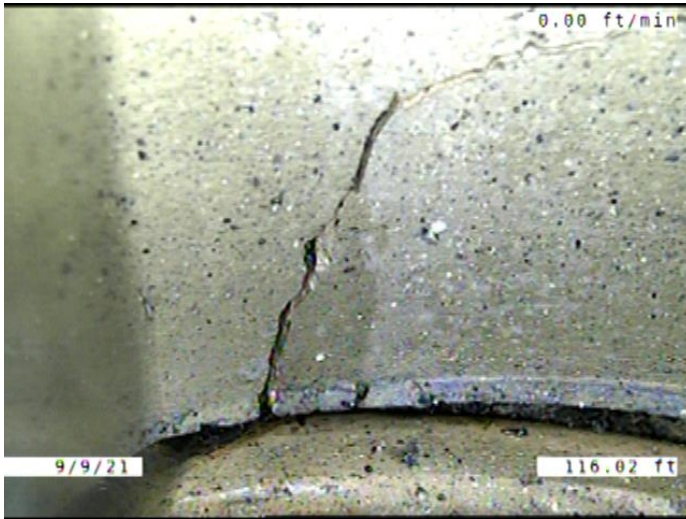
Code: **B**  
Description: **Broken**

Distance (ft): **116.0**  
Structural Grade: **4**  
O&M Grade: **0**  
Clock Start/From: **8**  
Clock To: **4**  
1st Value:  
2nd Value:  
Value Percent:  
Continuous Index:  
Within 8" of Joint: **YES**  
Remarks:

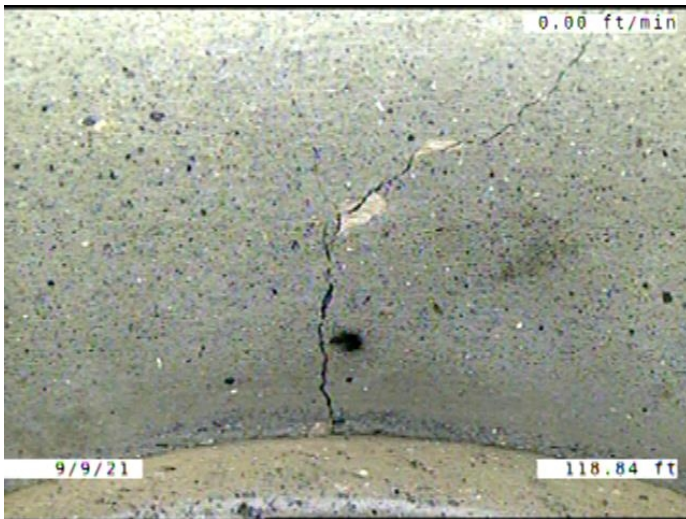
Code: **CM**  
Description: **Crack Multiple**

Distance (ft): **118.8**  
Structural Grade: **3**  
O&M Grade: **0**  
Clock Start/From: **9**  
Clock To: **4**  
1st Value:  
2nd Value:  
Value Percent:  
Continuous Index:  
Within 8" of Joint: **YES**  
Remarks:

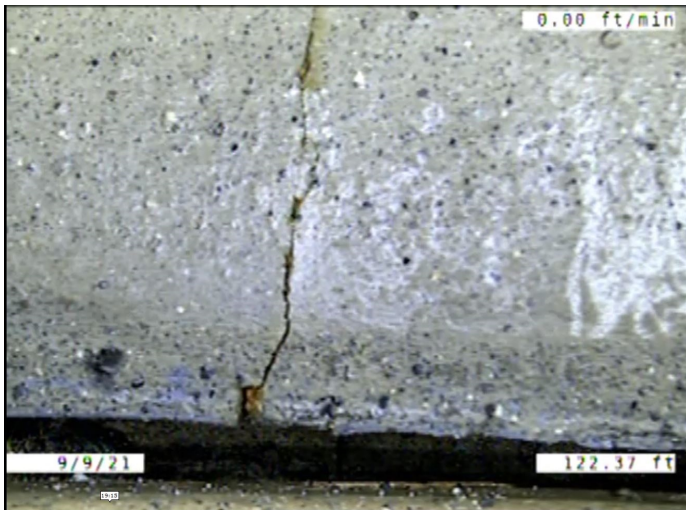
Code: **CM**  
Description: **Crack Multiple**

Distance (ft): **122.4**  
Structural Grade: **3**  
O&M Grade: **0**  
Clock Start/From: **12**  
Clock To: **4**  
1st Value:  
2nd Value:  
Value Percent:  
Continuous Index:  
Within 8" of Joint: **YES**  
Remarks:

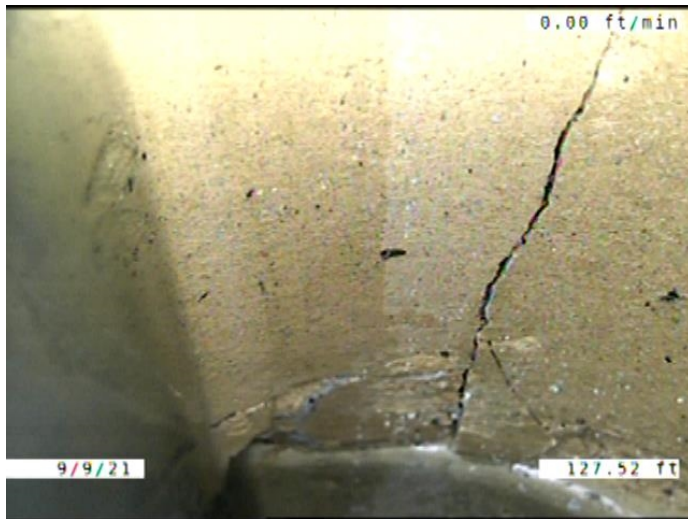
Code: **FM**  
 Description: **Fracture Multiple**

Distance (ft): **127.5**  
 Structural Grade: **4**  
 O&M Grade: **0**  
 Clock Start/From: **8**  
 Clock To: **3**  
 1st Value:  
 2nd Value:  
 Value Percent:  
 Continuous Index:  
 Within 8" of Joint: **YES**  
 Remarks:

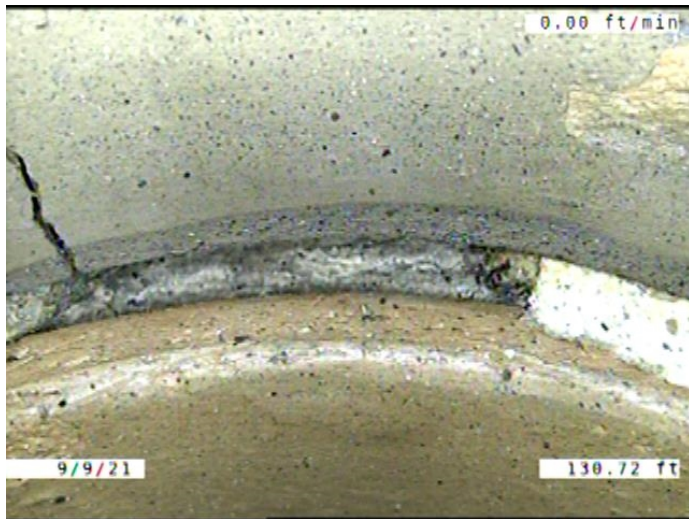
Code: **JOMD**  
 Description: **Joint Offset Medium Defective**

Distance (ft): **130.7**  
 Structural Grade: **3**  
 O&M Grade: **0**  
 Clock Start/From:  
 Clock To:  
 1st Value:  
 2nd Value:  
 Value Percent:  
 Continuous Index:  
 Within 8" of Joint: **NO**  
 Remarks:

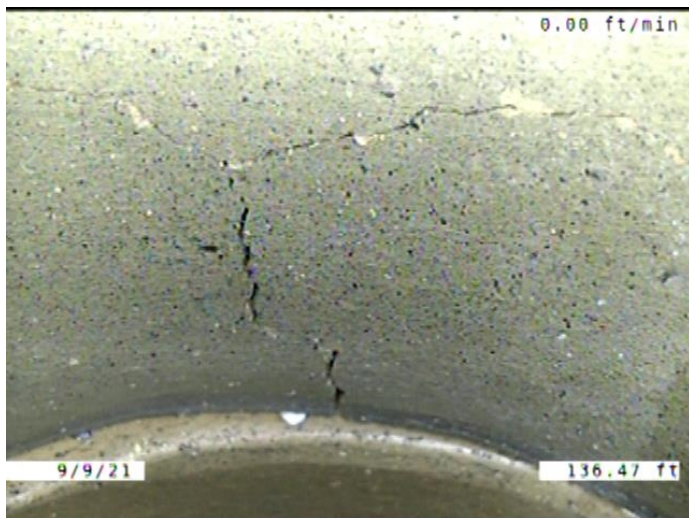
Code: **FM**  
 Description: **Fracture Multiple**

Distance (ft): **136.5**  
 Structural Grade: **4**  
 O&M Grade: **0**  
 Clock Start/From: **8**  
 Clock To: **4**  
 1st Value:  
 2nd Value:  
 Value Percent:  
 Continuous Index:  
 Within 8" of Joint: **YES**  
 Remarks:

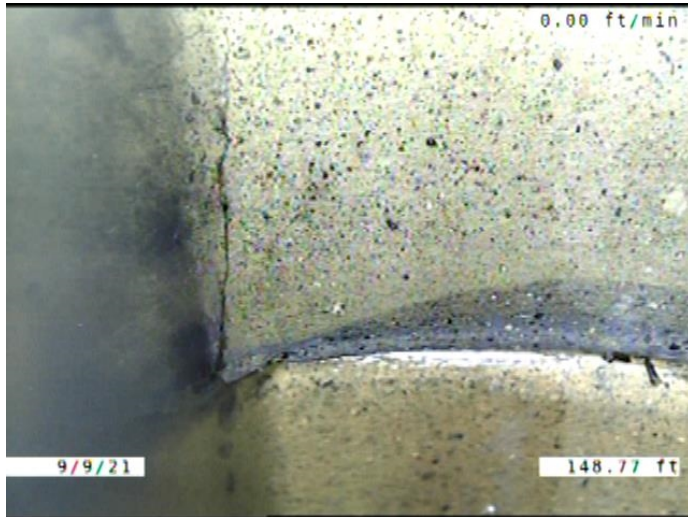
Code: **CM**  
 Description: **Crack Multiple**

Distance (ft): **148.8**  
 Structural Grade: **3**  
 O&M Grade: **0**  
 Clock Start/From: **8**  
 Clock To: **4**  
 1st Value:  
 2nd Value:  
 Value Percent:  
 Continuous Index:  
 Within 8" of Joint: **YES**  
 Remarks:

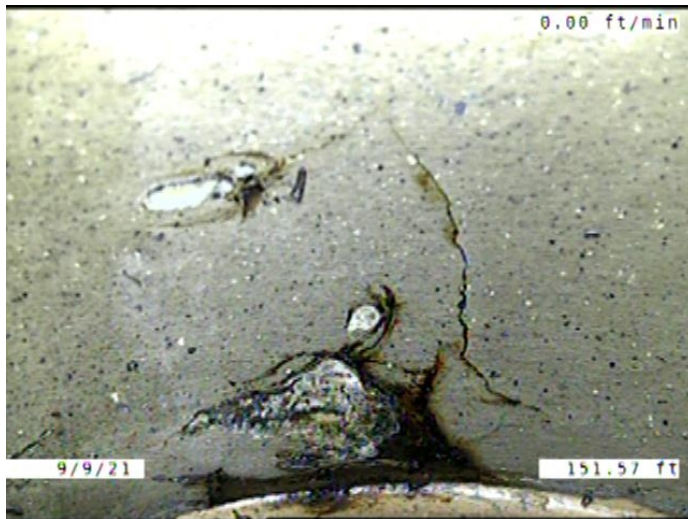
Code: **CM**  
 Description: **Crack Multiple**

Distance (ft): **151.6**  
 Structural Grade: **3**  
 O&M Grade: **0**  
 Clock Start/From: **8**  
 Clock To: **4**  
 1st Value:  
 2nd Value:  
 Value Percent:  
 Continuous Index:  
 Within 8" of Joint: **YES**  
 Remarks:

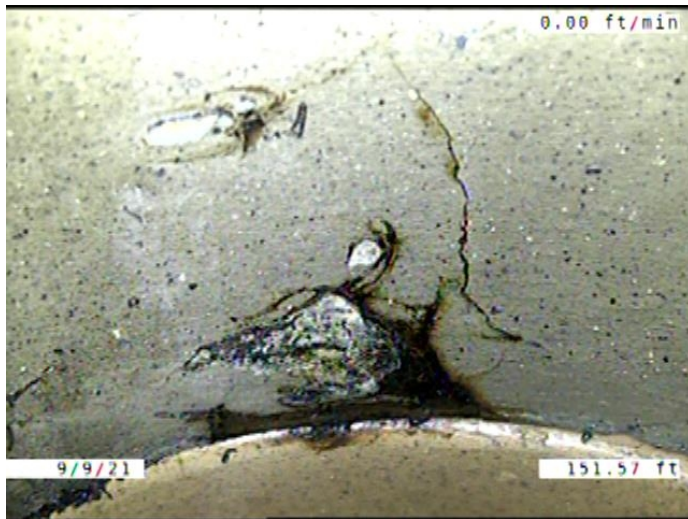
Code: **ISB**  
 Description: **Infiltration Stain Barrel**

Distance (ft): **151.6**  
 Structural Grade: **0**  
 O&M Grade: **1**  
 Clock Start/From: **9**  
 Clock To: **10**  
 1st Value:  
 2nd Value:  
 Value Percent:  
 Continuous Index:  
 Within 8" of Joint: **YES**  
 Remarks:

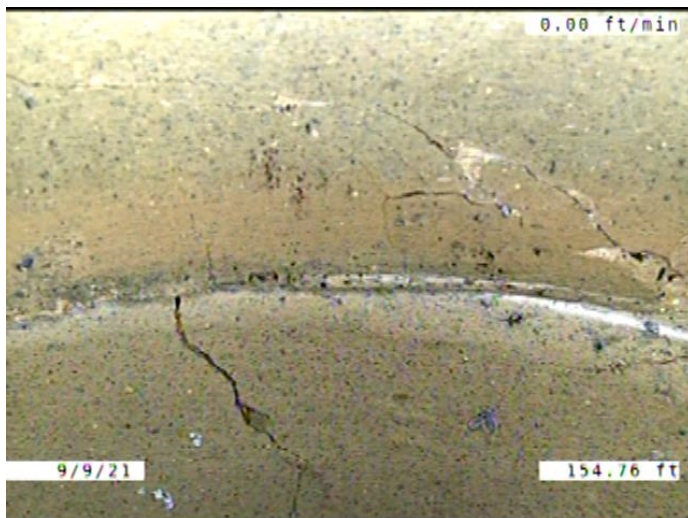
Code: **FM**  
 Description: **Fracture Multiple**

Distance (ft): **154.8**  
 Structural Grade: **4**  
 O&M Grade: **0**  
 Clock Start/From: **10**  
 Clock To: **4**  
 1st Value:  
 2nd Value:  
 Value Percent:  
 Continuous Index:  
 Within 8" of Joint: **YES**  
 Remarks:
