Profile/Photo Observation Report

Street:	W 41ST AVE	Flow Control:	Not Controlled
City:	Hobart, IN	Year Renewed:	
Location:	Other	Tape/Media #:	
Purpose:	Not Known	Dia/Height:	10"
Use:	Sanitary	Material:	CP
Drain Area:	NA	Lining:	
Category:	NA		
Comment:

Location Details:		Direction of Survey:	Downstream
US MH:	M-503-032	DS MH:	M-503-033
		Total Length Surveyed (ft):	29.1

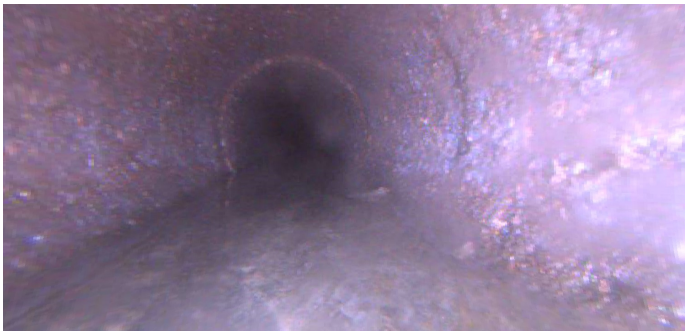
Code: **AMH**
Description: **Manhole**

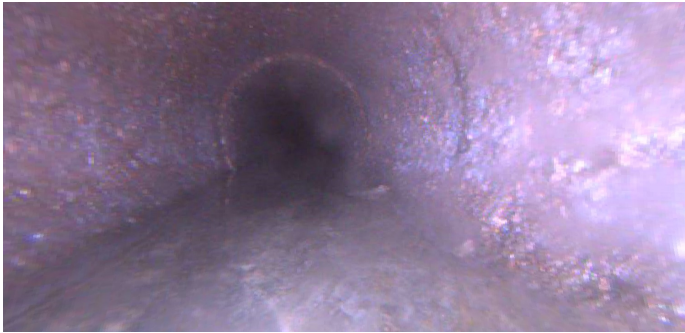
Code:	MWL
Description:	Water Level

Distance (ft):	.0
Structural Grade:	0
O&M Grade:	0
Clock Start/From:	
Clock To:	
1st Value:	
2nd Value:	
Value Percent:	5.000
Continuous Index:	
Within 8" of Joint:	NO
Remarks:

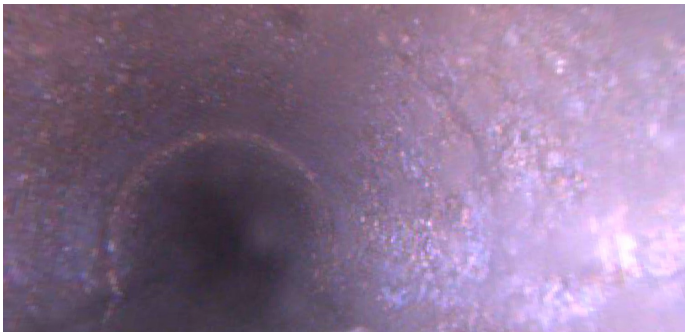
Code:	CC
Description:	Crack Circumferential

Distance (ft):	.0
Structural Grade:	1
O&M Grade:	0
Clock Start/From:	1
Clock To:	5
1st Value:	
2nd Value:	
Value Percent:	
Continuous Index:	
Within 8" of Joint:	
Remarks:

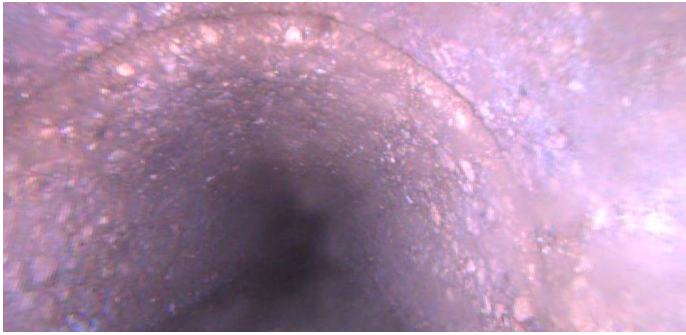
Code: **SAV**
Description: **Surface Aggregate Visible**

Distance (ft): **2.5**
Structural Grade: **3**
O&M Grade: **0**
Clock Start/From: **7**
Clock To: **5**
1st Value:
2nd Value:
Value Percent:
Continuous Index: **S01**
Within 8" of Joint:
Remarks:

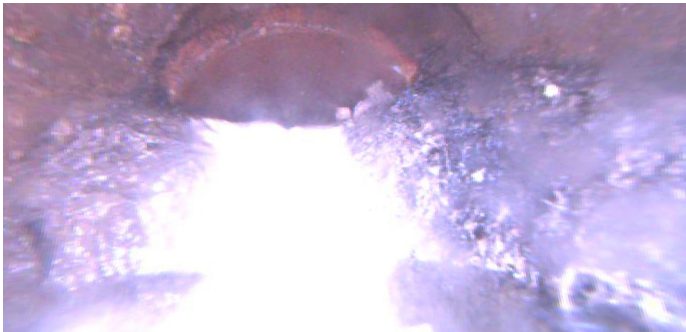
Code: **RBJ**
Description: **Roots Ball Joint**

Distance (ft): **28.5**
Structural Grade: **0**
O&M Grade: **4**
Clock Start/From: **2**
Clock To: **10**
1st Value:
2nd Value:
Value Percent: **75.000**
Continuous Index:
Within 8" of Joint: **YES**
Remarks:

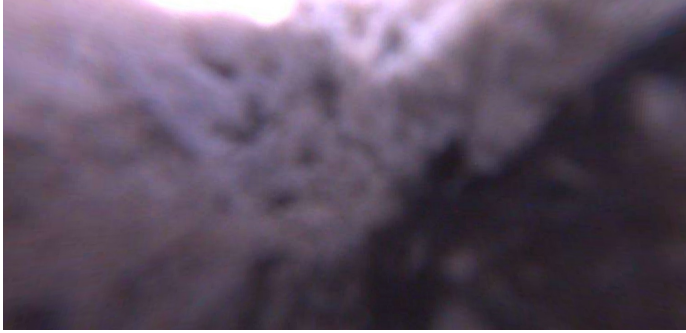
Code: **MSA**
Description: **Abandoned Survey**

Distance (ft): **29.1**
Structural Grade: **0**
O&M Grade: **0**
Clock Start/From:
Clock To:
1st Value:
2nd Value:
Value Percent:
Continuous Index:
Within 8" of Joint: **NO**
Remarks: **rbj**

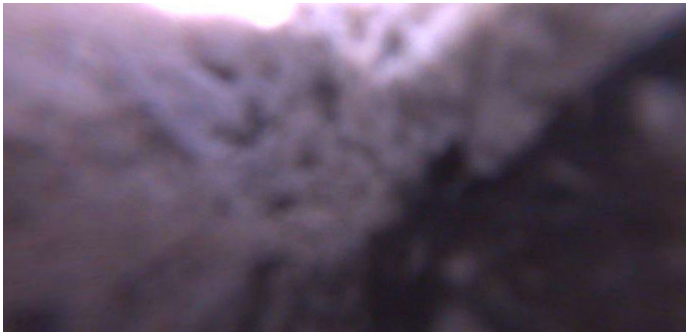
Code: **SAV**
Description: **Surface Aggregate Visible**

Distance (ft): **29.1**
Structural Grade: **3**
O&M Grade: **0**
Clock Start/From: **7**
Clock To: **5**
1st Value:
2nd Value:
Value Percent:
Continuous Index: **F01**
Within 8" of Joint:
Remarks:
