Profile/Photo Observation Report

Date:	04/09/2018	Weather:		Coding:	PACP 6.0
Pipe Length (ft):	331.2	Owner:	NA	Pre Clean:	Not Known
P.O.#:		Surveyor:	Byrd Fitzgerald	PSR:	P-503-033-032
Customer:		Clean Date:	01/01/1900	Shape:	C

Street:	W 40th ave	Flow Control:	Not Controlled
City:	Hobart, IN	Year Renewed:	
Location:	Other	Tape/Media #:	
Purpose:	Not Known	Dia/Height:	10"
Use:	Sanitary	Material:	CP
Drain Area:	NA	Lining:	
Category:	NA		
Comment:

Location Details:		Direction of Survey:	Downstream
US MH:	M-503-032	DS MH:	M-503-033
		Total Length Surveyed (ft):	29.1

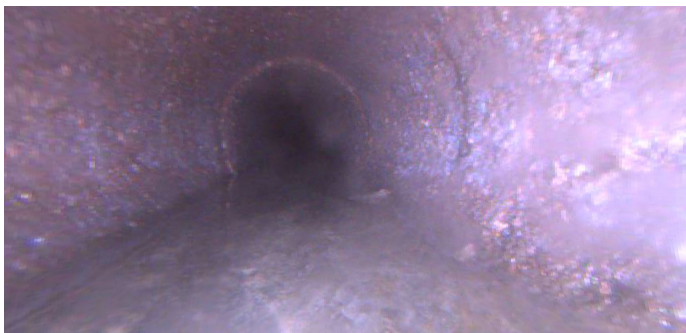
Code: **AMH**
Description: **Manhole**

Distance (ft): **.0**
Structural Grade: **0**
O&M Grade: **0**
Clock Start/From:
Clock To:
1st Value:
2nd Value:
Value Percent:
Continuous Index:
Within 8" of Joint: **NO**
Remarks: **M-503-032**

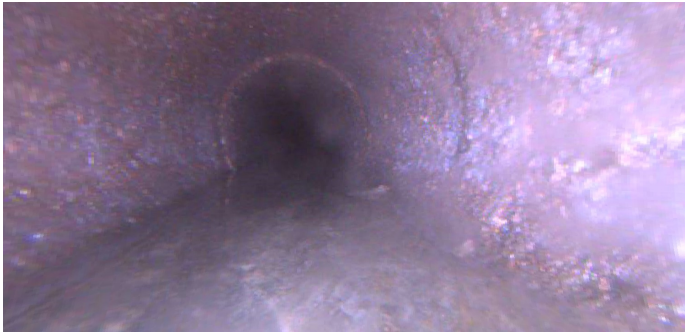
Code:	MWL
Description:	Water Level

Distance (ft):	.0
Structural Grade:	0
O&M Grade:	0
Clock Start/From:	
Clock To:	
1st Value:	
2nd Value:	
Value Percent:	5.000
Continuous Index:	
Within 8" of Joint:	NO
Remarks:

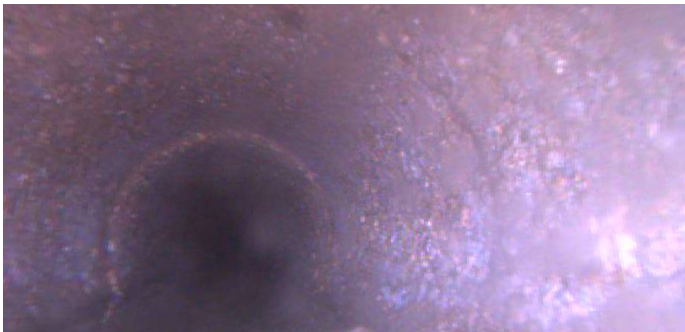
Code:	CC
Description:	Crack Circumferential

Distance (ft):	.0
Structural Grade:	1
O&M Grade:	0
Clock Start/From:	1
Clock To:	5
1st Value:	
2nd Value:	
Value Percent:	
Continuous Index:	
Within 8" of Joint:	
Remarks:

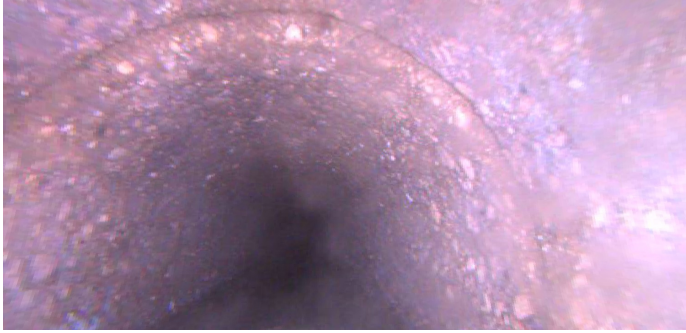
Code: **SAV**
Description: **Surface Aggregate Visible**

Distance (ft): **2.5**
Structural Grade: **3**
O&M Grade: **0**
Clock Start/From: **7**
Clock To: **5**
1st Value:
2nd Value:
Value Percent:
Continuous Index: **S01**
Within 8" of Joint:
Remarks:

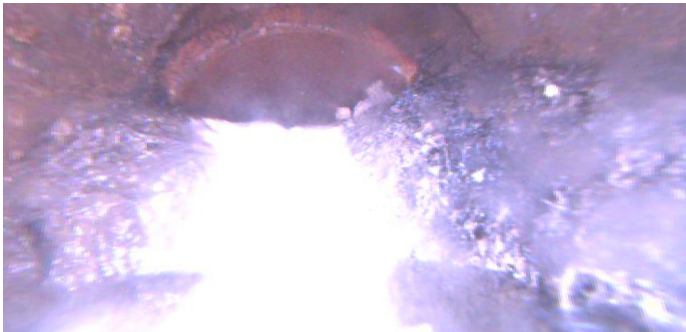
Code: **RBJ**
Description: **Roots Ball Joint**

Distance (ft): **28.5**
Structural Grade: **0**
O&M Grade: **4**
Clock Start/From: **2**
Clock To: **10**
1st Value:
2nd Value:
Value Percent: **75.000**
Continuous Index:
Within 8" of Joint: **YES**
Remarks:

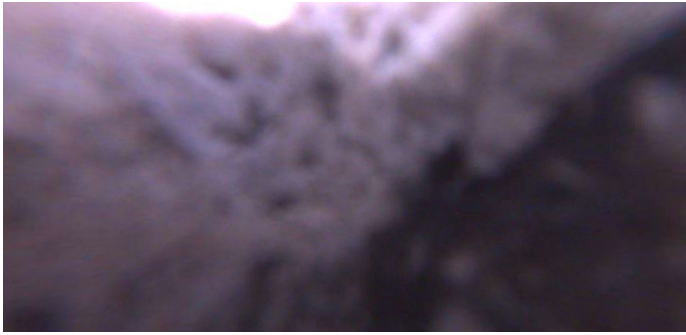
Code: **MSA**
Description: **Abandoned Survey**

Distance (ft): **29.1**
Structural Grade: **0**
O&M Grade: **0**
Clock Start/From:
Clock To:
1st Value:
2nd Value:
Value Percent:
Continuous Index:
Within 8" of Joint: **NO**
Remarks: **rbj**

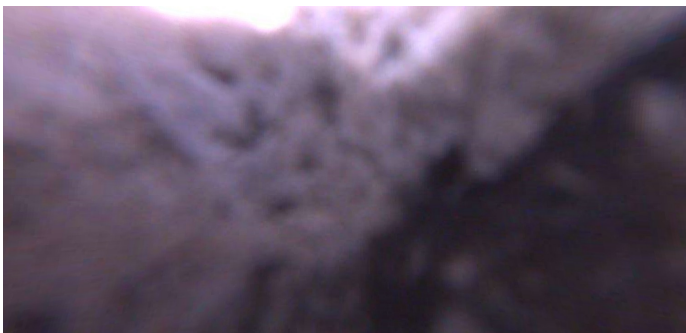
Code: **SAV**
Description: **Surface Aggregate Visible**

Distance (ft): **29.1**
Structural Grade: **3**
O&M Grade: **0**
Clock Start/From: **7**
Clock To: **5**
1st Value:
2nd Value:
Value Percent:
Continuous Index: **F01**
Within 8" of Joint:
Remarks:
