Profile/Photo Observation Report

Date:	09/07/2021	Weather:		Coding:	PACP 7.0
Pipe Length (ft):	331.0	Owner:	City of Hobart	Pre Clean:	Light Cleaning
P.O.#:	YES502259	Surveyor:	S. Bucklin	PSR:	P-503-033-032
Customer:	City of Hobart	Clean Date:	08/26/2021	Shape:	C

Street:	41st Avenue	Flow Control:	Not Controlled
City:	Hobart, IN	Year Renewed:	
Location:	Alley	Tape/Media #:	
Purpose:	Routine Assessment	Dia/Height:	8"
Use:	Sanitary Sewage Pipe	Material:	VCP
Drain Area:		Lining:	None
Category:	NA		
Comment:			
Location Details:		Direction of Survey:	Upstream
US MH:	M-503-032	DS MH:	M-503-033
		Total Length Surveyed (ft):	31.4

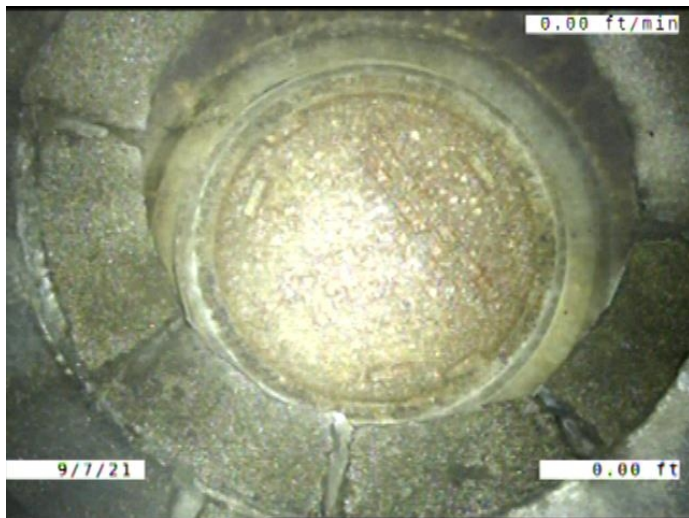
Code: **AMH**
Description: **Manhole**

Distance (ft): **.0**
Structural Grade: **0**
O&M Grade: **0**
Clock Start/From:
Clock To:
1st Value:
2nd Value:
Value Percent:
Continuous Index:
Within 8" of Joint: **NO**
Remarks: **M-503-033**

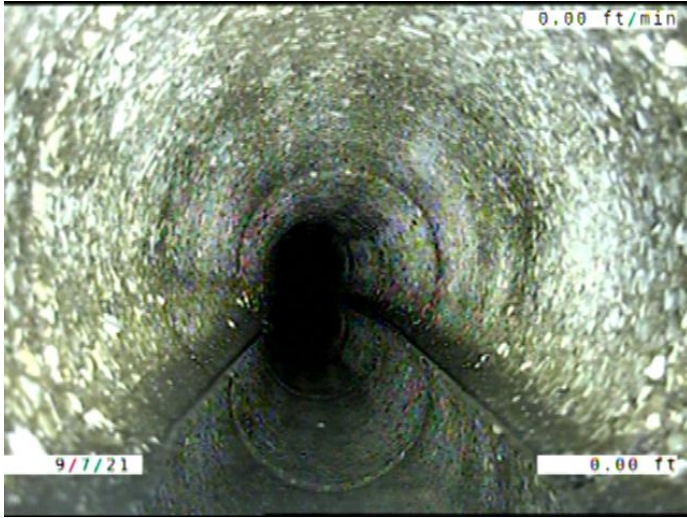
Code: **MWL**
Description: **Miscellaneous Water Level**

Distance (ft): **.0**
Structural Grade: **0**
O&M Grade: **0**
Clock Start/From:
Clock To:
1st Value:
2nd Value:
Value Percent: **5.000**
Continuous Index:
Within 8" of Joint: **NO**
Remarks:

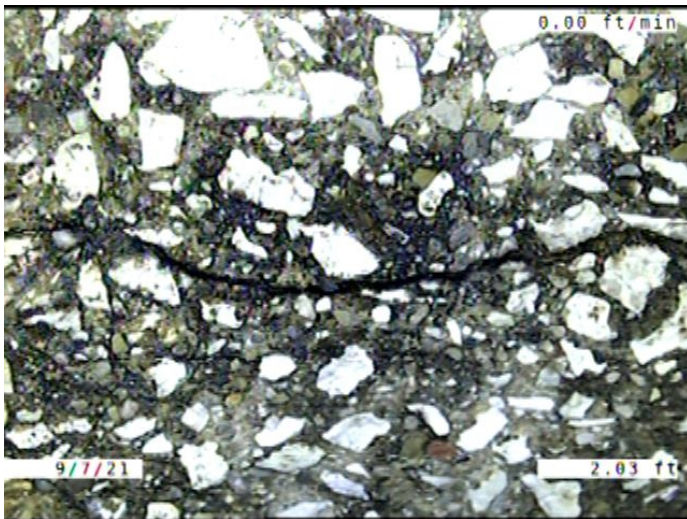
Code: **FM**
Description: **Fracture Multiple**

Distance (ft): **2.0**
Structural Grade: **4**
O&M Grade: **0**
Clock Start/From: **12**
Clock To: **12**
1st Value:
2nd Value:
Value Percent:
Continuous Index:
Within 8" of Joint: **NO**
Remarks:

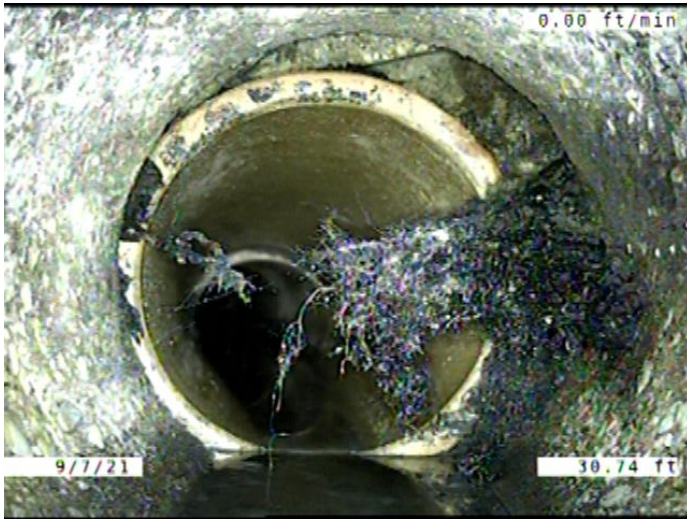
Code: **RMJ**
Description: **Roots Medium Joint**

Distance (ft): **30.7**
Structural Grade: **0**
O&M Grade: **3**
Clock Start/From: **9**
Clock To: **5**
1st Value:
2nd Value:
Value Percent: **10.000**
Continuous Index:
Within 8" of Joint: **YES**
Remarks:

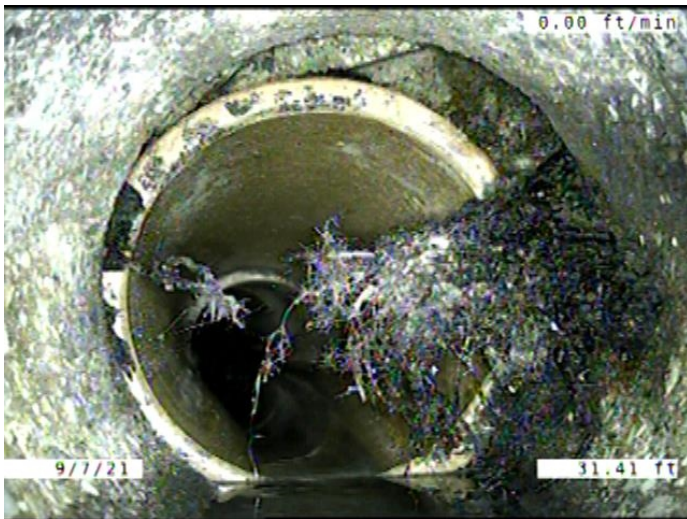
Code: **MMC**
Description: **Miscellaneous Material Change**

Distance (ft): **31.4**
Structural Grade: **0**
O&M Grade: **0**
Clock Start/From:
Clock To:
1st Value:
2nd Value:
Value Percent:
Continuous Index:
Within 8" of Joint: **NO**
Remarks: **CONCRETE TO VCP**

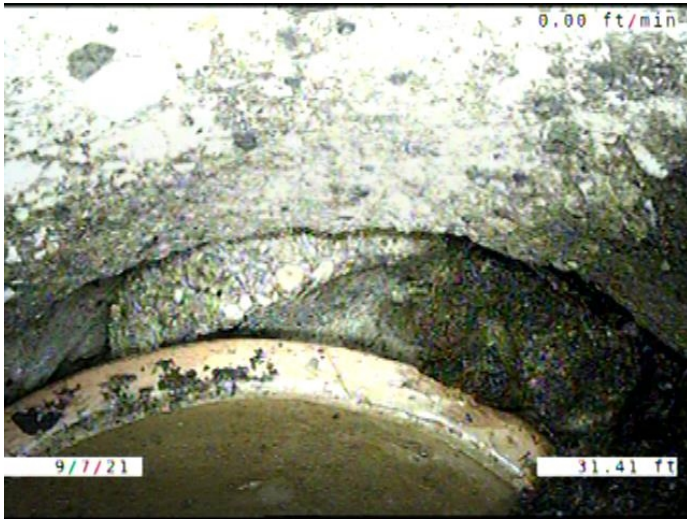
Code: **MSC**
 Description: **Miscellaneous Shape/Size Change**

Distance (ft): **31.4**
 Structural Grade: **0**
 O&M Grade: **0**
 Clock Start/From:
 Clock To:
 1st Value: **8.000**
 2nd Value:
 Value Percent:
 Continuous Index:
 Within 8" of Joint: **NO**
 Remarks: **10" TO 8"**

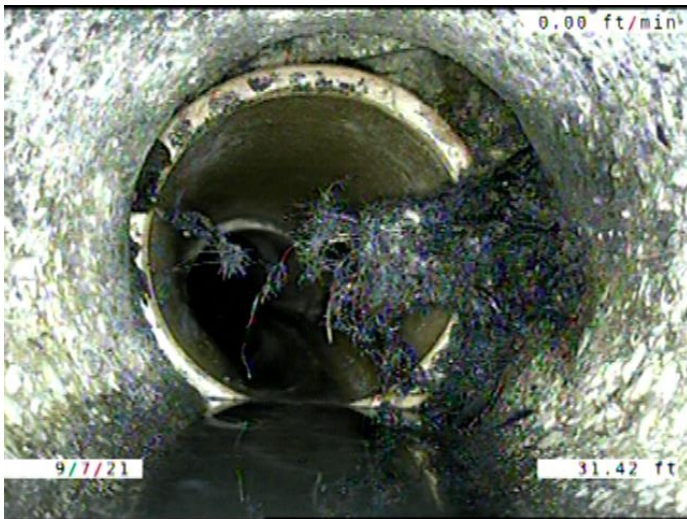
Code: **MSA**
 Description: **Miscellaneous Survey Abandoned**

Distance (ft): **31.4**
 Structural Grade: **0**
 O&M Grade: **0**
 Clock Start/From:
 Clock To:
 1st Value:
 2nd Value:
 Value Percent:
 Continuous Index:
 Within 8" of Joint: **NO**
 Remarks: **CAMERA CANT FIT INTO 8" PIPE**
