## Profile/Photo Observation Report

Date:	<b>09/07/2021</b>	Weather:		Coding:	<b>PACP 7.0</b>
Pipe Length (ft):	<b>331.0</b>	Owner:	<b>City of Hobart</b>	Pre Clean:	<b>Light Cleaning</b>
P.O.#:	<b>YES502259</b>	Surveyor:	<b>S. Bucklin</b>	PSR:	<b>P-503-033-032</b>
Customer:	<b>City of Hobart</b>	Clean Date:	<b>08/26/2021</b>	Shape:	<b>C</b>

Street:	<b>41st Avenue</b>	Flow Control:	<b>Not Controlled</b>
City:	<b>Hobart, IN</b>	Year Renewed:	
Location:	<b>Alley</b>	Tape/Media #:	
Purpose:	<b>Routine Assessment</b>	Dia/Height:	<b>8"</b>
Use:	<b>Sanitary Sewage Pipe</b>	Material:	<b>VCP</b>
Drain Area:		Lining:	<b>None</b>
Category:	<b>NA</b>		
Comment:			
Location Details:		Direction of Survey:	<b>Upstream</b>
US MH:	<b>M-503-032</b>	DS MH:	<b>M-503-033</b>
		Total Length Surveyed (ft):	<b>31.4</b>

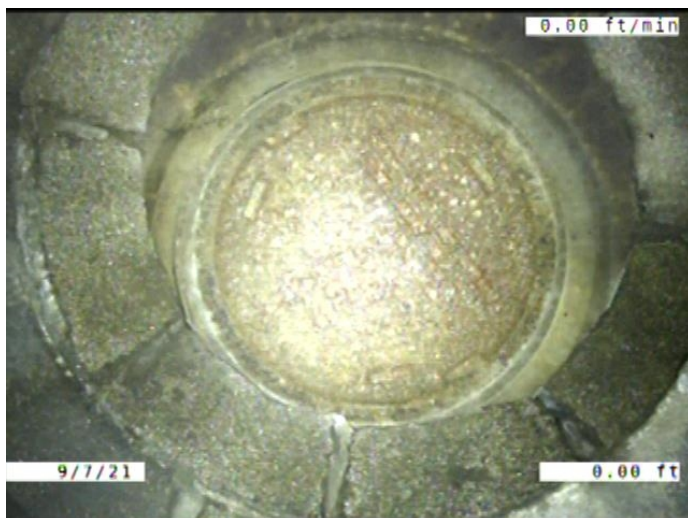
Code: **AMH**  
Description: **Manhole**

Distance (ft): **.0**  
Structural Grade: **0**  
O&M Grade: **0**  
Clock Start/From:  
Clock To:  
1st Value:  
2nd Value:  
Value Percent:  
Continuous Index:  
Within 8" of Joint: **NO**  
Remarks: **M-503-033**

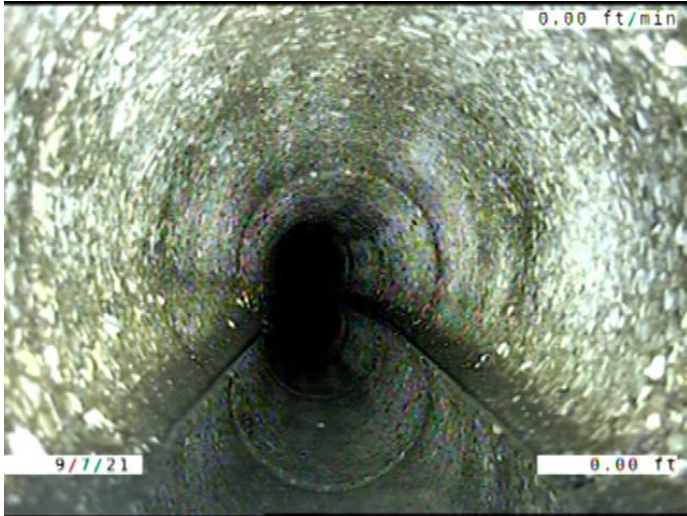
Code: **MWL**  
Description: **Miscellaneous Water Level**

Distance (ft): **.0**  
Structural Grade: **0**  
O&M Grade: **0**  
Clock Start/From:  
Clock To:  
1st Value:  
2nd Value:  
Value Percent: **5.000**  
Continuous Index:  
Within 8" of Joint: **NO**  
Remarks:

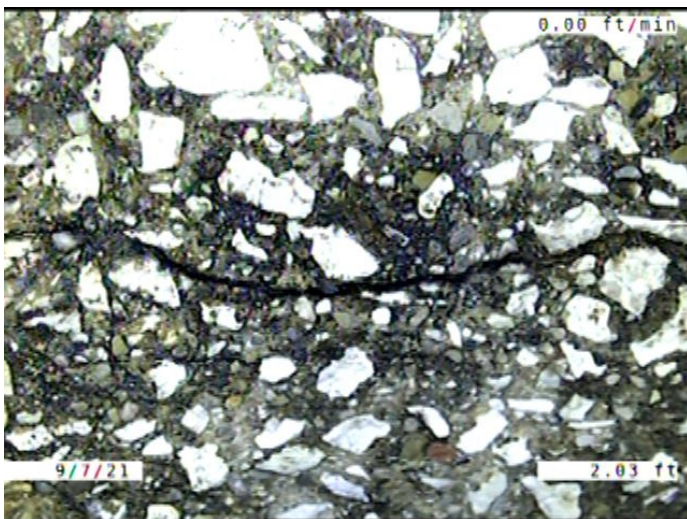
Code: **FM**  
Description: **Fracture Multiple**

Distance (ft): **2.0**  
Structural Grade: **4**  
O&M Grade: **0**  
Clock Start/From: **12**  
Clock To: **12**  
1st Value:  
2nd Value:  
Value Percent:  
Continuous Index:  
Within 8" of Joint: **NO**  
Remarks:

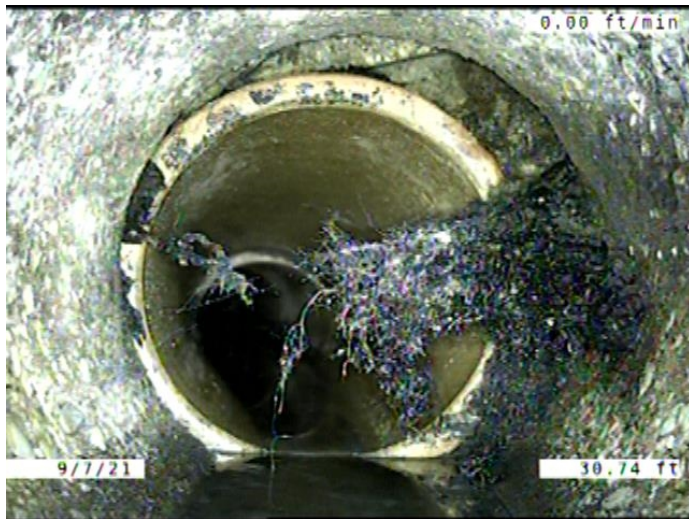
Code: **RMJ**  
 Description: **Roots Medium Joint**

Distance (ft): **30.7**  
 Structural Grade: **0**  
 O&M Grade: **3**  
 Clock Start/From: **9**  
 Clock To: **5**  
 1st Value:  
 2nd Value:  
 Value Percent: **10.000**  
 Continuous Index:  
 Within 8" of Joint: **YES**  
 Remarks:

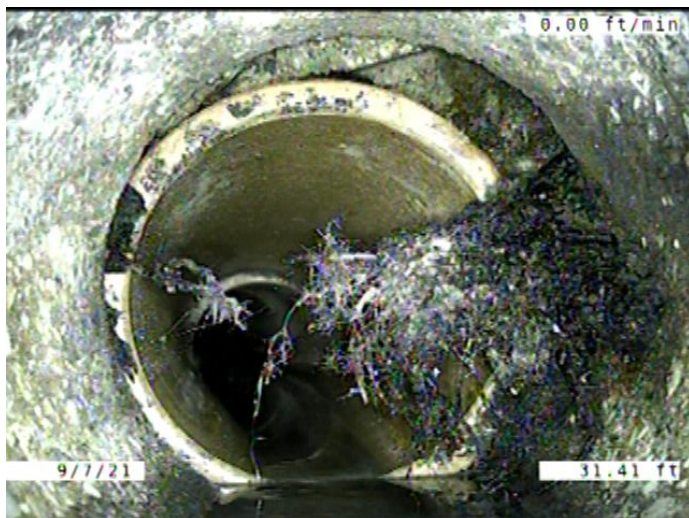
Code: **MMC**  
 Description: **Miscellaneous Material Change**

Distance (ft): **31.4**  
 Structural Grade: **0**  
 O&M Grade: **0**  
 Clock Start/From:  
 Clock To:  
 1st Value:  
 2nd Value:  
 Value Percent:  
 Continuous Index:  
 Within 8" of Joint: **NO**  
 Remarks: **CONCRETE TO VCP**
