Profile/Photo Observation Report

Date:	09/10/2021	Weather:		Coding:	PACP 7.0
Pipe Length (ft):	58.1	Owner:	City of Hobart	Pre Clean:	Light Cleaning
P.O.#:	YES502259	Surveyor:	S. Bucklin	PSR:	M-503-032.1_M-503-032
Customer:	City of Hobart	Clean Date:	09/10/2021	Shape:	C

Street:	West 41st Avenue	Flow Control:	Not Controlled
City:	Hobart, IN	Year Renewed:	
Location:	Local rural streets with light traffic, t	Tape/Media #:	
Purpose:	Routine Assessment	Dia/Height:	8"
Use:	Sanitary Sewage Pipe	Material:	CP
Drain Area:		Lining:	None
Category:	NA		
Comment:			
Location Details:		Direction of Survey:	Upstream
US MH:	M-503-032.1	DS MH:	M-503-032
		Total Length Surveyed (ft):	58.1

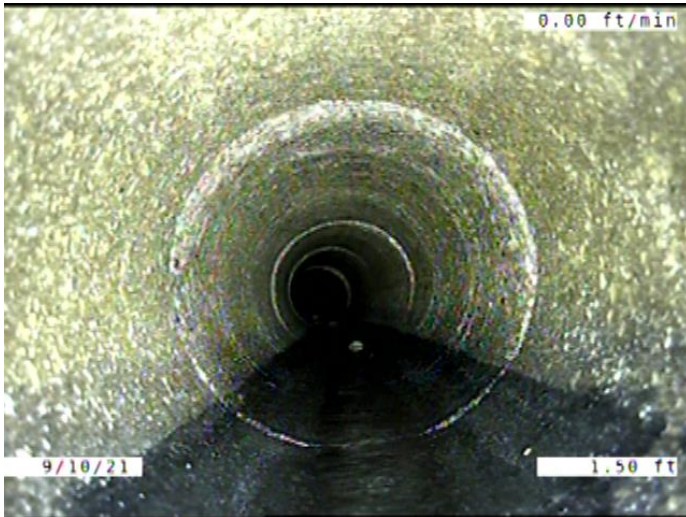
Code: **MGO**
 Description: **Miscellaneous General Observation**

Distance (ft): **1.5**
 Structural Grade: **0**
 O&M Grade: **0**
 Clock Start/From:
 Clock To:
 1st Value:
 2nd Value:
 Value Percent:
 Continuous Index:
 Within 8" of Joint: **NO**
 Remarks: **DROP INTO THE MANHOLE. HAD TO START IN THE PIPE.**

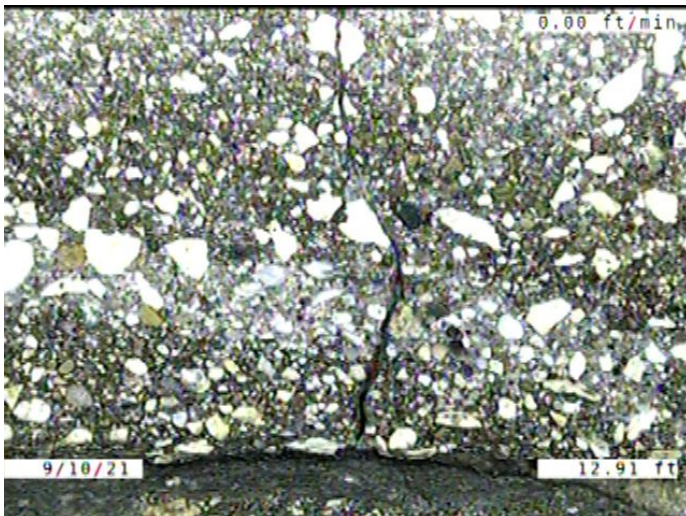
Code: **FS**
 Description: **Fracture Spiral**

Distance (ft): **12.9**
 Structural Grade: **3**
 O&M Grade: **0**
 Clock Start/From: **12**
 Clock To: **1**
 1st Value:
 2nd Value:
 Value Percent:
 Continuous Index:
 Within 8" of Joint: **YES**
 Remarks:

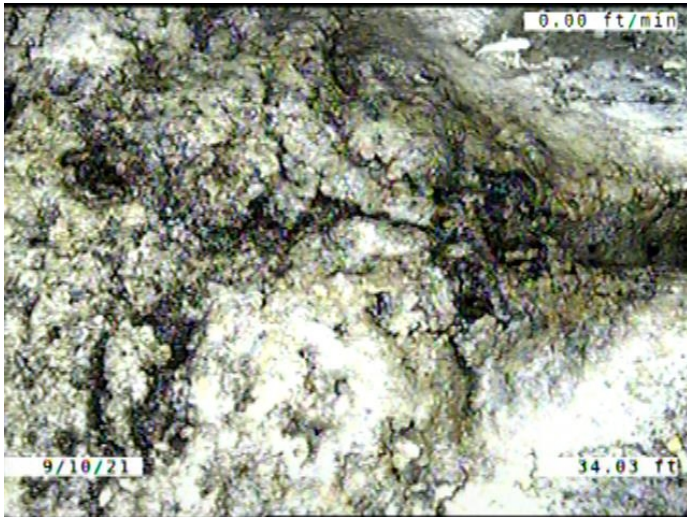
Code: **DAE**
Description: **Deposits Attached Encrustation**

Distance (ft): **34.0**
Structural Grade: **0**
O&M Grade: **2**
Clock Start/From: **2**
Clock To: **5**
1st Value:
2nd Value:
Value Percent: **5.000**
Continuous Index:
Within 8" of Joint: **YES**
Remarks:

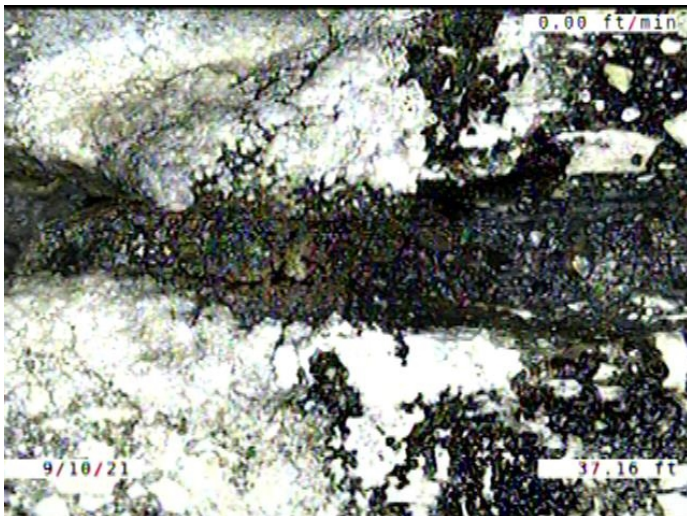
Code: **DAE**
Description: **Deposits Attached Encrustation**

Distance (ft): **37.2**
Structural Grade: **0**
O&M Grade: **2**
Clock Start/From: **7**
Clock To: **8**
1st Value:
2nd Value:
Value Percent: **5.000**
Continuous Index:
Within 8" of Joint: **YES**
Remarks:

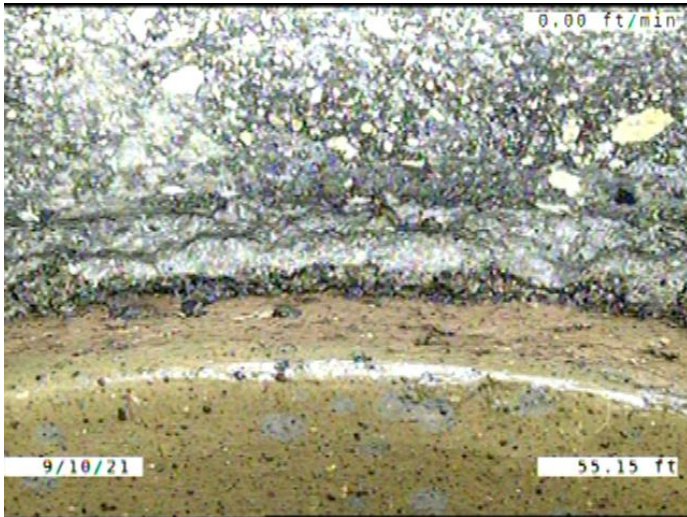
Code: **MMC**
 Description: **Miscellaneous Material Change**

Distance (ft): **55.1**
 Structural Grade: **0**
 O&M Grade: **0**
 Clock Start/From:
 Clock To:
 1st Value:
 2nd Value:
 Value Percent:
 Continuous Index:
 Within 8" of Joint: **NO**
 Remarks: **CONCRETE TO VCP**

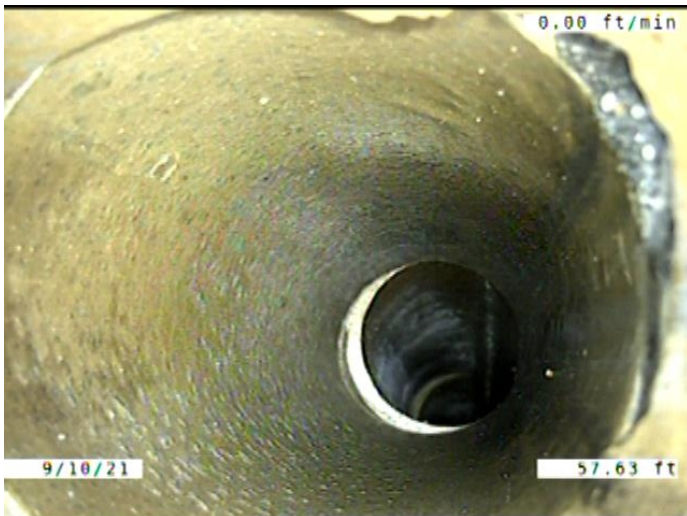
Code: **TFA**
 Description: **Tap Factory Activity**

Distance (ft): **57.6**
 Structural Grade: **0**
 O&M Grade: **0**
 Clock Start/From: **3**
 Clock To:
 1st Value: **4.000**
 2nd Value:
 Value Percent:
 Continuous Index:
 Within 8" of Joint: **YES**
 Remarks:
