Profile/Photo Observation Report

| Street: | W 40th ave | Flow Control: | Not Controlled |
| City: | Hobart, IN | Year Renewed: | |

| US MH: | M-503-034 | DS MH: | M-503-033 |

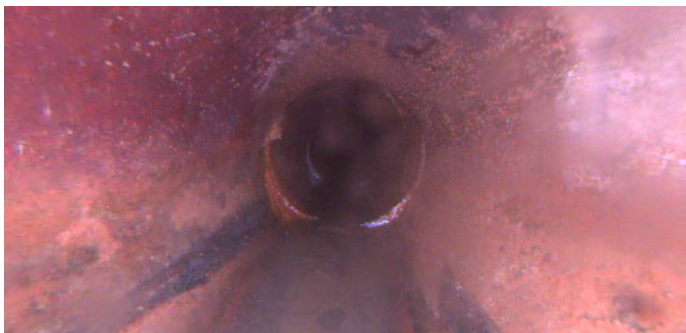
Code: **AMH**
Description: **Manhole**

Distance (ft): **.0**
Structural Grade: **0**
O&M Grade: **0**
Clock Start/From:
Clock To:
1st Value:
2nd Value:
Value Percent:
Continuous Index:
Within 8" of Joint: **NO**
Remarks: **M-503-034**

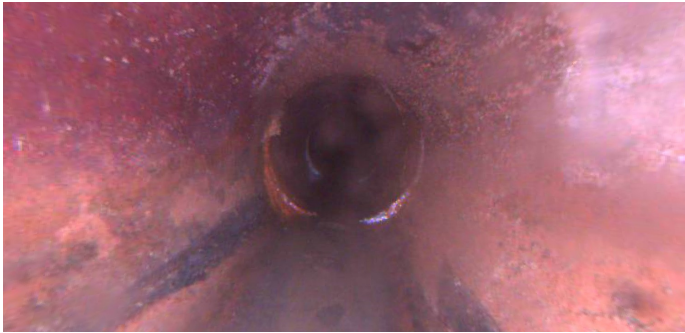
| Code: | MWL |
| Description: | Water Level |

| Value Percent: | 5.000 |

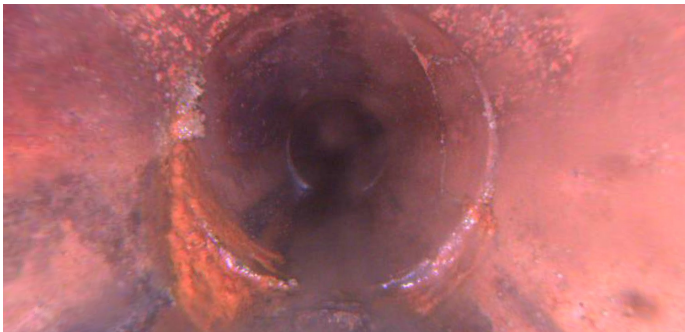
| Code: | IW |
| Description: | Infil Weeper |

| Distance (ft): | 1.8 |
| O&M Grade: | 2 |

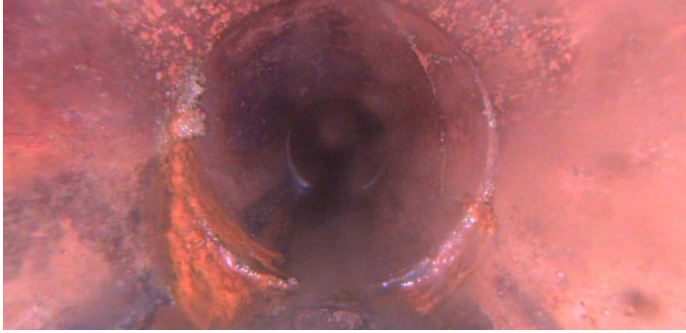
Code: **FM**
Description: **Fracture Multiple**

Distance (ft): **1.8**
Structural Grade: **4**
O&M Grade: **0**
Clock Start/From: **12**
Clock To: **4**
1st Value:
2nd Value:
Value Percent:
Continuous Index:
Within 8" of Joint: **YES**
Remarks:

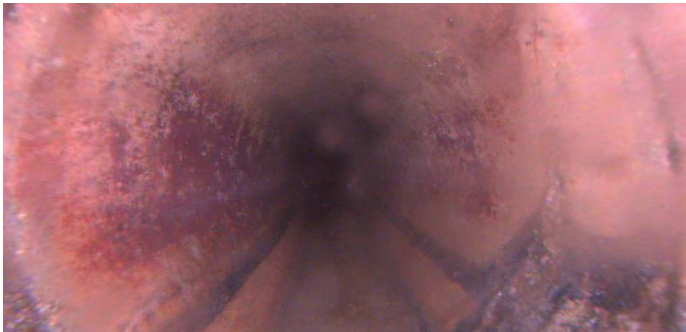
Code: **FM**
Description: **Fracture Multiple**

Distance (ft): **6.4**
Structural Grade: **4**
O&M Grade: **0**
Clock Start/From: **1**
Clock To: **4**
1st Value:
2nd Value:
Value Percent:
Continuous Index:
Within 8" of Joint: **YES**
Remarks:

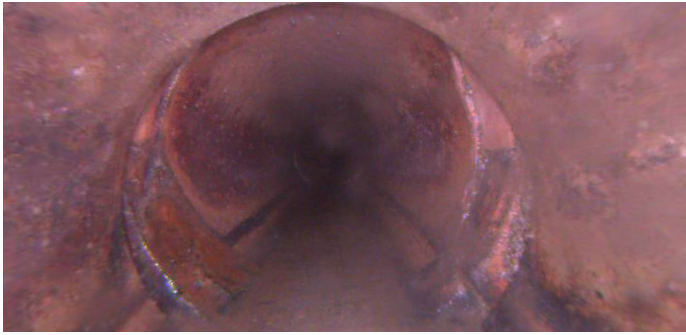
Code: **FM**
Description: **Fracture Multiple**

Distance (ft): **9.1**
Structural Grade: **4**
O&M Grade: **0**
Clock Start/From: **8**
Clock To: **4**
1st Value:
2nd Value:
Value Percent:
Continuous Index:
Within 8" of Joint: **YES**
Remarks:

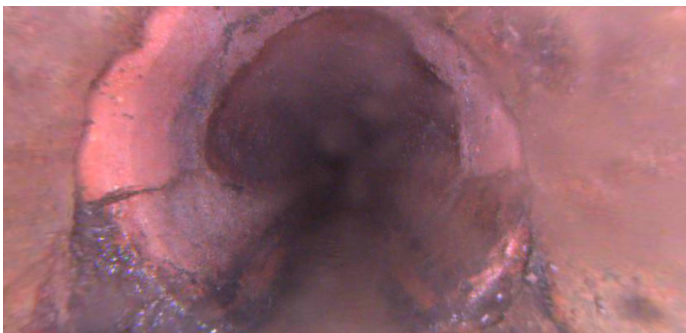
Code: **IW**
Description: **Infil Weeper**

Distance (ft): **11.3**
Structural Grade: **0**
O&M Grade: **2**
Clock Start/From: **8**
Clock To: **4**
1st Value:
2nd Value:
Value Percent:
Continuous Index:
Within 8" of Joint: **YES**
Remarks:

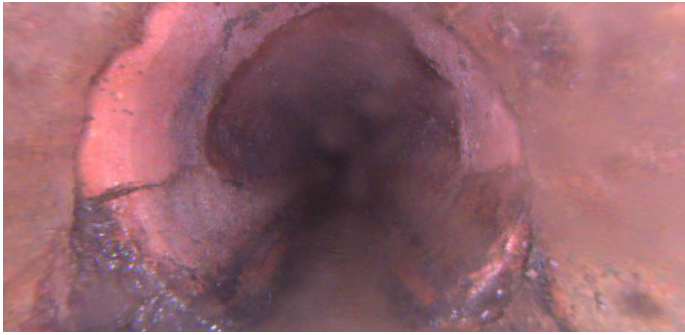
Code: **FL**
Description: **Fracture Longitudinal**

Distance (ft): **11.3**
Structural Grade: **3**
O&M Grade: **0**
Clock Start/From: **9**
Clock To:
1st Value:
2nd Value:
Value Percent:
Continuous Index:
Within 8" of Joint: **YES**
Remarks:

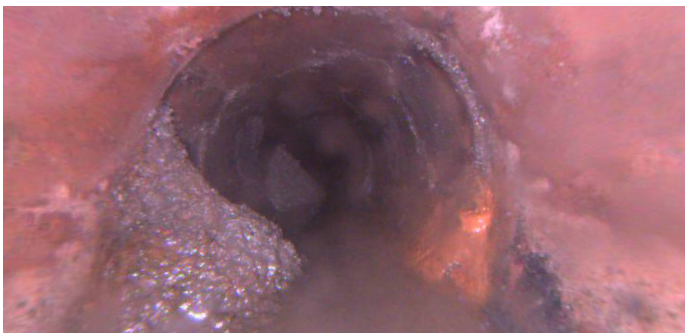
Code: **DAZ**
Description: **Deposits Attached Other**

Distance (ft): **14.2**
Structural Grade: **0**
O&M Grade: **2**
Clock Start/From: **7**
Clock To: **9**
1st Value:
2nd Value:
Value Percent: **10.000**
Continuous Index:
Within 8" of Joint: **YES**
Remarks:

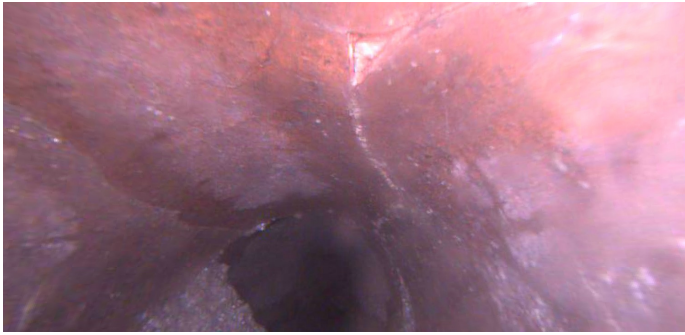
Code: **FM**
Description: **Fracture Multiple**

Distance (ft): **15.2**
Structural Grade: **4**
O&M Grade: **0**
Clock Start/From: **10**
Clock To: **1**
1st Value:
2nd Value:
Value Percent:
Continuous Index:
Within 8" of Joint: **YES**
Remarks:

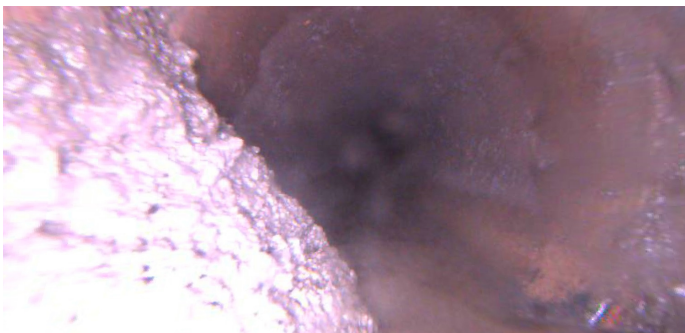
Code: **DAZ**
Description: **Deposits Attached Other**

Distance (ft): **15.8**
Structural Grade: **0**
O&M Grade: **4**
Clock Start/From: **6**
Clock To: **11**
1st Value:
2nd Value:
Value Percent: **30.000**
Continuous Index:
Within 8" of Joint: **NO**
Remarks:

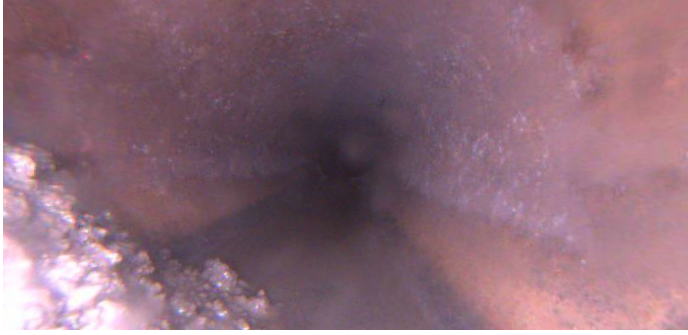
| Code: | MSA |
| Description: | Abandoned Survey |
| Remarks: | DAZ |
