# Profile/Photo Observation Report

Date:	09/08/2021	Weather:		Coding:	PACP 7.0
Pipe Length (ft):	308.1	Owner:	City of Hobart	Pre Clean:	Light Cleaning
P.O.#:	YES502259	Surveyor:	S. Bucklin	PSR:	P-503-034-033
Customer:	City of Hobart	Clean Date:	08/26/2021	Shape:	C

Street:	40th Avenue	Flow Control:	Not Controlled
City:	Hobart, IN	Year Renewed:	
Location:		Tape/Media #:	
Purpose:	Routine Assessment	Dia/Height:	8"
Use:	Sanitary Sewage Pipe	Material:	VCP
Drain Area:		Lining:	None
Category:	NA		
Comment:			
Location Details:		Direction of Survey:	Upstream
US MH:	M-503-033	DS MH:	M-503-034
		Total Length Surveyed (ft):	308.1

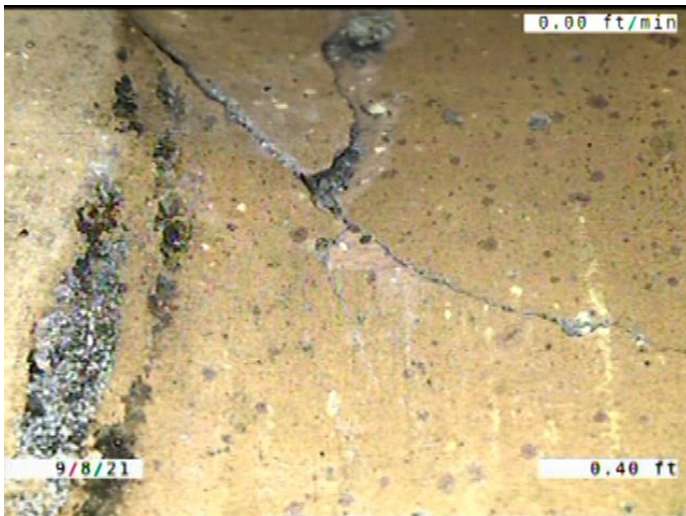
Code: **BSV**  
 Description: **Broken Soil Visible**

Distance (ft): **.4**  
 Structural Grade: **5**  
 O&M Grade: **0**  
 Clock Start/From: **3**  
 Clock To: **7**  
 1st Value:  
 2nd Value:  
 Value Percent:  
 Continuous Index:  
 Within 8" of Joint: **YES**  
 Remarks:

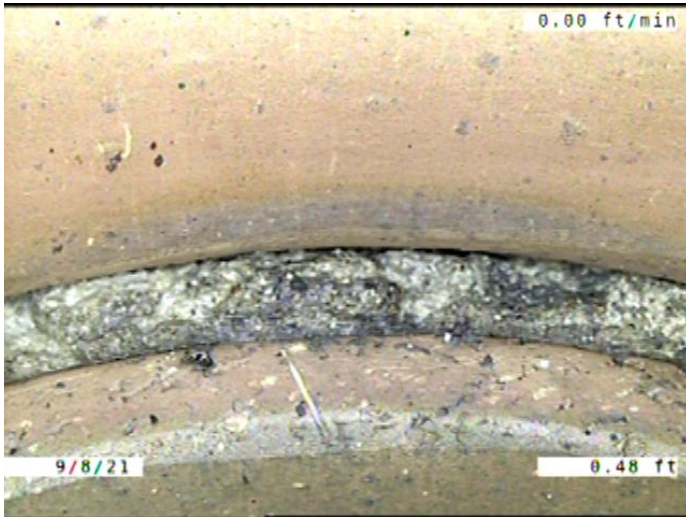
Code: **JOLD**  
 Description: **Joint Offset Large Defective**

Distance (ft): **.5**  
 Structural Grade: **4**  
 O&M Grade: **0**  
 Clock Start/From:  
 Clock To:  
 1st Value:  
 2nd Value:  
 Value Percent:  
 Continuous Index:  
 Within 8" of Joint: **NO**  
 Remarks:

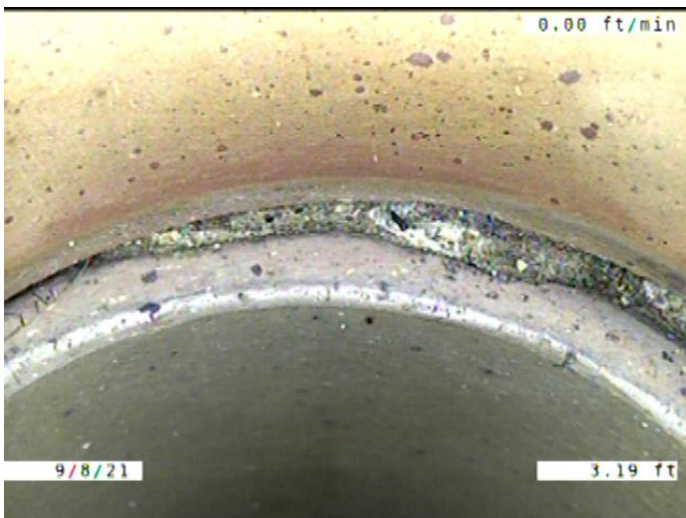
Code: **JOM**  
 Description: **Joint Offset Medium**

Distance (ft): **3.2**  
 Structural Grade: **3**  
 O&M Grade: **0**  
 Clock Start/From:  
 Clock To:  
 1st Value:  
 2nd Value:  
 Value Percent:  
 Continuous Index:  
 Within 8" of Joint: **NO**  
 Remarks:

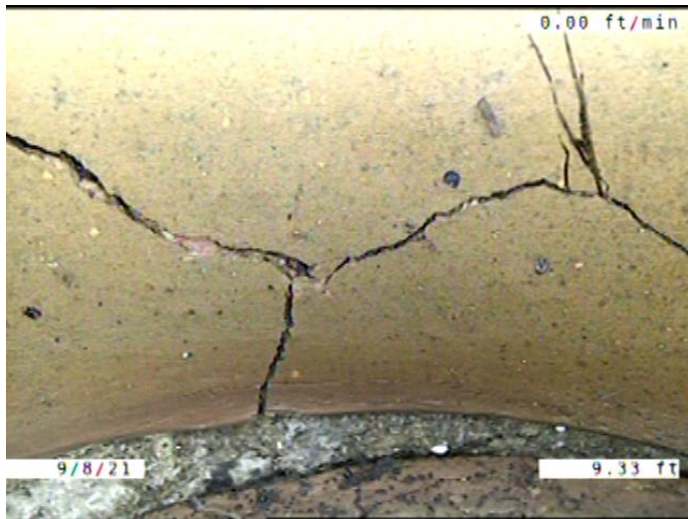
Code: **B**  
 Description: **Broken**

Distance (ft): **9.3**  
 Structural Grade: **4**  
 O&M Grade: **0**  
 Clock Start/From: **7**  
 Clock To: **3**  
 1st Value:  
 2nd Value:  
 Value Percent:  
 Continuous Index:  
 Within 8" of Joint: **YES**  
 Remarks:

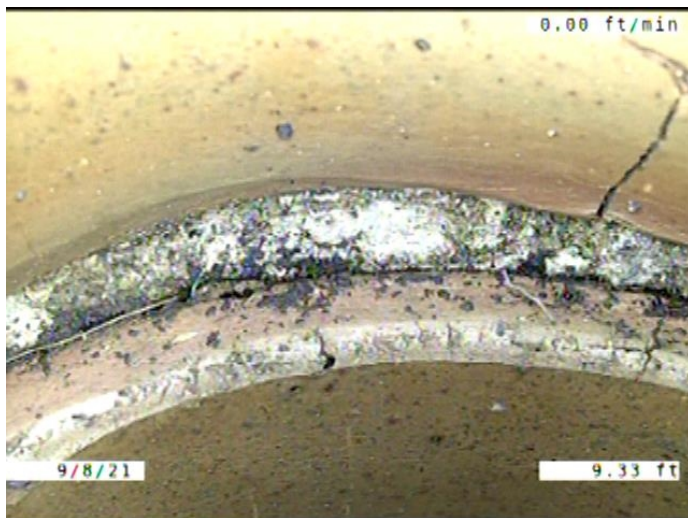
Code: **JOMD**  
 Description: **Joint Offset Medium Defective**

Distance (ft): **9.3**  
 Structural Grade: **3**  
 O&M Grade: **0**  
 Clock Start/From:  
 Clock To:  
 1st Value:  
 2nd Value:  
 Value Percent:  
 Continuous Index:  
 Within 8" of Joint: **NO**  
 Remarks:

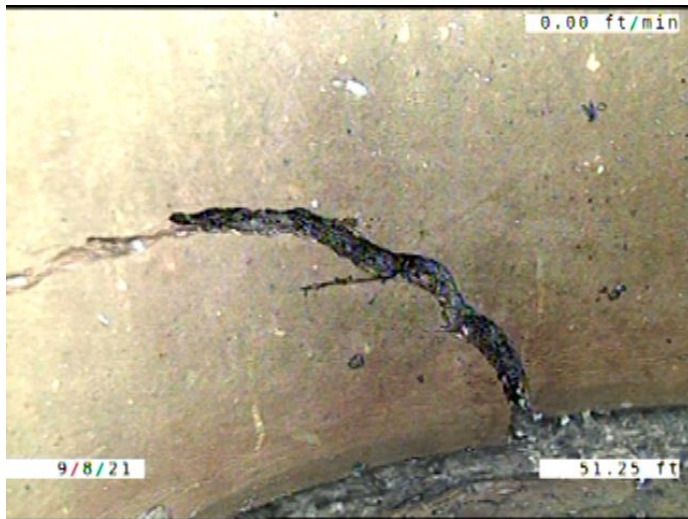
Code: **B**  
 Description: **Broken**

Distance (ft): **51.3**  
 Structural Grade: **4**  
 O&M Grade: **0**  
 Clock Start/From: **4**  
 Clock To: **12**  
 1st Value:  
 2nd Value:  
 Value Percent:  
 Continuous Index:  
 Within 8" of Joint: **YES**  
 Remarks:

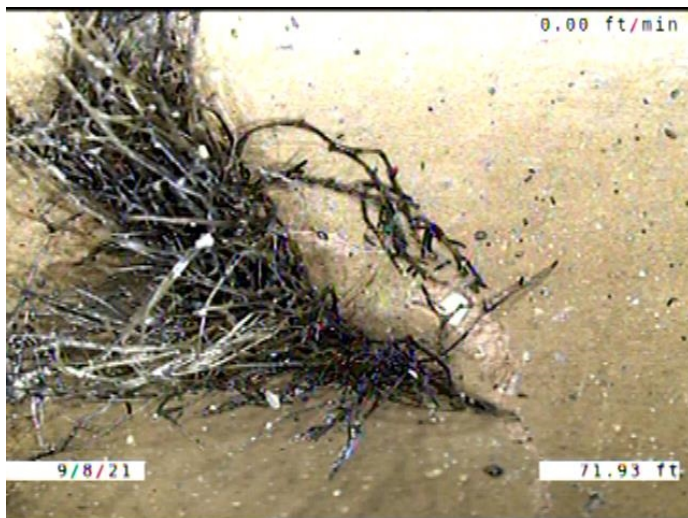
Code: **RFJ**  
 Description: **Roots Fine Joint**

Distance (ft): **71.9**  
 Structural Grade: **0**  
 O&M Grade: **1**  
 Clock Start/From: **9**  
 Clock To: **10**  
 1st Value:  
 2nd Value:  
 Value Percent:  
 Continuous Index:  
 Within 8" of Joint: **YES**  
 Remarks:

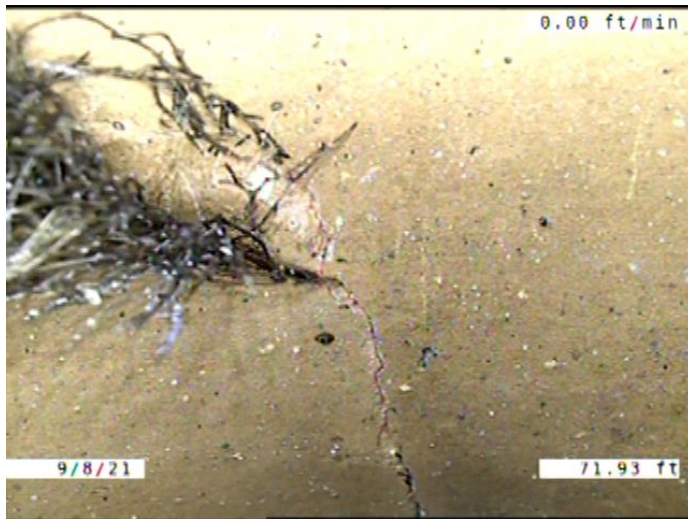
Code: **CM**  
Description: **Crack Multiple**

Distance (ft): **71.9**  
Structural Grade: **3**  
O&M Grade: **0**  
Clock Start/From: **10**  
Clock To: **11**  
1st Value:  
2nd Value:  
Value Percent:  
Continuous Index:  
Within 8" of Joint: **YES**  
Remarks:

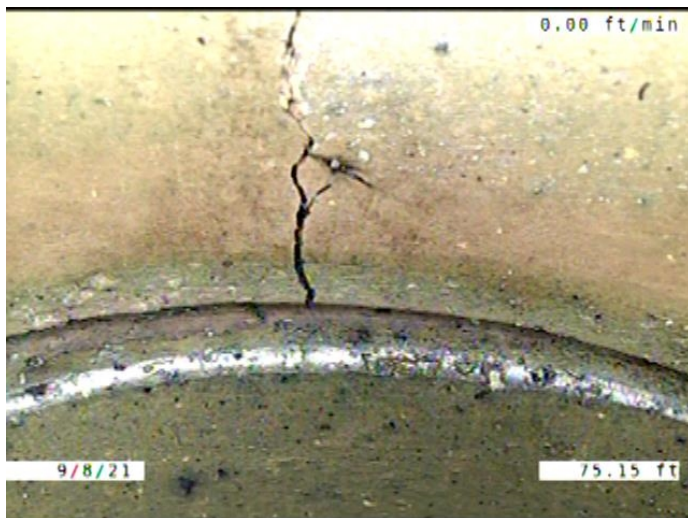
Code: **FM**  
Description: **Fracture Multiple**

Distance (ft): **75.2**  
Structural Grade: **4**  
O&M Grade: **0**  
Clock Start/From: **2**  
Clock To: **5**  
1st Value:  
2nd Value:  
Value Percent:  
Continuous Index:  
Within 8" of Joint: **YES**  
Remarks:

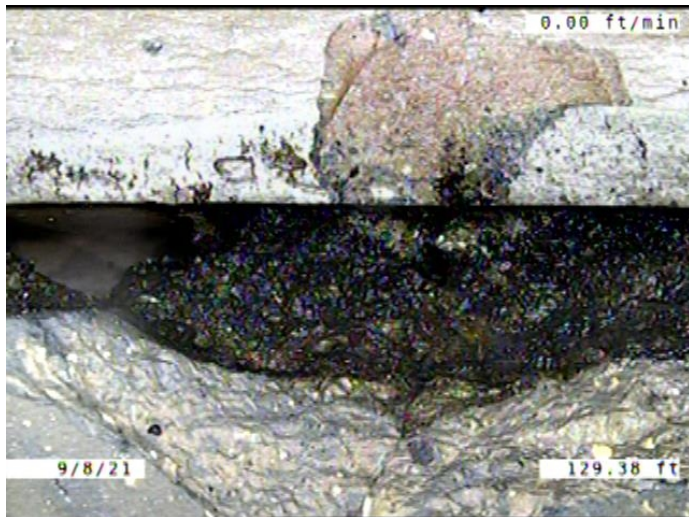
Code: **SMW**  
 Description: **Surface Damage Missing Wall**

Distance (ft): **129.4**  
 Structural Grade: **5**  
 O&M Grade: **0**  
 Clock Start/From: **3**  
 Clock To:  
 1st Value:  
 2nd Value:  
 Value Percent:  
 Continuous Index:  
 Within 8" of Joint: **YES**  
 Remarks:

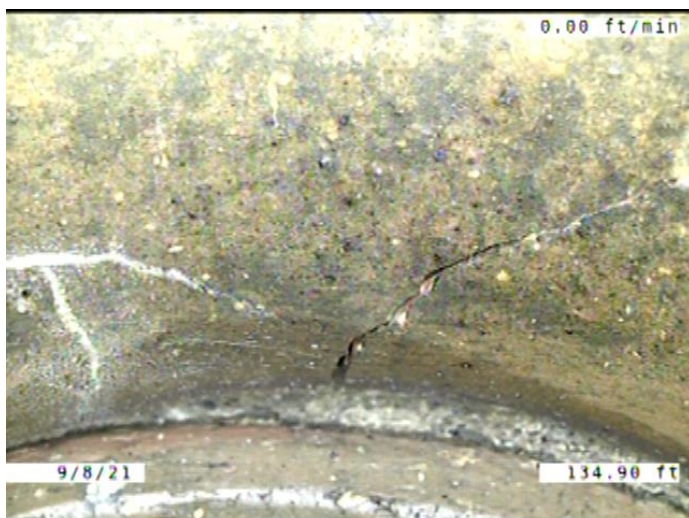
Code: **FM**  
 Description: **Fracture Multiple**

Distance (ft): **134.9**  
 Structural Grade: **4**  
 O&M Grade: **0**  
 Clock Start/From: **8**  
 Clock To: **5**  
 1st Value:  
 2nd Value:  
 Value Percent:  
 Continuous Index:  
 Within 8" of Joint: **YES**  
 Remarks:

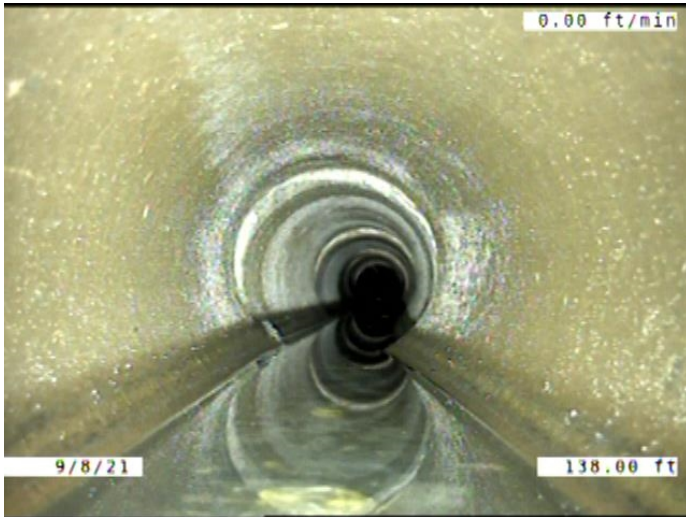
Code: **CM**  
Description: **Crack Multiple**

Distance (ft): **138.0**  
Structural Grade: **3**  
O&M Grade: **0**  
Clock Start/From: **3**  
Clock To: **12**  
1st Value:  
2nd Value:  
Value Percent:  
Continuous Index: **F03**  
Within 8" of Joint: **YES**  
Remarks:

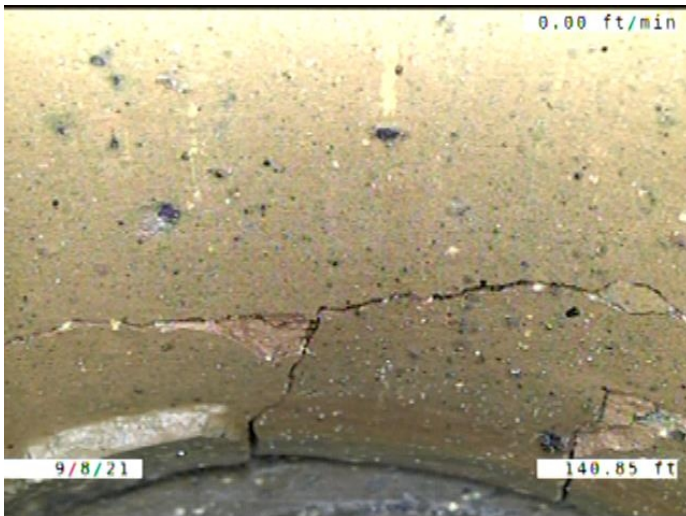
Code: **B**  
Description: **Broken**

Distance (ft): **140.9**  
Structural Grade: **4**  
O&M Grade: **0**  
Clock Start/From: **8**  
Clock To: **5**  
1st Value:  
2nd Value:  
Value Percent:  
Continuous Index:  
Within 8" of Joint: **YES**  
Remarks:

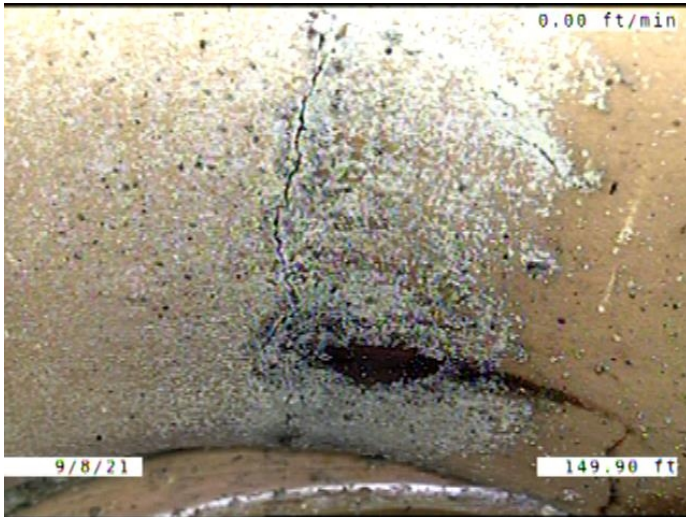
Code: **ISB**  
 Description: **Infiltration Stain Barrel**

Distance (ft): **149.9**  
 Structural Grade: **0**  
 O&M Grade: **1**  
 Clock Start/From: **3**  
 Clock To: **4**  
 1st Value:  
 2nd Value:  
 Value Percent:  
 Continuous Index:  
 Within 8" of Joint: **YES**  
 Remarks:

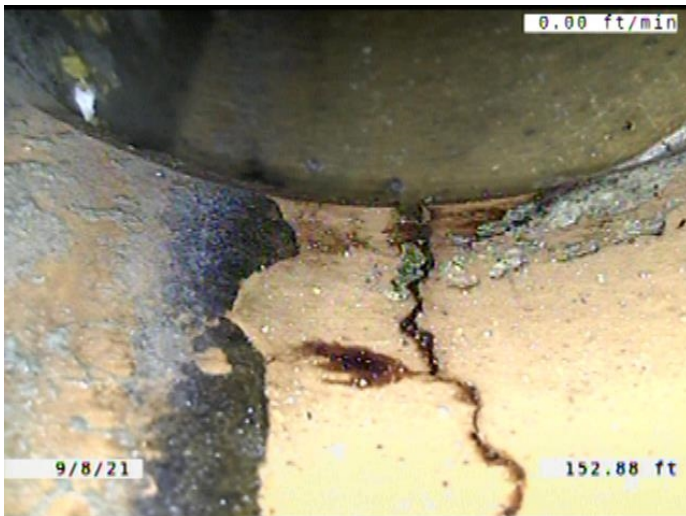
Code: **CM**  
 Description: **Crack Multiple**

Distance (ft): **152.9**  
 Structural Grade: **3**  
 O&M Grade: **0**  
 Clock Start/From: **3**  
 Clock To: **4**  
 1st Value:  
 2nd Value:  
 Value Percent:  
 Continuous Index:  
 Within 8" of Joint: **YES**  
 Remarks:

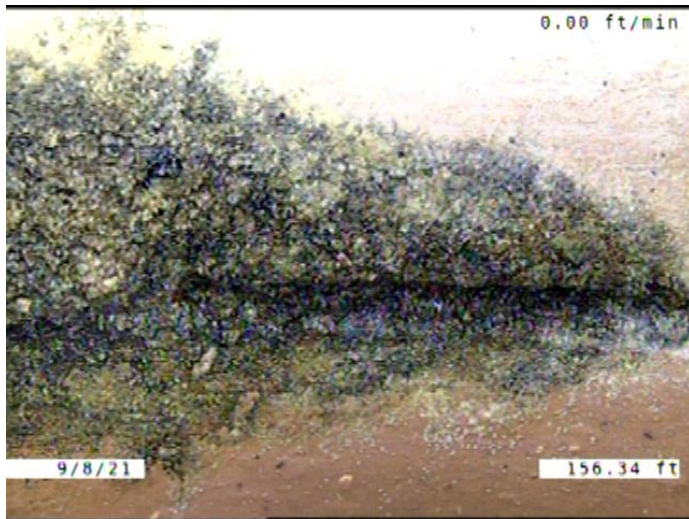
Code: **ISJ**  
Description: **Infiltration Stain Joint**

Distance (ft): **156.3**  
Structural Grade: **0**  
O&M Grade: **1**  
Clock Start/From: **7**  
Clock To: **10**  
1st Value:  
2nd Value:  
Value Percent:  
Continuous Index:  
Within 8" of Joint: **YES**  
Remarks:

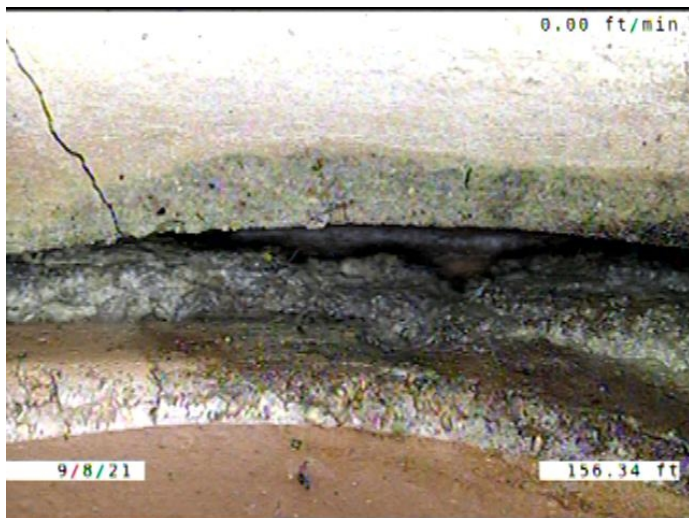
Code: **DAE**  
Description: **Deposits Attached Encrustation**

Distance (ft): **156.3**  
Structural Grade: **0**  
O&M Grade: **2**  
Clock Start/From: **1**  
Clock To: **5**  
1st Value:  
2nd Value:  
Value Percent: **5.000**  
Continuous Index:  
Within 8" of Joint: **YES**  
Remarks:

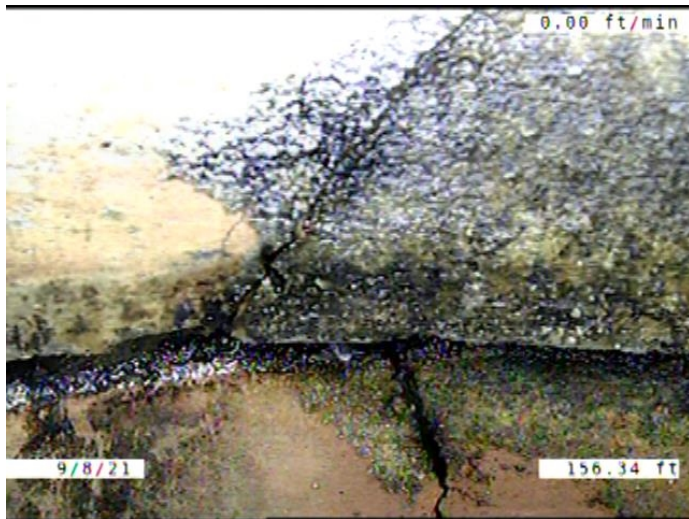
Code: **FM**  
Description: **Fracture Multiple**

Distance (ft): **156.3**  
Structural Grade: **4**  
O&M Grade: **0**  
Clock Start/From: **7**  
Clock To: **1**  
1st Value:  
2nd Value:  
Value Percent:  
Continuous Index:  
Within 8" of Joint: **YES**  
Remarks:

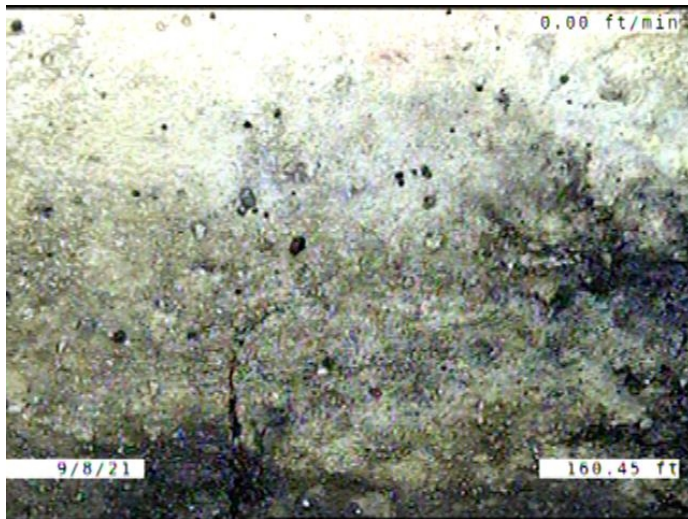
Code: **CM**  
 Description: **Crack Multiple**

Distance (ft): **160.5**  
 Structural Grade: **3**  
 O&M Grade: **0**  
 Clock Start/From: **7**  
 Clock To: **9**  
 1st Value:  
 2nd Value:  
 Value Percent:  
 Continuous Index:  
 Within 8" of Joint: **YES**  
 Remarks:

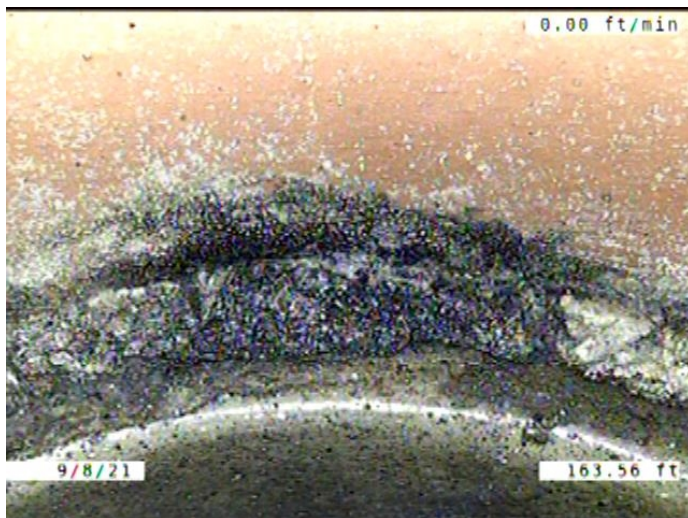
Code: **DAE**  
 Description: **Deposits Attached Encrustation**

Distance (ft): **163.6**  
 Structural Grade: **0**  
 O&M Grade: **2**  
 Clock Start/From: **8**  
 Clock To: **12**  
 1st Value:  
 2nd Value:  
 Value Percent: **5.000**  
 Continuous Index:  
 Within 8" of Joint: **YES**  
 Remarks:

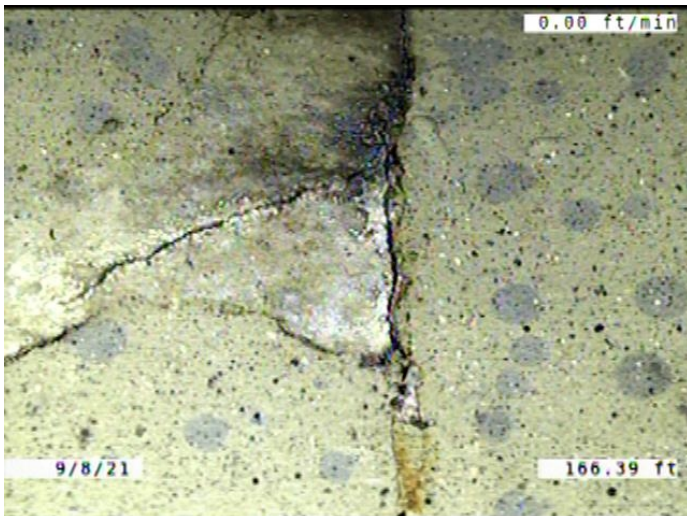
Code: **CM**  
Description: **Crack Multiple**

Distance (ft): **166.4**  
Structural Grade: **3**  
O&M Grade: **0**  
Clock Start/From: **2**  
Clock To: **3**  
1st Value:  
2nd Value:  
Value Percent:  
Continuous Index:  
Within 8" of Joint: **YES**  
Remarks:

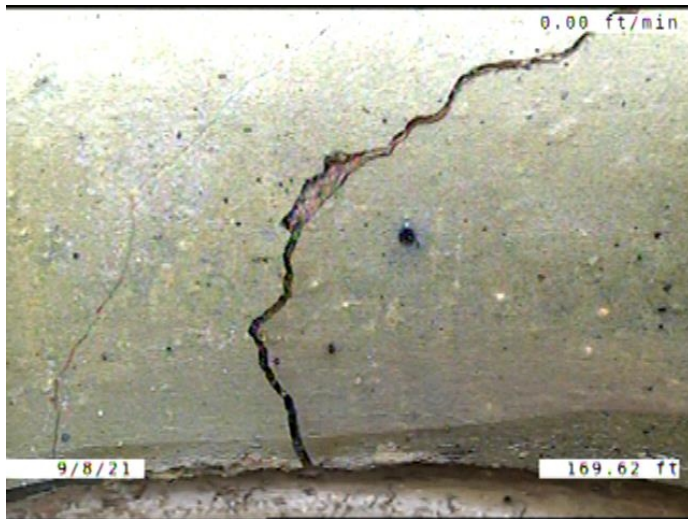
Code: **FM**  
Description: **Fracture Multiple**

Distance (ft): **169.6**  
Structural Grade: **4**  
O&M Grade: **0**  
Clock Start/From: **9**  
Clock To: **3**  
1st Value:  
2nd Value:  
Value Percent:  
Continuous Index:  
Within 8" of Joint: **YES**  
Remarks:

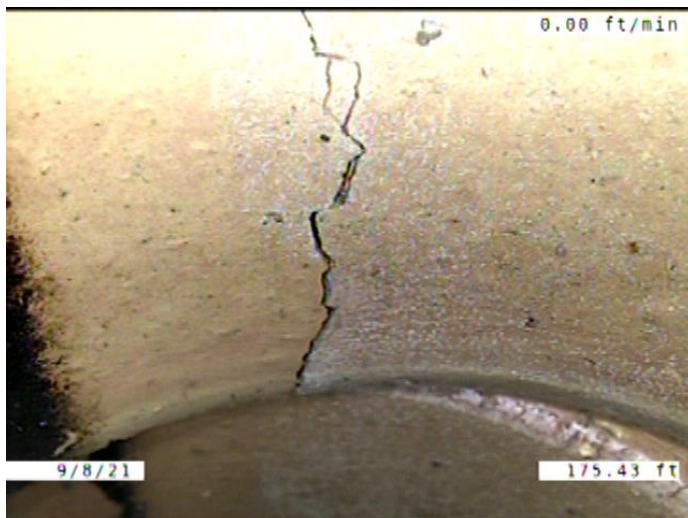
Code: **FM**  
Description: **Fracture Multiple**

Distance (ft): **175.4**  
Structural Grade: **4**  
O&M Grade: **0**  
Clock Start/From: **7**  
Clock To: **4**  
1st Value:  
2nd Value:  
Value Percent:  
Continuous Index:  
Within 8" of Joint: **YES**  
Remarks:

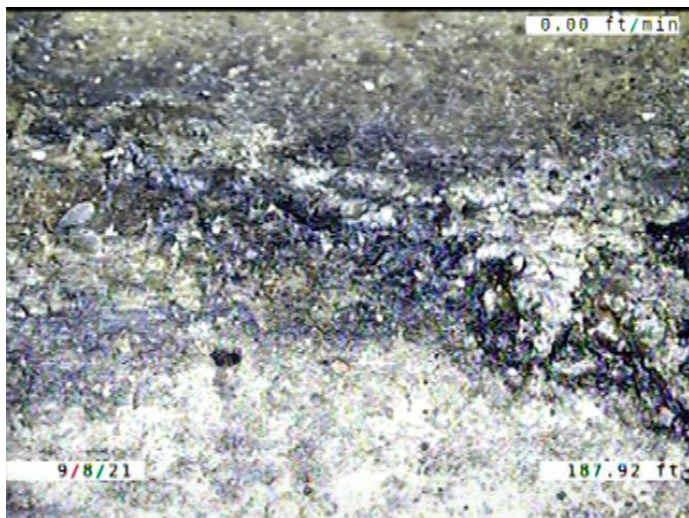
Code: **FM**  
 Description: **Fracture Multiple**

Distance (ft): **187.9**  
 Structural Grade: **4**  
 O&M Grade: **0**  
 Clock Start/From: **12**  
 Clock To: **3**  
 1st Value:  
 2nd Value:  
 Value Percent:  
 Continuous Index:  
 Within 8" of Joint: **YES**  
 Remarks:

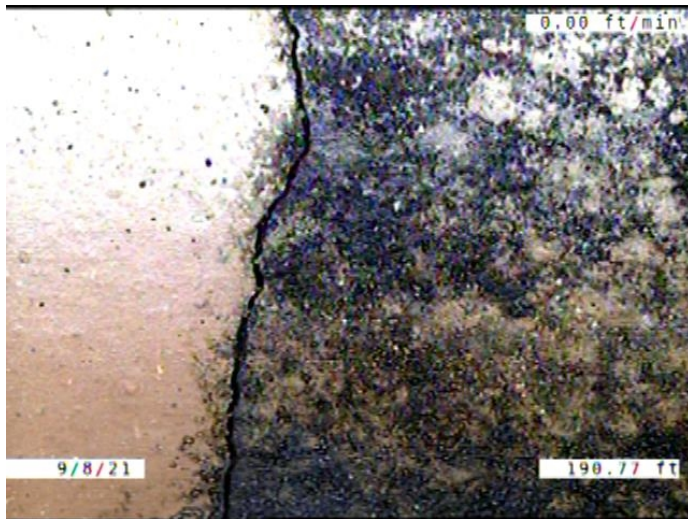
Code: **FS**  
 Description: **Fracture Spiral**

Distance (ft): **190.8**  
 Structural Grade: **3**  
 O&M Grade: **0**  
 Clock Start/From: **12**  
 Clock To: **1**  
 1st Value:  
 2nd Value:  
 Value Percent:  
 Continuous Index:  
 Within 8" of Joint: **YES**  
 Remarks:

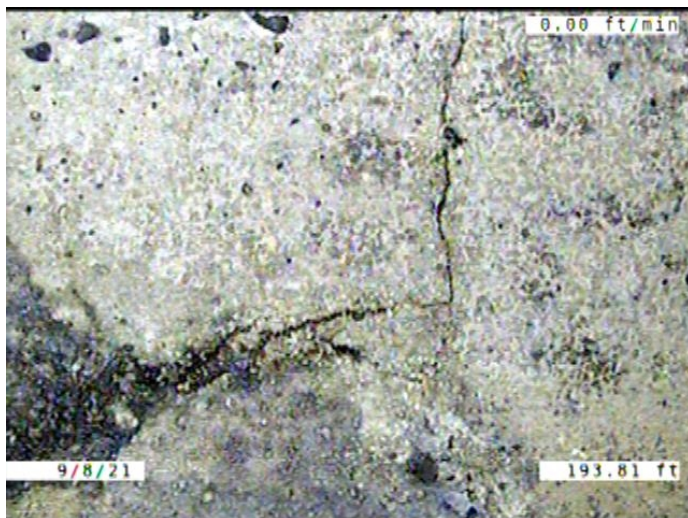
Code: **FM**  
 Description: **Fracture Multiple**

Distance (ft): **193.8**  
 Structural Grade: **4**  
 O&M Grade: **0**  
 Clock Start/From: **7**  
 Clock To: **12**  
 1st Value:  
 2nd Value:  
 Value Percent:  
 Continuous Index:  
 Within 8" of Joint: **YES**  
 Remarks:

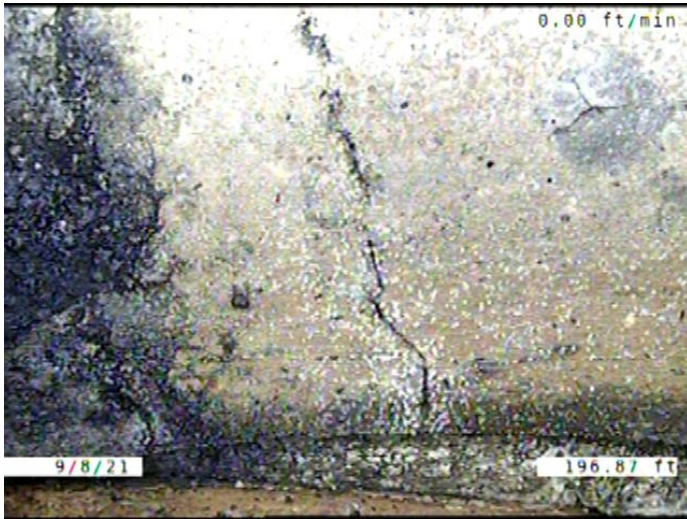
Code: **FM**  
 Description: **Fracture Multiple**

Distance (ft): **196.9**  
 Structural Grade: **4**  
 O&M Grade: **0**  
 Clock Start/From: **7**  
 Clock To: **5**  
 1st Value:  
 2nd Value:  
 Value Percent:  
 Continuous Index:  
 Within 8" of Joint: **YES**  
 Remarks:

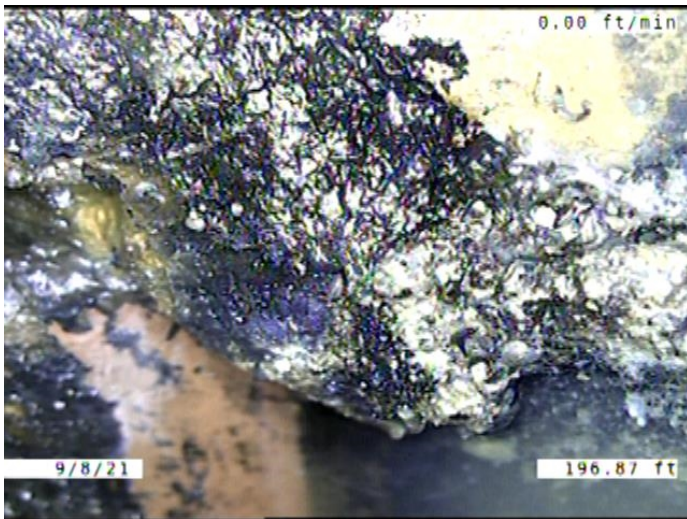
Code: **DAE**  
 Description: **Deposits Attached Encrustation**

Distance (ft): **196.9**  
 Structural Grade: **0**  
 O&M Grade: **2**  
 Clock Start/From: **12**  
 Clock To: **12**  
 1st Value:  
 2nd Value:  
 Value Percent: **5.000**  
 Continuous Index:  
 Within 8" of Joint: **YES**  
 Remarks:

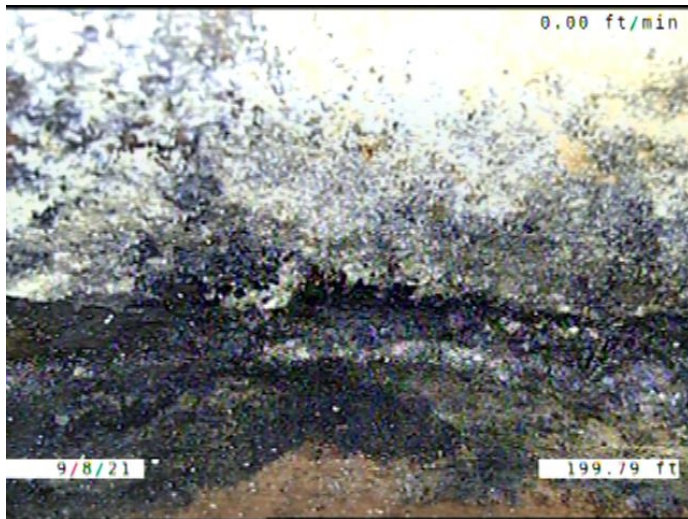
Code: **ISJ**  
 Description: **Infiltration Stain Joint**

Distance (ft): **199.8**  
 Structural Grade: **0**  
 O&M Grade: **1**  
 Clock Start/From: **7**  
 Clock To: **5**  
 1st Value:  
 2nd Value:  
 Value Percent:  
 Continuous Index: **S04**  
 Within 8" of Joint: **YES**  
 Remarks:

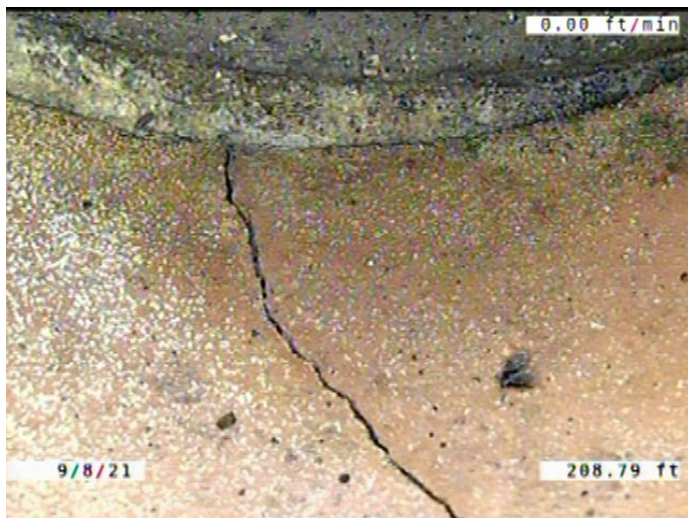
Code: **FM**  
 Description: **Fracture Multiple**

Distance (ft): **208.8**  
 Structural Grade: **4**  
 O&M Grade: **0**  
 Clock Start/From: **8**  
 Clock To: **11**  
 1st Value:  
 2nd Value:  
 Value Percent:  
 Continuous Index:  
 Within 8" of Joint: **YES**  
 Remarks:

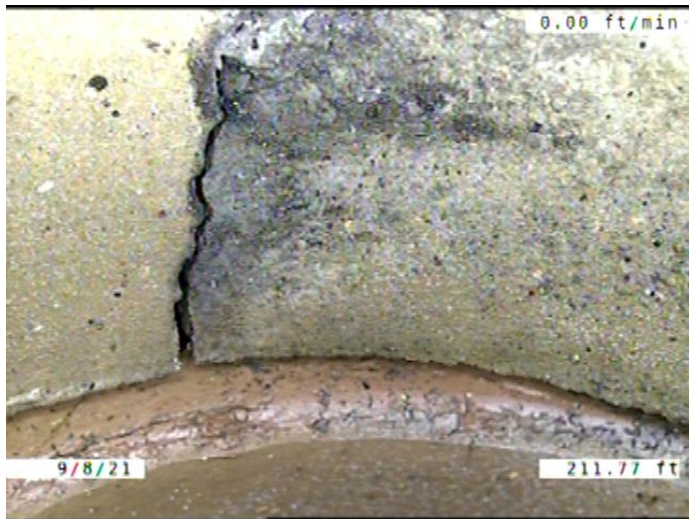
Code: **FS**  
Description: **Fracture Spiral**

Distance (ft): **211.8**  
Structural Grade: **3**  
O&M Grade: **0**  
Clock Start/From: **1**  
Clock To: **5**  
1st Value:  
2nd Value:  
Value Percent:  
Continuous Index:  
Within 8" of Joint: **YES**  
Remarks:

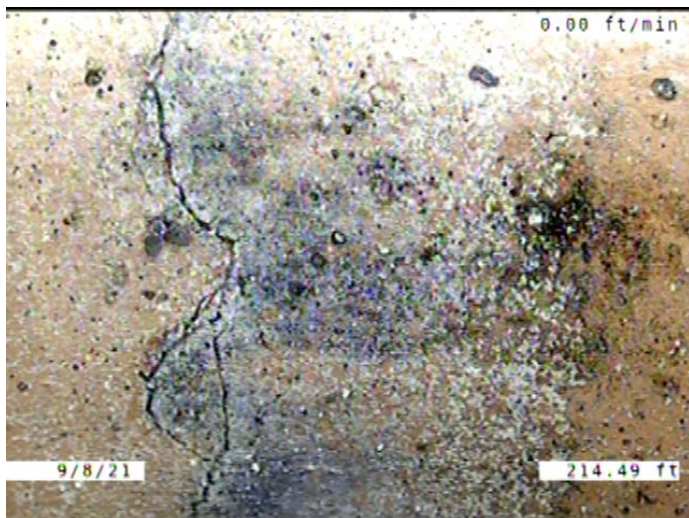
Code: **CM**  
Description: **Crack Multiple**

Distance (ft): **214.5**  
Structural Grade: **3**  
O&M Grade: **0**  
Clock Start/From: **2**  
Clock To: **5**  
1st Value:  
2nd Value:  
Value Percent:  
Continuous Index:  
Within 8" of Joint: **YES**  
Remarks:

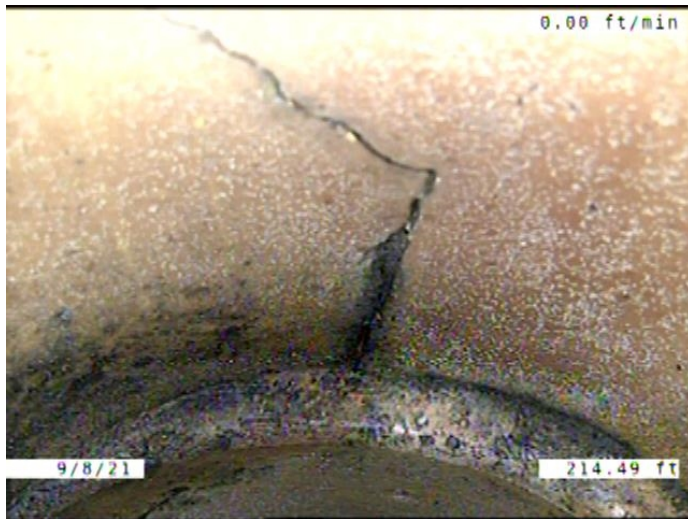
Code: **FM**  
 Description: **Fracture Multiple**

Distance (ft): **214.5**  
 Structural Grade: **4**  
 O&M Grade: **0**  
 Clock Start/From: **9**  
 Clock To: **4**  
 1st Value:  
 2nd Value:  
 Value Percent:  
 Continuous Index:  
 Within 8" of Joint: **YES**  
 Remarks:

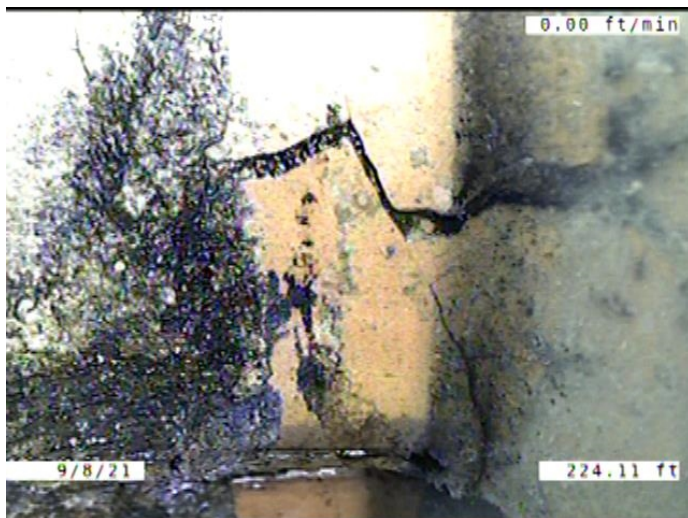
Code: **B**  
 Description: **Broken**

Distance (ft): **224.1**  
 Structural Grade: **4**  
 O&M Grade: **0**  
 Clock Start/From: **4**  
 Clock To: **6**  
 1st Value:  
 2nd Value:  
 Value Percent:  
 Continuous Index:  
 Within 8" of Joint: **YES**  
 Remarks:

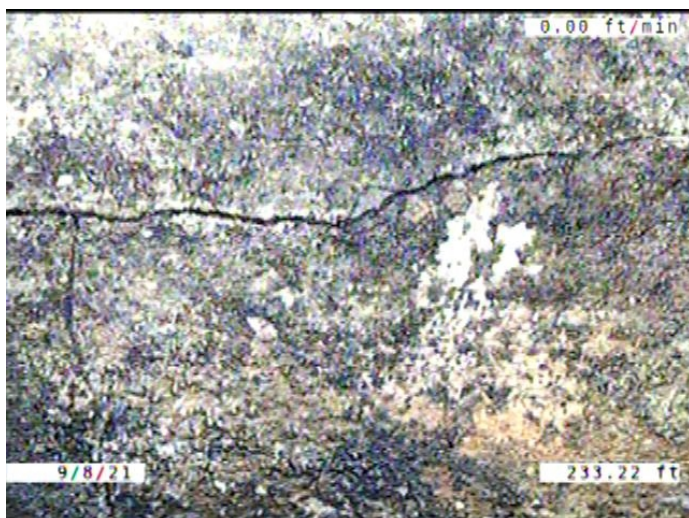
Code: **FM**  
 Description: **Fracture Multiple**

Distance (ft): **233.2**  
 Structural Grade: **4**  
 O&M Grade: **0**  
 Clock Start/From: **7**  
 Clock To: **12**  
 1st Value:  
 2nd Value:  
 Value Percent:  
 Continuous Index:  
 Within 8" of Joint: **YES**  
 Remarks:

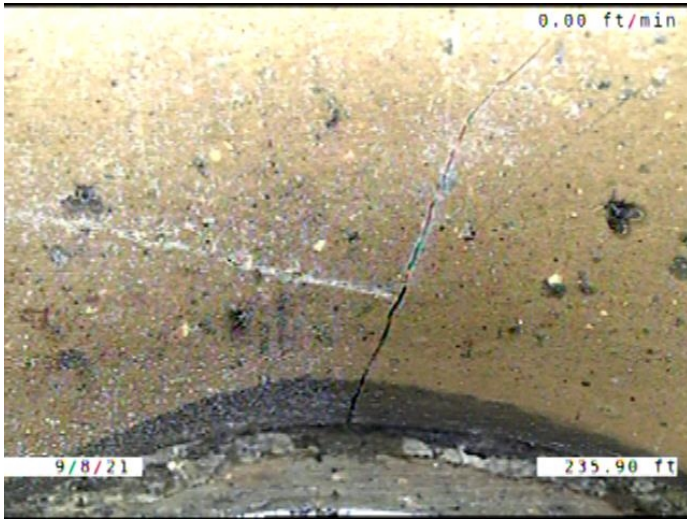
Code: **CM**  
Description: **Crack Multiple**

Distance (ft): **235.9**  
Structural Grade: **3**  
O&M Grade: **0**  
Clock Start/From: **9**  
Clock To: **3**  
1st Value:  
2nd Value:  
Value Percent:  
Continuous Index:  
Within 8" of Joint: **YES**  
Remarks:

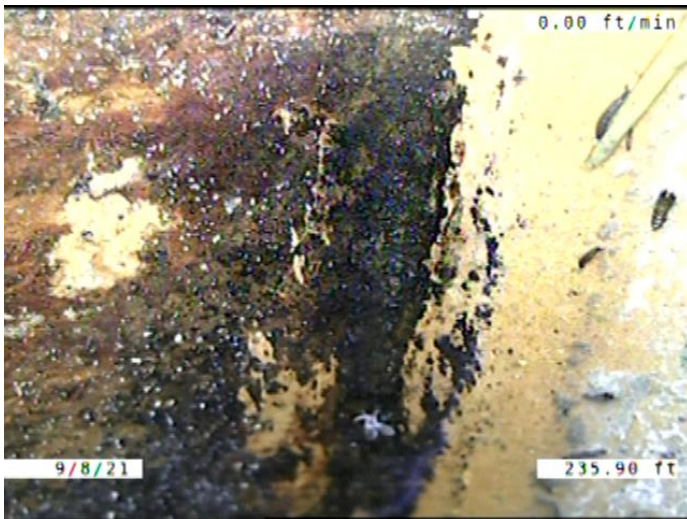
Code: **ISB**  
Description: **Infiltration Stain Barrel**

Distance (ft): **235.9**  
Structural Grade: **0**  
O&M Grade: **1**  
Clock Start/From: **1**  
Clock To: **4**  
1st Value:  
2nd Value:  
Value Percent:  
Continuous Index:  
Within 8" of Joint: **YES**  
Remarks:

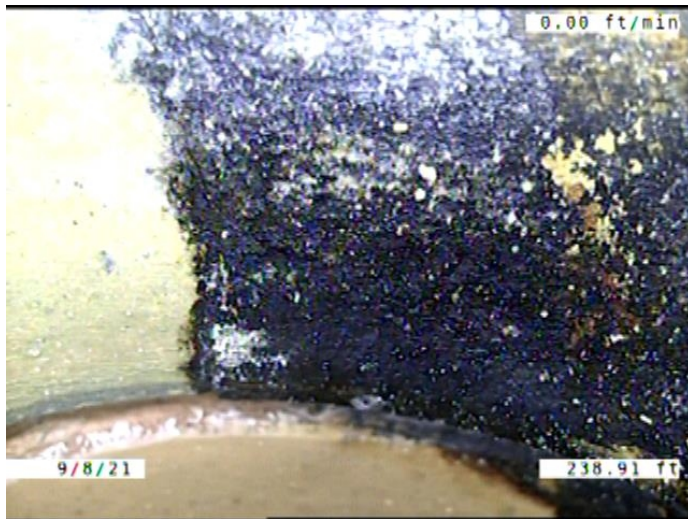
Code: **FM**  
 Description: **Fracture Multiple**

Distance (ft): **238.9**  
 Structural Grade: **4**  
 O&M Grade: **0**  
 Clock Start/From: **12**  
 Clock To: **4**  
 1st Value:  
 2nd Value:  
 Value Percent:  
 Continuous Index:  
 Within 8" of Joint: **YES**  
 Remarks:

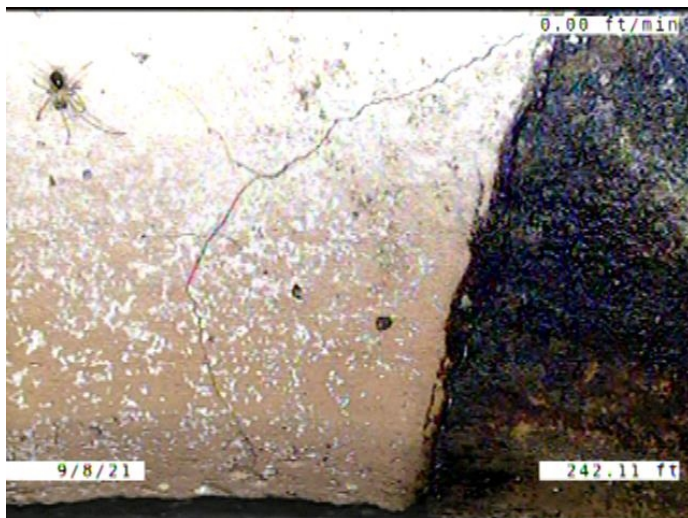
Code: **CM**  
 Description: **Crack Multiple**

Distance (ft): **242.1**  
 Structural Grade: **3**  
 O&M Grade: **0**  
 Clock Start/From: **2**  
 Clock To: **10**  
 1st Value:  
 2nd Value:  
 Value Percent:  
 Continuous Index:  
 Within 8" of Joint: **YES**  
 Remarks:

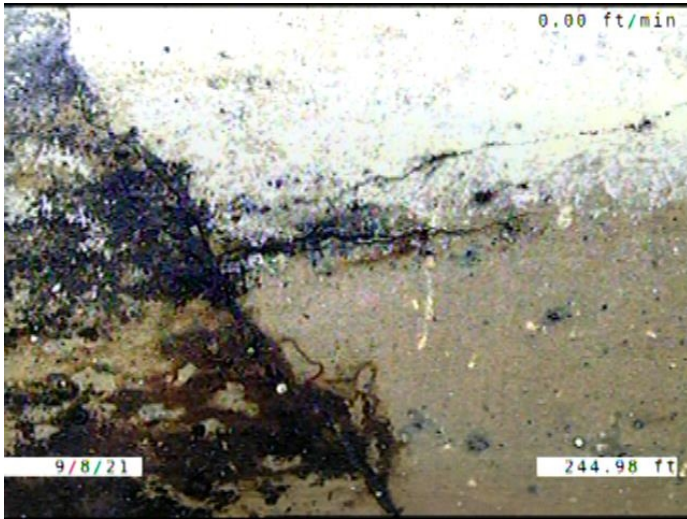
Code: **CM**  
Description: **Crack Multiple**

Distance (ft): **245.0**  
Structural Grade: **3**  
O&M Grade: **0**  
Clock Start/From: **7**  
Clock To: **3**  
1st Value:  
2nd Value:  
Value Percent:  
Continuous Index:  
Within 8" of Joint: **YES**  
Remarks:

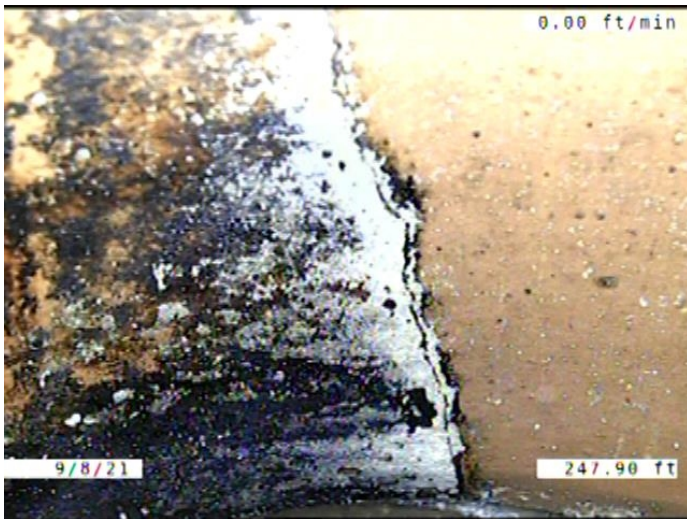
Code: **CS**  
Description: **Crack Spiral**

Distance (ft): **247.9**  
Structural Grade: **2**  
O&M Grade: **0**  
Clock Start/From: **8**  
Clock To: **9**  
1st Value:  
2nd Value:  
Value Percent:  
Continuous Index:  
Within 8" of Joint: **YES**  
Remarks:

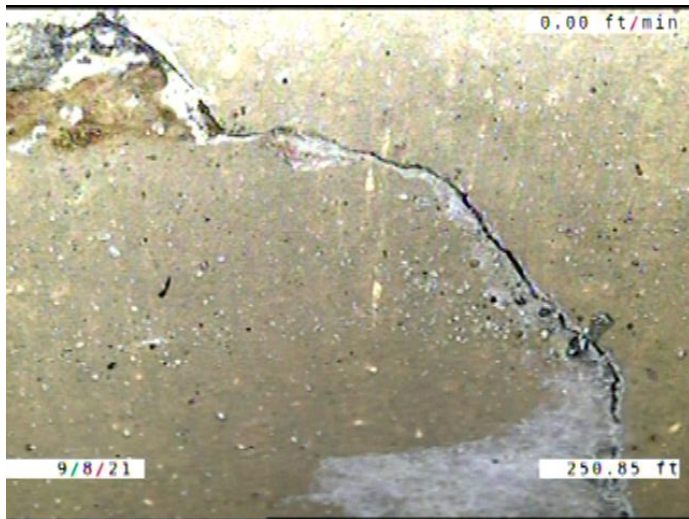
Code: **FM**  
 Description: **Fracture Multiple**

Distance (ft): **250.8**  
 Structural Grade: **4**  
 O&M Grade: **0**  
 Clock Start/From: **7**  
 Clock To: **12**  
 1st Value:  
 2nd Value:  
 Value Percent:  
 Continuous Index:  
 Within 8" of Joint: **YES**  
 Remarks:

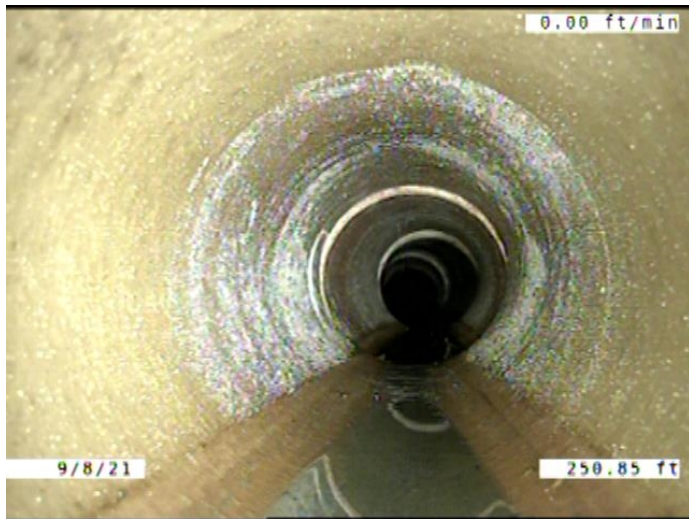
Code: **ISJ**  
 Description: **Infiltration Stain Joint**

Distance (ft): **250.8**  
 Structural Grade: **0**  
 O&M Grade: **1**  
 Clock Start/From: **7**  
 Clock To: **5**  
 1st Value:  
 2nd Value:  
 Value Percent:  
 Continuous Index: **F04**  
 Within 8" of Joint: **YES**  
 Remarks:

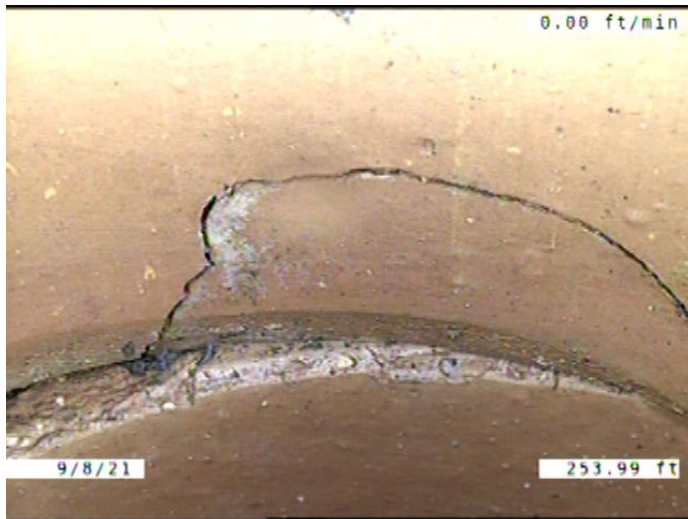
Code: **FM**  
 Description: **Fracture Multiple**

Distance (ft): **254.0**  
 Structural Grade: **4**  
 O&M Grade: **0**  
 Clock Start/From: **12**  
 Clock To: **12**  
 1st Value:  
 2nd Value:  
 Value Percent:  
 Continuous Index:  
 Within 8" of Joint: **YES**  
 Remarks:

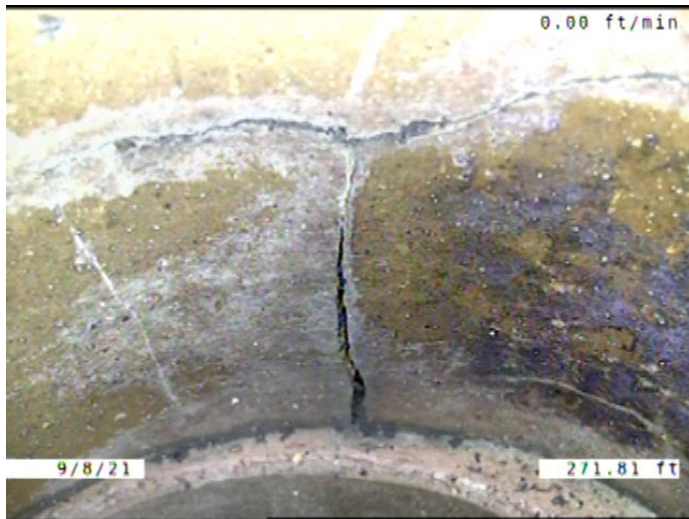
Code: **FM**  
 Description: **Fracture Multiple**

Distance (ft): **271.8**  
 Structural Grade: **4**  
 O&M Grade: **0**  
 Clock Start/From: **7**  
 Clock To: **1**  
 1st Value:  
 2nd Value:  
 Value Percent:  
 Continuous Index:  
 Within 8" of Joint: **YES**  
 Remarks:

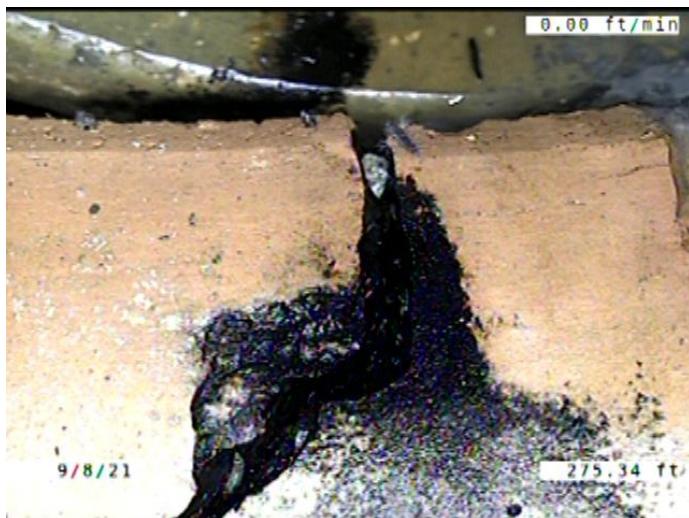
Code: **B**  
 Description: **Broken**

Distance (ft): **275.3**  
 Structural Grade: **4**  
 O&M Grade: **0**  
 Clock Start/From: **8**  
 Clock To: **10**  
 1st Value:  
 2nd Value:  
 Value Percent:  
 Continuous Index:  
 Within 8" of Joint: **YES**  
 Remarks:

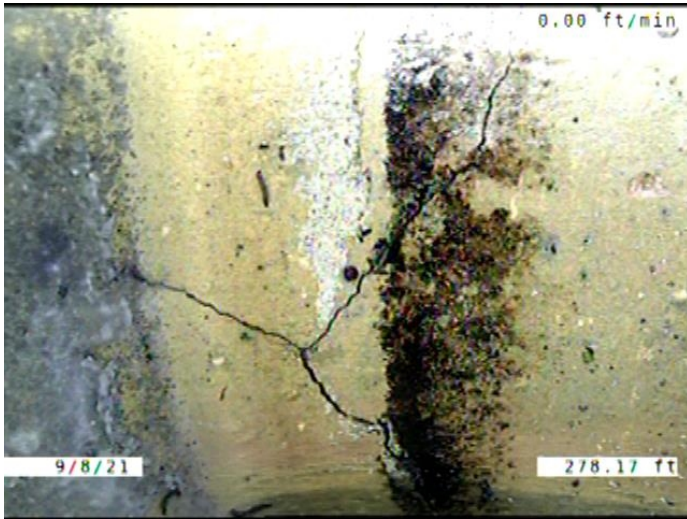
Code: **CM**  
Description: **Crack Multiple**

Distance (ft): **278.2**  
Structural Grade: **3**  
O&M Grade: **0**  
Clock Start/From: **11**  
Clock To: **9**  
1st Value:  
2nd Value:  
Value Percent:  
Continuous Index:  
Within 8" of Joint: **YES**  
Remarks:

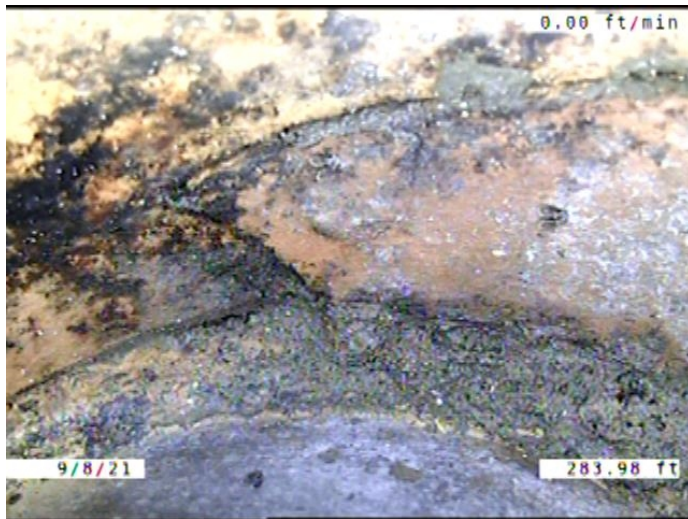
Code: **B**  
Description: **Broken**

Distance (ft): **284.0**  
Structural Grade: **4**  
O&M Grade: **0**  
Clock Start/From: **12**  
Clock To: **12**  
1st Value:  
2nd Value:  
Value Percent:  
Continuous Index:  
Within 8" of Joint: **YES**  
Remarks:

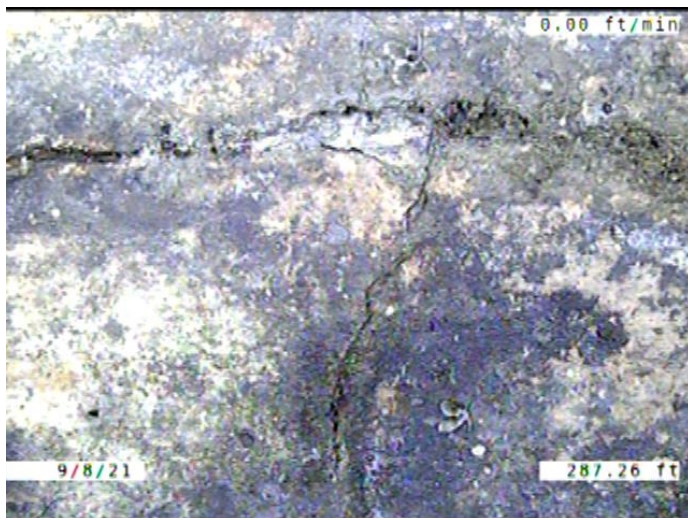
Code: **FM**  
Description: **Fracture Multiple**

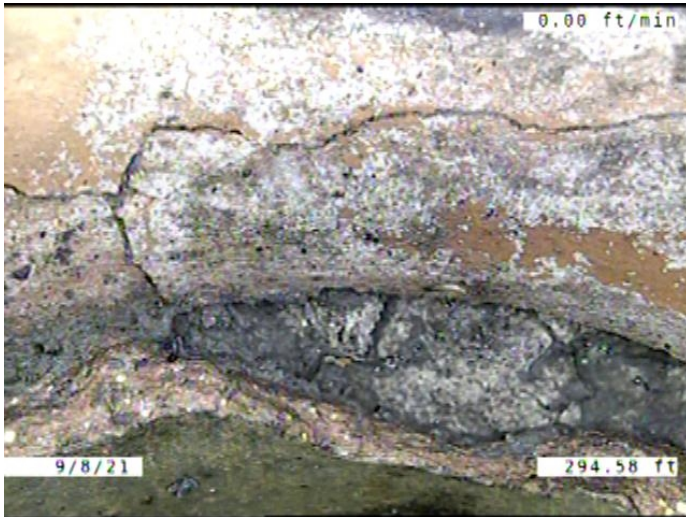
Code: **BSV**  
Description: **Broken Soil Visible**

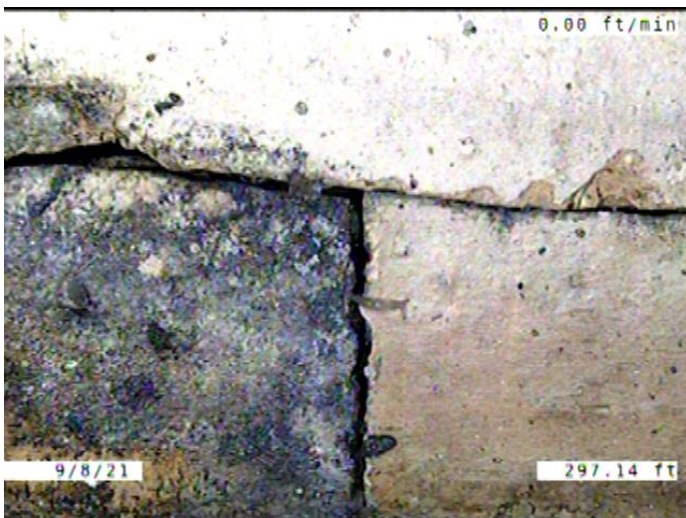
Code: **B**  
Description: **Broken**

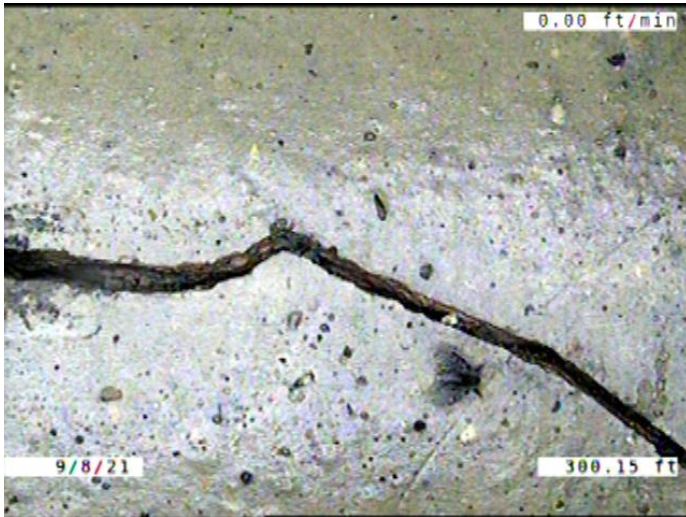
Code: **B**  
 Description: **Broken**

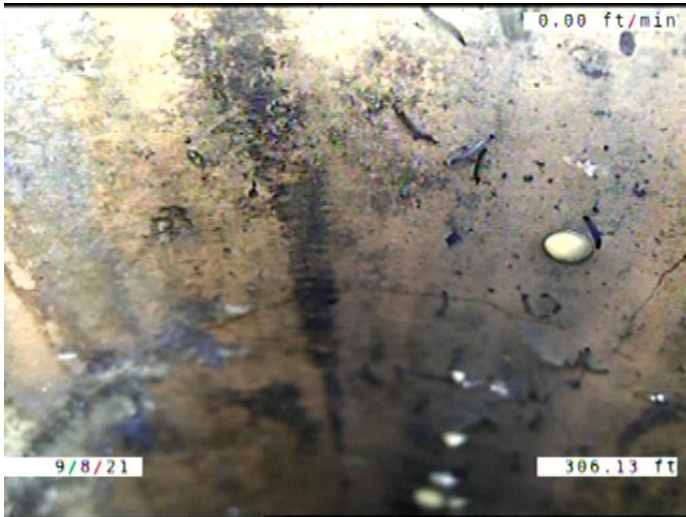
Code: **B**  
Description: **Broken**
