Profile/Photo Observation Report

Date:	09/08/2021	Weather:		Coding:	PACP 7.0
Pipe Length (ft):	308.1	Owner:	City of Hobart	Pre Clean:	Light Cleaning
P.O.#:	YES502259	Surveyor:	S. Bucklin	PSR:	P-503-034-033
Customer:	City of Hobart	Clean Date:	08/26/2021	Shape:	C

Street:	40th Avenue	Flow Control:	Not Controlled
City:	Hobart, IN	Year Renewed:	
Location:		Tape/Media #:	
Purpose:	Routine Assessment	Dia/Height:	8"
Use:	Sanitary Sewage Pipe	Material:	VCP
Drain Area:		Lining:	None
Category:	NA		
Comment:			
Location Details:		Direction of Survey:	Upstream
US MH:	M-503-033	DS MH:	M-503-034
		Total Length Surveyed (ft):	308.1

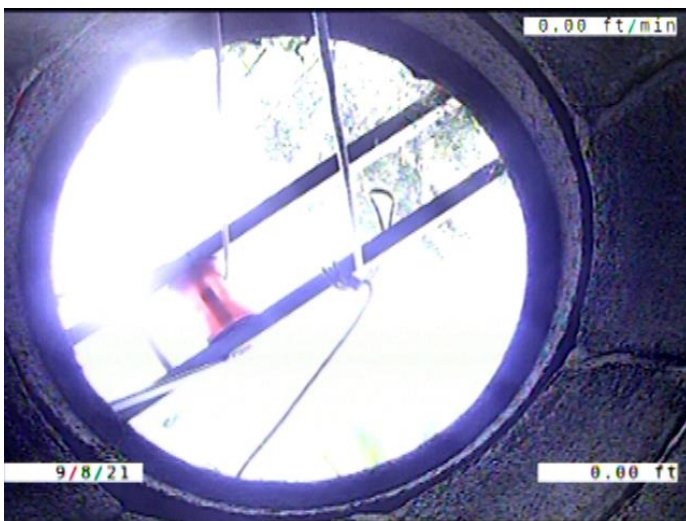
M-503-033

Code: **AMH**
Description: **Manhole**

Distance (ft): **.0**
Structural Grade: **0**
O&M Grade: **0**
Clock Start/From:
Clock To:
1st Value:
2nd Value:
Value Percent:
Continuous Index:
Within 8" of Joint: **NO**
Remarks: **M-503-034**

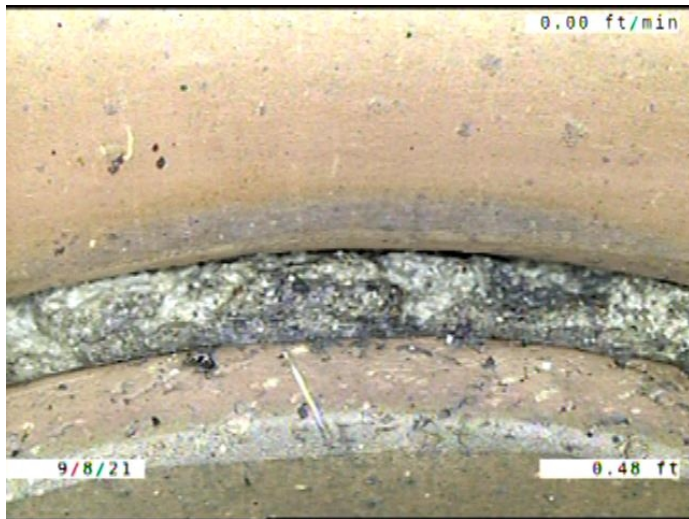
Code: **JOLD**
 Description: **Joint Offset Large Defective**

Distance (ft): **.5**
 Structural Grade: **4**
 O&M Grade: **0**
 Clock Start/From:
 Clock To:
 1st Value:
 2nd Value:
 Value Percent:
 Continuous Index:
 Within 8" of Joint: **NO**
 Remarks:

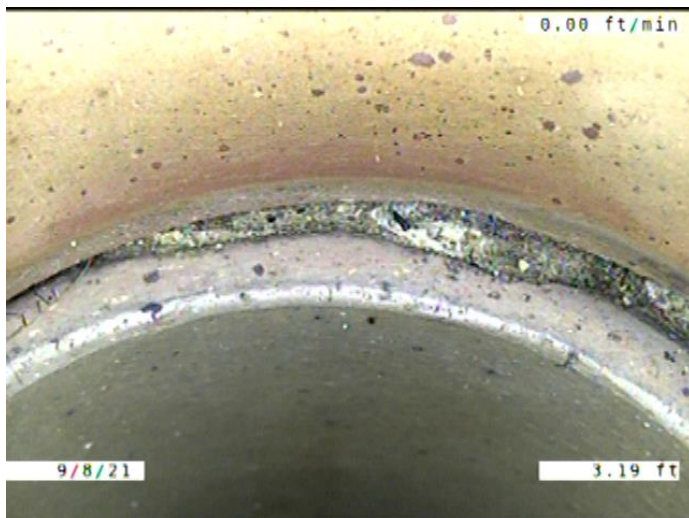
Code: **JOM**
 Description: **Joint Offset Medium**

Distance (ft): **3.2**
 Structural Grade: **3**
 O&M Grade: **0**
 Clock Start/From:
 Clock To:
 1st Value:
 2nd Value:
 Value Percent:
 Continuous Index:
 Within 8" of Joint: **NO**
 Remarks:

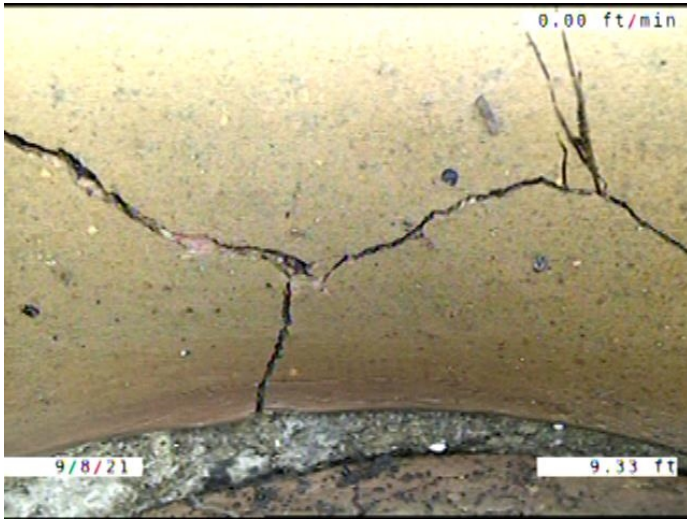
Code: **B**
Description: **Broken**

Distance (ft): **9.3**
Structural Grade: **4**
O&M Grade: **0**
Clock Start/From: **7**
Clock To: **3**
1st Value:
2nd Value:
Value Percent:
Continuous Index:
Within 8" of Joint: **YES**
Remarks:

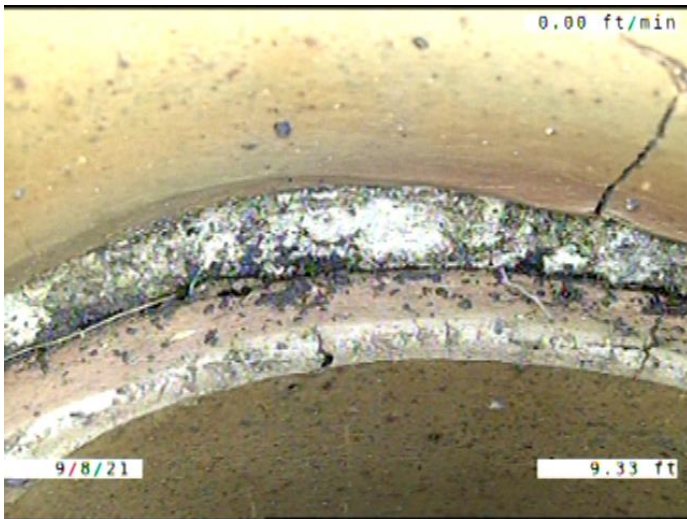
Code: **JOMD**
Description: **Joint Offset Medium Defective**

Distance (ft): **9.3**
Structural Grade: **3**
O&M Grade: **0**
Clock Start/From:
Clock To:
1st Value:
2nd Value:
Value Percent:
Continuous Index:
Within 8" of Joint: **NO**
Remarks:

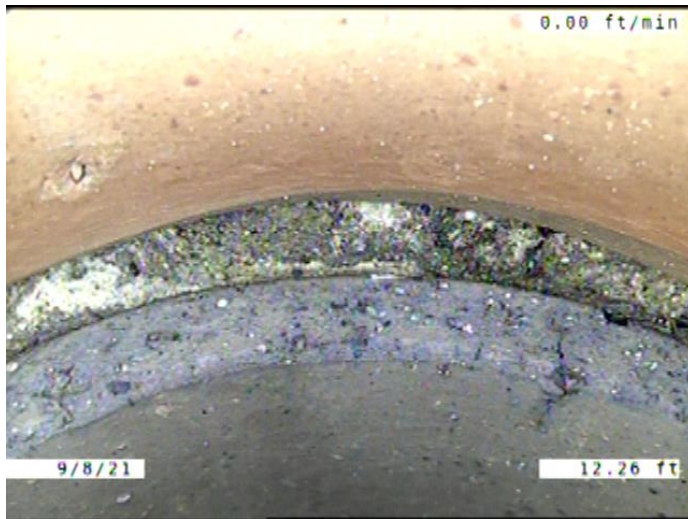
Code: **JOLD**
 Description: **Joint Offset Large Defective**

Distance (ft): **12.3**
 Structural Grade: **4**
 O&M Grade: **0**
 Clock Start/From:
 Clock To:
 1st Value:
 2nd Value:
 Value Percent:
 Continuous Index:
 Within 8" of Joint: **NO**
 Remarks:

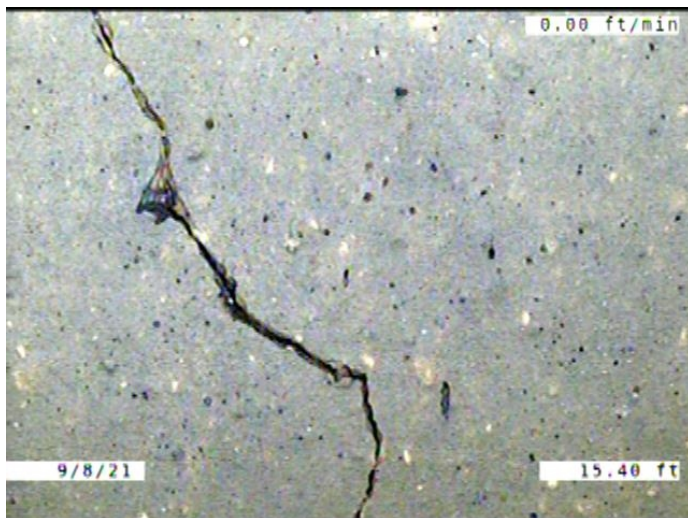
Code: **FM**
 Description: **Fracture Multiple**

Distance (ft): **15.4**
 Structural Grade: **4**
 O&M Grade: **0**
 Clock Start/From: **10**
 Clock To: **1**
 1st Value:
 2nd Value:
 Value Percent:
 Continuous Index:
 Within 8" of Joint: **YES**
 Remarks:

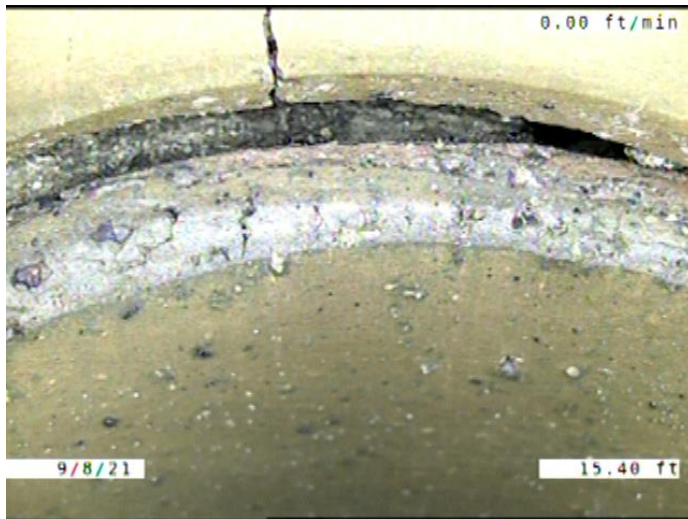
Code: **JOMD**
 Description: **Joint Offset Medium Defective**

Distance (ft): **15.4**
 Structural Grade: **3**
 O&M Grade: **0**
 Clock Start/From:
 Clock To:
 1st Value:
 2nd Value:
 Value Percent:
 Continuous Index:
 Within 8" of Joint: **NO**
 Remarks: **VOID VISIBLE**

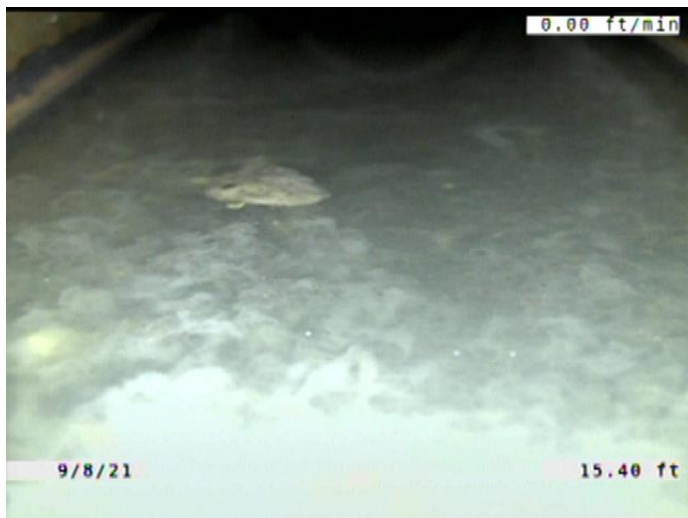
Code: **DSF**
 Description: **Deposits Settled Fine**

Distance (ft): **15.4**
 Structural Grade: **0**
 O&M Grade: **2**
 Clock Start/From: **5**
 Clock To: **7**
 1st Value:
 2nd Value:
 Value Percent: **5.000**
 Continuous Index: **S01**
 Within 8" of Joint: **YES**
 Remarks:

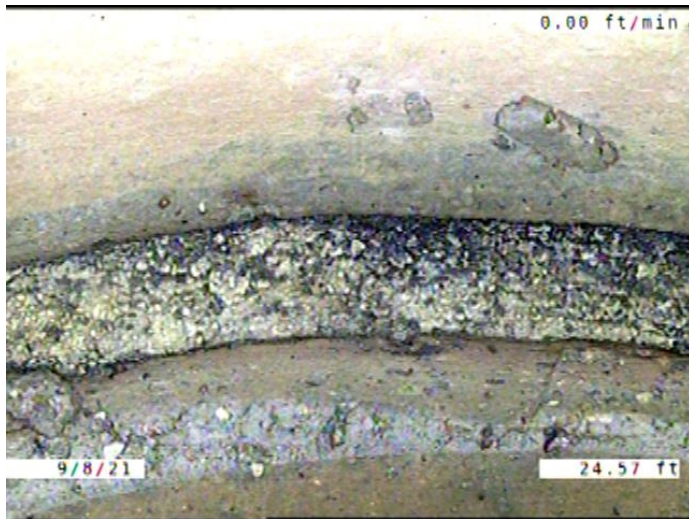
Code: **JOMD**
 Description: **Joint Offset Medium Defective**

Distance (ft): **24.6**
 Structural Grade: **3**
 O&M Grade: **0**
 Clock Start/From:
 Clock To:
 1st Value:
 2nd Value:
 Value Percent:
 Continuous Index:
 Within 8" of Joint: **NO**
 Remarks:

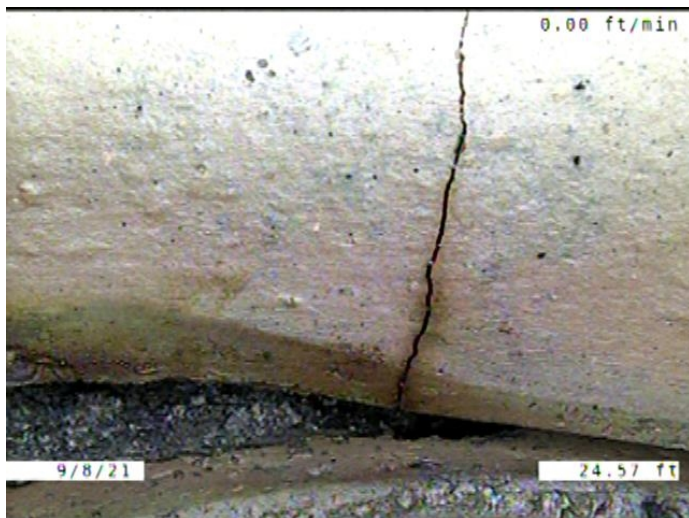
Code: **CM**
 Description: **Crack Multiple**

Distance (ft): **24.6**
 Structural Grade: **3**
 O&M Grade: **0**
 Clock Start/From: **9**
 Clock To: **2**
 1st Value:
 2nd Value:
 Value Percent:
 Continuous Index:
 Within 8" of Joint: **YES**
 Remarks:

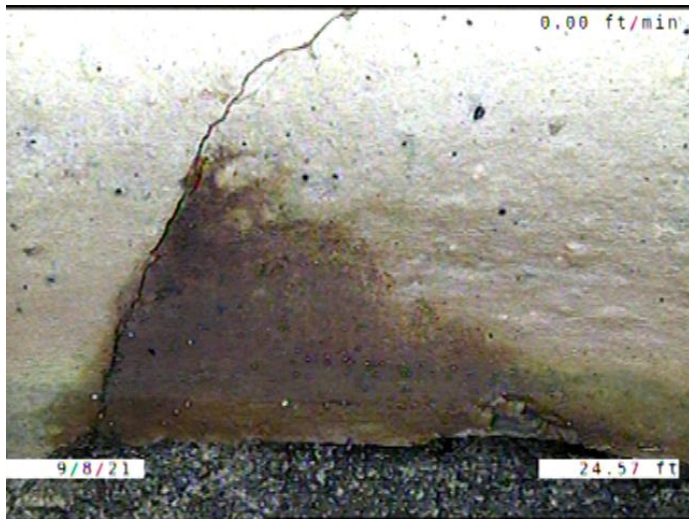
Code: **ISB**
 Description: **Infiltration Stain Barrel**

Distance (ft): **24.6**
 Structural Grade: **0**
 O&M Grade: **1**
 Clock Start/From: **1**
 Clock To: **2**
 1st Value:
 2nd Value:
 Value Percent:
 Continuous Index:
 Within 8" of Joint: **YES**
 Remarks:

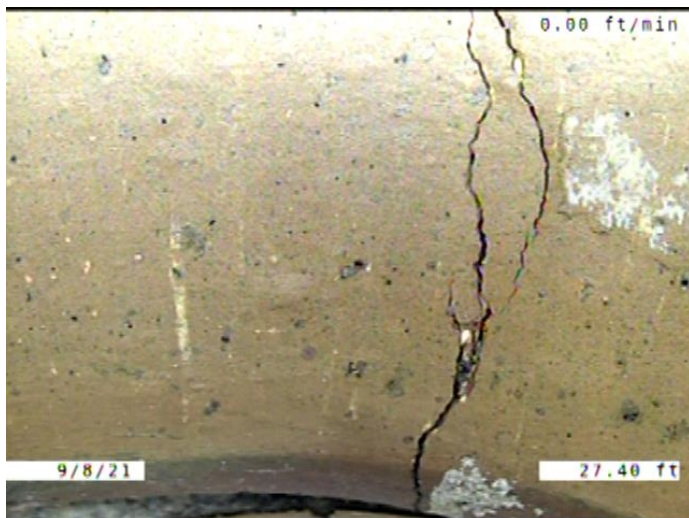
Code: **FM**
 Description: **Fracture Multiple**

Distance (ft): **27.4**
 Structural Grade: **4**
 O&M Grade: **0**
 Clock Start/From: **10**
 Clock To: **2**
 1st Value:
 2nd Value:
 Value Percent:
 Continuous Index:
 Within 8" of Joint: **YES**
 Remarks:

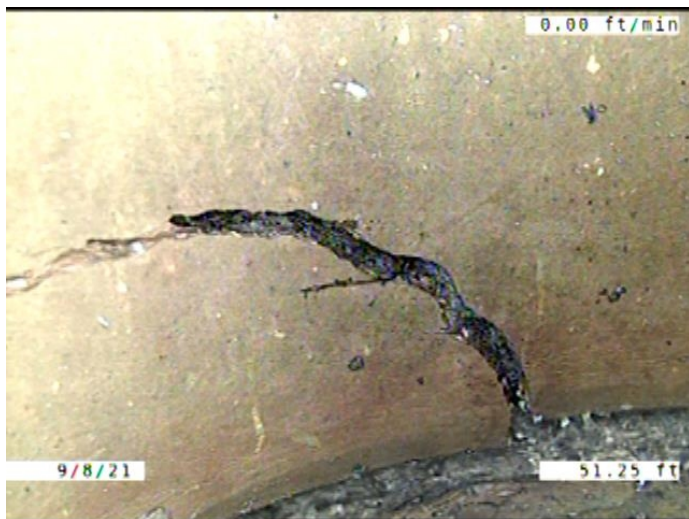
Code: **B**
 Description: **Broken**

Distance (ft): **51.3**
 Structural Grade: **4**
 O&M Grade: **0**
 Clock Start/From: **4**
 Clock To: **12**
 1st Value:
 2nd Value:
 Value Percent:
 Continuous Index:
 Within 8" of Joint: **YES**
 Remarks:

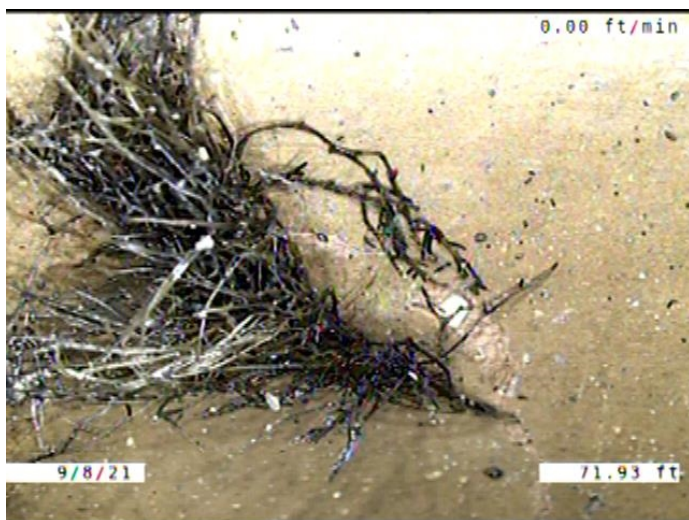
Code: **RFJ**
 Description: **Roots Fine Joint**

Distance (ft): **71.9**
 Structural Grade: **0**
 O&M Grade: **1**
 Clock Start/From: **9**
 Clock To: **10**
 1st Value:
 2nd Value:
 Value Percent:
 Continuous Index:
 Within 8" of Joint: **YES**
 Remarks:

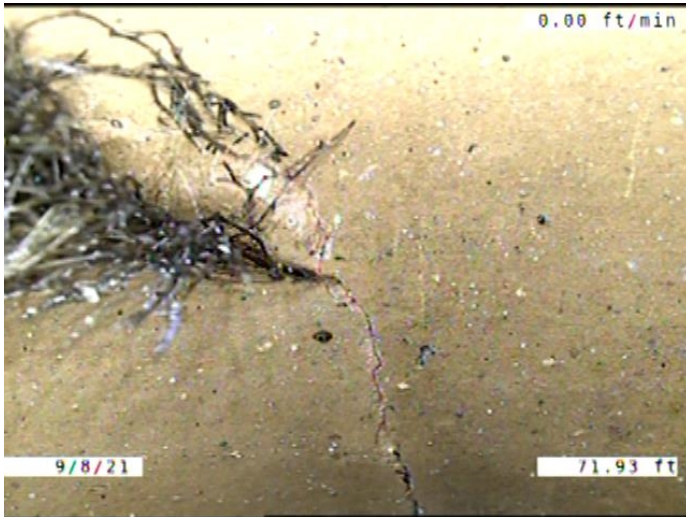
Code: **CM**
 Description: **Crack Multiple**

Distance (ft): **71.9**
 Structural Grade: **3**
 O&M Grade: **0**
 Clock Start/From: **10**
 Clock To: **11**
 1st Value:
 2nd Value:
 Value Percent:
 Continuous Index:
 Within 8" of Joint: **YES**
 Remarks:

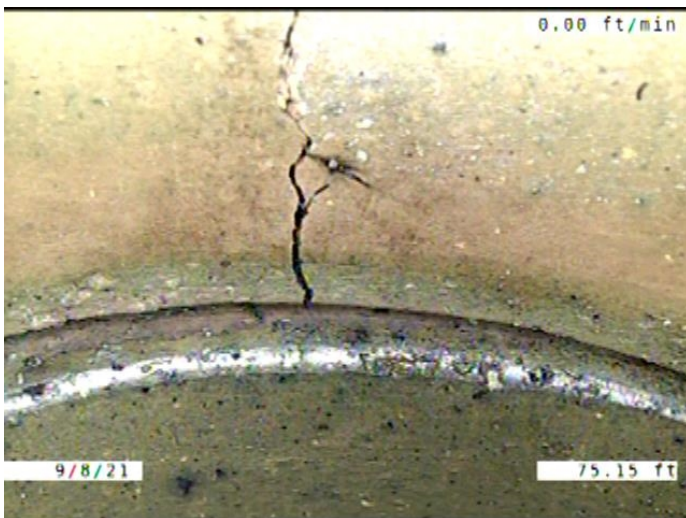
Code: **FM**
 Description: **Fracture Multiple**

Distance (ft): **75.2**
 Structural Grade: **4**
 O&M Grade: **0**
 Clock Start/From: **2**
 Clock To: **5**
 1st Value:
 2nd Value:
 Value Percent:
 Continuous Index:
 Within 8" of Joint: **YES**
 Remarks:

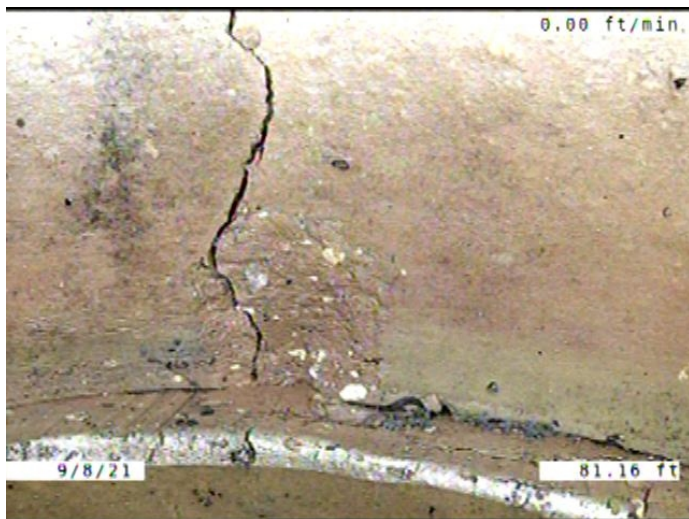
Code: **CM**
 Description: **Crack Multiple**

Distance (ft): **81.2**
 Structural Grade: **3**
 O&M Grade: **0**
 Clock Start/From: **1**
 Clock To: **3**
 1st Value:
 2nd Value:
 Value Percent:
 Continuous Index:
 Within 8" of Joint: **YES**
 Remarks:

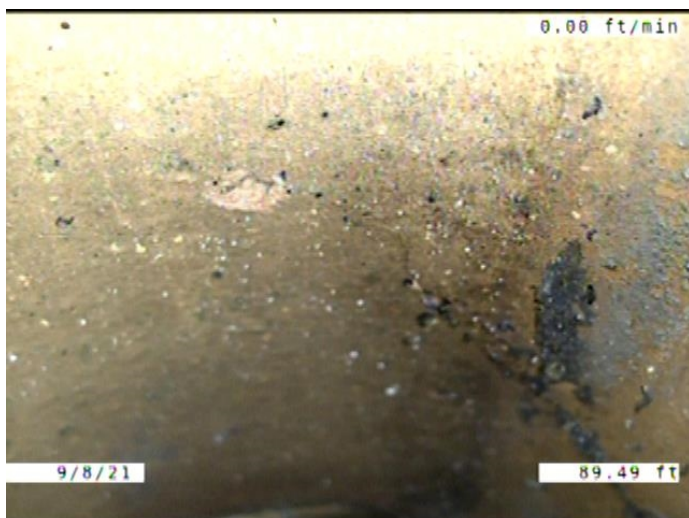
Code: **CM**
 Description: **Crack Multiple**

Distance (ft): **89.5**
 Structural Grade: **3**
 O&M Grade: **0**
 Clock Start/From: **3**
 Clock To: **12**
 1st Value:
 2nd Value:
 Value Percent:
 Continuous Index: **S03**
 Within 8" of Joint: **YES**
 Remarks:

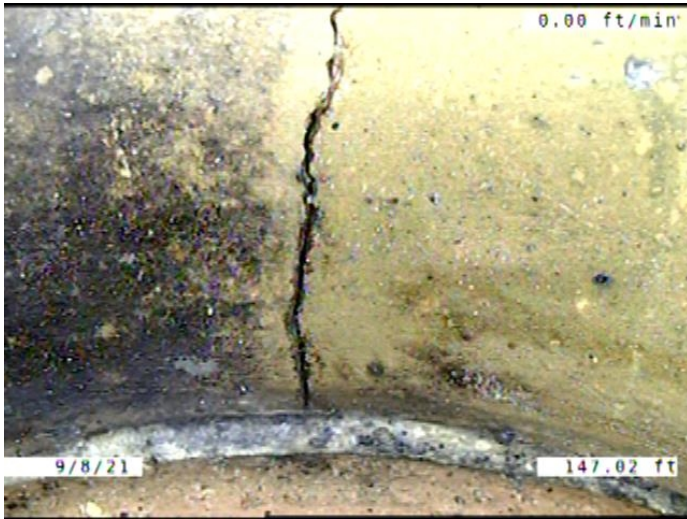
Code: **FM**
Description: **Fracture Multiple**

Distance (ft): **147.0**
Structural Grade: **4**
O&M Grade: **0**
Clock Start/From: **12**
Clock To: **5**
1st Value:
2nd Value:
Value Percent:
Continuous Index:
Within 8" of Joint: **YES**
Remarks:

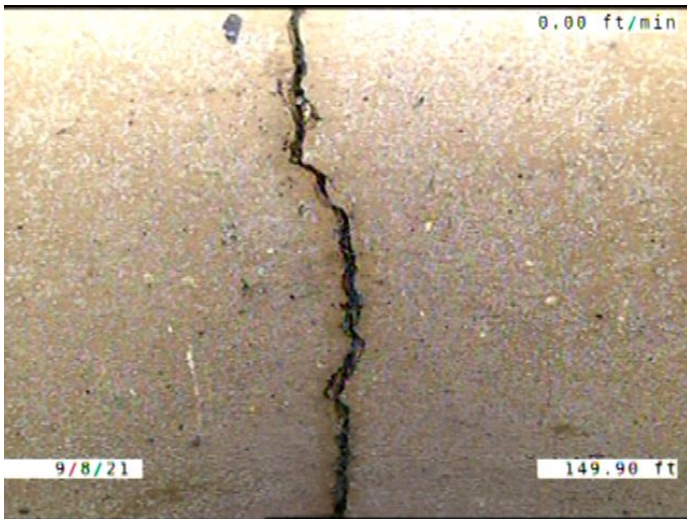
Code: **B**
Description: **Broken**

Distance (ft): **149.9**
Structural Grade: **4**
O&M Grade: **0**
Clock Start/From: **3**
Clock To: **12**
1st Value:
2nd Value:
Value Percent:
Continuous Index:
Within 8" of Joint: **YES**
Remarks:

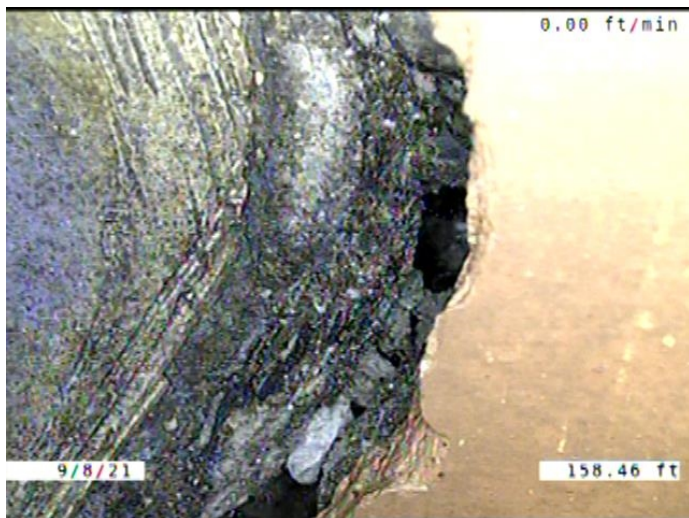
Code: **BSV**
 Description: **Broken Soil Visible**

Distance (ft): **158.5**
 Structural Grade: **5**
 O&M Grade: **0**
 Clock Start/From: **8**
 Clock To: **11**
 1st Value:
 2nd Value:
 Value Percent:
 Continuous Index:
 Within 8" of Joint: **YES**
 Remarks:

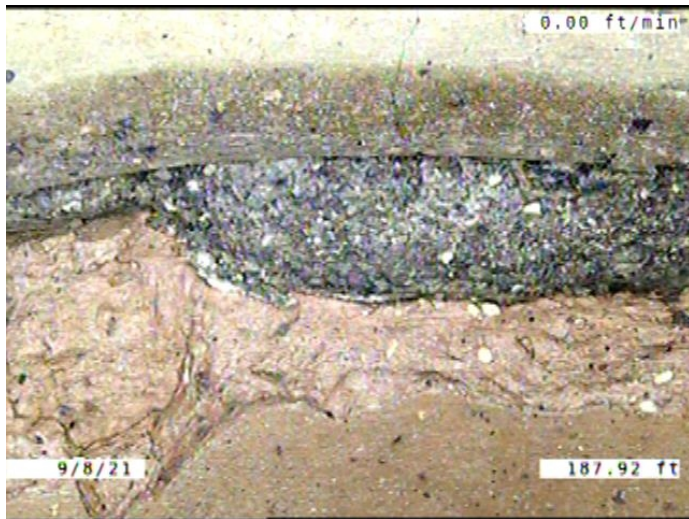
Code: **SMW**
 Description: **Surface Damage Missing Wall**

Distance (ft): **187.9**
 Structural Grade: **5**
 O&M Grade: **0**
 Clock Start/From: **10**
 Clock To: **12**
 1st Value:
 2nd Value:
 Value Percent:
 Continuous Index:
 Within 8" of Joint: **YES**
 Remarks:

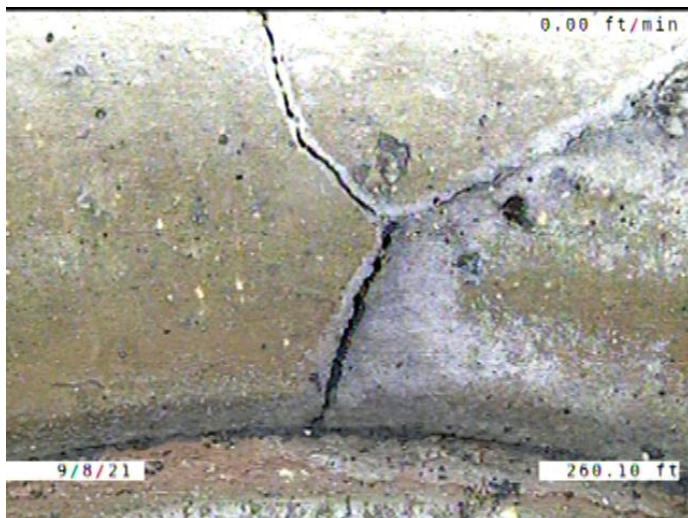
Code: **B**
 Description: **Broken**

Distance (ft): **260.1**
 Structural Grade: **4**
 O&M Grade: **0**
 Clock Start/From: **7**
 Clock To: **5**
 1st Value:
 2nd Value:
 Value Percent:
 Continuous Index:
 Within 8" of Joint: **YES**
 Remarks:
