Profile/Photo Observation Report

Street:	ALLEY BETWEEN N COLORADO ST &	Flow Control:	Not Controlled
City:	Hobart, IN	Year Renewed:	
Location:	Light Highway	Tape/Media #:	
Purpose:	Routine Assessment	Dia/Height:	8"
Use:	Sanitary	Material:	VCP
Drain Area:	NA	Lining:	
Category:	NA		
Comment:

Location Details:		Direction of Survey:	Downstream
US MH:	M-503-036	DS MH:	M-503-035
		Total Length Surveyed (ft):	5.0

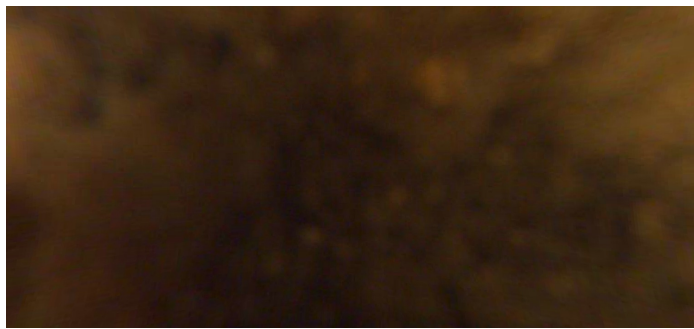
Code: **AMH**
Description: **Manhole**

Distance (ft): **.0**
Structural Grade: **0**
O&M Grade: **0**
Clock Start/From:
Clock To:
1st Value:
2nd Value:
Value Percent:
Continuous Index:
Within 8" of Joint: **NO**
Remarks: **M-503-036**

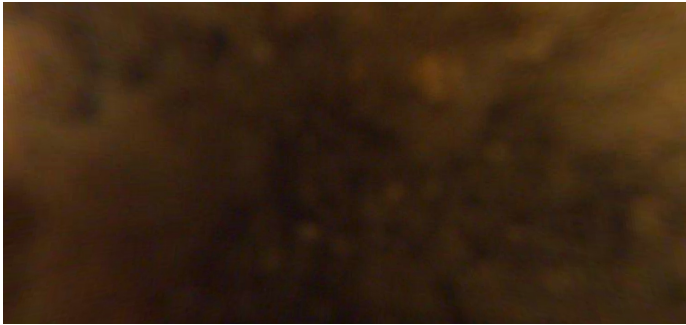
Code:	MWL
Description:	Water Level

Distance (ft):	.0
Structural Grade:	0
O&M Grade:	0
Clock Start/From:	
Clock To:	
1st Value:	
2nd Value:	
Value Percent:	5.000
Continuous Index:	
Within 8" of Joint:	NO
Remarks:
