Profile/Photo Observation Report

Date:	09/29/2018	Weather:		Coding:	PACP 6.0
Pipe Length (ft):	190.2	Owner:	NA	Pre Clean:	Not Known
P.O.#:		Surveyor:	Selasie Honu	PSR:	P-503-035-036
Customer:		Clean Date:	01/01/1900	Shape:	C

Street:	40th. Ave.	Flow Control:	Not Controlled
City:	Hobart, IN	Year Renewed:	
Location:	Light Highway	Tape/Media #:	
Purpose:	Routine Assessment	Dia/Height:	8"
Use:	Sanitary	Material:	VCP
Drain Area:	NA	Lining:	
Category:	NA		
Comment:

Location Details:		Direction of Survey:	Downstream
US MH:	M-503-036	DS MH:	M-503-035
		Total Length Surveyed (ft):	5.0

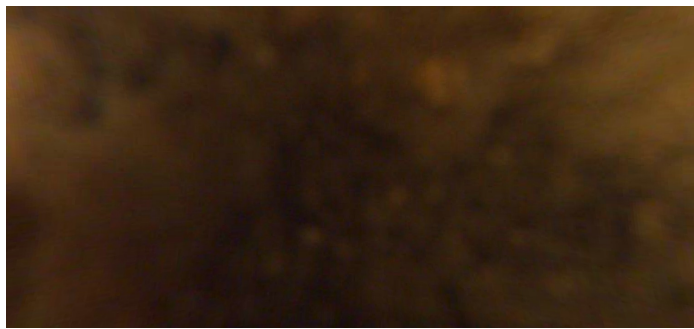
Code: **AMH**
Description: **Manhole**

Distance (ft): **.0**
Structural Grade: **0**
O&M Grade: **0**
Clock Start/From:
Clock To:
1st Value:
2nd Value:
Value Percent:
Continuous Index:
Within 8" of Joint: **NO**
Remarks: **M-503-036**

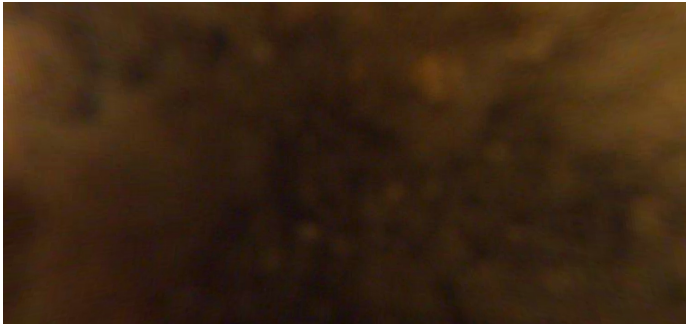
Code:	MWL
Description:	Water Level

Distance (ft):	.0
Structural Grade:	0
O&M Grade:	0
Clock Start/From:	
Clock To:	
1st Value:	
2nd Value:	
Value Percent:	5.000
Continuous Index:	
Within 8" of Joint:	NO
Remarks:
