## Profile/Photo Observation Report

Street:	<b>ALLEY BETWEEN N COLORADO ST &amp;</b>	Flow Control:	<b>Not Controlled</b>
City:	<b>Hobart, IN</b>	Year Renewed:	
Location:	<b>Light Highway</b>	Tape/Media #:	
Purpose:	<b>Routine Assessment</b>	Dia/Height:	<b>10"</b>
Use:	<b>Sanitary</b>	Material:	<b>VCP</b>
Drain Area:	<b>NA</b>	Lining:	
Category:	<b>NA</b>		
Comment:

Location Details:		Direction of Survey:	<b>Upstream</b>
US MH:	<b>M-503-036</b>	DS MH:	<b>M-503-035</b>
		Total Length Surveyed (ft):	<b>28.3</b>

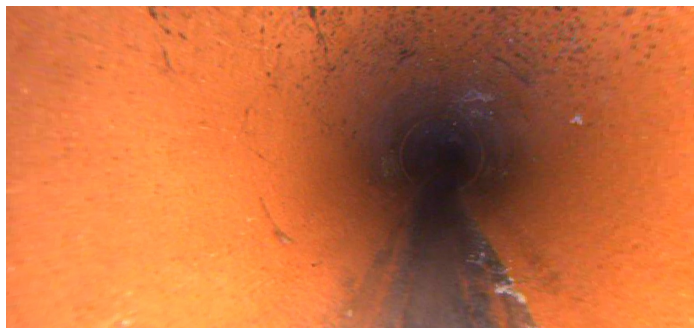
Code: **AMH**  
Description: **Manhole**

Distance (ft): **.0**  
Structural Grade: **0**  
O&M Grade: **0**  
Clock Start/From:  
Clock To:  
1st Value:  
2nd Value:  
Value Percent:  
Continuous Index:  
Within 8" of Joint: **NO**  
Remarks: **M-503-035**

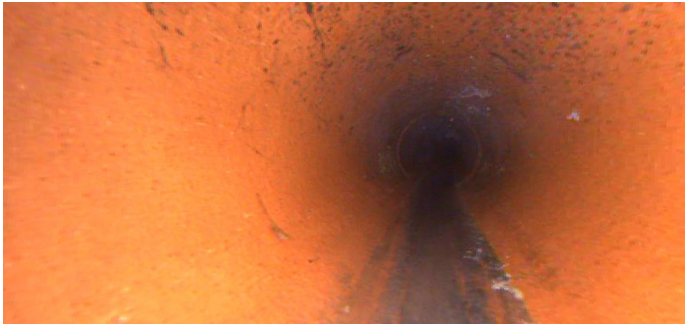
Code:	<b>MWL</b>
Description:	<b>Water Level</b>

Distance (ft):	<b>.0</b>
Structural Grade:	<b>0</b>
O&M Grade:	<b>0</b>
Clock Start/From:	
Clock To:	
1st Value:	
2nd Value:	
Value Percent:	<b>5.000</b>
Continuous Index:	
Within 8" of Joint:	<b>NO</b>
Remarks:

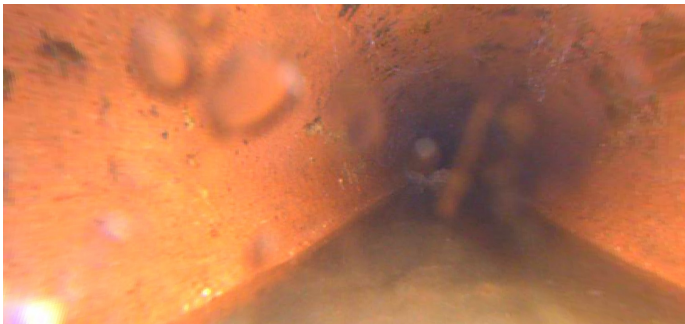
Code:	<b>DSZ</b>
Description:	<b>Deposits Settled Other</b>

Distance (ft):	<b>25.6</b>
Structural Grade:	<b>0</b>
O&M Grade:	<b>5</b>
Clock Start/From:	<b>6</b>
Clock To:	<b>7</b>
1st Value:	
2nd Value:	
Value Percent:	<b>50.000</b>
Continuous Index:	
Within 8" of Joint:	<b>YES</b>
Remarks:	<b>mixed material</b>

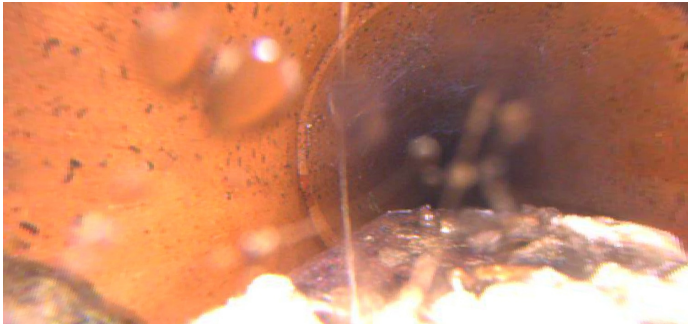
Code:	<b>MSA</b>
Description:	<b>Abandoned Survey</b>
Distance (ft):	<b>28.3</b>
Structural Grade:	<b>0</b>
O&M Grade:	<b>0</b>
Clock Start/From:	
Clock To:	
1st Value:	
2nd Value:	
Value Percent:	
Continuous Index:	
Within 8" of Joint:	<b>NO</b>
Remarks:	<b>mixed material blocking camera</b>
