Profile/Photo Observation Report

Street:	40th. Ave.	Flow Control:	Not Controlled
City:	Hobart, IN	Year Renewed:	
Location:	Light Highway	Tape/Media #:	
Purpose:	Routine Assessment	Dia/Height:	10"
Use:	Sanitary	Material:	VCP
Drain Area:	NA	Lining:	
Category:	NA		
Comment:

Location Details:		Direction of Survey:	Upstream
US MH:	M-503-036	DS MH:	M-503-035
		Total Length Surveyed (ft):	28.3

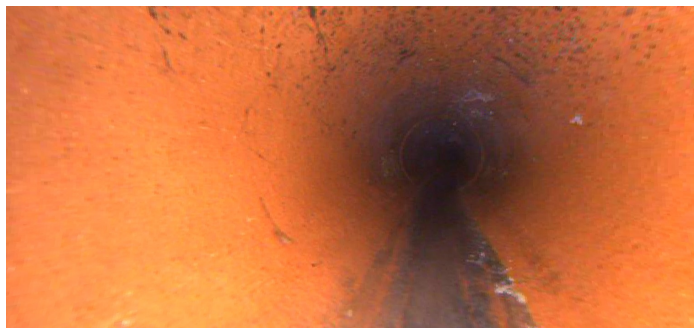
Code: **AMH**
Description: **Manhole**

Distance (ft): **.0**
Structural Grade: **0**
O&M Grade: **0**
Clock Start/From:
Clock To:
1st Value:
2nd Value:
Value Percent:
Continuous Index:
Within 8" of Joint: **NO**
Remarks: **M-503-035**

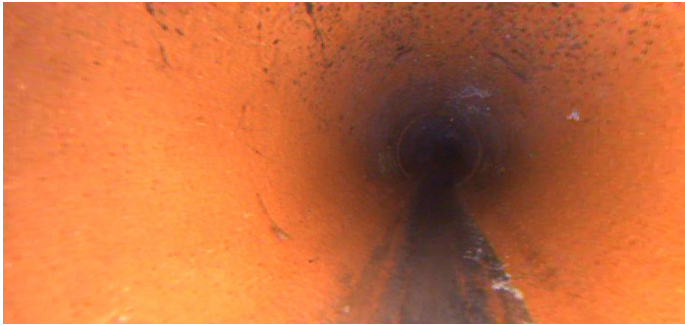
Code:	MWL
Description:	Water Level

Distance (ft):	.0
Structural Grade:	0
O&M Grade:	0
Clock Start/From:	
Clock To:	
1st Value:	
2nd Value:	
Value Percent:	5.000
Continuous Index:	
Within 8" of Joint:	NO
Remarks:

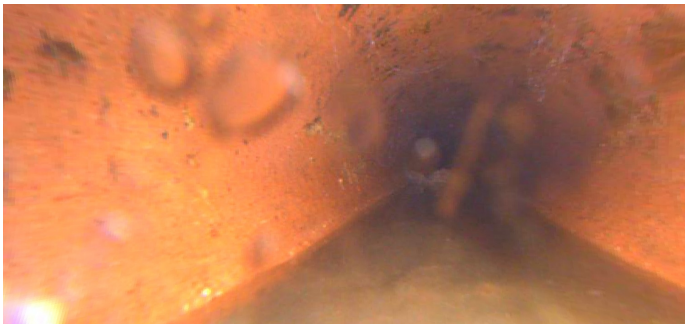
Code:	DSZ
Description:	Deposits Settled Other

Distance (ft):	25.6
Structural Grade:	0
O&M Grade:	5
Clock Start/From:	6
Clock To:	7
1st Value:	
2nd Value:	
Value Percent:	50.000
Continuous Index:	
Within 8" of Joint:	YES
Remarks:	mixed material

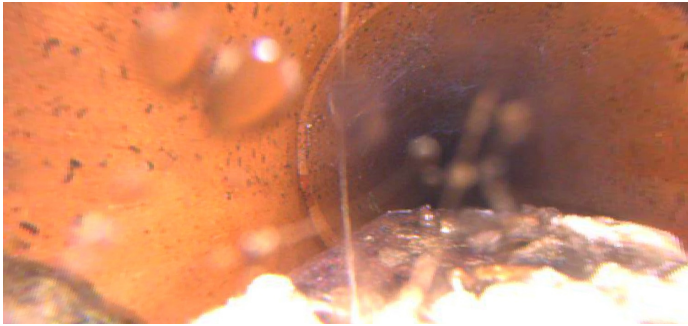
Code:	MSA
Description:	Abandoned Survey
Distance (ft):	28.3
Structural Grade:	0
O&M Grade:	0
Clock Start/From:	
Clock To:	
1st Value:	
2nd Value:	
Value Percent:	
Continuous Index:	
Within 8" of Joint:	NO
Remarks:	mixed material blocking camera
