Profile/Photo Observation Report

Date:	09/30/2018	Weather:		Coding:	PACP 6.0
Pipe Length (ft):	207.9	Owner:	NA	Pre Clean:	Not Known
P.O.#:		Surveyor:	Selasie Honu	PSR:	P-503-036-037
Customer:		Clean Date:	01/01/1900	Shape:	C

Street:	W 40TH AVE	Flow Control:	Not Controlled
City:	Hobart, IN	Year Renewed:	
Location:	Light Highway	Tape/Media #:	
Purpose:	Routine Assessment	Dia/Height:	10"
Use:	Sanitary	Material:	VCP
Drain Area:	NA	Lining:	
Category:	NA		
Comment:

Location Details:		Direction of Survey:	Downstream
US MH:	M-503-037	DS MH:	M-503-036
		Total Length Surveyed (ft):	191.9

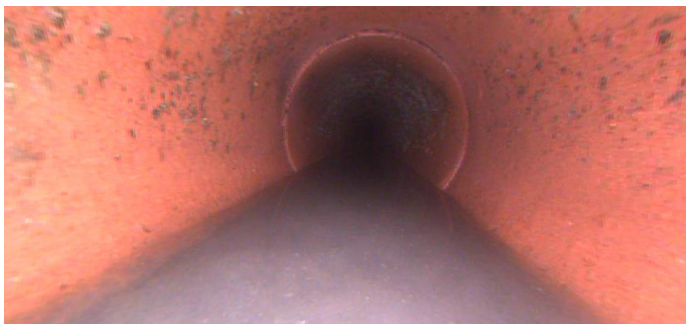
Code: **AMH**
Description: **Manhole**

Distance (ft): **.0**
Structural Grade: **0**
O&M Grade: **0**
Clock Start/From:
Clock To:
1st Value:
2nd Value:
Value Percent:
Continuous Index:
Within 8" of Joint: **NO**
Remarks: **M-503-037**

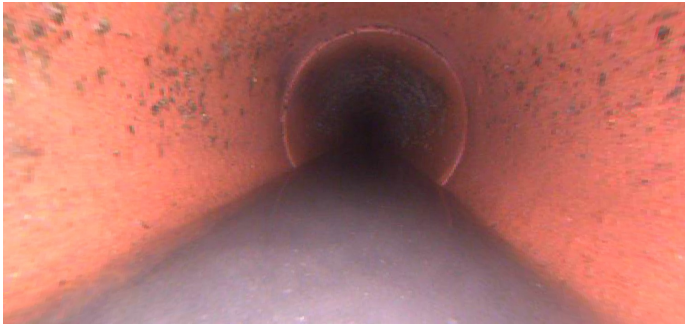
Code:	MWL
Description:	Water Level

Distance (ft):	.0
Structural Grade:	0
O&M Grade:	0
Clock Start/From:	
Clock To:	
1st Value:	
2nd Value:	
Value Percent:	5.000
Continuous Index:	
Within 8" of Joint:	NO
Remarks:

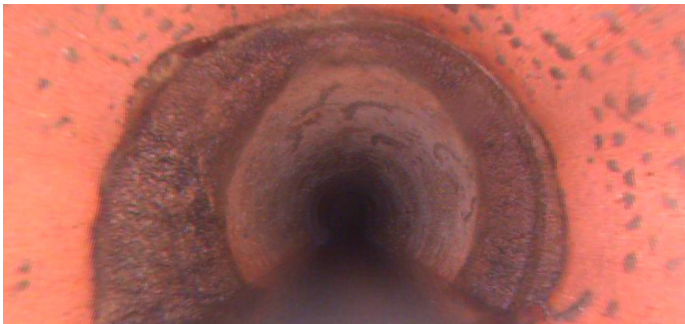
Code:	DAE
Description:	Deposits Attached Encrustation

Distance (ft):	15.5
Structural Grade:	0
O&M Grade:	3
Clock Start/From:	8
Clock To:	4
1st Value:	
2nd Value:	
Value Percent:	20.000
Continuous Index:	
Within 8" of Joint:	YES
Remarks:

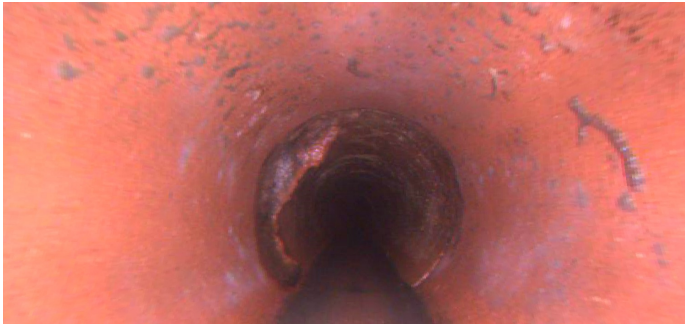
Code: **DAE**
Description: **Deposits Attached Encrustation**

Distance (ft): **24.9**
Structural Grade: **0**
O&M Grade: **4**
Clock Start/From: **7**
Clock To: **5**
1st Value:
2nd Value:
Value Percent: **30.000**
Continuous Index:
Within 8" of Joint: **YES**
Remarks:

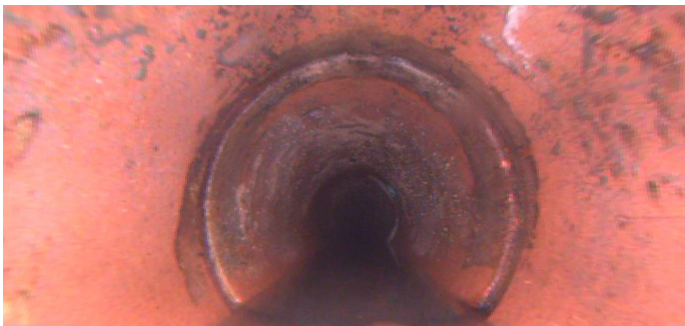
Code: **DAE**
Description: **Deposits Attached Encrustation**

Distance (ft): **40.3**
Structural Grade: **0**
O&M Grade: **2**
Clock Start/From: **8**
Clock To: **4**
1st Value:
2nd Value:
Value Percent: **10.000**
Continuous Index:
Within 8" of Joint: **YES**
Remarks:

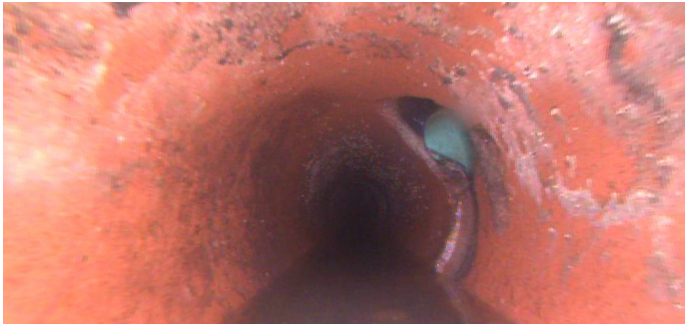
Code: **TF**
Description: **Tap Factory**

Distance (ft): **42.1**
Structural Grade: **0**
O&M Grade: **0**
Clock Start/From: **2**
Clock To:
1st Value: **4.000**
2nd Value:
Value Percent:
Continuous Index:
Within 8" of Joint:
Remarks:

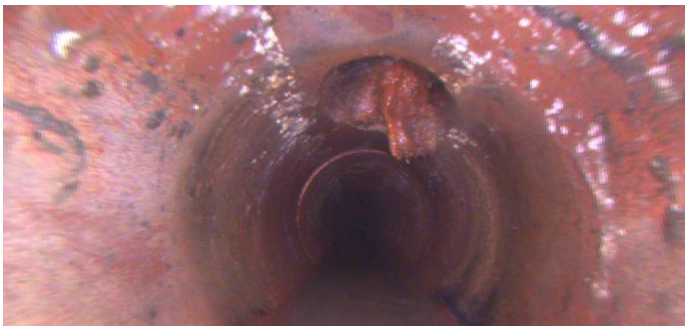
Code: **TFD**
Description: **Tap Factory Defective**

Distance (ft): **51.3**
Structural Grade: **0**
O&M Grade: **2**
Clock Start/From: **12**
Clock To:
1st Value: **4.000**
2nd Value:
Value Percent:
Continuous Index:
Within 8" of Joint:
Remarks: **DAE**

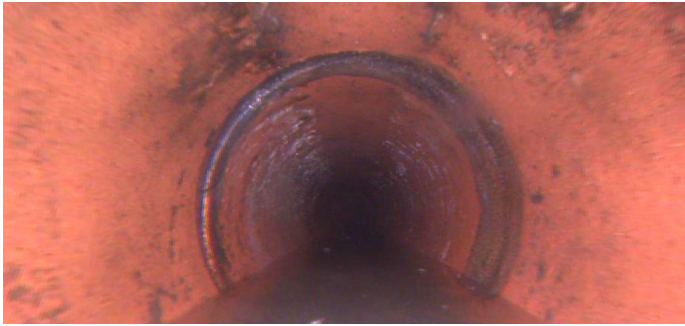
Code: **IS**
Description: **Infil Stain**

Distance (ft): **57.3**
Structural Grade: **0**
O&M Grade: **0**
Clock Start/From: **8**
Clock To: **4**
1st Value:
2nd Value:
Value Percent:
Continuous Index:
Within 8" of Joint: **YES**
Remarks:

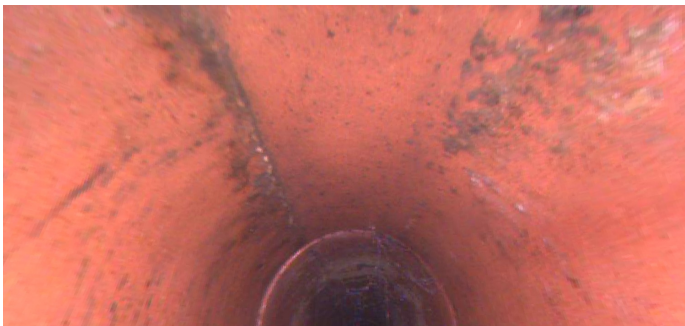
Code: **FL**
Description: **Fracture Longitudinal**

Distance (ft): **61.6**
Structural Grade: **3**
O&M Grade: **0**
Clock Start/From: **11**
Clock To:
1st Value:
2nd Value:
Value Percent:
Continuous Index:
Within 8" of Joint: **YES**
Remarks:

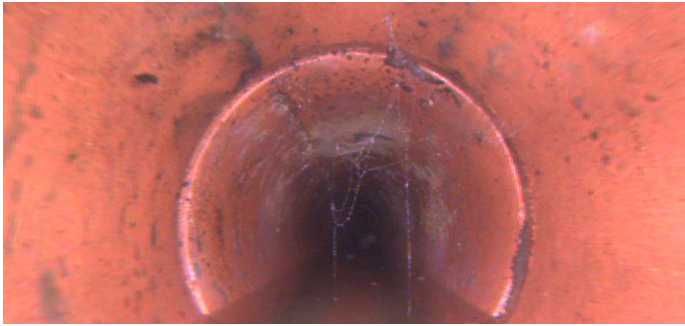
Code: **RFJ**
Description: **Roots Fine Joint**

Distance (ft): **62.3**
Structural Grade: **0**
O&M Grade: **1**
Clock Start/From: **3**
Clock To: **4**
1st Value:
2nd Value:
Value Percent:
Continuous Index:
Within 8" of Joint: **YES**
Remarks:

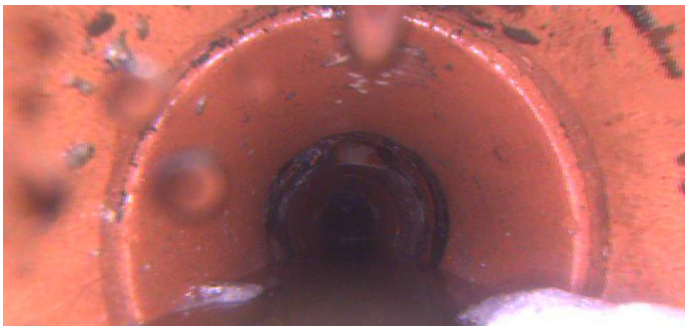
Code: **TF**
Description: **Tap Factory**

Distance (ft): **67.5**
Structural Grade: **0**
O&M Grade: **0**
Clock Start/From: **12**
Clock To:
1st Value: **4.000**
2nd Value:
Value Percent:
Continuous Index:
Within 8" of Joint:
Remarks:

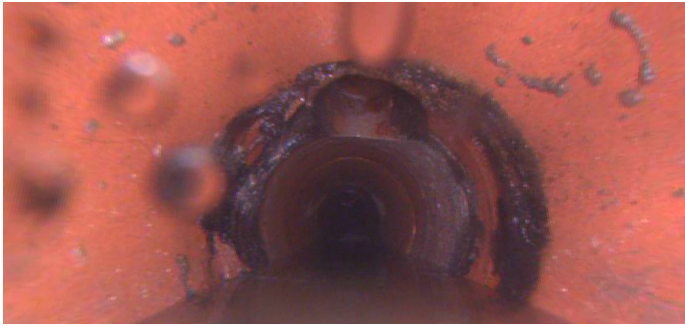
Code: **DAE**
Description: **Deposits Attached Encrustation**

Distance (ft): **68.0**
Structural Grade: **0**
O&M Grade: **3**
Clock Start/From: **8**
Clock To: **4**
1st Value:
2nd Value:
Value Percent: **15.000**
Continuous Index:
Within 8" of Joint: **NO**
Remarks:

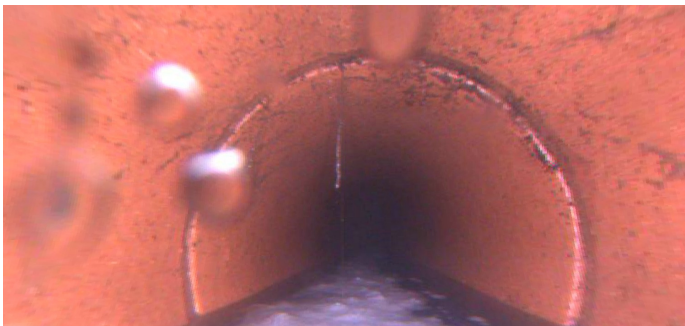
Code: **RFJ**
Description: **Roots Fine Joint**

Distance (ft): **84.2**
Structural Grade: **0**
O&M Grade: **1**
Clock Start/From: **12**
Clock To:
1st Value:
2nd Value:
Value Percent:
Continuous Index:
Within 8" of Joint: **YES**
Remarks:

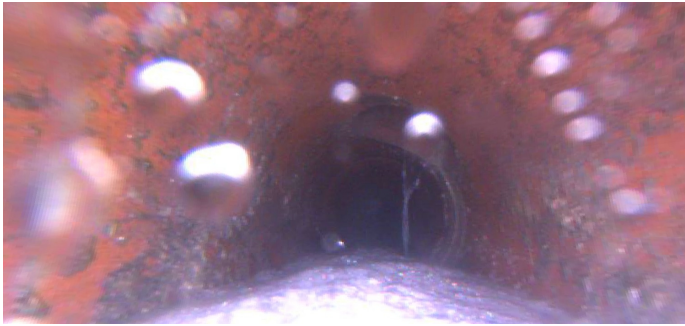
Code: **TFA**
Description: **Tap Factory Active**

Distance (ft): **114.5**
Structural Grade: **0**
O&M Grade: **0**
Clock Start/From: **1**
Clock To:
1st Value: **4.000**
2nd Value:
Value Percent:
Continuous Index:
Within 8" of Joint:
Remarks:

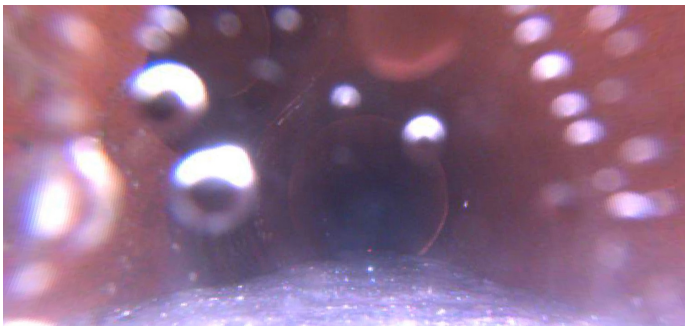
Code: **TF**
Description: **Tap Factory**

Distance (ft): **122.2**
Structural Grade: **0**
O&M Grade: **0**
Clock Start/From: **11**
Clock To:
1st Value: **4.000**
2nd Value:
Value Percent:
Continuous Index:
Within 8" of Joint:
Remarks:

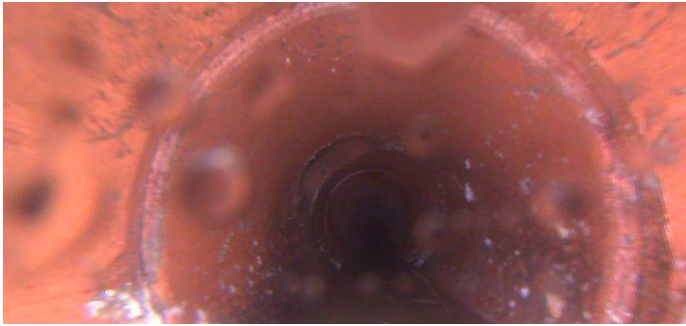
Code: **TF**
Description: **Tap Factory**

Distance (ft): **162.9**
Structural Grade: **0**
O&M Grade: **0**
Clock Start/From: **11**
Clock To:
1st Value: **4.000**
2nd Value:
Value Percent:
Continuous Index:
Within 8" of Joint:
Remarks:

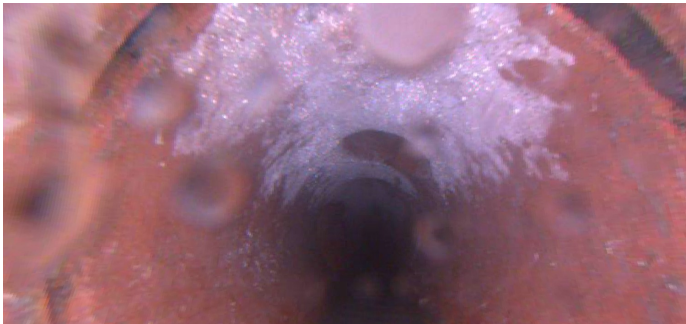
Code: **TF**
Description: **Tap Factory**

Distance (ft): **175.0**
Structural Grade: **0**
O&M Grade: **0**
Clock Start/From: **12**
Clock To:
1st Value: **4.000**
2nd Value:
Value Percent:
Continuous Index:
Within 8" of Joint:
Remarks:

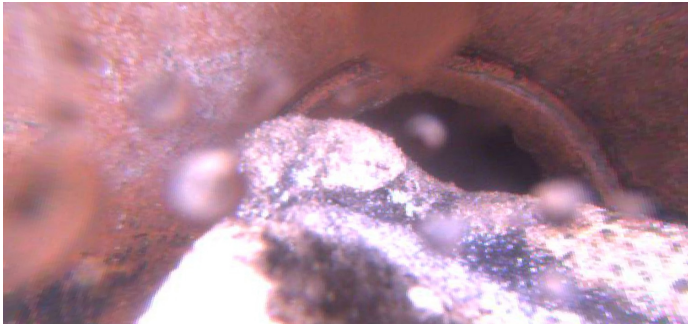
Code:	MSA
Description:	Abandoned Survey
Distance (ft):	191.9
Structural Grade:	0
O&M Grade:	0
Clock Start/From:	
Clock To:	
1st Value:	
2nd Value:	
Value Percent:	
Continuous Index:	
Within 8" of Joint:	NO
Remarks:	mixed material blocking camera passage
