Profile/Photo Observation Report

Date:	09/30/2018	Weather:		Coding:	PACP 6.0
Pipe Length (ft):	207.9	Owner:	NA	Pre Clean:	Not Known
P.O.#:		Surveyor:	Selasie Honu	PSR:	P-503-036-037
Customer:		Clean Date:	01/01/1900	Shape:	C

Street:	40th. Ave.	Flow Control:	Not Controlled
City:	Hobart, IN	Year Renewed:	
Location:	Light Highway	Tape/Media #:	
Purpose:	Routine Assessment	Dia/Height:	10"
Use:	Sanitary	Material:	VCP
Drain Area:	NA	Lining:	
Category:	NA		
Comment:

Location Details:		Direction of Survey:	Downstream
US MH:	M-503-037	DS MH:	M-503-036
		Total Length Surveyed (ft):	191.9

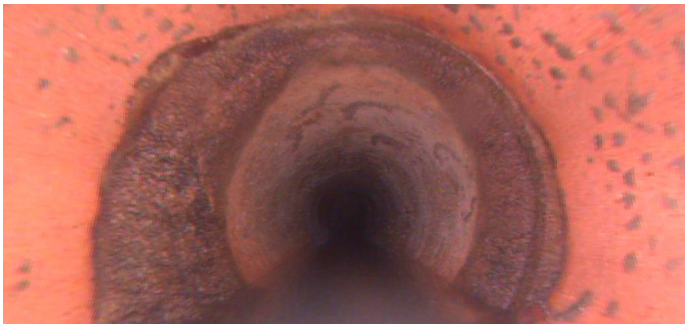
Code:	DAE
Description:	Deposits Attached Encrustation

Distance (ft):	15.5
Structural Grade:	0
O&M Grade:	3
Clock Start/From:	8
Clock To:	4
1st Value:	
2nd Value:	
Value Percent:	20.000
Continuous Index:	
Within 8" of Joint:	YES
Remarks:

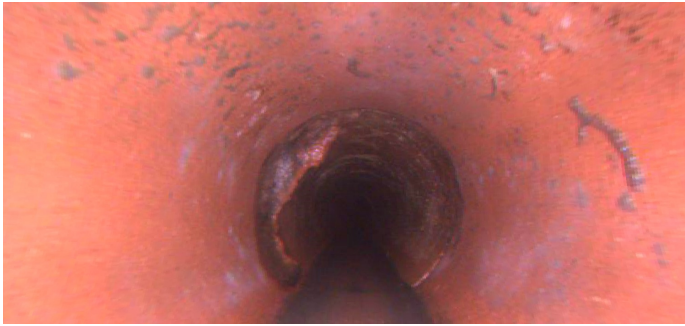
Code: **DAE**
Description: **Deposits Attached Encrustation**

Distance (ft): **24.9**
Structural Grade: **0**
O&M Grade: **4**
Clock Start/From: **7**
Clock To: **5**
1st Value:
2nd Value:
Value Percent: **30.000**
Continuous Index:
Within 8" of Joint: **YES**
Remarks:

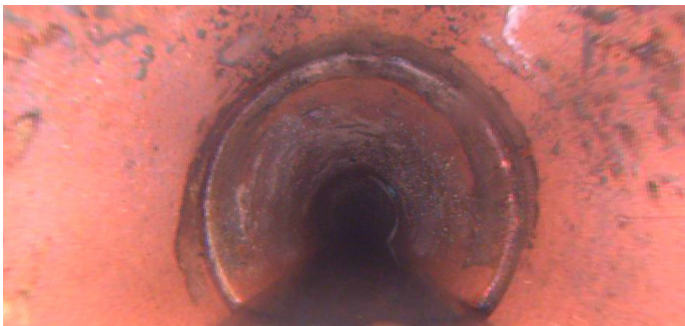
Code: **DAE**
Description: **Deposits Attached Encrustation**

Distance (ft): **40.3**
Structural Grade: **0**
O&M Grade: **2**
Clock Start/From: **8**
Clock To: **4**
1st Value:
2nd Value:
Value Percent: **10.000**
Continuous Index:
Within 8" of Joint: **YES**
Remarks:

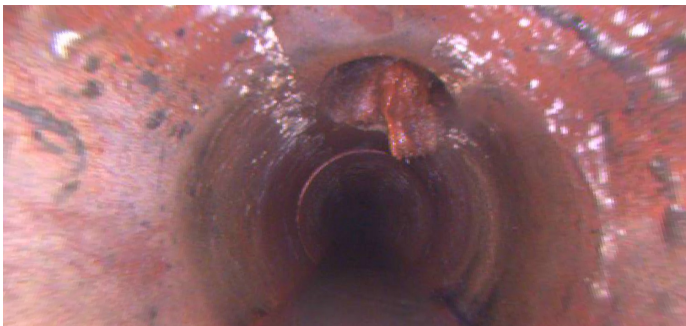
Code: **TFD**
Description: **Tap Factory Defective**

Distance (ft): **51.3**
Structural Grade: **0**
O&M Grade: **2**
Clock Start/From: **12**
Clock To:
1st Value: **4.000**
2nd Value:
Value Percent:
Continuous Index:
Within 8" of Joint:
Remarks: **DAE**

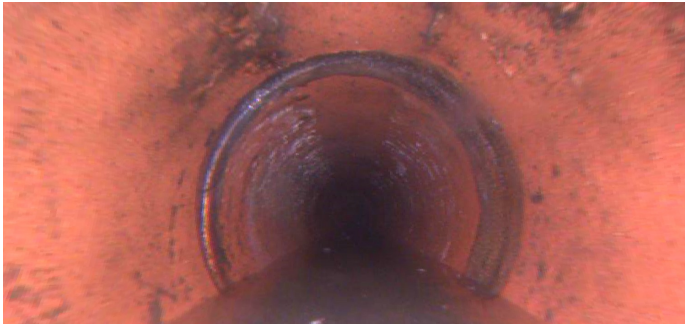
Code: **IS**
Description: **Infil Stain**

Distance (ft): **57.3**
Structural Grade: **0**
O&M Grade: **0**
Clock Start/From: **8**
Clock To: **4**
1st Value:
2nd Value:
Value Percent:
Continuous Index:
Within 8" of Joint: **YES**
Remarks:

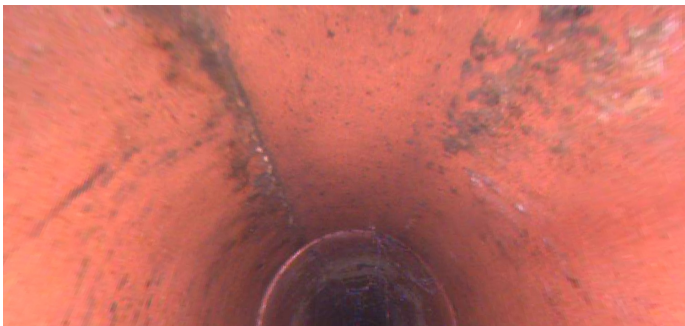
Code: **FL**
Description: **Fracture Longitudinal**

Distance (ft): **61.6**
Structural Grade: **3**
O&M Grade: **0**
Clock Start/From: **11**
Clock To:
1st Value:
2nd Value:
Value Percent:
Continuous Index:
Within 8" of Joint: **YES**
Remarks:

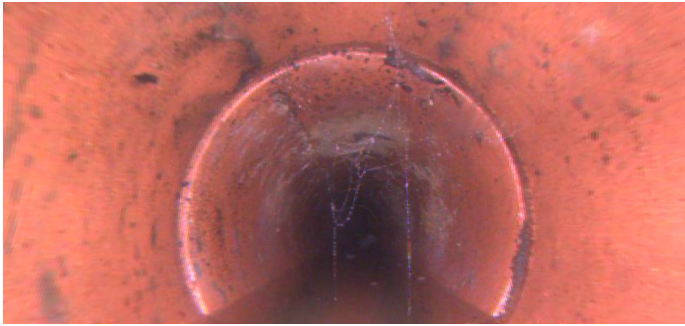
Code: **RFJ**
Description: **Roots Fine Joint**

Distance (ft): **62.3**
Structural Grade: **0**
O&M Grade: **1**
Clock Start/From: **3**
Clock To: **4**
1st Value:
2nd Value:
Value Percent:
Continuous Index:
Within 8" of Joint: **YES**
Remarks:

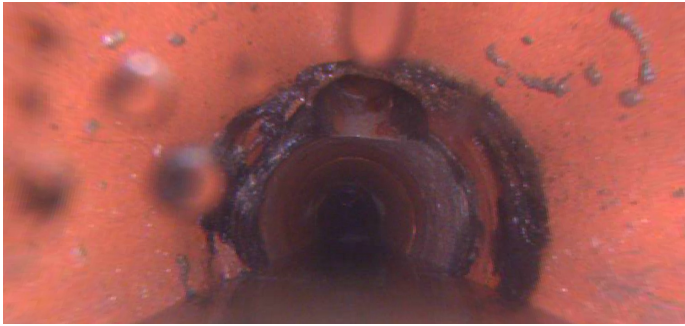
Code: **DAE**
Description: **Deposits Attached Encrustation**

Distance (ft): **68.0**
Structural Grade: **0**
O&M Grade: **3**
Clock Start/From: **8**
Clock To: **4**
1st Value:
2nd Value:
Value Percent: **15.000**
Continuous Index:
Within 8" of Joint: **NO**
Remarks:

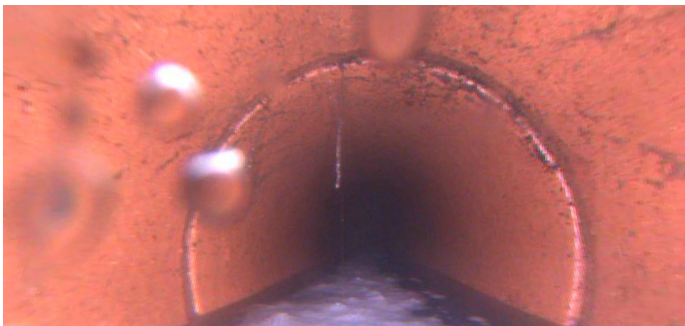
Code: **RFJ**
Description: **Roots Fine Joint**

Distance (ft): **84.2**
Structural Grade: **0**
O&M Grade: **1**
Clock Start/From: **12**
Clock To:
1st Value:
2nd Value:
Value Percent:
Continuous Index:
Within 8" of Joint: **YES**
Remarks:

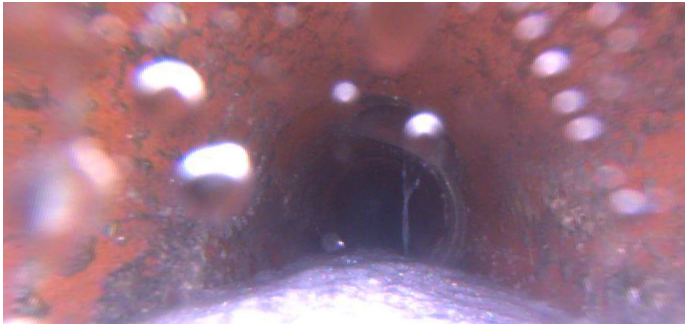
Code: **TFA**
Description: **Tap Factory Active**

Distance (ft): **114.5**
Structural Grade: **0**
O&M Grade: **0**
Clock Start/From: **1**
Clock To:
1st Value: **4.000**
2nd Value:
Value Percent:
Continuous Index:
Within 8" of Joint:
Remarks:

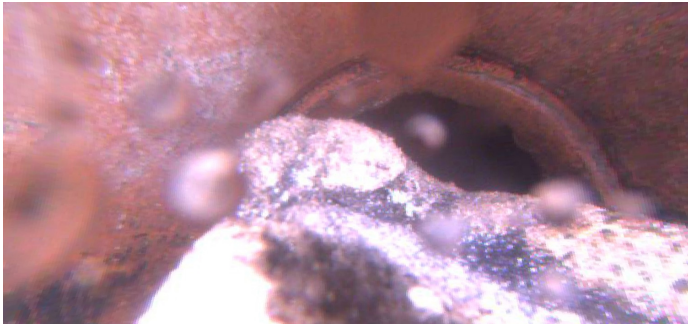
Code:	MSA
Description:	Abandoned Survey
Distance (ft):	191.9
Structural Grade:	0
O&M Grade:	0
Clock Start/From:	
Clock To:	
1st Value:	
2nd Value:	
Value Percent:	
Continuous Index:	
Within 8" of Joint:	NO
Remarks:	mixed material blocking camera passage
