Profile/Photo Observation Report

Date:	04/07/2018	Weather:		Coding:	PACP 6.0
Pipe Length (ft):	195.9	Owner:	NA	Pre Clean:	Not Known
P.O.#:		Surveyor:	Mark Ruby	PSR:	P-503-038-039
Customer:		Clean Date:	01/01/1900	Shape:	C

Street:	PENNSYLVANIA ST	Flow Control:	Not Controlled
City:	Hobart, IN	Year Renewed:	
Location:	Other	Tape/Media #:	
Purpose:	Not Known	Dia/Height:	10"
Use:	Sanitary	Material:	VCP
Drain Area:	NA	Lining:	
Category:	NA		
Comment:

Location Details:		Direction of Survey:	Downstream
US MH:	M-503-039	DS MH:	M-503-038
		Total Length Surveyed (ft):	194.5

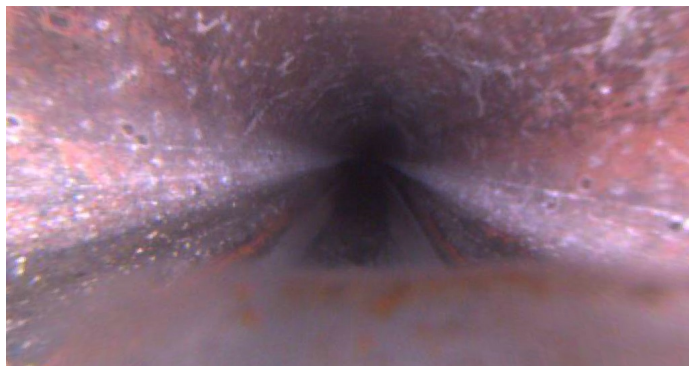
Code: **AMH**
Description: **Manhole**

Distance (ft): **.0**
Structural Grade: **0**
O&M Grade: **0**
Clock Start/From:
Clock To:
1st Value:
2nd Value:
Value Percent:
Continuous Index:
Within 8" of Joint: **NO**
Remarks: **M-503-039**

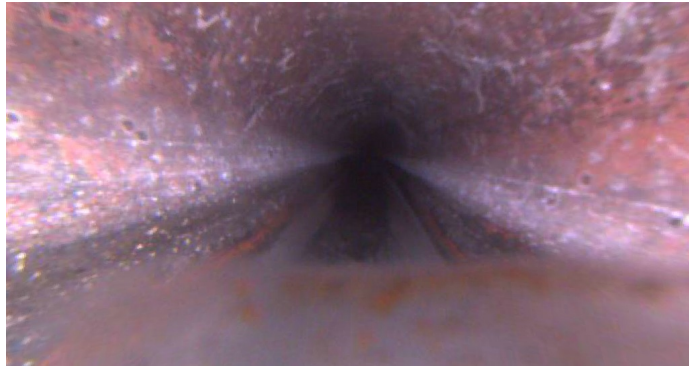
Code: **MWL**
Description: **Water Level**

Distance (ft): **.0**
Structural Grade: **0**
O&M Grade: **0**
Clock Start/From:
Clock To:
1st Value:
2nd Value:
Value Percent: **10.000**
Continuous Index:
Within 8" of Joint: **NO**
Remarks:

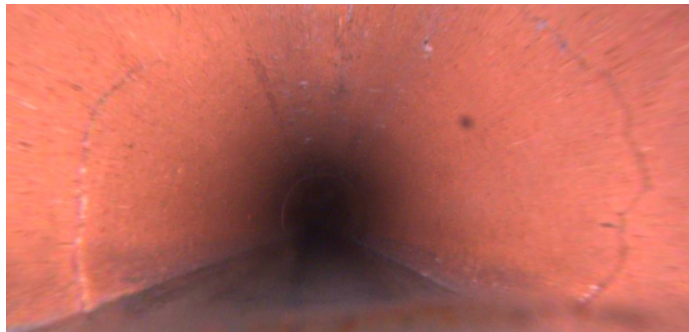
Code: **FC**
Description: **Fracture Circumferential**

Distance (ft): **42.0**
Structural Grade: **2**
O&M Grade: **0**
Clock Start/From: **8**
Clock To: **4**
1st Value:
2nd Value:
Value Percent:
Continuous Index:
Within 8" of Joint:
Remarks:

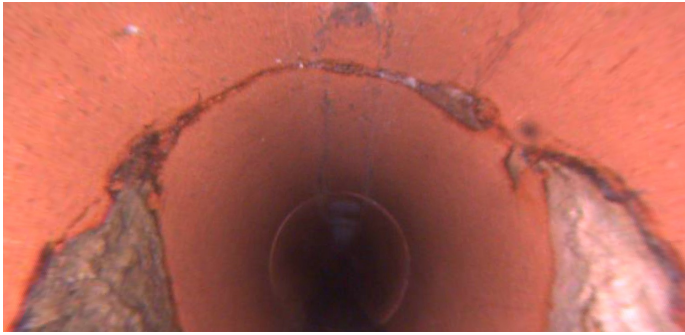
Code: **FC**
Description: **Fracture Circumferential**

Distance (ft): **52.3**
Structural Grade: **2**
O&M Grade: **0**
Clock Start/From: **8**
Clock To: **4**
1st Value:
2nd Value:
Value Percent:
Continuous Index:
Within 8" of Joint:
Remarks:

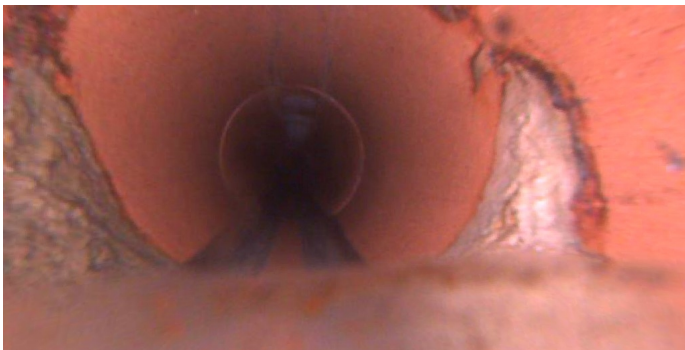
Code: **DAZ**
Description: **Deposits Attached Other**

Distance (ft): **52.3**
Structural Grade: **0**
O&M Grade: **2**
Clock Start/From: **7**
Clock To: **5**
1st Value:
2nd Value:
Value Percent: **5.000**
Continuous Index:
Within 8" of Joint: **YES**
Remarks:

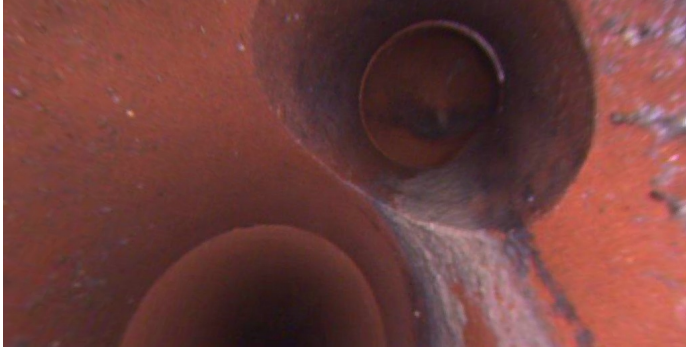
Code: **TF**
Description: **Tap Factory**

Distance (ft): **59.9**
Structural Grade: **0**
O&M Grade: **0**
Clock Start/From: **2**
Clock To:
1st Value: **4.000**
2nd Value:
Value Percent:
Continuous Index:
Within 8" of Joint:
Remarks:

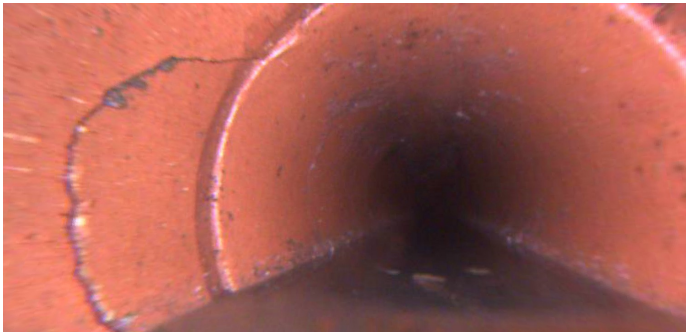
Code: **FC**
Description: **Fracture Circumferential**

Distance (ft): **75.4**
Structural Grade: **2**
O&M Grade: **0**
Clock Start/From: **7**
Clock To: **10**
1st Value:
2nd Value:
Value Percent:
Continuous Index:
Within 8" of Joint: **YES**
Remarks:

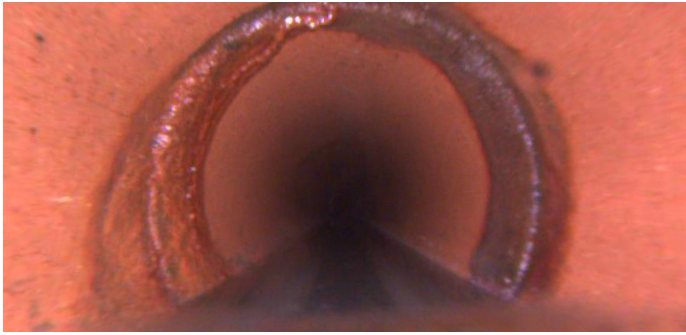
Code: **IW**
Description: **Infil Weeper**

Distance (ft): **90.1**
Structural Grade: **0**
O&M Grade: **2**
Clock Start/From: **8**
Clock To: **4**
1st Value:
2nd Value:
Value Percent:
Continuous Index:
Within 8" of Joint: **YES**
Remarks:

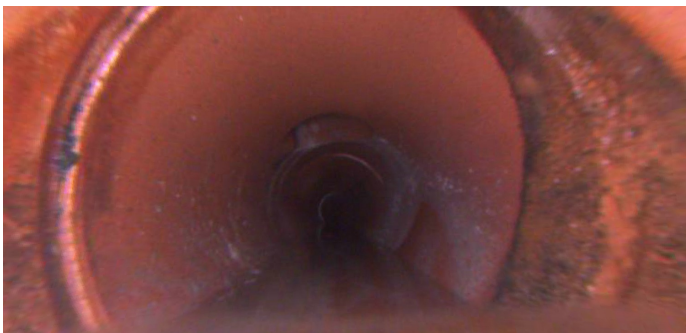
Code: **IW**
Description: **Infil Weeper**

Distance (ft): **95.3**
Structural Grade: **0**
O&M Grade: **2**
Clock Start/From: **8**
Clock To: **4**
1st Value:
2nd Value:
Value Percent:
Continuous Index:
Within 8" of Joint: **YES**
Remarks:

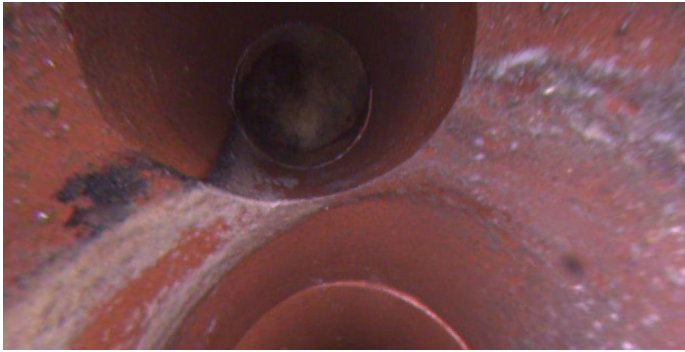
Code: **TF**
Description: **Tap Factory**

Distance (ft): **96.6**
Structural Grade: **0**
O&M Grade: **0**
Clock Start/From: **11**
Clock To:
1st Value: **4.000**
2nd Value:
Value Percent:
Continuous Index:
Within 8" of Joint:
Remarks:

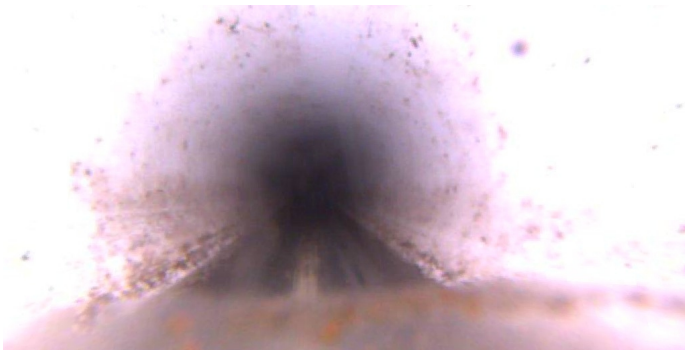
Code: **MMC**
Description: **Material Change**

Distance (ft): **102.1**
Structural Grade: **0**
O&M Grade: **0**
Clock Start/From:
Clock To:
1st Value:
2nd Value:
Value Percent:
Continuous Index:
Within 8" of Joint: **NO**
Remarks: **PVC**

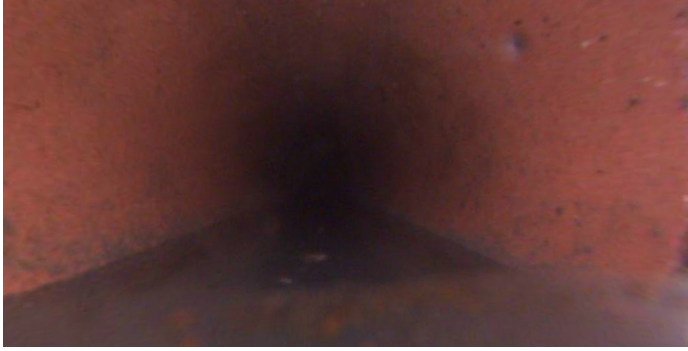
Code: **MMC**
Description: **Material Change**

Distance (ft): **107.6**
Structural Grade: **0**
O&M Grade: **0**
Clock Start/From:
Clock To:
1st Value:
2nd Value:
Value Percent:
Continuous Index:
Within 8" of Joint: **NO**
Remarks: **VCP**

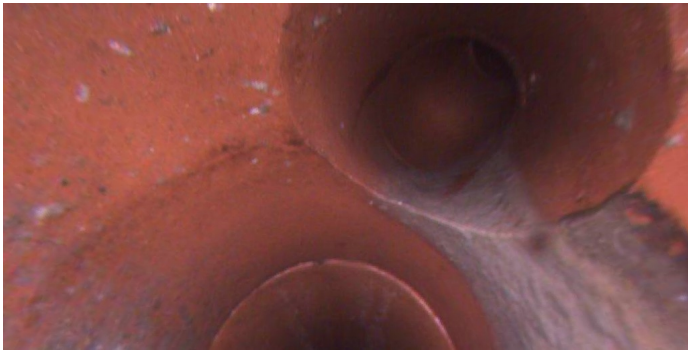
Code: **TF**
Description: **Tap Factory**

Distance (ft): **133.1**
Structural Grade: **0**
O&M Grade: **0**
Clock Start/From: **2**
Clock To:
1st Value: **4.000**
2nd Value:
Value Percent:
Continuous Index:
Within 8" of Joint:
Remarks:

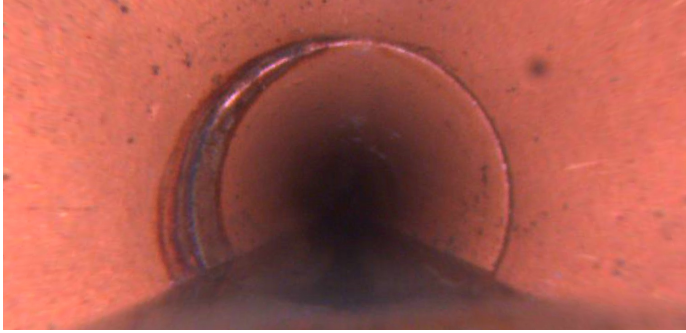
Code: **IS**
Description: **Infil Stain**

Distance (ft): **148.4**
Structural Grade: **0**
O&M Grade: **0**
Clock Start/From: **8**
Clock To: **12**
1st Value:
2nd Value:
Value Percent:
Continuous Index:
Within 8" of Joint: **YES**
Remarks:

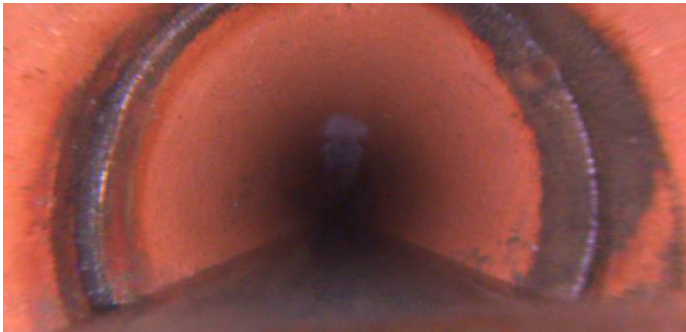
Code: **IS**
Description: **Infil Stain**

Distance (ft): **153.7**
Structural Grade: **0**
O&M Grade: **0**
Clock Start/From: **8**
Clock To: **4**
1st Value:
2nd Value:
Value Percent:
Continuous Index:
Within 8" of Joint: **YES**
Remarks:

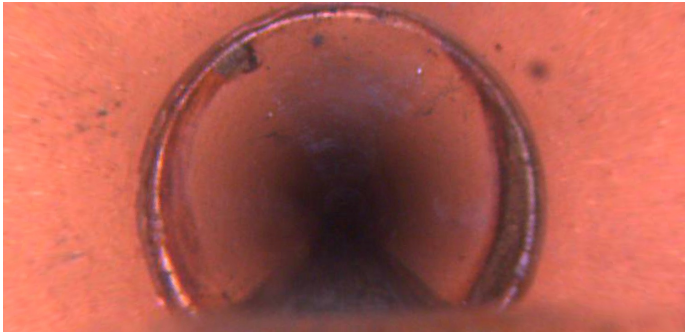
Code: **IS**
Description: **Infil Stain**

Distance (ft): **158.4**
Structural Grade: **0**
O&M Grade: **0**
Clock Start/From: **8**
Clock To: **4**
1st Value:
2nd Value:
Value Percent:
Continuous Index:
Within 8" of Joint: **YES**
Remarks:

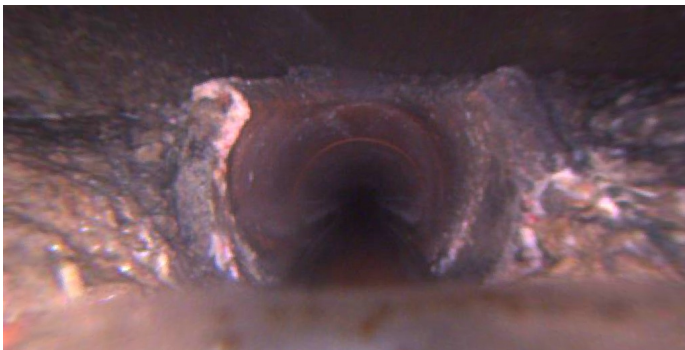
Code: **AMH**
Description: **Manhole**

Distance (ft): **194.5**
Structural Grade: **0**
O&M Grade: **0**
Clock Start/From:
Clock To:
1st Value:
2nd Value:
Value Percent:
Continuous Index:
Within 8" of Joint: **NO**
Remarks: **M-503-038**
