Profile/Photo Observation Report

Date:	04/07/2018	Weather:		Coding:	PACP 6.0
Pipe Length (ft):	195.9	Owner:	NA	Pre Clean:	Not Known
P.O.#:		Surveyor:	Mark Ruby	PSR:	P-503-038-039
Customer:		Clean Date:	01/01/1900	Shape:	C

Street:	canender st	Flow Control:	Not Controlled
City:	Hobart, IN	Year Renewed:	
Location:	Other	Tape/Media #:	
Purpose:	Not Known	Dia/Height:	10"
Use:	Sanitary	Material:	VCP
Drain Area:	NA	Lining:	
Category:	NA		
Comment:

Location Details:		Direction of Survey:	Downstream
US MH:	M-503-039	DS MH:	M-503-038
		Total Length Surveyed (ft):	194.5

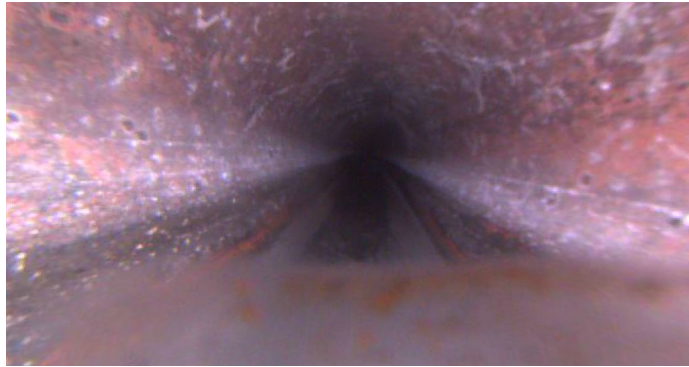
Code: **MWL**
Description: **Water Level**

Distance (ft): **.0**
Structural Grade: **0**
O&M Grade: **0**
Clock Start/From:
Clock To:
1st Value:
2nd Value:
Value Percent: **10.000**
Continuous Index:
Within 8" of Joint: **NO**
Remarks:

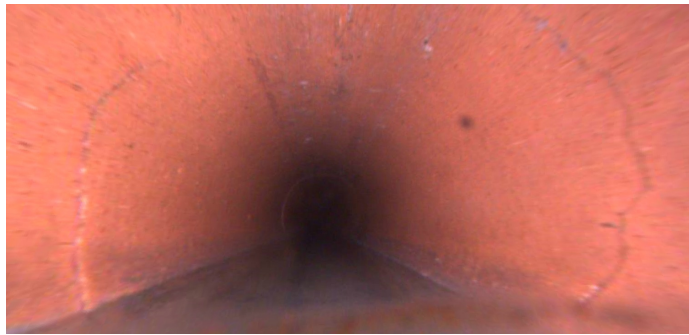
Code: **FC**
Description: **Fracture Circumferential**

Distance (ft): **42.0**
Structural Grade: **2**
O&M Grade: **0**
Clock Start/From: **8**
Clock To: **4**
1st Value:
2nd Value:
Value Percent:
Continuous Index:
Within 8" of Joint:
Remarks:

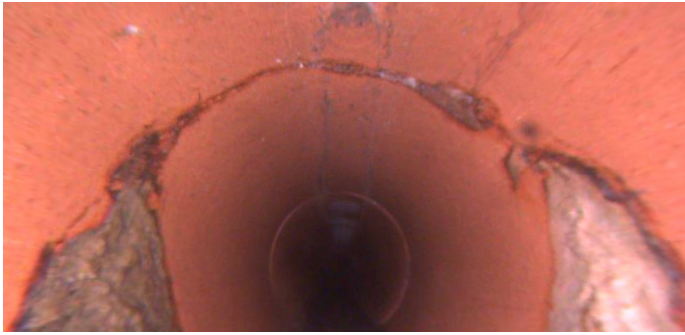
Code: **FC**
Description: **Fracture Circumferential**

Distance (ft): **52.3**
Structural Grade: **2**
O&M Grade: **0**
Clock Start/From: **8**
Clock To: **4**
1st Value:
2nd Value:
Value Percent:
Continuous Index:
Within 8" of Joint:
Remarks:

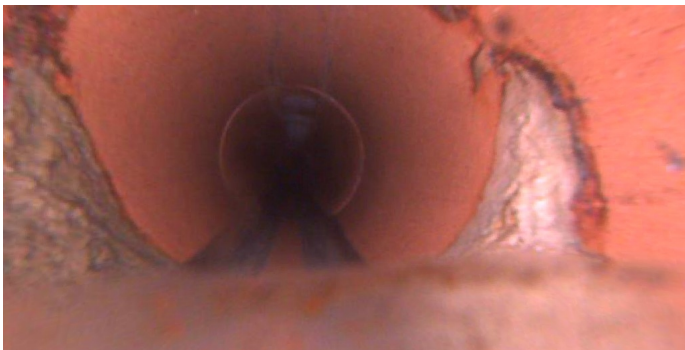
Code: **DAZ**
Description: **Deposits Attached Other**

Distance (ft): **52.3**
Structural Grade: **0**
O&M Grade: **2**
Clock Start/From: **7**
Clock To: **5**
1st Value:
2nd Value:
Value Percent: **5.000**
Continuous Index:
Within 8" of Joint: **YES**
Remarks:

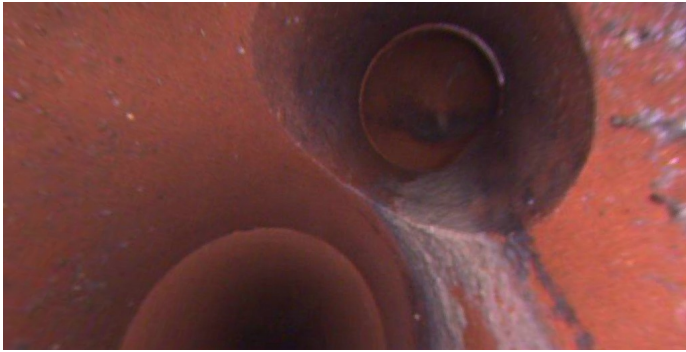
Code: **TF**
Description: **Tap Factory**

Distance (ft): **59.9**
Structural Grade: **0**
O&M Grade: **0**
Clock Start/From: **2**
Clock To:
1st Value: **4.000**
2nd Value:
Value Percent:
Continuous Index:
Within 8" of Joint:
Remarks:

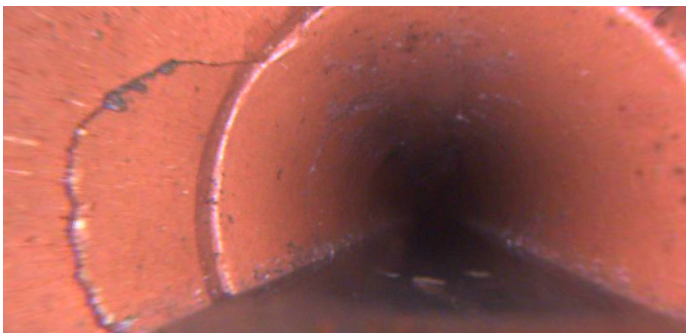
Code: **FC**
Description: **Fracture Circumferential**

Distance (ft): **75.4**
Structural Grade: **2**
O&M Grade: **0**
Clock Start/From: **7**
Clock To: **10**
1st Value:
2nd Value:
Value Percent:
Continuous Index:
Within 8" of Joint: **YES**
Remarks:

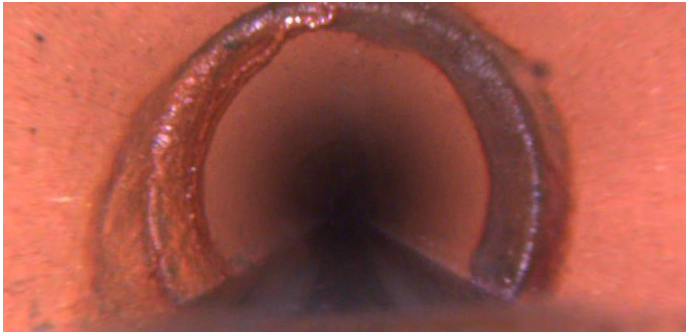
Code: **IW**
Description: **Infil Weeper**

Distance (ft): **90.1**
Structural Grade: **0**
O&M Grade: **2**
Clock Start/From: **8**
Clock To: **4**
1st Value:
2nd Value:
Value Percent:
Continuous Index:
Within 8" of Joint: **YES**
Remarks:

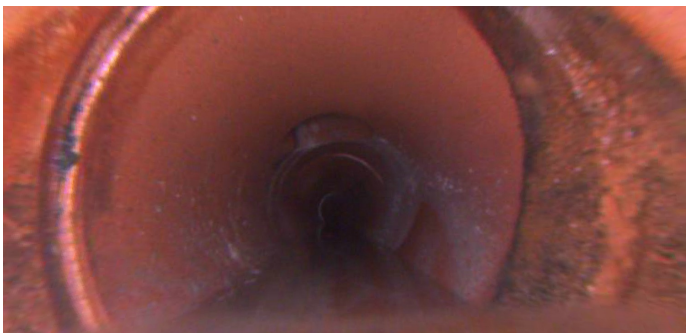
Code: **IW**
Description: **Infil Weeper**

Distance (ft): **95.3**
Structural Grade: **0**
O&M Grade: **2**
Clock Start/From: **8**
Clock To: **4**
1st Value:
2nd Value:
Value Percent:
Continuous Index:
Within 8" of Joint: **YES**
Remarks:

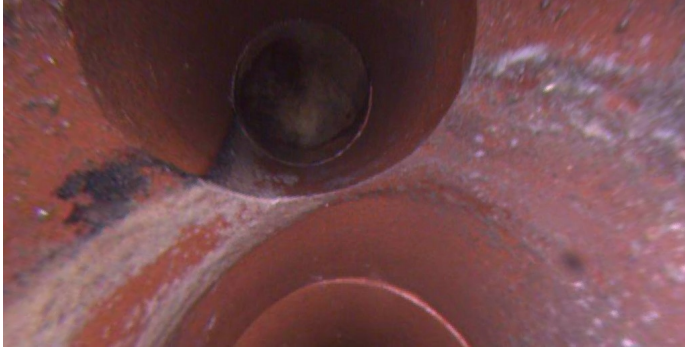
Code: **TF**
Description: **Tap Factory**

Distance (ft): **96.6**
Structural Grade: **0**
O&M Grade: **0**
Clock Start/From: **11**
Clock To:
1st Value: **4.000**
2nd Value:
Value Percent:
Continuous Index:
Within 8" of Joint:
Remarks:

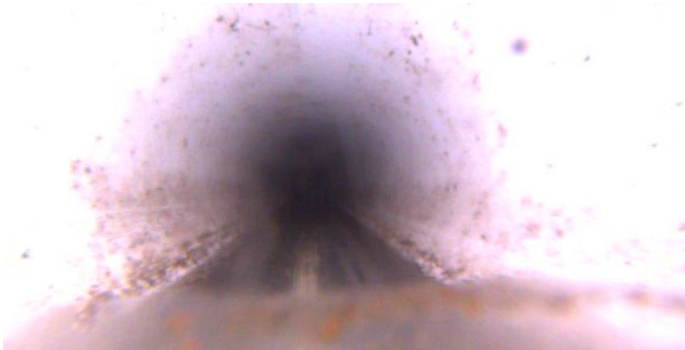
Code: **MMC**
Description: **Material Change**

Distance (ft): **102.1**
Structural Grade: **0**
O&M Grade: **0**
Clock Start/From:
Clock To:
1st Value:
2nd Value:
Value Percent:
Continuous Index:
Within 8" of Joint: **NO**
Remarks: **PVC**

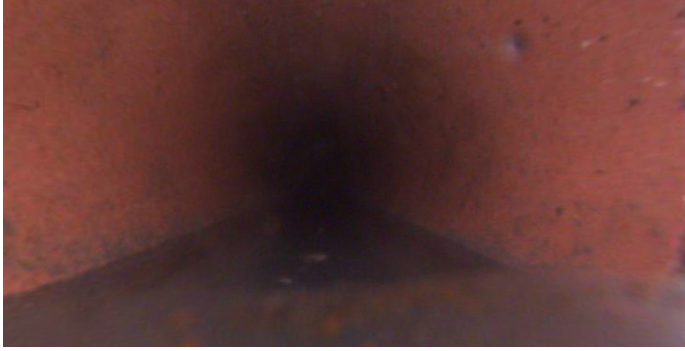
Code: **MMC**
Description: **Material Change**

Distance (ft): **107.6**
Structural Grade: **0**
O&M Grade: **0**
Clock Start/From:
Clock To:
1st Value:
2nd Value:
Value Percent:
Continuous Index:
Within 8" of Joint: **NO**
Remarks: **VCP**

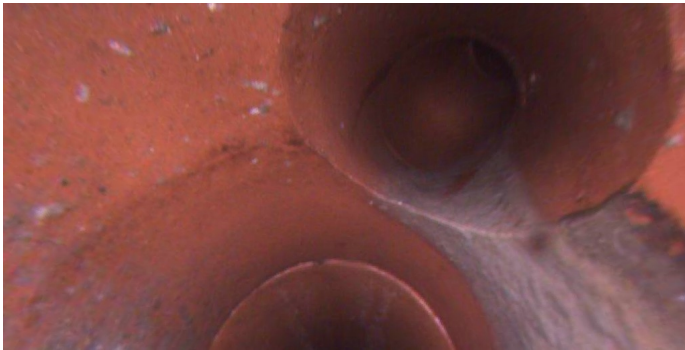
Code: **TF**
Description: **Tap Factory**

Distance (ft): **133.1**
Structural Grade: **0**
O&M Grade: **0**
Clock Start/From: **2**
Clock To:
1st Value: **4.000**
2nd Value:
Value Percent:
Continuous Index:
Within 8" of Joint:
Remarks:

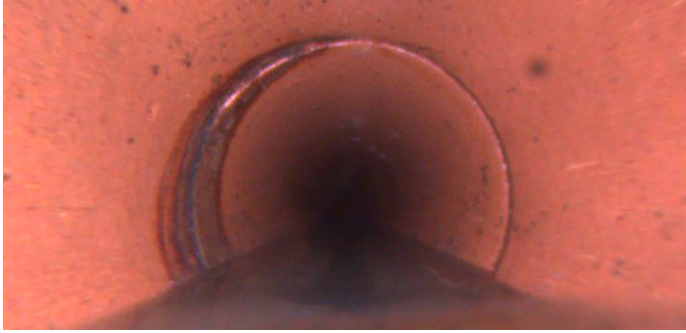
Code: **IS**
Description: **Infil Stain**

Distance (ft): **148.4**
Structural Grade: **0**
O&M Grade: **0**
Clock Start/From: **8**
Clock To: **12**
1st Value:
2nd Value:
Value Percent:
Continuous Index:
Within 8" of Joint: **YES**
Remarks:

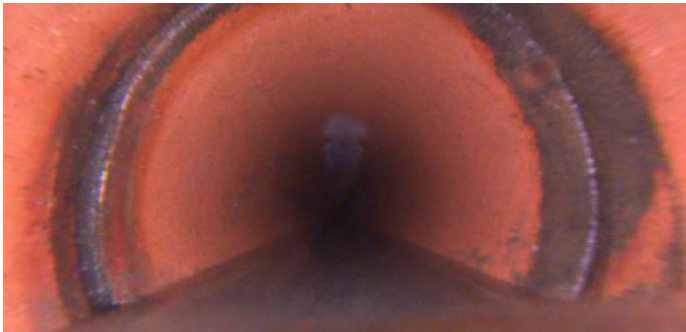
Code: **IS**
Description: **Infil Stain**

Distance (ft): **153.7**
Structural Grade: **0**
O&M Grade: **0**
Clock Start/From: **8**
Clock To: **4**
1st Value:
2nd Value:
Value Percent:
Continuous Index:
Within 8" of Joint: **YES**
Remarks:

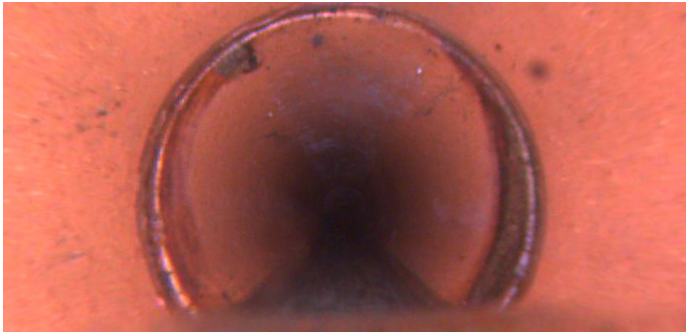
Code: **IS**
Description: **Infil Stain**

Distance (ft): **158.4**
Structural Grade: **0**
O&M Grade: **0**
Clock Start/From: **8**
Clock To: **4**
1st Value:
2nd Value:
Value Percent:
Continuous Index:
Within 8" of Joint: **YES**
Remarks:

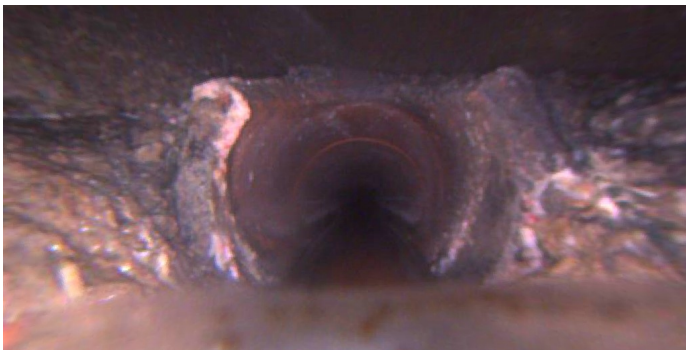
Code: **AMH**
Description: **Manhole**

Distance (ft): **194.5**
Structural Grade: **0**
O&M Grade: **0**
Clock Start/From:
Clock To:
1st Value:
2nd Value:
Value Percent:
Continuous Index:
Within 8" of Joint: **NO**
Remarks: **M-503-038**
