# Profile/Photo Observation Report

Date:	<b>04/07/2018</b>	Weather:		Coding:	<b>PACP 6.0</b>
Pipe Length (ft):	<b>478.8</b>	Owner:	<b>NA</b>	Pre Clean:	<b>Not Known</b>
P.O.#:		Surveyor:	<b>Mark Ruby</b>	PSR:	<b>P-503-042-041</b>
Customer:		Clean Date:	<b>01/01/1900</b>	Shape:	<b>C</b>

Street:	<b>guyer st</b>	Flow Control:	<b>Not Controlled</b>
City:	<b>Hobart, IN</b>	Year Renewed:	
Location:	<b>Other</b>	Tape/Media #:	
Purpose:	<b>Not Known</b>	Dia/Height:	<b>10"</b>
Use:	<b>Sanitary</b>	Material:	<b>VCP</b>
Drain Area:	<b>NA</b>	Lining:	
Category:	<b>NA</b>		
Comment:			
Location Details:		Direction of Survey:	<b>Downstream</b>
US MH:	<b>M-503-041</b>	DS MH:	<b>M-503-042</b>
		Total Length Surveyed (ft):	<b>301.4</b>

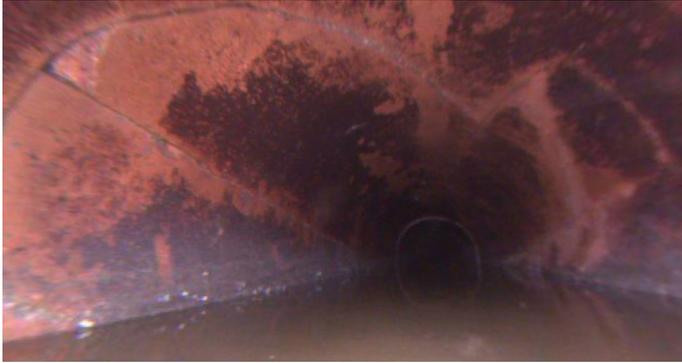
Code: **FM**  
Description: **Fracture Multiple**

Distance (ft): **5.7**  
Structural Grade: **4**  
O&M Grade: **0**  
Clock Start/From: **7**  
Clock To: **5**  
1st Value:  
2nd Value:  
Value Percent:  
Continuous Index:  
Within 8" of Joint:  
Remarks:

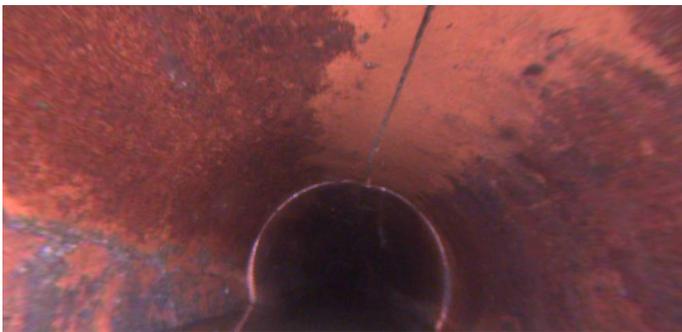
Code: **FL**  
Description: **Fracture Longitudinal**

Distance (ft): **47.8**  
Structural Grade: **3**  
O&M Grade: **0**  
Clock Start/From: **9**  
Clock To:  
1st Value:  
2nd Value:  
Value Percent:  
Continuous Index:  
Within 8" of Joint:  
Remarks:

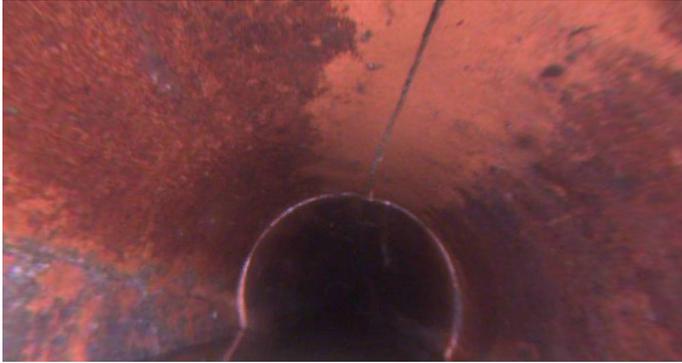
Code: **FL**  
Description: **Fracture Longitudinal**

Distance (ft): **47.8**  
Structural Grade: **3**  
O&M Grade: **0**  
Clock Start/From: **1**  
Clock To:  
1st Value:  
2nd Value:  
Value Percent:  
Continuous Index:  
Within 8" of Joint:  
Remarks:

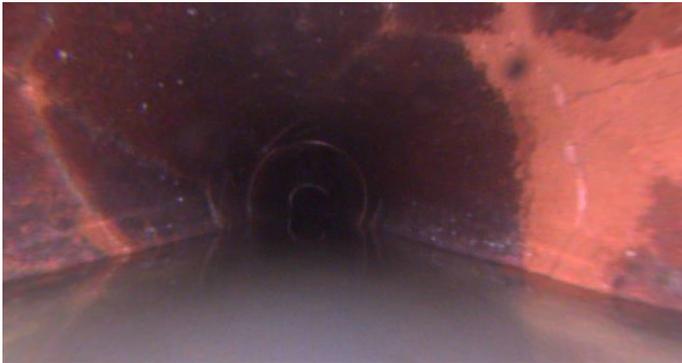
Code: **FM**  
Description: **Fracture Multiple**

Distance (ft): **51.8**  
Structural Grade: **4**  
O&M Grade: **0**  
Clock Start/From: **7**  
Clock To: **5**  
1st Value:  
2nd Value:  
Value Percent:  
Continuous Index:  
Within 8" of Joint:  
Remarks:

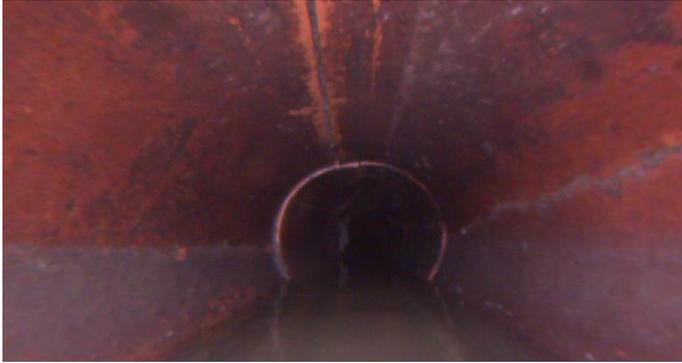
Code: **FL**  
Description: **Fracture Longitudinal**

Distance (ft): **67.4**  
Structural Grade: **3**  
O&M Grade: **0**  
Clock Start/From: **11**  
Clock To:  
1st Value:  
2nd Value:  
Value Percent:  
Continuous Index:  
Within 8" of Joint:  
Remarks:

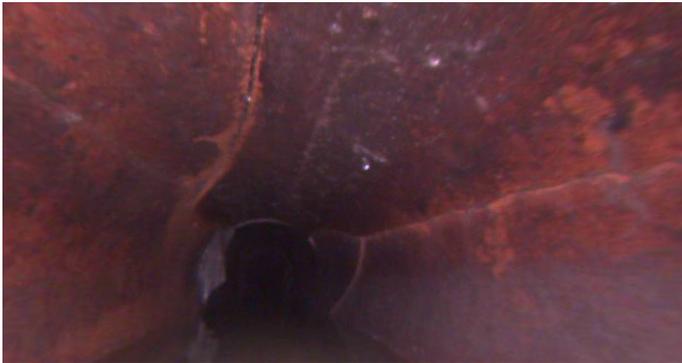
Code: **FM**  
Description: **Fracture Multiple**

Distance (ft): **69.6**  
Structural Grade: **4**  
O&M Grade: **0**  
Clock Start/From: **7**  
Clock To: **5**  
1st Value:  
2nd Value:  
Value Percent:  
Continuous Index:  
Within 8" of Joint:  
Remarks:

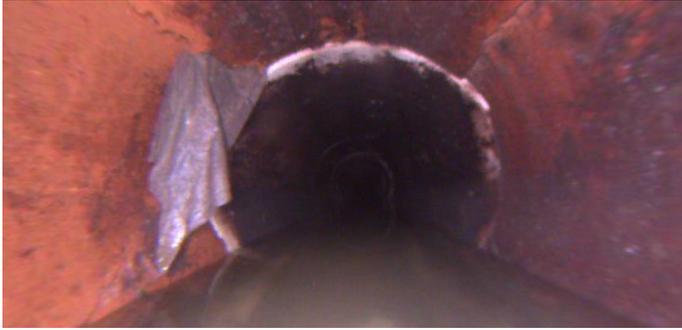
Code: **DAR**  
Description: **Deposits Attached Ragging**

Distance (ft): **71.2**  
Structural Grade: **0**  
O&M Grade: **2**  
Clock Start/From: **10**  
Clock To:  
1st Value:  
2nd Value:  
Value Percent: **5.000**  
Continuous Index:  
Within 8" of Joint: **NO**  
Remarks:

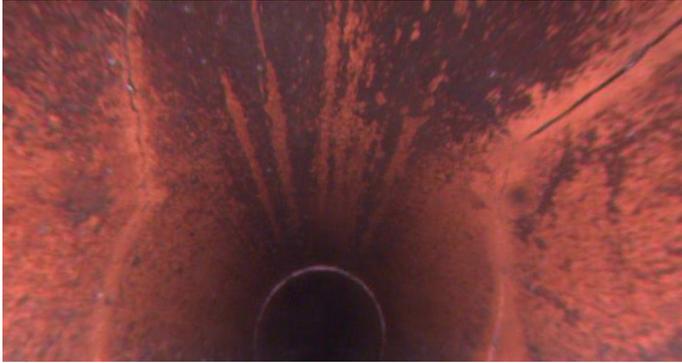
Code: **FM**  
Description: **Fracture Multiple**

Distance (ft): **117.0**  
Structural Grade: **4**  
O&M Grade: **0**  
Clock Start/From: **7**  
Clock To: **5**  
1st Value:  
2nd Value:  
Value Percent:  
Continuous Index:  
Within 8" of Joint:  
Remarks:

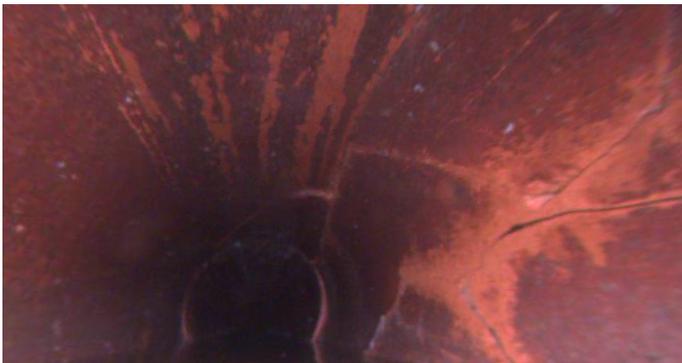
Code: **FM**  
Description: **Fracture Multiple**

Distance (ft): **127.2**  
Structural Grade: **4**  
O&M Grade: **0**  
Clock Start/From: **7**  
Clock To: **5**  
1st Value:  
2nd Value:  
Value Percent:  
Continuous Index:  
Within 8" of Joint:  
Remarks:

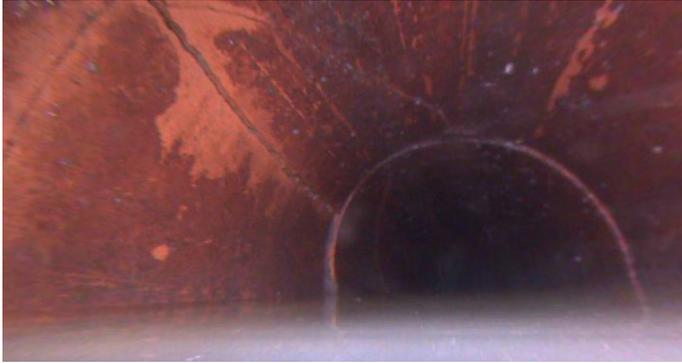
Code: **FM**  
Description: **Fracture Multiple**

Distance (ft): **138.2**  
Structural Grade: **4**  
O&M Grade: **0**  
Clock Start/From: **7**  
Clock To: **12**  
1st Value:  
2nd Value:  
Value Percent:  
Continuous Index:  
Within 8" of Joint:  
Remarks:

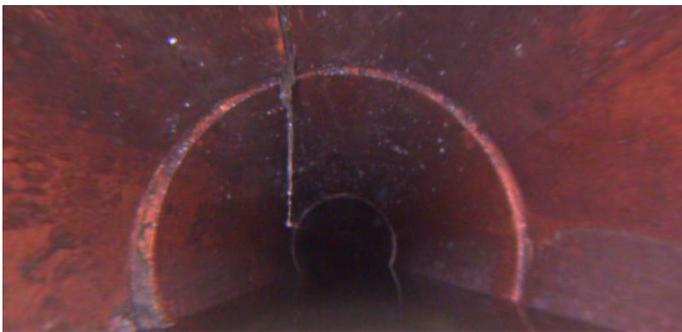
Code: **RFJ**  
Description: **Roots Fine Joint**

Distance (ft): **143.7**  
Structural Grade: **0**  
O&M Grade: **1**  
Clock Start/From: **12**  
Clock To:  
1st Value:  
2nd Value:  
Value Percent:  
Continuous Index:  
Within 8" of Joint: **YES**  
Remarks:

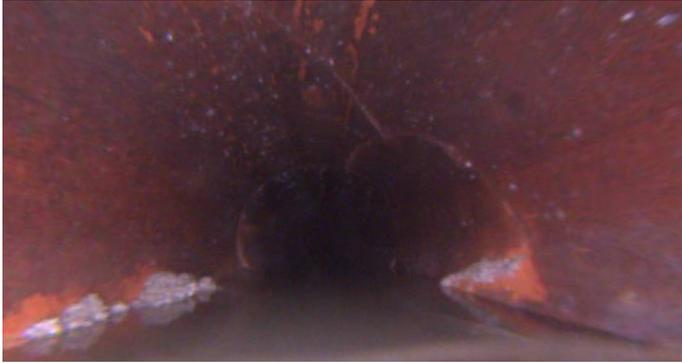
Code: **FM**  
Description: **Fracture Multiple**

Distance (ft): **157.6**  
Structural Grade: **4**  
O&M Grade: **0**  
Clock Start/From: **7**  
Clock To: **5**  
1st Value:  
2nd Value:  
Value Percent:  
Continuous Index: **S01**  
Within 8" of Joint:  
Remarks:

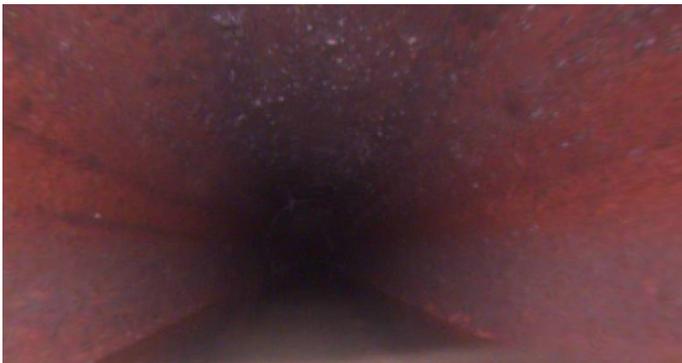
Code: **FM**  
Description: **Fracture Multiple**

Distance (ft): **176.3**  
Structural Grade: **4**  
O&M Grade: **0**  
Clock Start/From: **7**  
Clock To: **5**  
1st Value:  
2nd Value:  
Value Percent:  
Continuous Index: **F01**  
Within 8" of Joint:  
Remarks:

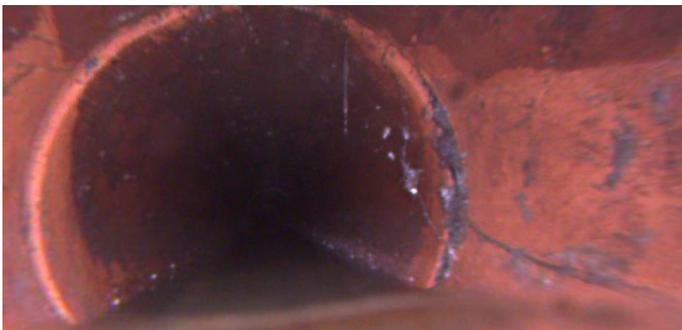
Code: **RFJ**  
Description: **Roots Fine Joint**

Distance (ft): **200.8**  
Structural Grade: **0**  
O&M Grade: **1**  
Clock Start/From: **8**  
Clock To: **4**  
1st Value:  
2nd Value:  
Value Percent:  
Continuous Index:  
Within 8" of Joint: **YES**  
Remarks:

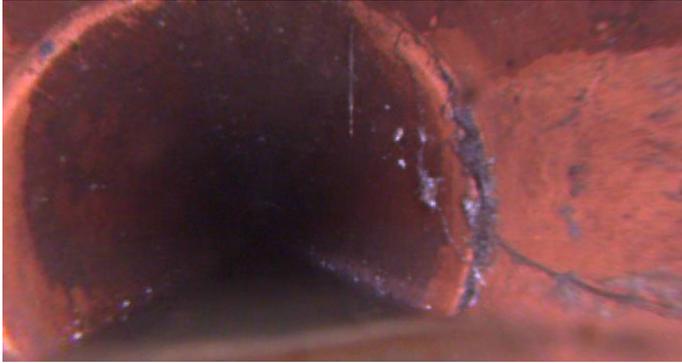
Code: **CM**  
Description: **Crack Multiple**

Distance (ft): **200.8**  
Structural Grade: **3**  
O&M Grade: **0**  
Clock Start/From: **7**  
Clock To: **5**  
1st Value:  
2nd Value:  
Value Percent:  
Continuous Index:  
Within 8" of Joint:  
Remarks:

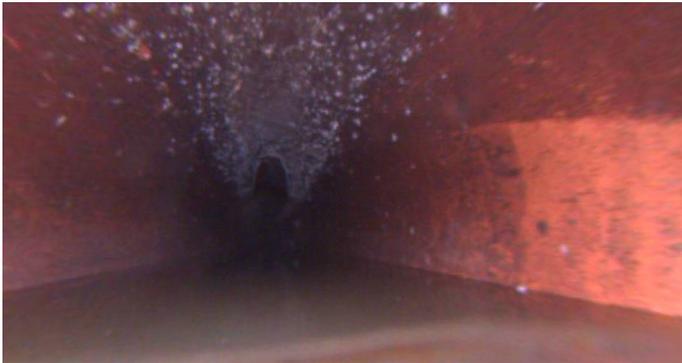
Code: **CL**  
Description: **Crack Longitudinal**

Distance (ft): **248.7**  
Structural Grade: **2**  
O&M Grade: **0**  
Clock Start/From: **4**  
Clock To:  
1st Value:  
2nd Value:  
Value Percent:  
Continuous Index:  
Within 8" of Joint: **YES**  
Remarks:

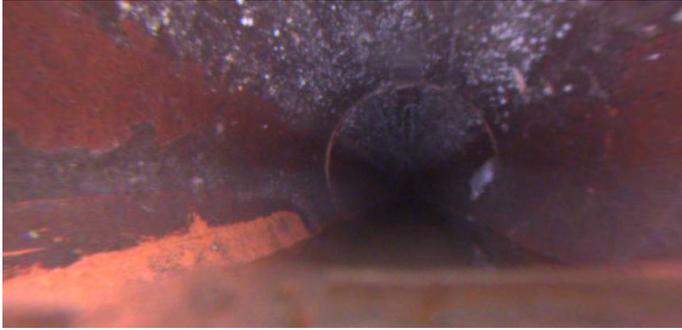
Code: **CL**  
Description: **Crack Longitudinal**

Distance (ft): **262.2**  
Structural Grade: **2**  
O&M Grade: **0**  
Clock Start/From: **8**  
Clock To:  
1st Value:  
2nd Value:  
Value Percent:  
Continuous Index:  
Within 8" of Joint:  
Remarks:

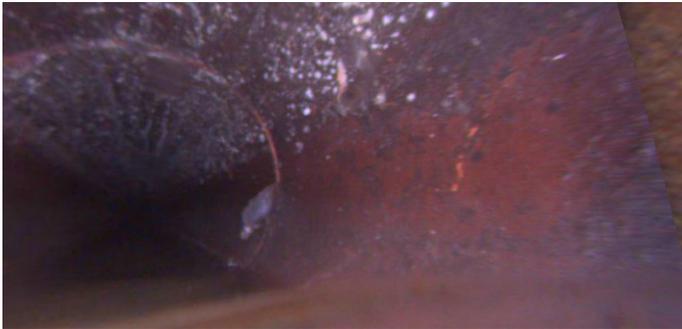
Code: **CM**  
Description: **Crack Multiple**

Distance (ft): **262.6**  
Structural Grade: **3**  
O&M Grade: **0**  
Clock Start/From: **12**  
Clock To: **3**  
1st Value:  
2nd Value:  
Value Percent:  
Continuous Index:  
Within 8" of Joint: **YES**  
Remarks:

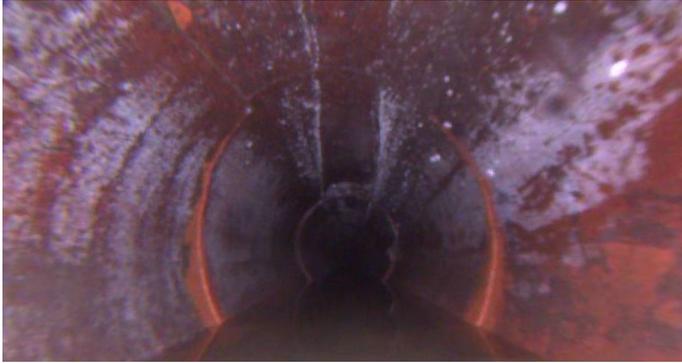
Code: **CL**  
Description: **Crack Longitudinal**

Distance (ft): **271.0**  
Structural Grade: **2**  
O&M Grade: **0**  
Clock Start/From: **10**  
Clock To:  
1st Value:  
2nd Value:  
Value Percent:  
Continuous Index:  
Within 8" of Joint:  
Remarks:

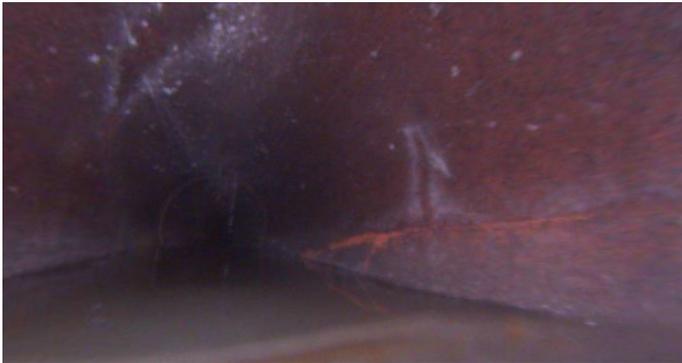
Code: **CL**  
Description: **Crack Longitudinal**

Distance (ft): **293.2**  
Structural Grade: **2**  
O&M Grade: **0**  
Clock Start/From: **4**  
Clock To:  
1st Value:  
2nd Value:  
Value Percent:  
Continuous Index:  
Within 8" of Joint:  
Remarks:

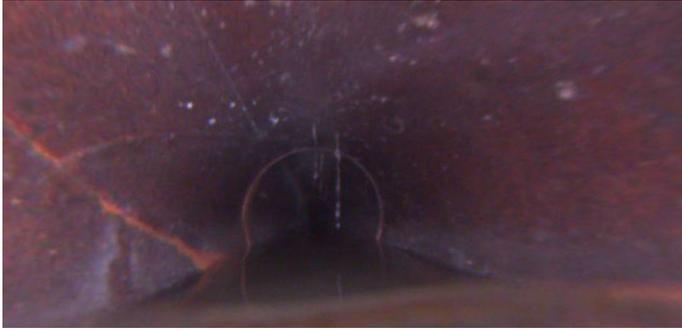
Code: **FM**  
Description: **Fracture Multiple**

Distance (ft): **294.1**  
Structural Grade: **4**  
O&M Grade: **0**  
Clock Start/From: **8**  
Clock To: **4**  
1st Value:  
2nd Value:  
Value Percent:  
Continuous Index:  
Within 8" of Joint:  
Remarks:
