Profile/Photo Observation Report

Date:	04/07/2018	Weather:		Coding:	PACP 6.0
Pipe Length (ft):	478.8	Owner:	NA	Pre Clean:	Not Known
P.O.#:		Surveyor:	Mark Ruby	PSR:	P-503-042-041
Customer:		Clean Date:	01/01/1900	Shape:	C

Street:	PENNSYLVANIA ST	Flow Control:	Not Controlled
City:	Hobart, IN	Year Renewed:	
Location:	Other	Tape/Media #:	
Purpose:	Not Known	Dia/Height:	12"
Use:	Sanitary	Material:	VCP
Drain Area:	NA	Lining:	
Category:	NA		
Comment:			
Location Details:		Direction of Survey:	Upstream
US MH:	M-503-041	DS MH:	M-503-042
		Total Length Surveyed (ft):	65.4

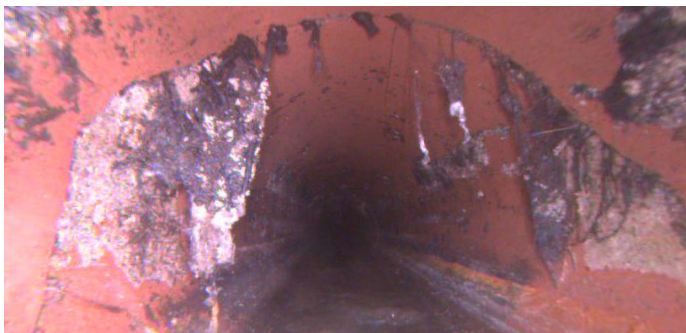
Code: **RMB**
Description: **Roots Medium Barrel**

Distance (ft): **.0**
Structural Grade: **0**
O&M Grade: **4**
Clock Start/From: **8**
Clock To: **4**
1st Value:
2nd Value:
Value Percent: **10.000**
Continuous Index:
Within 8" of Joint: **NO**
Remarks:

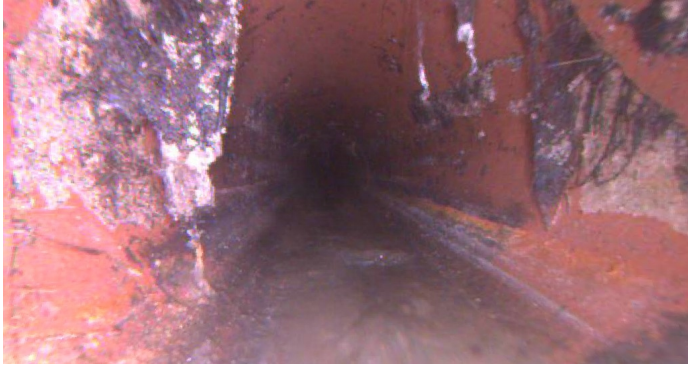
Code: **CS**
Description: **Crack Spiral**

Distance (ft): **.0**
Structural Grade: **2**
O&M Grade: **0**
Clock Start/From: **7**
Clock To: **5**
1st Value:
2nd Value:
Value Percent:
Continuous Index:
Within 8" of Joint:
Remarks:

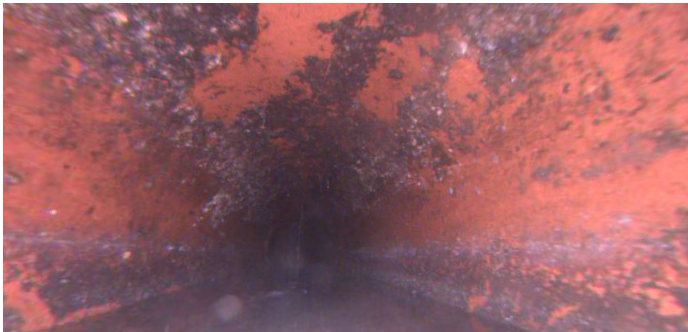
Code: **DAGS**
Description: **Deposits Attached Grease**

Distance (ft): **6.0**
Structural Grade: **0**
O&M Grade: **2**
Clock Start/From: **8**
Clock To: **4**
1st Value:
2nd Value:
Value Percent: **5.000**
Continuous Index: **S02**
Within 8" of Joint: **NO**
Remarks:

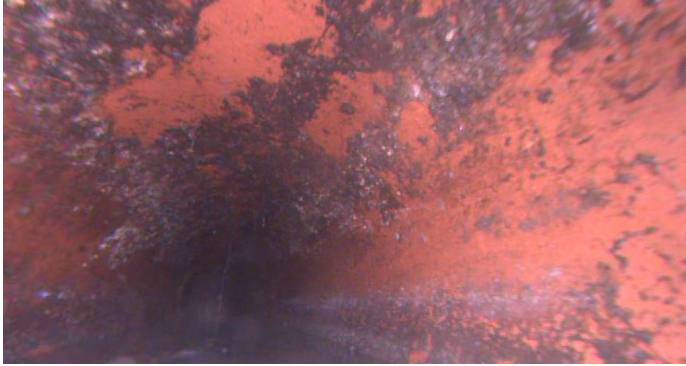
Code: **FL**
Description: **Fracture Longitudinal**

Distance (ft): **6.0**
Structural Grade: **3**
O&M Grade: **0**
Clock Start/From: **12**
Clock To:
1st Value:
2nd Value:
Value Percent:
Continuous Index: **S01**
Within 8" of Joint:
Remarks:

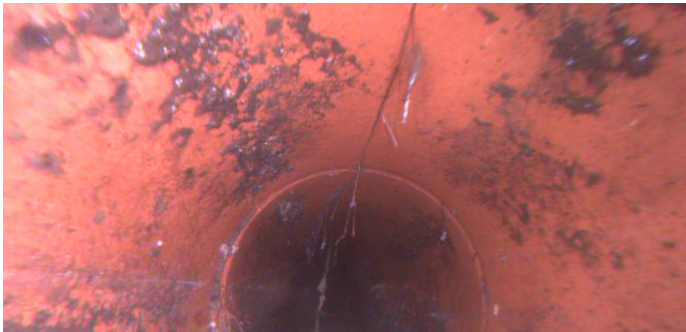
Code: **RFB**
Description: **Roots Fine Barrel**

Distance (ft): **8.4**
Structural Grade: **0**
O&M Grade: **2**
Clock Start/From: **12**
Clock To:
1st Value:
2nd Value:
Value Percent:
Continuous Index: **S03**
Within 8" of Joint: **NO**
Remarks:

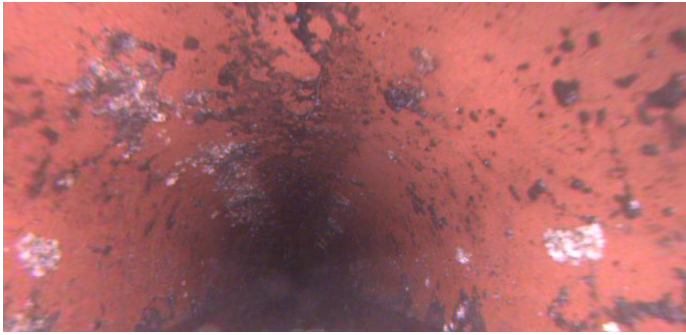
Code: **RFB**
Description: **Roots Fine Barrel**

Distance (ft): **15.6**
Structural Grade: **0**
O&M Grade: **2**
Clock Start/From: **12**
Clock To:
1st Value:
2nd Value:
Value Percent:
Continuous Index: **F03**
Within 8" of Joint: **NO**
Remarks:

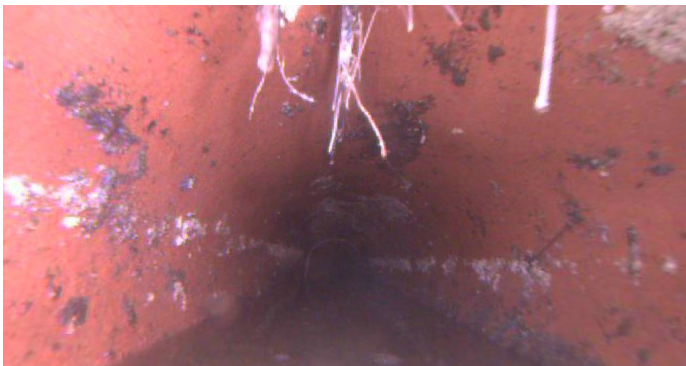
Code: **RFJ**
Description: **Roots Fine Joint**

Distance (ft): **19.1**
Structural Grade: **0**
O&M Grade: **1**
Clock Start/From: **7**
Clock To: **5**
1st Value:
2nd Value:
Value Percent:
Continuous Index:
Within 8" of Joint: **YES**
Remarks:

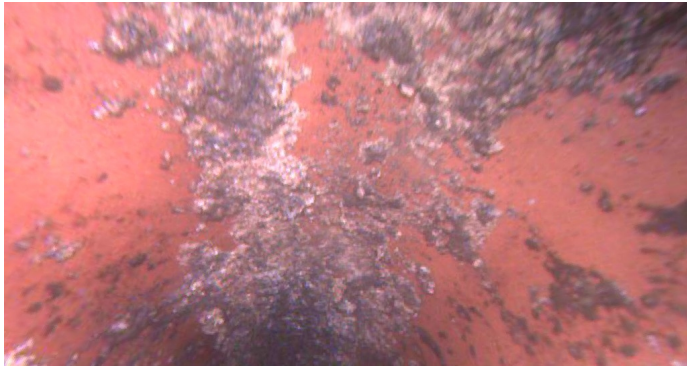
Code: **CL**
Description: **Crack Longitudinal**

Distance (ft): **21.0**
Structural Grade: **2**
O&M Grade: **0**
Clock Start/From: **12**
Clock To:
1st Value:
2nd Value:
Value Percent:
Continuous Index: **F01**
Within 8" of Joint:
Remarks:

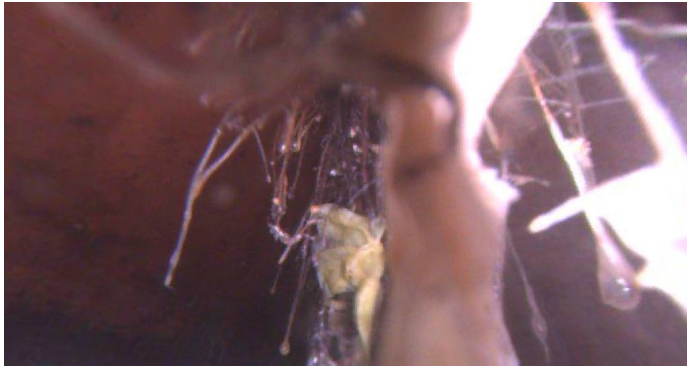
Code: **RFB**
Description: **Roots Fine Barrel**

Distance (ft): **49.5**
Structural Grade: **0**
O&M Grade: **2**
Clock Start/From: **12**
Clock To:
1st Value:
2nd Value:
Value Percent:
Continuous Index:
Within 8" of Joint: **NO**
Remarks:

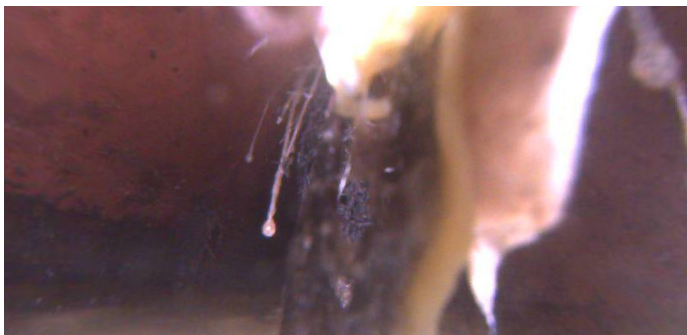
Code: **DAGS**
Description: **Deposits Attached Grease**

Distance (ft): **49.6**
Structural Grade: **0**
O&M Grade: **2**
Clock Start/From: **8**
Clock To: **4**
1st Value:
2nd Value:
Value Percent: **5.000**
Continuous Index: **F02**
Within 8" of Joint: **NO**
Remarks:

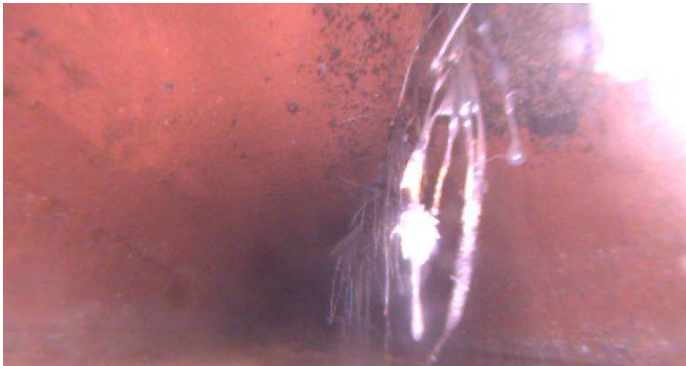
Code: **RFB**
Description: **Roots Fine Barrel**

Distance (ft): **54.1**
Structural Grade: **0**
O&M Grade: **2**
Clock Start/From: **1**
Clock To:
1st Value:
2nd Value:
Value Percent:
Continuous Index:
Within 8" of Joint: **NO**
Remarks:

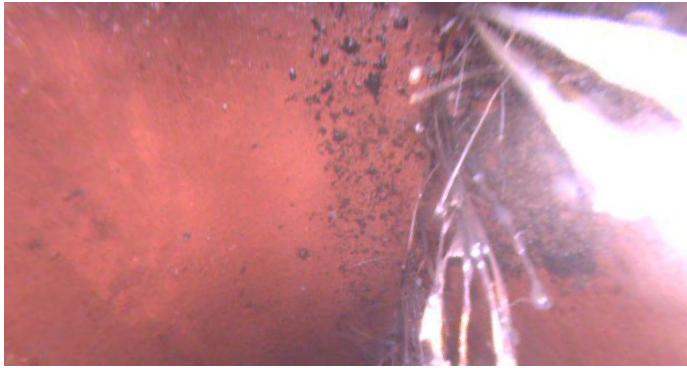
Code: **CL**
Description: **Crack Longitudinal**

Distance (ft): **54.1**
Structural Grade: **2**
O&M Grade: **0**
Clock Start/From: **1**
Clock To:
1st Value:
2nd Value:
Value Percent:
Continuous Index:
Within 8" of Joint:
Remarks:

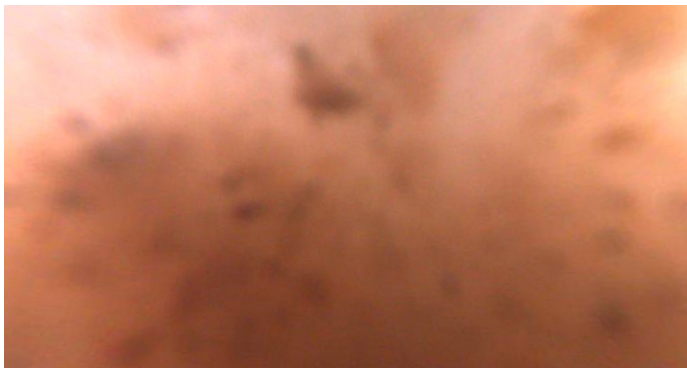
Code: **MCU**
Description: **Camera Underwater**

Distance (ft): **59.0**
Structural Grade: **0**
O&M Grade: **4**
Clock Start/From:
Clock To:
1st Value:
2nd Value:
Value Percent:
Continuous Index:
Within 8" of Joint: **NO**
Remarks:

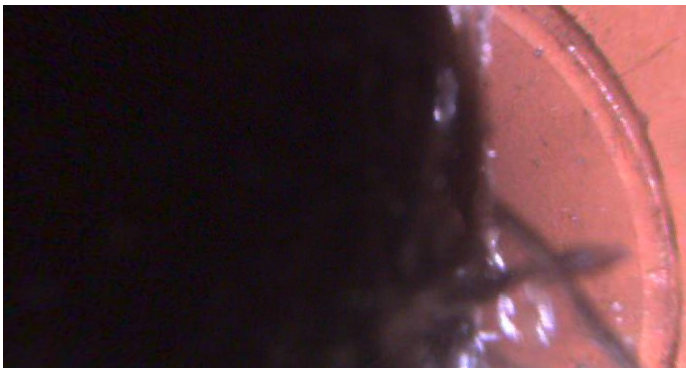
Code: **RMJ**
Description: **Roots Medium Joint**

Distance (ft): **65.4**
Structural Grade: **0**
O&M Grade: **3**
Clock Start/From: **5**
Clock To: **1**
1st Value:
2nd Value:
Value Percent: **40.000**
Continuous Index:
Within 8" of Joint: **YES**
Remarks:
