Profile/Photo Observation Report

Street:	guyer st	Flow Control:	Not Controlled
City:	Hobart, IN	Year Renewed:	
Location:	Other	Tape/Media #:	
Purpose:	Not Known	Dia/Height:	12"
Use:	Sanitary	Material:	VCP
Drain Area:	NA	Lining:	
Category:	NA		
Comment:

Location Details:		Direction of Survey:	Upstream
US MH:	M-503-041	DS MH:	M-503-042
		Total Length Surveyed (ft):	65.4

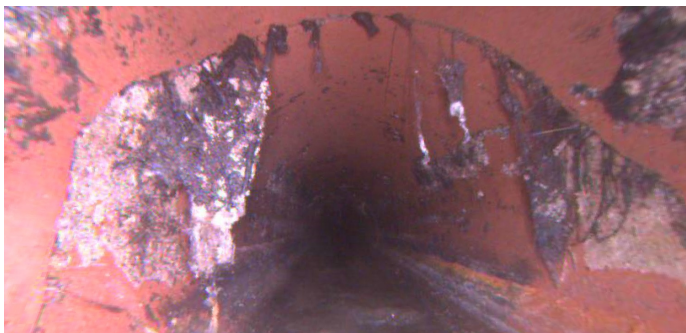
Code: **RMB**
Description: **Roots Medium Barrel**

Distance (ft): **.0**
Structural Grade: **0**
O&M Grade: **4**
Clock Start/From: **8**
Clock To: **4**
1st Value:
2nd Value:
Value Percent: **10.000**
Continuous Index:
Within 8" of Joint: **NO**
Remarks:

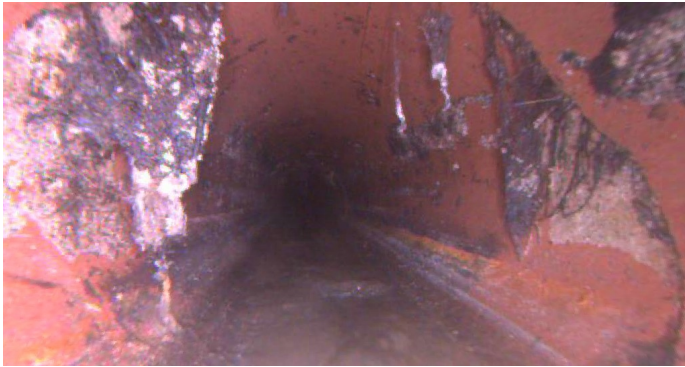
Code: **AMH**
Description: **Manhole**

Distance (ft): **.0**
Structural Grade: **0**
O&M Grade: **0**
Clock Start/From:
Clock To:
1st Value:
2nd Value:
Value Percent:
Continuous Index:
Within 8" of Joint: **NO**
Remarks: **M-503-042**

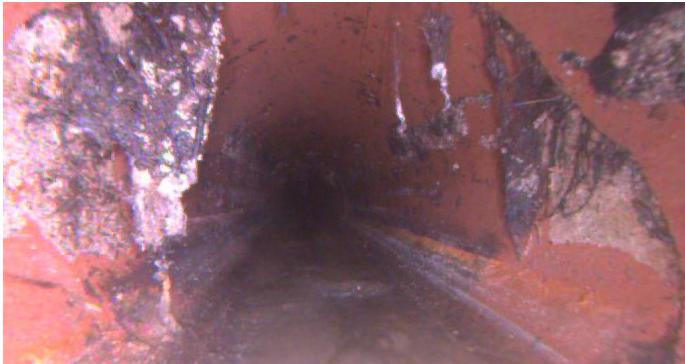
Code: **MWL**
Description: **Water Level**

Distance (ft): **.0**
Structural Grade: **0**
O&M Grade: **0**
Clock Start/From:
Clock To:
1st Value:
2nd Value:
Value Percent: **10.000**
Continuous Index:
Within 8" of Joint: **NO**
Remarks:

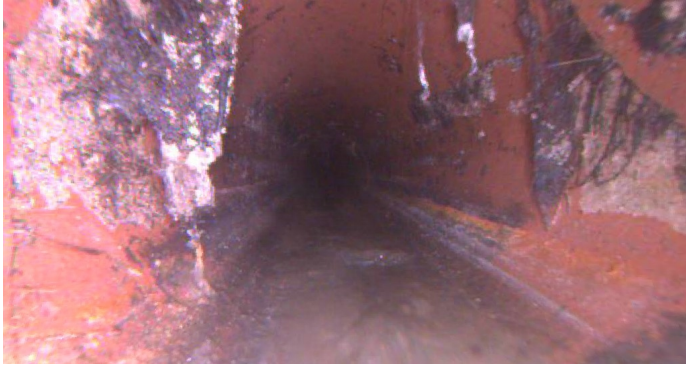
Code: **CS**
Description: **Crack Spiral**

Distance (ft): **.0**
Structural Grade: **2**
O&M Grade: **0**
Clock Start/From: **7**
Clock To: **5**
1st Value:
2nd Value:
Value Percent:
Continuous Index:
Within 8" of Joint:
Remarks:

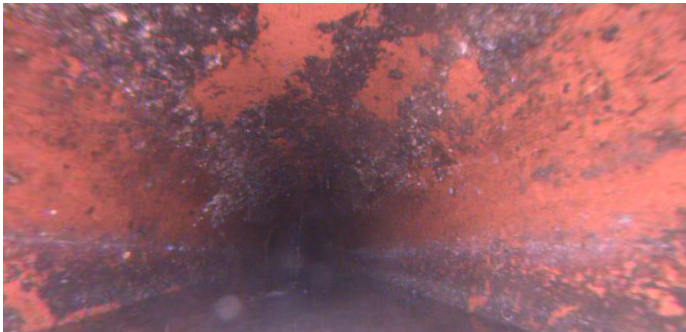
Code: **DAGS**
Description: **Deposits Attached Grease**

Distance (ft): **6.0**
Structural Grade: **0**
O&M Grade: **2**
Clock Start/From: **8**
Clock To: **4**
1st Value:
2nd Value:
Value Percent: **5.000**
Continuous Index: **S02**
Within 8" of Joint: **NO**
Remarks:

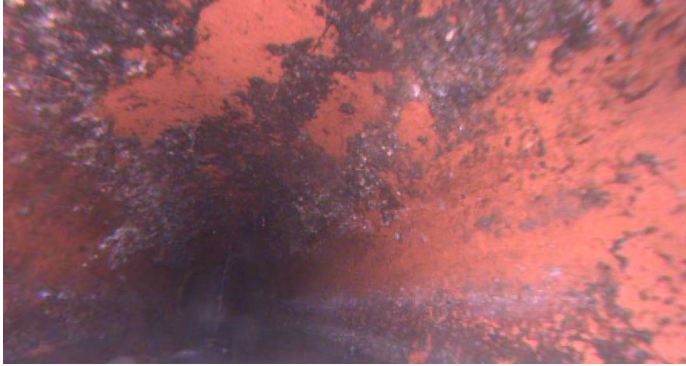
Code: **FL**
Description: **Fracture Longitudinal**

Distance (ft): **6.0**
Structural Grade: **3**
O&M Grade: **0**
Clock Start/From: **12**
Clock To:
1st Value:
2nd Value:
Value Percent:
Continuous Index: **S01**
Within 8" of Joint:
Remarks:

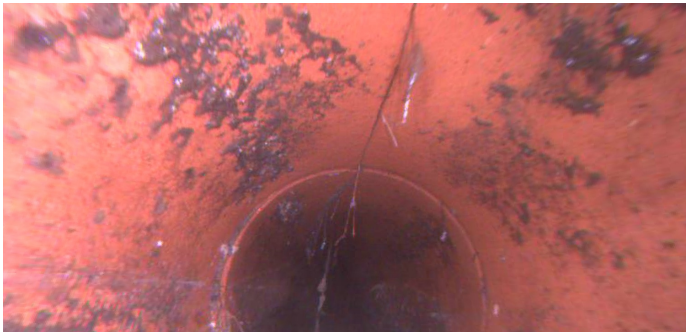
Code: **RFB**
Description: **Roots Fine Barrel**

Distance (ft): **8.4**
Structural Grade: **0**
O&M Grade: **2**
Clock Start/From: **12**
Clock To:
1st Value:
2nd Value:
Value Percent:
Continuous Index: **S03**
Within 8" of Joint: **NO**
Remarks:

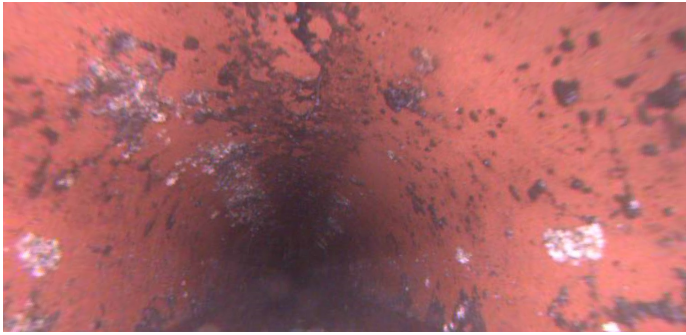
Code: **RFB**
Description: **Roots Fine Barrel**

Distance (ft): **15.6**
Structural Grade: **0**
O&M Grade: **2**
Clock Start/From: **12**
Clock To:
1st Value:
2nd Value:
Value Percent:
Continuous Index: **F03**
Within 8" of Joint: **NO**
Remarks:

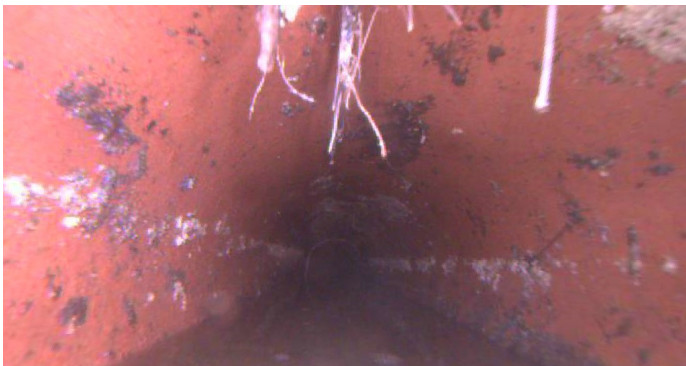
Code: **RFJ**
Description: **Roots Fine Joint**

Distance (ft): **19.1**
Structural Grade: **0**
O&M Grade: **1**
Clock Start/From: **7**
Clock To: **5**
1st Value:
2nd Value:
Value Percent:
Continuous Index:
Within 8" of Joint: **YES**
Remarks:

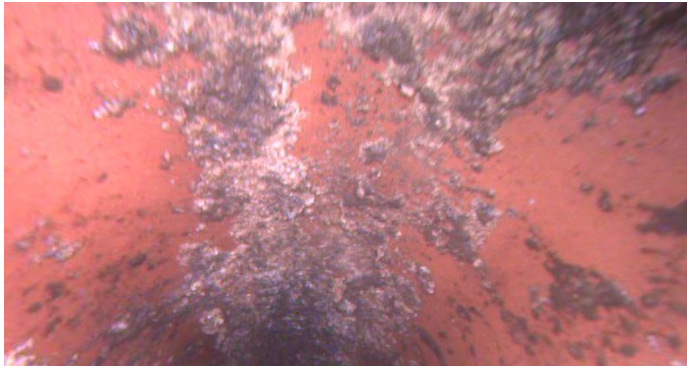
Code: **CL**
Description: **Crack Longitudinal**

Distance (ft): **21.0**
Structural Grade: **2**
O&M Grade: **0**
Clock Start/From: **12**
Clock To:
1st Value:
2nd Value:
Value Percent:
Continuous Index: **F01**
Within 8" of Joint:
Remarks:

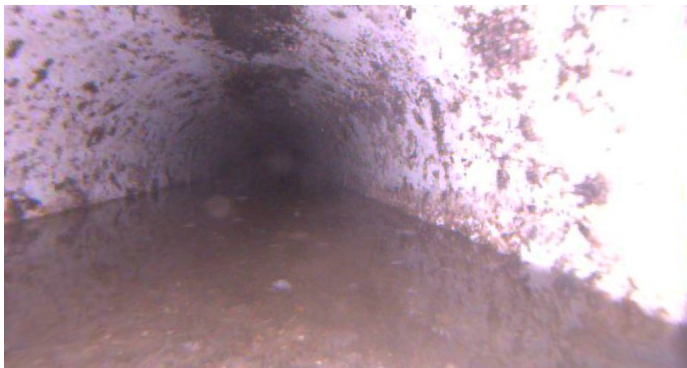
Code: **MMC**
Description: **Material Change**

Distance (ft): **23.8**
Structural Grade: **0**
O&M Grade: **0**
Clock Start/From:
Clock To:
1st Value:
2nd Value:
Value Percent:
Continuous Index:
Within 8" of Joint: **NO**
Remarks: **PVC**

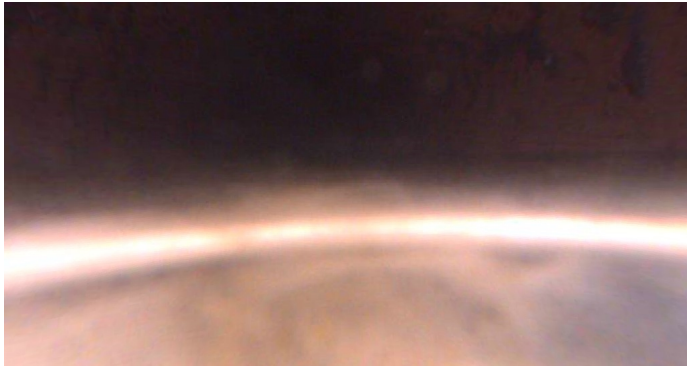
Code: **MMC**
Description: **Material Change**

Distance (ft): **44.4**
Structural Grade: **0**
O&M Grade: **0**
Clock Start/From:
Clock To:
1st Value:
2nd Value:
Value Percent:
Continuous Index:
Within 8" of Joint: **NO**
Remarks: **VCP**

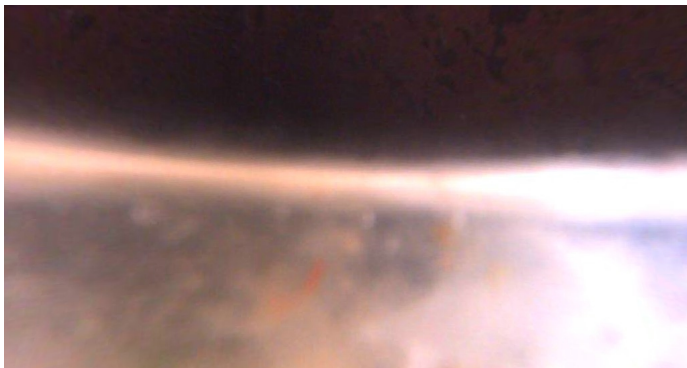
Code: **MWL**
Description: **Water Level**

Distance (ft): **45.7**
Structural Grade: **0**
O&M Grade: **0**
Clock Start/From:
Clock To:
1st Value:
2nd Value:
Value Percent: **40.000**
Continuous Index:
Within 8" of Joint: **NO**
Remarks:

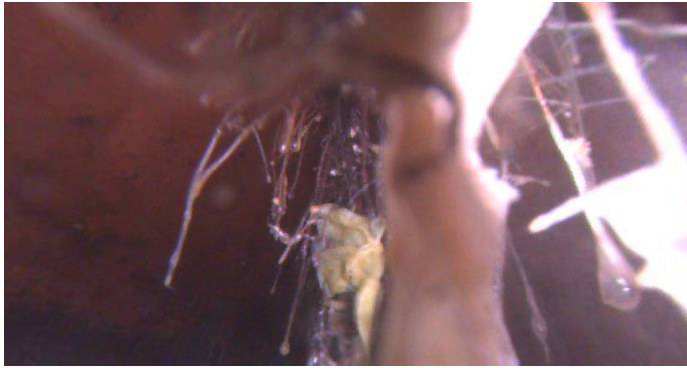
Code: **RFB**
Description: **Roots Fine Barrel**

Distance (ft): **49.5**
Structural Grade: **0**
O&M Grade: **2**
Clock Start/From: **12**
Clock To:
1st Value:
2nd Value:
Value Percent:
Continuous Index:
Within 8" of Joint: **NO**
Remarks:

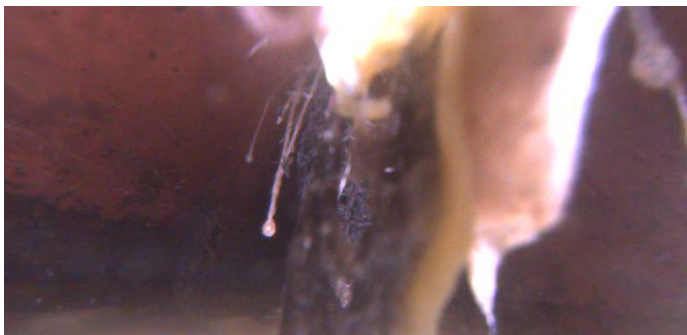
Code: **DAGS**
Description: **Deposits Attached Grease**

Distance (ft): **49.6**
Structural Grade: **0**
O&M Grade: **2**
Clock Start/From: **8**
Clock To: **4**
1st Value:
2nd Value:
Value Percent: **5.000**
Continuous Index: **F02**
Within 8" of Joint: **NO**
Remarks:

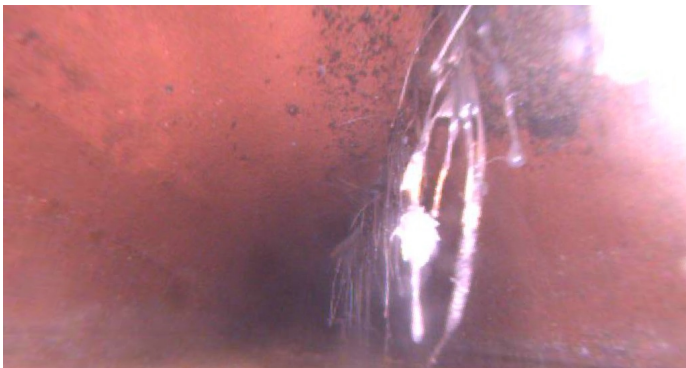
Code: **RFB**
Description: **Roots Fine Barrel**

Distance (ft): **54.1**
Structural Grade: **0**
O&M Grade: **2**
Clock Start/From: **1**
Clock To:
1st Value:
2nd Value:
Value Percent:
Continuous Index:
Within 8" of Joint: **NO**
Remarks:

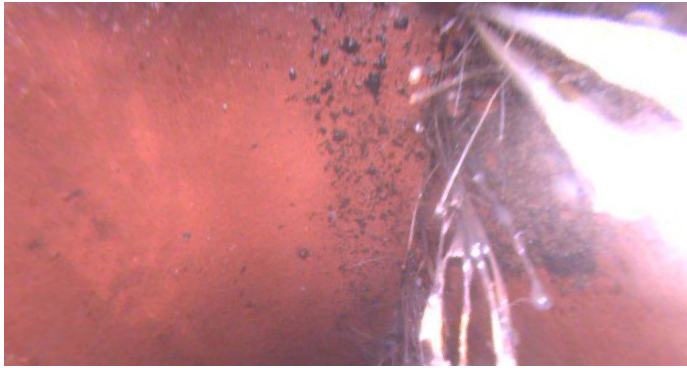
Code: **CL**
Description: **Crack Longitudinal**

Distance (ft): **54.1**
Structural Grade: **2**
O&M Grade: **0**
Clock Start/From: **1**
Clock To:
1st Value:
2nd Value:
Value Percent:
Continuous Index:
Within 8" of Joint:
Remarks:

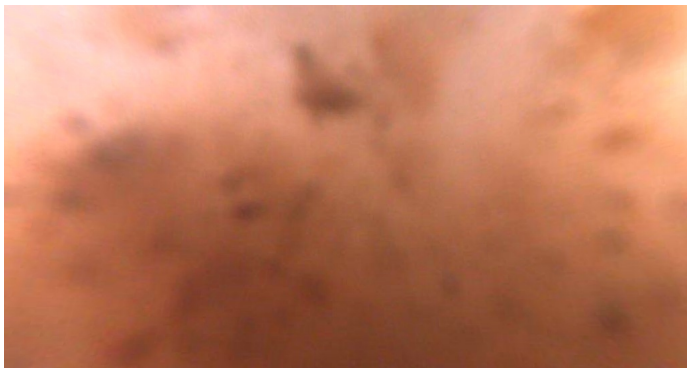
Code: **MCU**
Description: **Camera Underwater**

Distance (ft): **59.0**
Structural Grade: **0**
O&M Grade: **4**
Clock Start/From:
Clock To:
1st Value:
2nd Value:
Value Percent:
Continuous Index:
Within 8" of Joint: **NO**
Remarks:

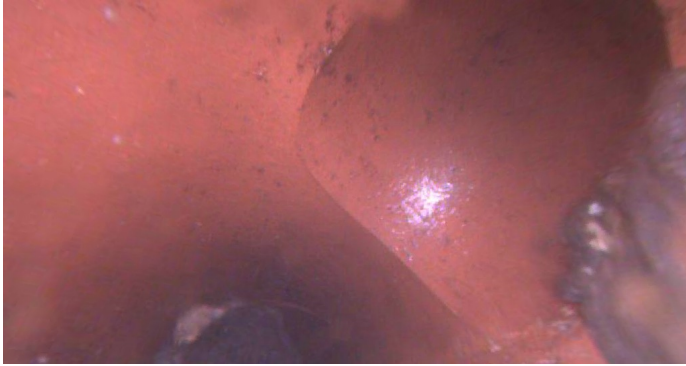
Code: **TF**
Description: **Tap Factory**

Distance (ft): **64.1**
Structural Grade: **0**
O&M Grade: **0**
Clock Start/From: **2**
Clock To:
1st Value: **4.000**
2nd Value:
Value Percent:
Continuous Index:
Within 8" of Joint:
Remarks:

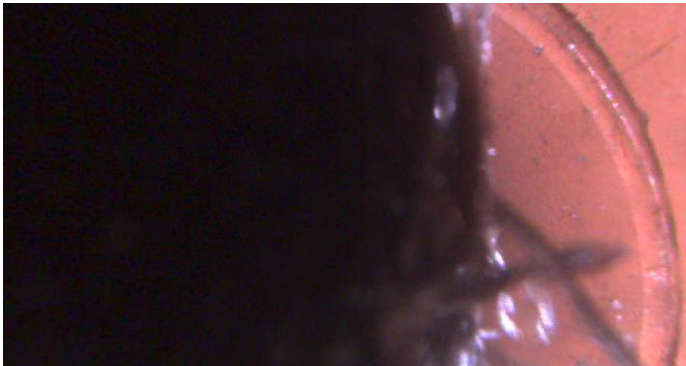
Code: **RMJ**
Description: **Roots Medium Joint**

Distance (ft): **65.4**
Structural Grade: **0**
O&M Grade: **3**
Clock Start/From: **5**
Clock To: **1**
1st Value:
2nd Value:
Value Percent: **40.000**
Continuous Index:
Within 8" of Joint: **YES**
Remarks:

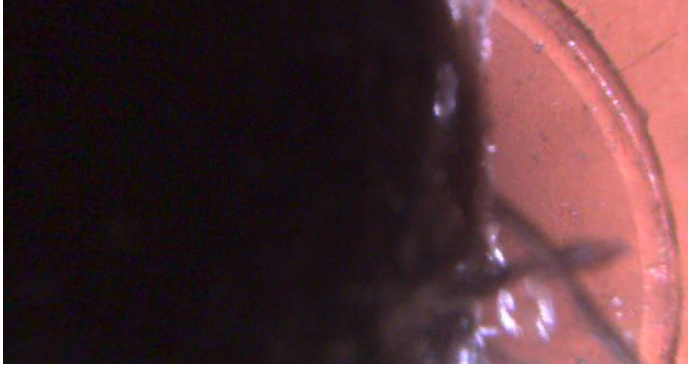
Code:	MSA
Description:	Abandoned Survey
Distance (ft):	65.4
Structural Grade:	0
O&M Grade:	0
Clock Start/From:	
Clock To:	
1st Value:	
2nd Value:	
Value Percent:	
Continuous Index:	
Within 8" of Joint:	NO
Remarks:	RMJ
