## Profile/Photo Observation Report

Street:	<b>guyer st</b>	Flow Control:	<b>Not Controlled</b>
City:	<b>Hobart, IN</b>	Year Renewed:	
Location:	<b>Other</b>	Tape/Media #:	
Purpose:	<b>Not Known</b>	Dia/Height:	<b>8"</b>
Use:	<b>Sanitary</b>	Material:	<b>PVC</b>
Drain Area:	<b>NA</b>	Lining:	
Category:	<b>NA</b>		
Comment:

Location Details:		Direction of Survey:	<b>Downstream</b>
US MH:	<b>M-503-042</b>	DS MH:	<b>M-503-088</b>
		Total Length Surveyed (ft):	<b>166.9</b>

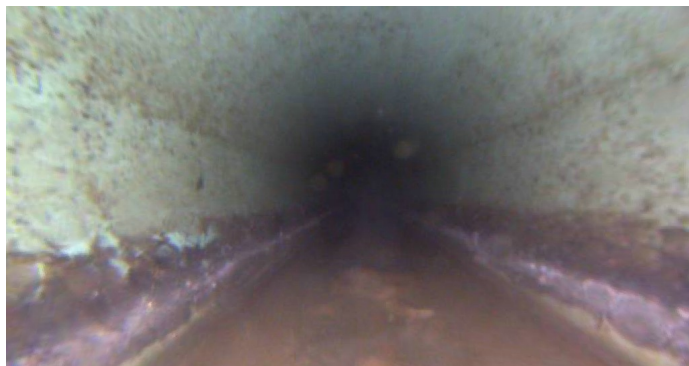
Code: **AMH**  
Description: **Manhole**

Distance (ft): **.0**  
Structural Grade: **0**  
O&M Grade: **0**  
Clock Start/From:  
Clock To:  
1st Value:  
2nd Value:  
Value Percent:  
Continuous Index:  
Within 8" of Joint: **NO**  
Remarks: **M-503-042**

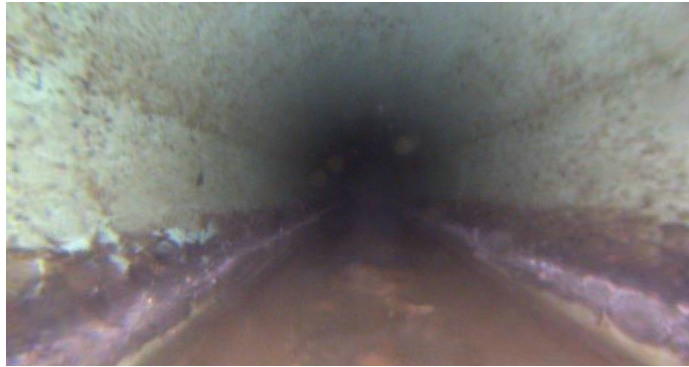
Code: **MWL**  
Description: **Water Level**

Distance (ft): **.0**  
Structural Grade: **0**  
O&M Grade: **0**  
Clock Start/From:  
Clock To:  
1st Value:  
2nd Value:  
Value Percent: **10.000**  
Continuous Index:  
Within 8" of Joint: **NO**  
Remarks:

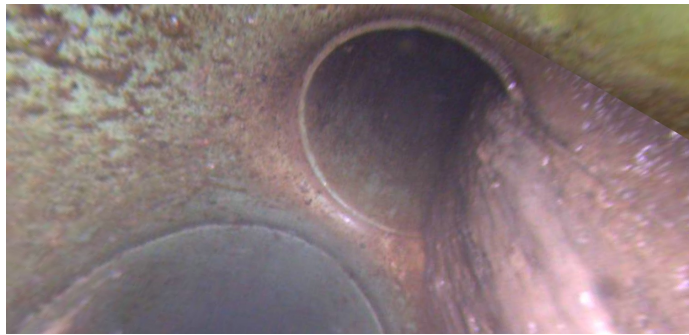
Code: **TFD**  
Description: **Tap Factory Defective**

Distance (ft): **10.5**  
Structural Grade: **0**  
O&M Grade: **2**  
Clock Start/From: **1**  
Clock To:  
1st Value: **4.000**  
2nd Value:  
Value Percent:  
Continuous Index:  
Within 8" of Joint:  
Remarks: **dae**

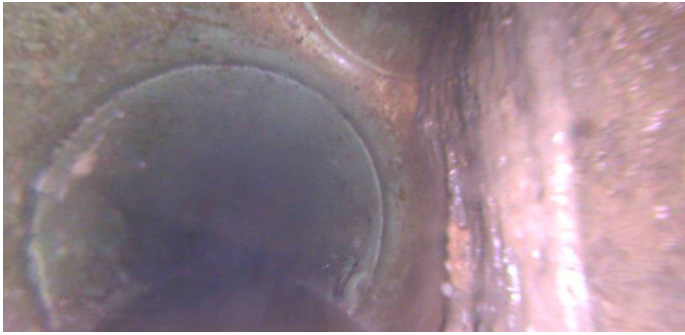
Code: **DAE**  
Description: **Deposits Attached Encrustation**

Distance (ft): **10.5**  
Structural Grade: **0**  
O&M Grade: **2**  
Clock Start/From: **1**  
Clock To: **4**  
1st Value:  
2nd Value:  
Value Percent: **5.000**  
Continuous Index:  
Within 8" of Joint: **NO**  
Remarks:

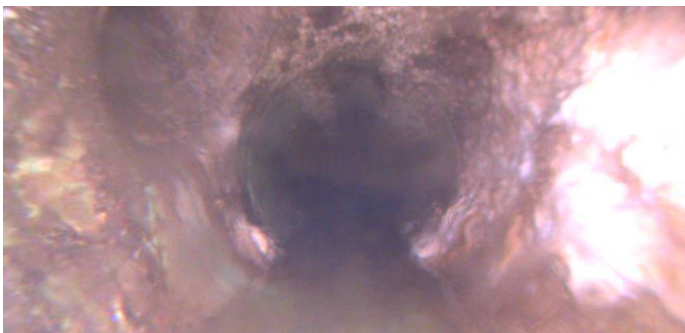
Code: **DAGS**  
Description: **Deposits Attached Grease**

Distance (ft): **33.6**  
Structural Grade: **0**  
O&M Grade: **2**  
Clock Start/From: **8**  
Clock To: **4**  
1st Value:  
2nd Value:  
Value Percent: **5.000**  
Continuous Index:  
Within 8" of Joint: **NO**  
Remarks:

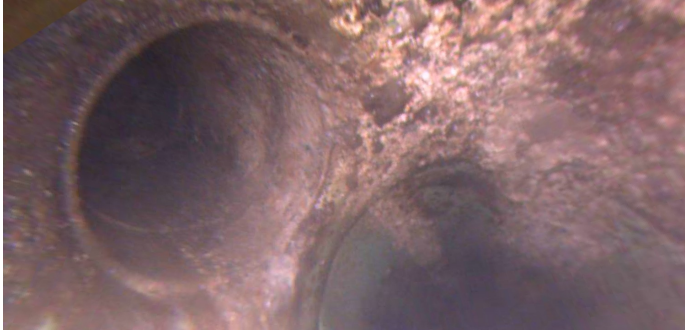
Code: **TF**  
Description: **Tap Factory**

Distance (ft): **33.9**  
Structural Grade: **0**  
O&M Grade: **0**  
Clock Start/From: **10**  
Clock To:  
1st Value: **4.000**  
2nd Value:  
Value Percent:  
Continuous Index:  
Within 8" of Joint:  
Remarks:

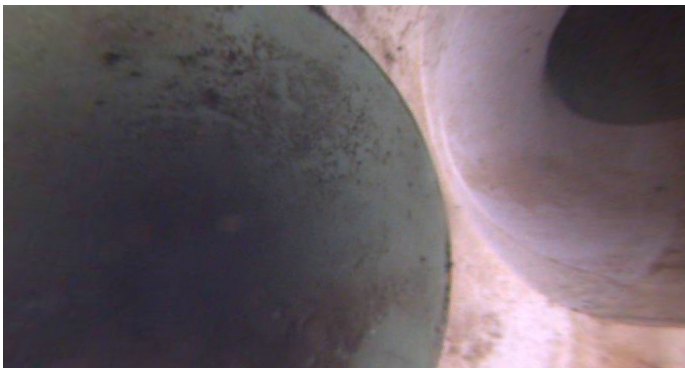
Code: **TF**  
Description: **Tap Factory**

Distance (ft): **70.0**  
Structural Grade: **0**  
O&M Grade: **0**  
Clock Start/From: **3**  
Clock To:  
1st Value: **4.000**  
2nd Value:  
Value Percent:  
Continuous Index:  
Within 8" of Joint:  
Remarks:

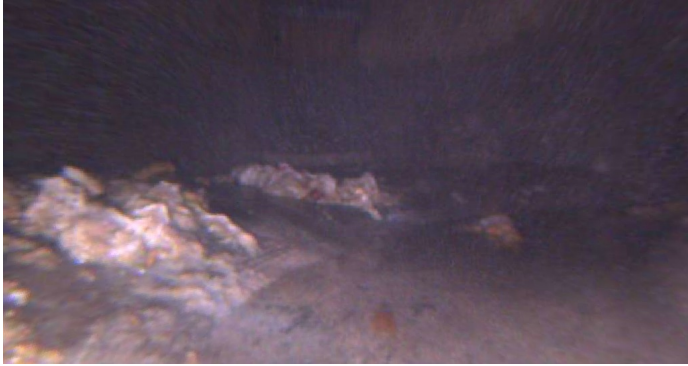
Code:	AMH
Description:	Manhole
Distance (ft):	166.9
Structural Grade:	0
O&M Grade:	0
Clock Start/From:	
Clock To:	
1st Value:	
2nd Value:	
Value Percent:	
Continuous Index:	
Within 8" of Joint:	NO
Remarks:	M-503-088
