Profile/Photo Observation Report

Date:	04/07/2018	Weather:		Coding:	PACP 6.0
Pipe Length (ft):	311.7	Owner:	NA	Pre Clean:	Not Known
P.O.#:		Surveyor:	Mark Ruby	PSR:	P-503-041-043
Customer:		Clean Date:	01/01/1900	Shape:	C

Street:	N GUYER ST & PENNSYLVANIA ST	Flow Control:	Not Controlled
City:	Hobart, IN	Year Renewed:	
Location:	Other	Tape/Media #:	
Purpose:	Not Known	Dia/Height:	10"
Use:	Sanitary	Material:	VCP
Drain Area:	NA	Lining:	
Category:	NA		
Comment:

Location Details:		Direction of Survey:	Upstream
US MH:	M-503-043	DS MH:	M-503-041
		Total Length Surveyed (ft):	173.5

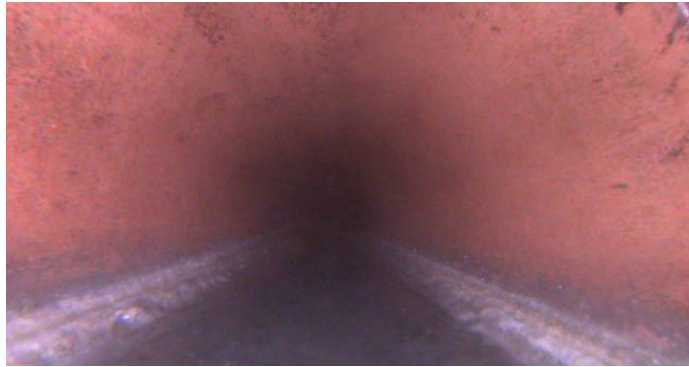
Code: **MWL**
Description: **Water Level**

Distance (ft): **.0**
Structural Grade: **0**
O&M Grade: **0**
Clock Start/From:
Clock To:
1st Value:
2nd Value:
Value Percent: **10.000**
Continuous Index:
Within 8" of Joint: **NO**
Remarks:

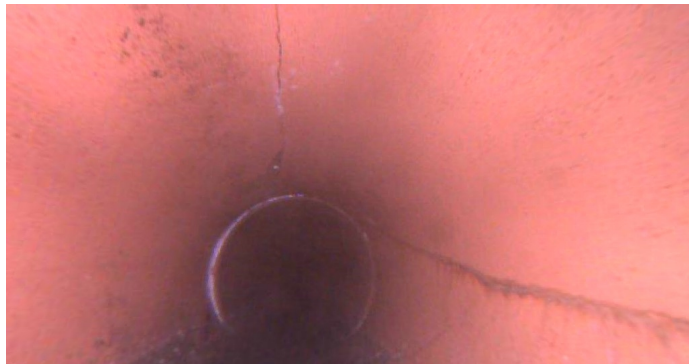
Code: **FL**
Description: **Fracture Longitudinal**

Distance (ft): **28.7**
Structural Grade: **3**
O&M Grade: **0**
Clock Start/From: **12**
Clock To:
1st Value:
2nd Value:
Value Percent:
Continuous Index:
Within 8" of Joint: **NO**
Remarks:

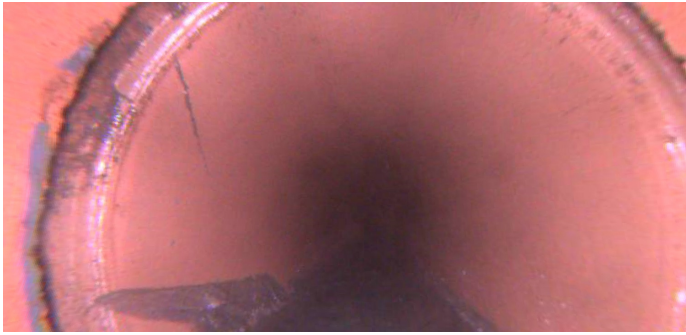
Code: **FM**
Description: **Fracture Multiple**

Distance (ft): **49.6**
Structural Grade: **4**
O&M Grade: **0**
Clock Start/From: **8**
Clock To: **10**
1st Value:
2nd Value:
Value Percent:
Continuous Index:
Within 8" of Joint: **YES**
Remarks:

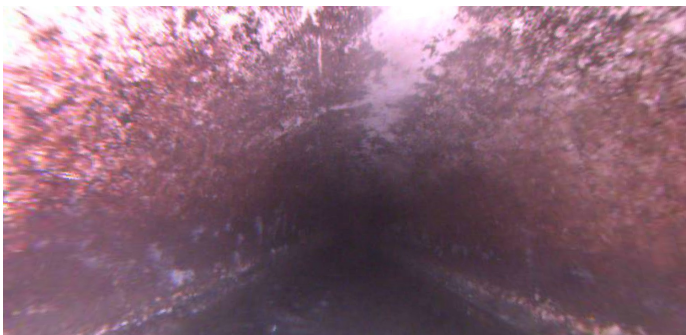
Code: **MMC**
Description: **Material Change**

Distance (ft): **59.2**
Structural Grade: **0**
O&M Grade: **0**
Clock Start/From:
Clock To:
1st Value:
2nd Value:
Value Percent:
Continuous Index:
Within 8" of Joint: **NO**
Remarks: **PVC**

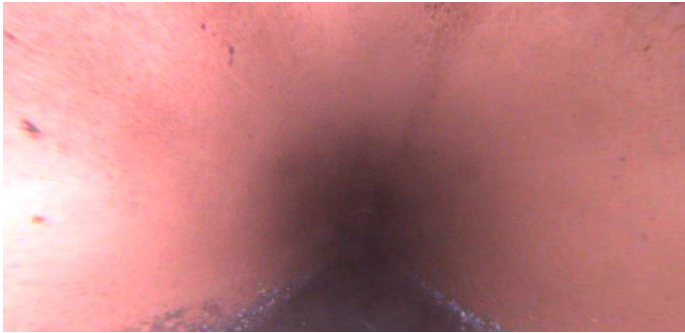
Code: **MMC**
Description: **Material Change**

Distance (ft): **69.8**
Structural Grade: **0**
O&M Grade: **0**
Clock Start/From:
Clock To:
1st Value:
2nd Value:
Value Percent:
Continuous Index:
Within 8" of Joint: **NO**
Remarks: **vcp**

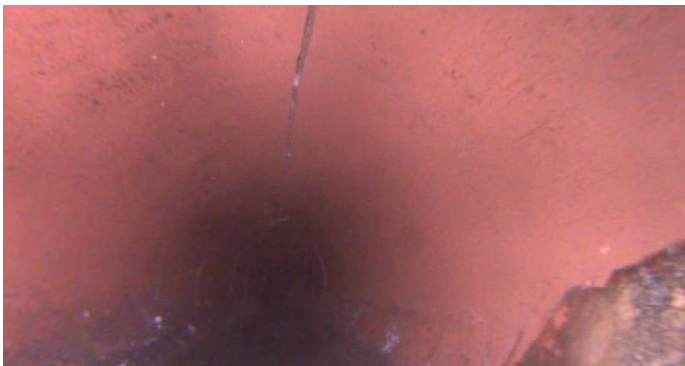
Code: **FM**
Description: **Fracture Multiple**

Distance (ft): **74.8**
Structural Grade: **4**
O&M Grade: **0**
Clock Start/From: **7**
Clock To: **5**
1st Value:
2nd Value:
Value Percent:
Continuous Index:
Within 8" of Joint:
Remarks:

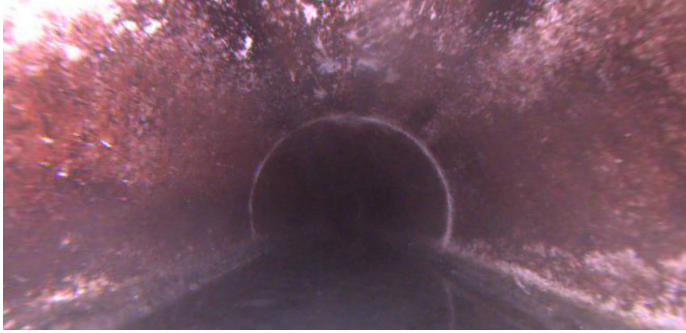
Code: **MMC**
Description: **Material Change**

Distance (ft): **83.9**
Structural Grade: **0**
O&M Grade: **0**
Clock Start/From:
Clock To:
1st Value:
2nd Value:
Value Percent:
Continuous Index:
Within 8" of Joint: **NO**
Remarks: **PVC**

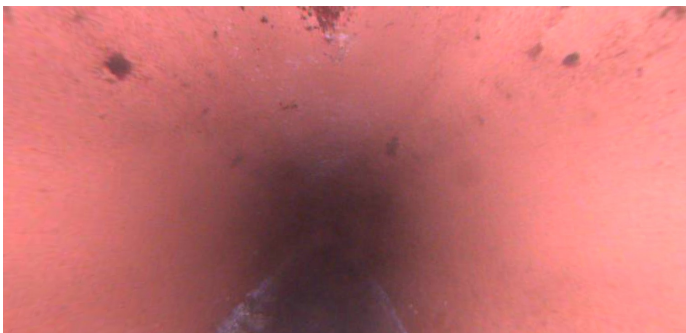
Code: **MMC**
Description: **Material Change**

Distance (ft): **89.7**
Structural Grade: **0**
O&M Grade: **0**
Clock Start/From:
Clock To:
1st Value:
2nd Value:
Value Percent:
Continuous Index:
Within 8" of Joint: **NO**
Remarks: **vcp**

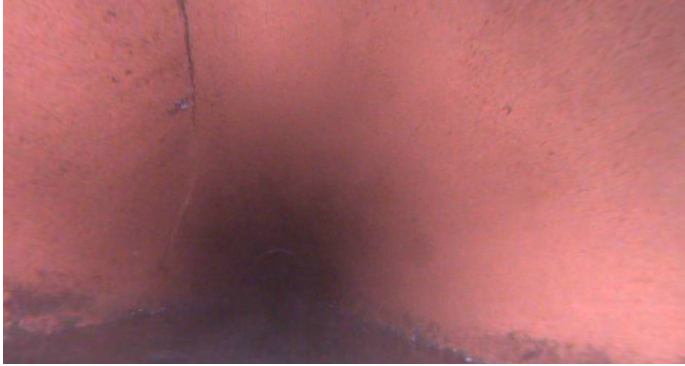
Code: **FS**
Description: **Fracture Spiral**

Distance (ft): **94.3**
Structural Grade: **3**
O&M Grade: **0**
Clock Start/From: **7**
Clock To: **12**
1st Value:
2nd Value:
Value Percent:
Continuous Index:
Within 8" of Joint:
Remarks:

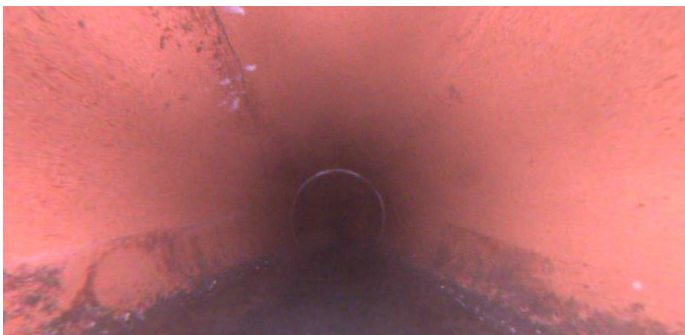
Code: **FM**
Description: **Fracture Multiple**

Distance (ft): **96.7**
Structural Grade: **4**
O&M Grade: **0**
Clock Start/From: **8**
Clock To: **4**
1st Value:
2nd Value:
Value Percent:
Continuous Index:
Within 8" of Joint:
Remarks:

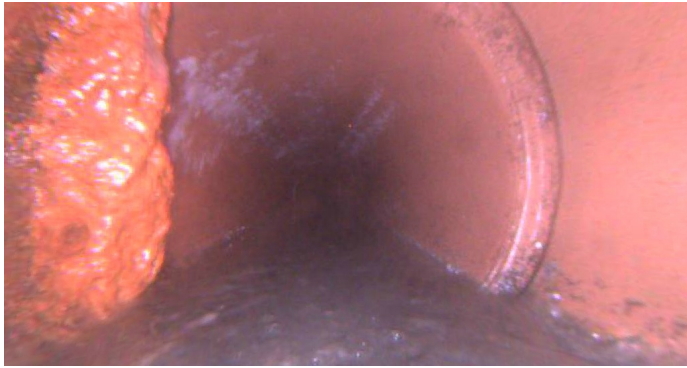
Code:	DAE
Description:	Deposits Attached Encrustation
Distance (ft):	147.9
Structural Grade:	0
O&M Grade:	2
Clock Start/From:	7
Clock To:	11
1st Value:	
2nd Value:	
Value Percent:	5.000
Continuous Index:	
Within 8" of Joint:	YES
Remarks:

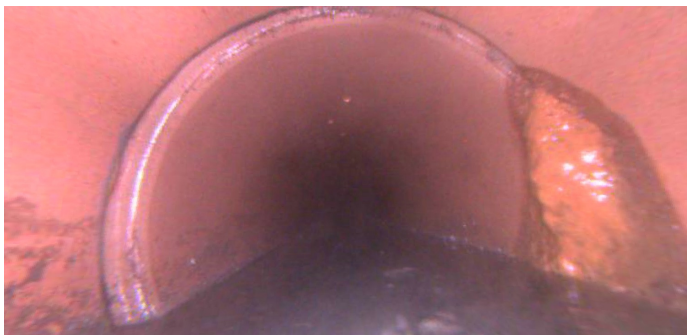
Code:	DAE
Description:	Deposits Attached Encrustation
Distance (ft):	152.8
Structural Grade:	0
O&M Grade:	2
Clock Start/From:	2
Clock To:	3
1st Value:	
2nd Value:	
Value Percent:	5.000
Continuous Index:	
Within 8" of Joint:	YES
Remarks:

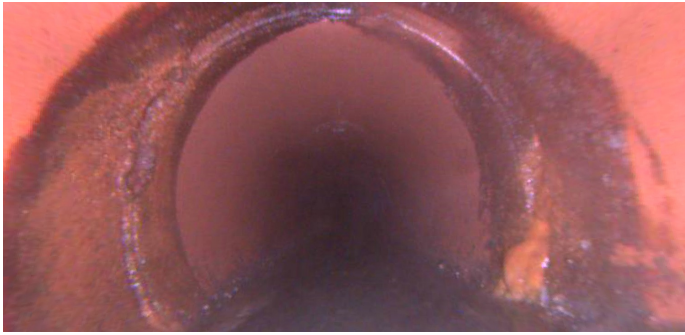
Code: **IW**
Description: **Infil Weeper**

Distance (ft): **157.7**
Structural Grade: **0**
O&M Grade: **2**
Clock Start/From: **8**
Clock To: **4**
1st Value:
2nd Value:
Value Percent:
Continuous Index:
Within 8" of Joint: **YES**
Remarks:

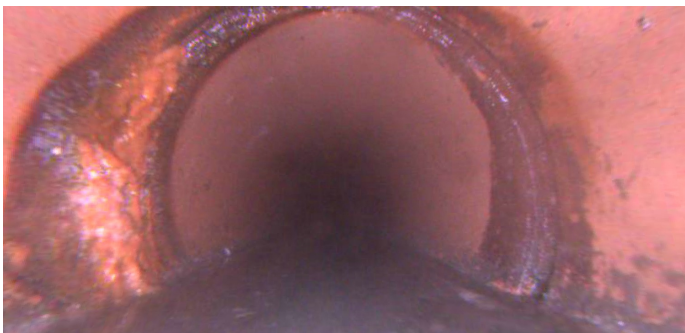
Code: **DAE**
Description: **Deposits Attached Encrustation**

Distance (ft): **167.7**
Structural Grade: **0**
O&M Grade: **2**
Clock Start/From: **8**
Clock To: **4**
1st Value:
2nd Value:
Value Percent: **5.000**
Continuous Index:
Within 8" of Joint: **YES**
Remarks:

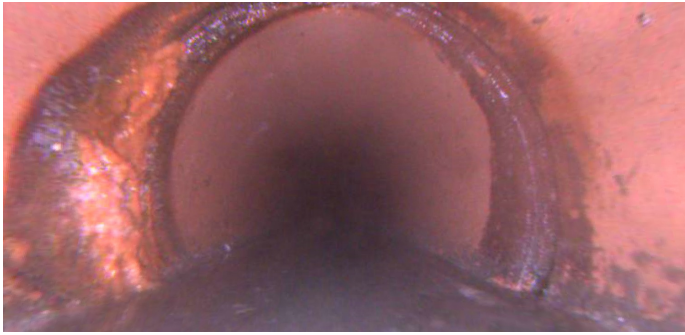
Code: **IW**
Description: **Infil Weeper**

Distance (ft): **167.7**
Structural Grade: **0**
O&M Grade: **2**
Clock Start/From: **8**
Clock To: **4**
1st Value:
2nd Value:
Value Percent:
Continuous Index:
Within 8" of Joint: **YES**
Remarks:

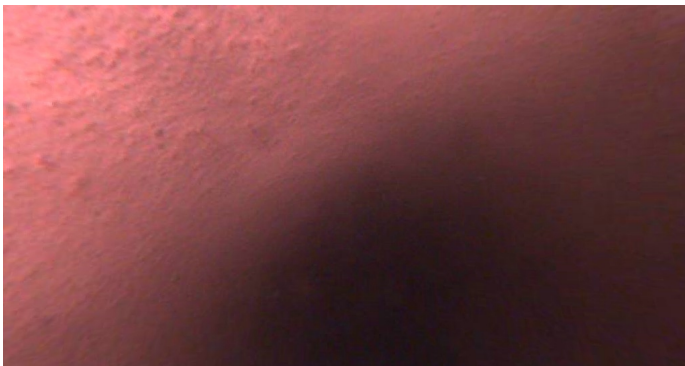
Code: **MSA**
Description: **Abandoned Survey**

Distance (ft): **173.5**
Structural Grade: **0**
O&M Grade: **0**
Clock Start/From:
Clock To:
1st Value:
2nd Value:
Value Percent:
Continuous Index:
Within 8" of Joint: **NO**
Remarks: **Debris under water**
