## Profile/Photo Observation Report

Date:	<b>04/07/2018</b>	Weather:		Coding:	<b>PACP 6.0</b>
Pipe Length (ft):	<b>311.7</b>	Owner:	<b>NA</b>	Pre Clean:	<b>Not Known</b>
P.O.#:		Surveyor:	<b>Mark Ruby</b>	PSR:	<b>P-503-041-043</b>
Customer:		Clean Date:	<b>01/01/1900</b>	Shape:	<b>C</b>

Street:	<b>guyer st</b>	Flow Control:	<b>Not Controlled</b>
City:	<b>Hobart, IN</b>	Year Renewed:	
Location:	<b>Other</b>	Tape/Media #:	
Purpose:	<b>Not Known</b>	Dia/Height:	<b>10"</b>
Use:	<b>Sanitary</b>	Material:	<b>VCP</b>
Drain Area:	<b>NA</b>	Lining:	
Category:	<b>NA</b>		
Comment:

Location Details:		Direction of Survey:	<b>Upstream</b>
US MH:	<b>M-503-043</b>	DS MH:	<b>M-503-041</b>
		Total Length Surveyed (ft):	<b>173.5</b>

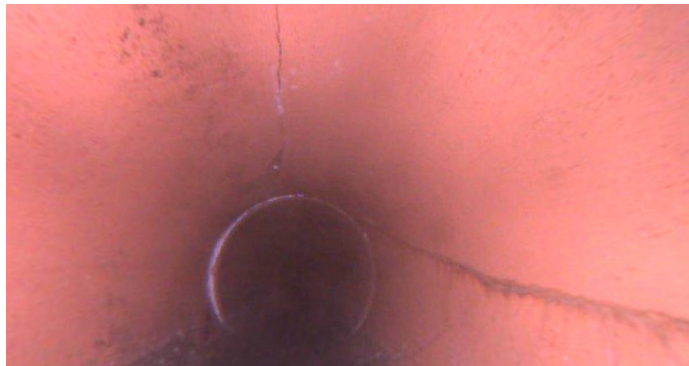
Code: **FL**  
Description: **Fracture Longitudinal**

Distance (ft): **28.7**  
Structural Grade: **3**  
O&M Grade: **0**  
Clock Start/From: **12**  
Clock To:  
1st Value:  
2nd Value:  
Value Percent:  
Continuous Index:  
Within 8" of Joint: **NO**  
Remarks:

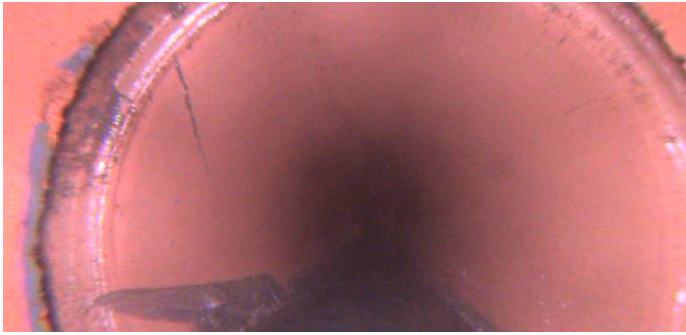
Code: **FM**  
Description: **Fracture Multiple**

Distance (ft): **49.6**  
Structural Grade: **4**  
O&M Grade: **0**  
Clock Start/From: **8**  
Clock To: **10**  
1st Value:  
2nd Value:  
Value Percent:  
Continuous Index:  
Within 8" of Joint: **YES**  
Remarks:

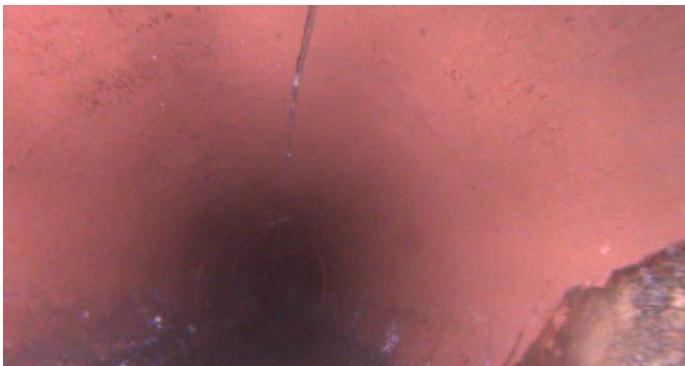
Code: **FM**  
Description: **Fracture Multiple**

Distance (ft): **74.8**  
Structural Grade: **4**  
O&M Grade: **0**  
Clock Start/From: **7**  
Clock To: **5**  
1st Value:  
2nd Value:  
Value Percent:  
Continuous Index:  
Within 8" of Joint:  
Remarks:

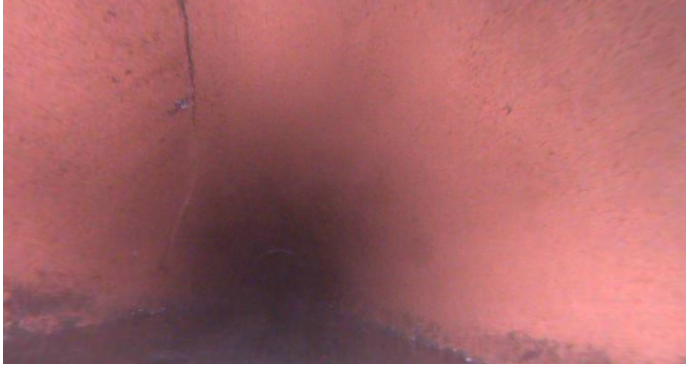
Code: **FS**  
Description: **Fracture Spiral**

Distance (ft): **94.3**  
Structural Grade: **3**  
O&M Grade: **0**  
Clock Start/From: **7**  
Clock To: **12**  
1st Value:  
2nd Value:  
Value Percent:  
Continuous Index:  
Within 8" of Joint:  
Remarks:

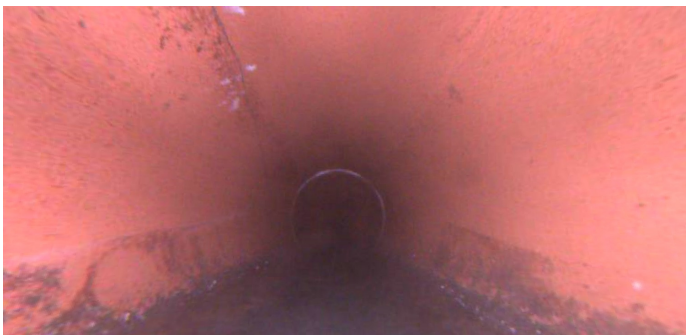
Code: **FM**  
Description: **Fracture Multiple**

Distance (ft): **96.7**  
Structural Grade: **4**  
O&M Grade: **0**  
Clock Start/From: **8**  
Clock To: **4**  
1st Value:  
2nd Value:  
Value Percent:  
Continuous Index:  
Within 8" of Joint:  
Remarks:

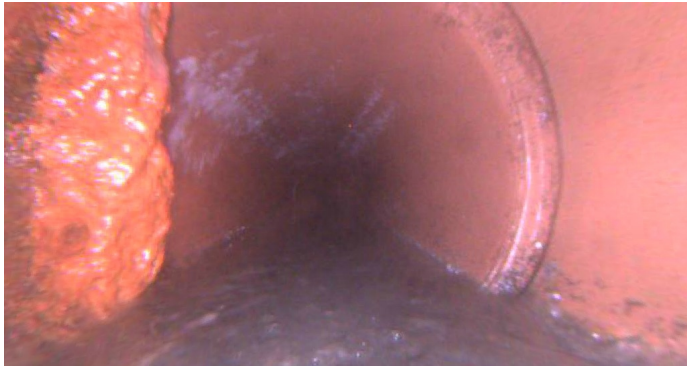
Code:	<b>DAE</b>
Description:	<b>Deposits Attached Encrustation</b>
Distance (ft):	<b>147.9</b>
Structural Grade:	<b>0</b>
O&M Grade:	<b>2</b>
Clock Start/From:	<b>7</b>
Clock To:	<b>11</b>
1st Value:	
2nd Value:	
Value Percent:	<b>5.000</b>
Continuous Index:	
Within 8" of Joint:	<b>YES</b>
Remarks:

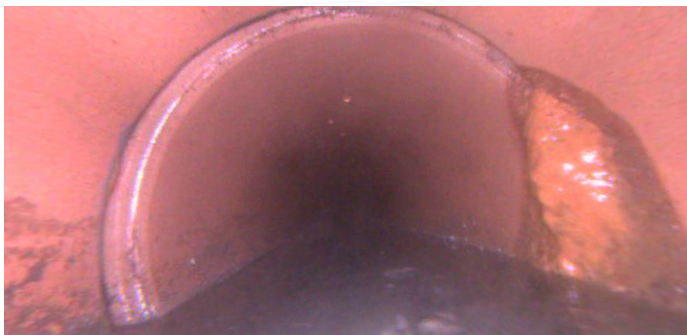
Code:	<b>DAE</b>
Description:	<b>Deposits Attached Encrustation</b>
Distance (ft):	<b>152.8</b>
Structural Grade:	<b>0</b>
O&M Grade:	<b>2</b>
Clock Start/From:	<b>2</b>
Clock To:	<b>3</b>
1st Value:	
2nd Value:	
Value Percent:	<b>5.000</b>
Continuous Index:	
Within 8" of Joint:	<b>YES</b>
Remarks:

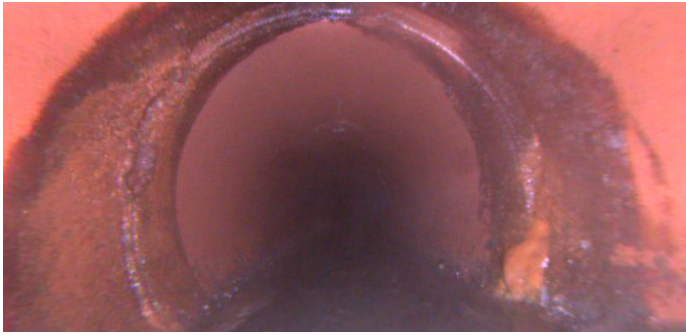
Code: **IW**  
Description: **Infil Weeper**

Distance (ft): **157.7**  
Structural Grade: **0**  
O&M Grade: **2**  
Clock Start/From: **8**  
Clock To: **4**  
1st Value:  
2nd Value:  
Value Percent:  
Continuous Index:  
Within 8" of Joint: **YES**  
Remarks:

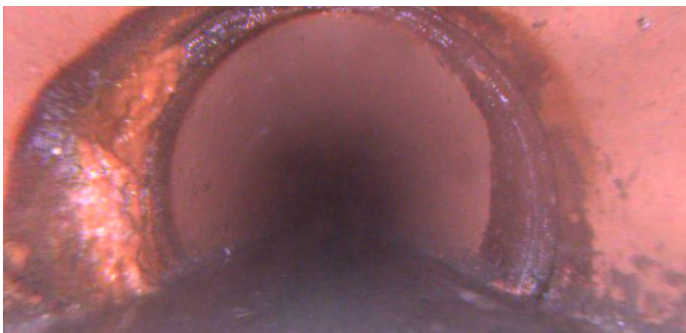
Code: **DAE**  
Description: **Deposits Attached Encrustation**

Distance (ft): **167.7**  
Structural Grade: **0**  
O&M Grade: **2**  
Clock Start/From: **8**  
Clock To: **4**  
1st Value:  
2nd Value:  
Value Percent: **5.000**  
Continuous Index:  
Within 8" of Joint: **YES**  
Remarks:

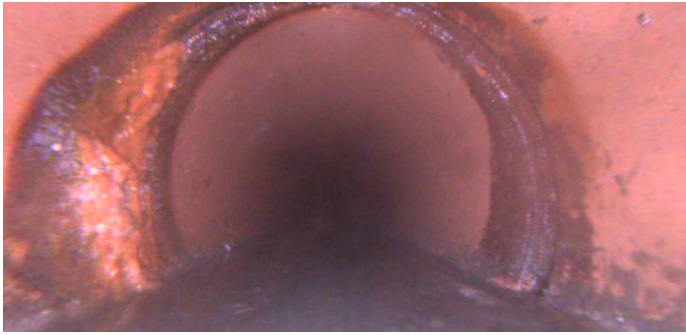
Code: **IW**  
Description: **Infil Weeper**

Distance (ft): **167.7**  
Structural Grade: **0**  
O&M Grade: **2**  
Clock Start/From: **8**  
Clock To: **4**  
1st Value:  
2nd Value:  
Value Percent:  
Continuous Index:  
Within 8" of Joint: **YES**  
Remarks:

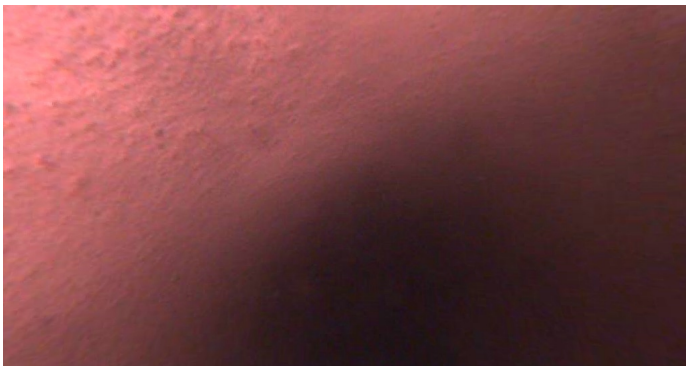
Code: **MSA**  
Description: **Abandoned Survey**

Distance (ft): **173.5**  
Structural Grade: **0**  
O&M Grade: **0**  
Clock Start/From:  
Clock To:  
1st Value:  
2nd Value:  
Value Percent:  
Continuous Index:  
Within 8" of Joint: **NO**  
Remarks: **Debris under water**
