Profile/Photo Observation Report

Date:	10/20/2021	Weather:		Coding:	PACP 7.0
Pipe Length (ft):	146.3	Owner:	City of Hobart	Pre Clean:	Heavy Cleaning
P.O.#:	YES502259	Surveyor:	S. Bucklin	PSR:	P-503-043-053
Customer:	City of Hobart	Clean Date:	08/24/2021	Shape:	C

Street:	North Guyer Street	Flow Control:	Not Controlled
City:	Hobart, IN	Year Renewed:	
Location:	Woods	Tape/Media #:	
Purpose:	Routine Assessment	Dia/Height:	10"
Use:	Sanitary Sewage Pipe	Material:	VCP
Drain Area:		Lining:	None
Category:	NA		
Comment:			
Location Details:		Direction of Survey:	Upstream
US MH:	M-503-043	DS MH:	M-503-053
		Total Length Surveyed (ft):	146.3

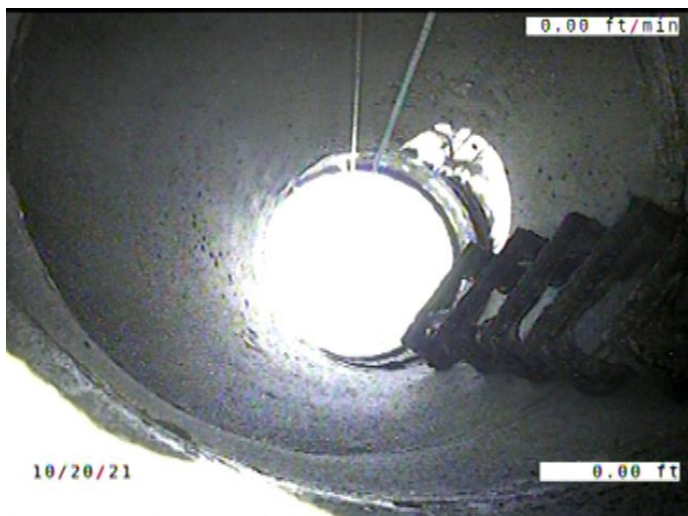
Code: **AMH**
 Description: **Manhole**

Distance (ft): **.0**
 Structural Grade: **0**
 O&M Grade: **0**
 Clock Start/From:
 Clock To:
 1st Value:
 2nd Value:
 Value Percent:
 Continuous Index:
 Within 8" of Joint: **NO**
 Remarks: **M-503-053**

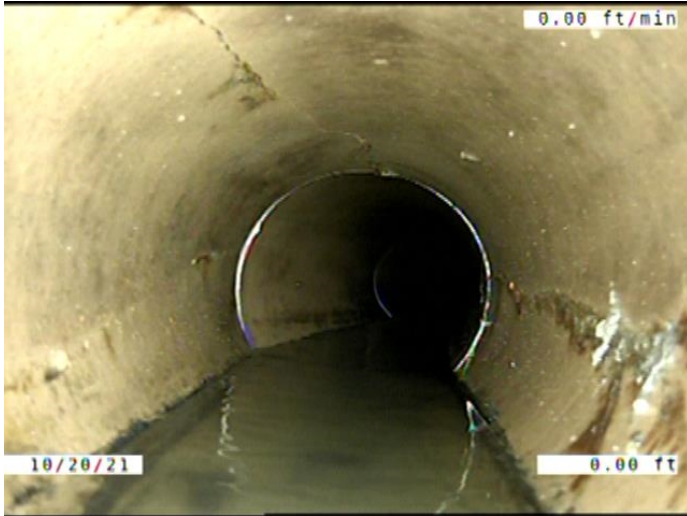
Code: **MWL**
Description: **Miscellaneous Water Level**

Distance (ft): **.0**
Structural Grade: **0**
O&M Grade: **0**
Clock Start/From:
Clock To:
1st Value:
2nd Value:
Value Percent: **5.000**
Continuous Index:
Within 8" of Joint: **NO**
Remarks:

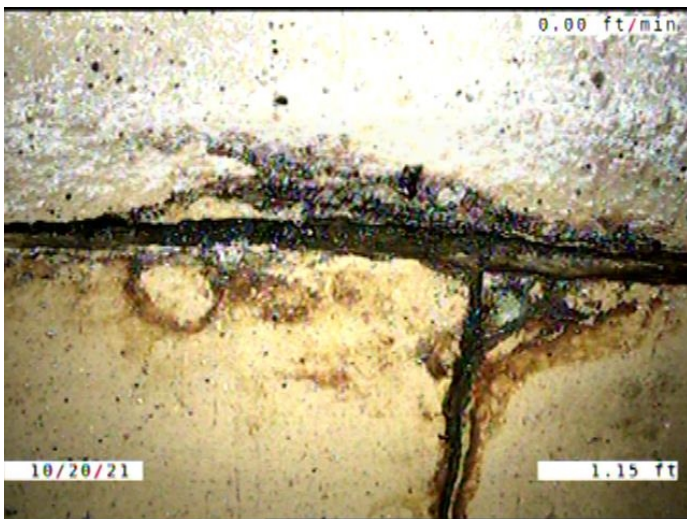
Code: **B**
Description: **Broken**

Distance (ft): **1.1**
Structural Grade: **4**
O&M Grade: **0**
Clock Start/From: **12**
Clock To: **12**
1st Value:
2nd Value:
Value Percent:
Continuous Index:
Within 8" of Joint: **YES**
Remarks:

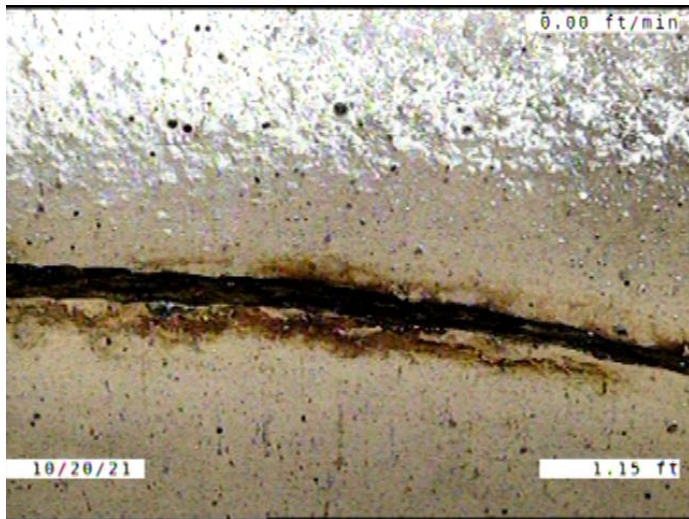
Code: **IRB**
 Description: **Infiltration Runner Barrel**

Distance (ft): **1.1**
 Structural Grade: **0**
 O&M Grade: **4**
 Clock Start/From: **1**
 Clock To:
 1st Value:
 2nd Value:
 Value Percent:
 Continuous Index:
 Within 8" of Joint: **NO**
 Remarks:

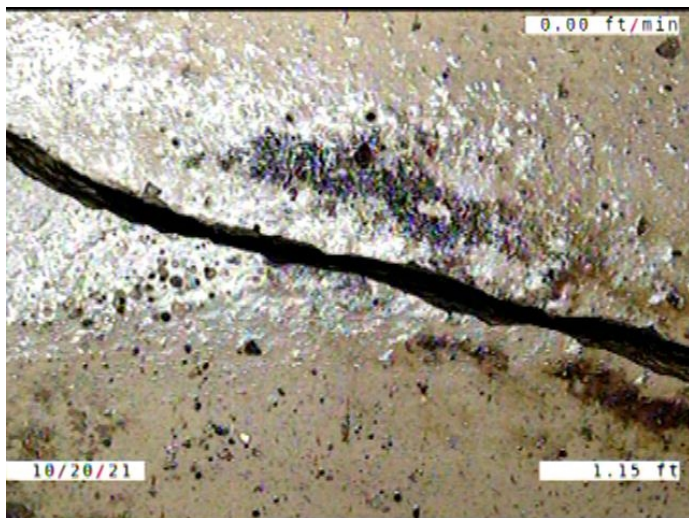
Code: **ISB**
 Description: **Infiltration Stain Barrel**

Distance (ft): **1.1**
 Structural Grade: **0**
 O&M Grade: **1**
 Clock Start/From: **9**
 Clock To: **5**
 1st Value:
 2nd Value:
 Value Percent:
 Continuous Index:
 Within 8" of Joint: **YES**
 Remarks:

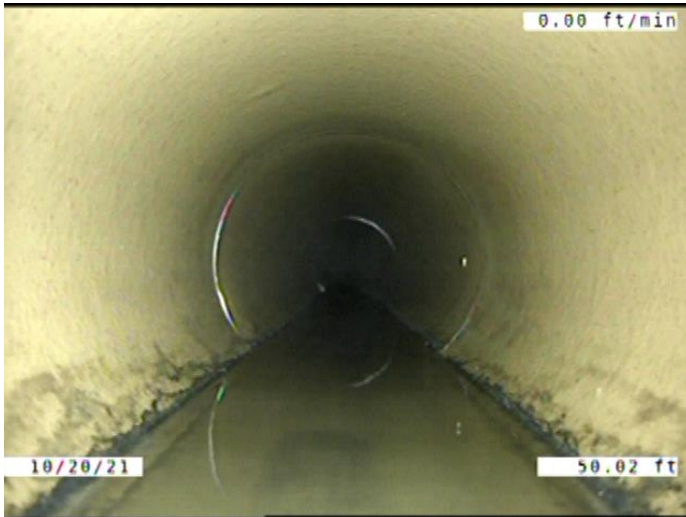
Code: **MWLS**
Description: **Miscellaneous Water Level Sag**

Distance (ft): **50.0**
Structural Grade: **2**
O&M Grade: **0**
Clock Start/From:
Clock To:
1st Value:
2nd Value:
Value Percent: **20.000**
Continuous Index: **S01**
Within 8" of Joint: **NO**
Remarks:

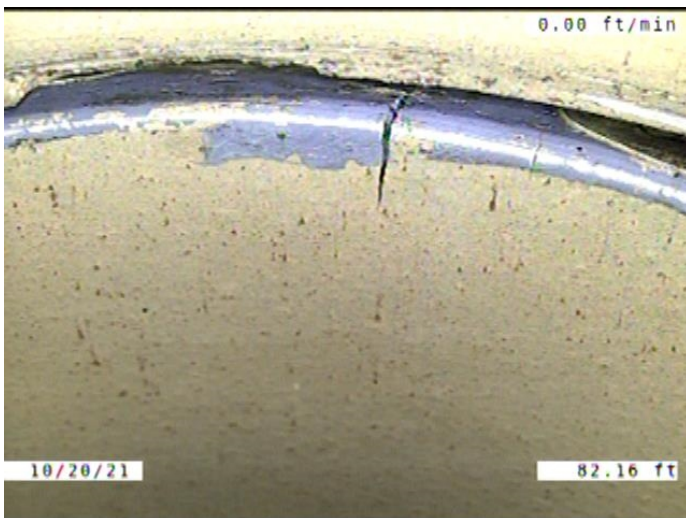
Code: **FL**
Description: **Fracture Longitudinal**

Distance (ft): **82.2**
Structural Grade: **3**
O&M Grade: **0**
Clock Start/From: **2**
Clock To:
1st Value:
2nd Value:
Value Percent:
Continuous Index:
Within 8" of Joint: **YES**
Remarks:

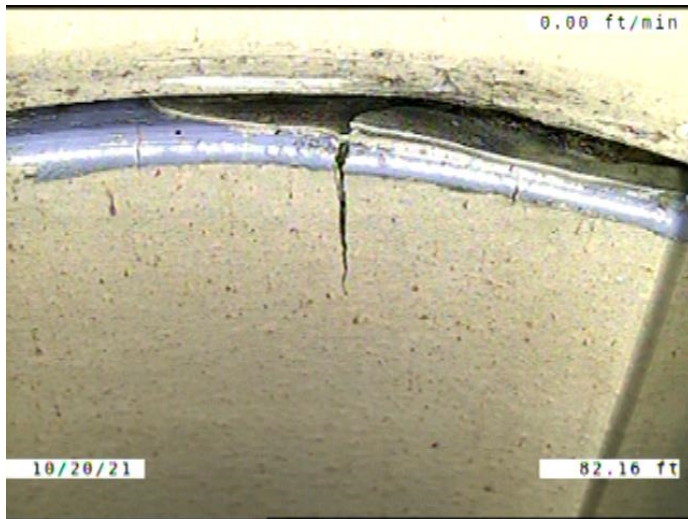
Code: **FL**
Description: **Fracture Longitudinal**

Distance (ft): **82.2**
Structural Grade: **3**
O&M Grade: **0**
Clock Start/From: **3**
Clock To:
1st Value:
2nd Value:
Value Percent:
Continuous Index:
Within 8" of Joint: **YES**
Remarks:

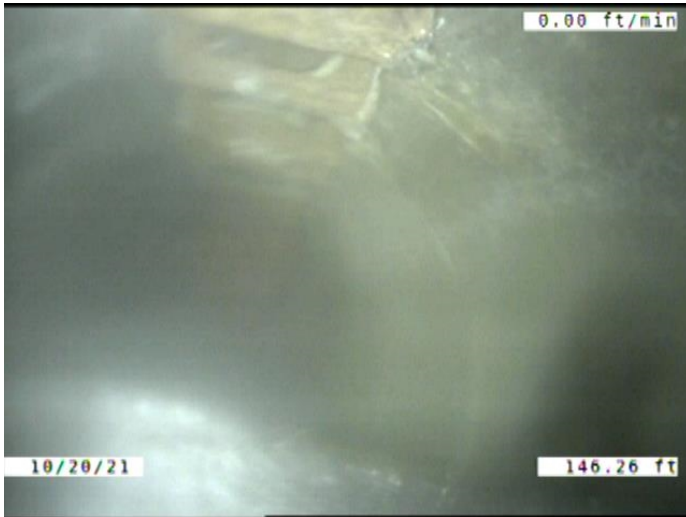
Code: **MWLS**
Description: **Miscellaneous Water Level Sag**

Distance (ft): **146.3**
Structural Grade: **2**
O&M Grade: **0**
Clock Start/From:
Clock To:
1st Value:
2nd Value:
Value Percent: **20.000**
Continuous Index: **F01**
Within 8" of Joint: **NO**
Remarks:

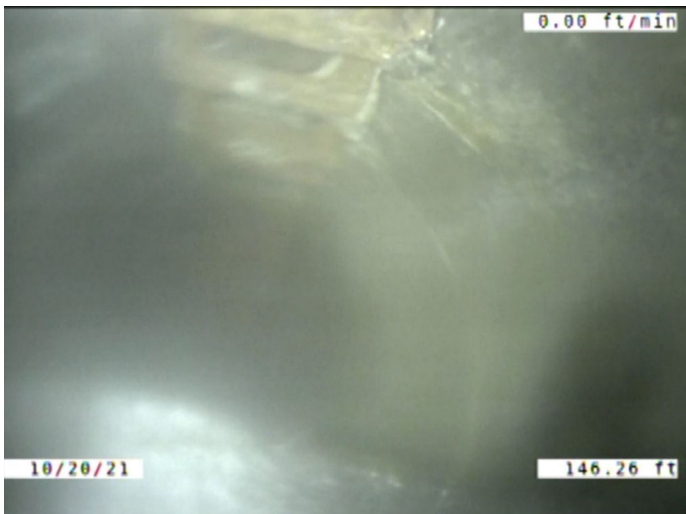
Code: **MCU**
Description: **Miscellaneous Camera Underwater**

Distance (ft): **146.3**
Structural Grade: **0**
O&M Grade: **4**
Clock Start/From:
Clock To:
1st Value:
2nd Value:
Value Percent:
Continuous Index: **F02**
Within 8" of Joint: **NO**
Remarks:

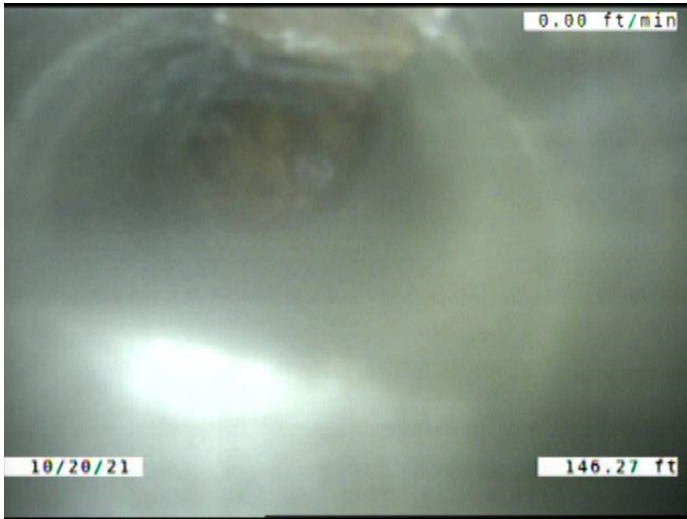
Code:	AMH
Description:	Manhole
Distance (ft):	146.3
Structural Grade:	0
O&M Grade:	0
Clock Start/From:	
Clock To:	
1st Value:	
2nd Value:	
Value Percent:	
Continuous Index:	
Within 8" of Joint:	NO
Remarks:	M-503-043
