Profile/Photo Observation Report

Date:	10/20/2021	Weather:		Coding:	PACP 7.0
Pipe Length (ft):	146.3	Owner:	City of Hobart	Pre Clean:	Heavy Cleaning
P.O.#:	YES502259	Surveyor:	S. Bucklin	PSR:	P-503-043-053
Customer:	City of Hobart	Clean Date:	08/24/2021	Shape:	C

Street:	North Guyer Street	Flow Control:	Not Controlled
City:	Hobart, IN	Year Renewed:	
Location:	Woods	Tape/Media #:	
Purpose:	Routine Assessment	Dia/Height:	10"
Use:	Sanitary Sewage Pipe	Material:	VCP
Drain Area:		Lining:	None
Category:	NA		
Comment:

Location Details:		Direction of Survey:	Upstream
US MH:	M-503-043	DS MH:	M-503-053
		Total Length Surveyed (ft):	146.3

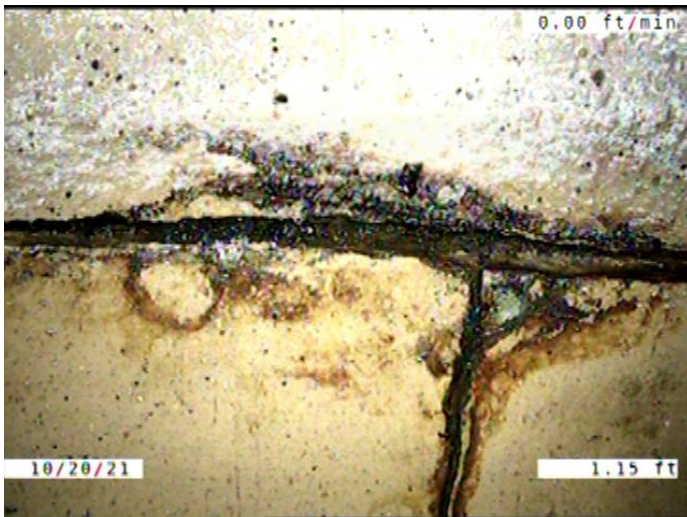
Code: **B**
Description: **Broken**

Distance (ft): **1.1**
Structural Grade: **4**
O&M Grade: **0**
Clock Start/From: **12**
Clock To: **12**
1st Value:
2nd Value:
Value Percent:
Continuous Index:
Within 8" of Joint: **YES**
Remarks:

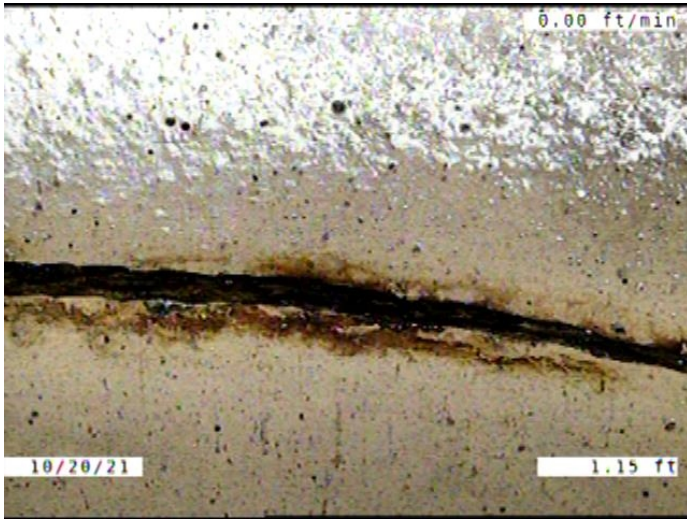
Code: **IRB**
Description: **Infiltration Runner Barrel**

Distance (ft): **1.1**
Structural Grade: **0**
O&M Grade: **4**
Clock Start/From: **1**
Clock To:
1st Value:
2nd Value:
Value Percent:
Continuous Index:
Within 8" of Joint: **NO**
Remarks:

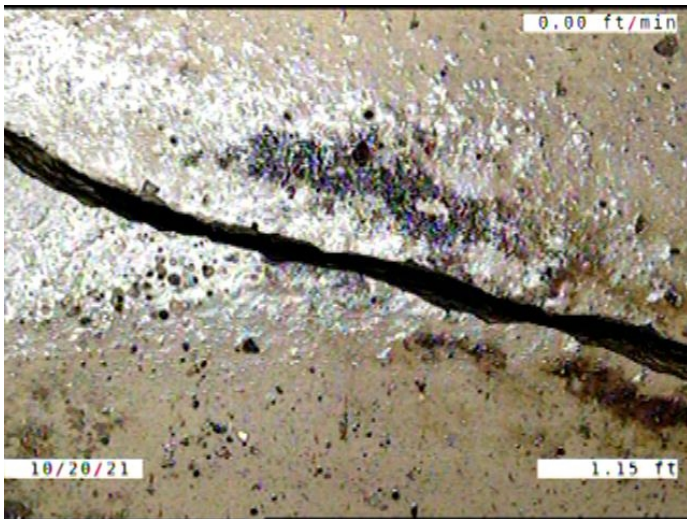
Code: **ISB**
Description: **Infiltration Stain Barrel**

Distance (ft): **1.1**
Structural Grade: **0**
O&M Grade: **1**
Clock Start/From: **9**
Clock To: **5**
1st Value:
2nd Value:
Value Percent:
Continuous Index:
Within 8" of Joint: **YES**
Remarks:

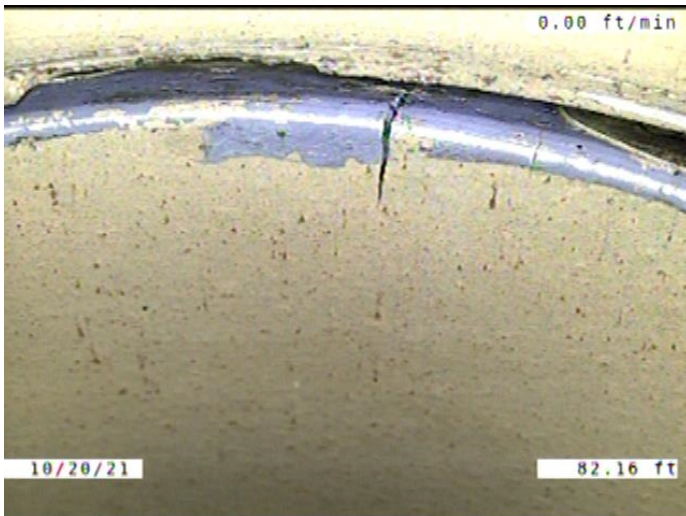
Code: **FL**
 Description: **Fracture Longitudinal**

Distance (ft): **82.2**
 Structural Grade: **3**
 O&M Grade: **0**
 Clock Start/From: **2**
 Clock To:
 1st Value:
 2nd Value:
 Value Percent:
 Continuous Index:
 Within 8" of Joint: **YES**
 Remarks:

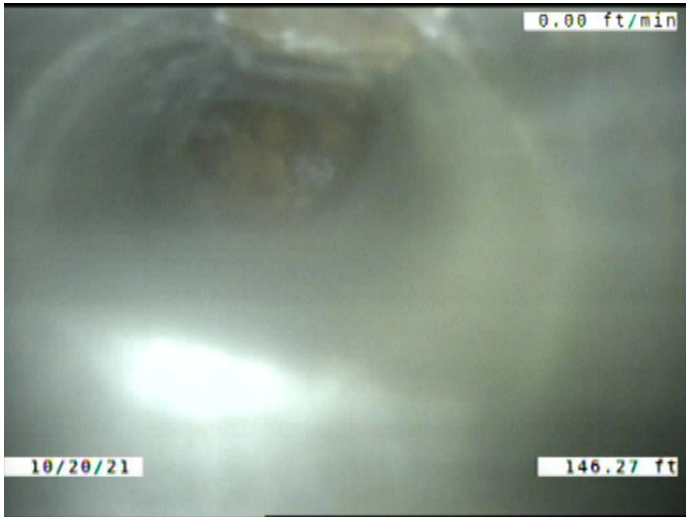
Code:	AMH
Description:	Manhole
Distance (ft):	146.3
Structural Grade:	0
O&M Grade:	0
Clock Start/From:	
Clock To:	
1st Value:	
2nd Value:	
Value Percent:	
Continuous Index:	
Within 8" of Joint:	NO
Remarks:	M-503-043
