## Profile/Photo Observation Report

Date:	<b>04/12/2018</b>	Weather:		Coding:	<b>PACP 6.0</b>
Pipe Length (ft):	<b>276.6</b>	Owner:	<b>NA</b>	Pre Clean:	<b>Not Known</b>
P.O.#:		Surveyor:	<b>Jen Costello</b>	PSR:	<b>P-503-046-045</b>
Customer:		Clean Date:	<b>01/01/1900</b>	Shape:	<b>C</b>

Street:	<b>W 39TH AVE &amp; W 38TH PL</b>	Flow Control:	<b>Not Controlled</b>
City:	<b>Hobart, IN</b>	Year Renewed:	
Location:	<b>Other</b>	Tape/Media #:	
Purpose:	<b>Not Known</b>	Dia/Height:	<b>10"</b>
Use:	<b>Sanitary</b>	Material:	<b>VCP</b>
Drain Area:	<b>NA</b>	Lining:	
Category:	<b>NA</b>		
Comment:

Location Details:		Direction of Survey:	<b>Upstream</b>
US MH:	<b>M-503-045</b>	DS MH:	<b>M-503-046</b>
		Total Length Surveyed (ft):	<b>89.9</b>

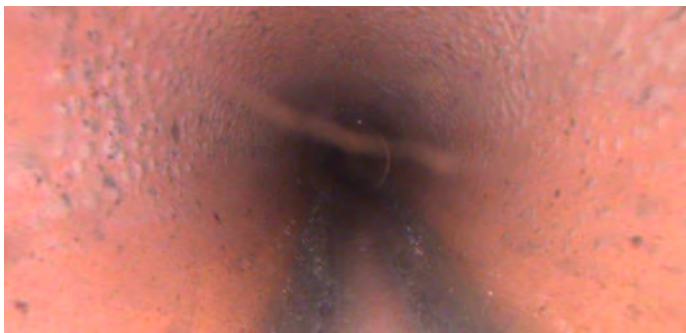
Code: **AMH**  
Description: **Manhole**

Distance (ft): **.0**  
Structural Grade: **0**  
O&M Grade: **0**  
Clock Start/From:  
Clock To:  
1st Value:  
2nd Value:  
Value Percent:  
Continuous Index:  
Within 8" of Joint: **NO**  
Remarks: **M-503-045**

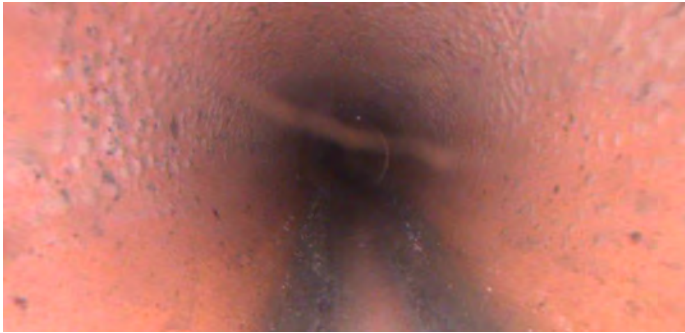
Code:	<b>MWL</b>
Description:	<b>Water Level</b>

Distance (ft):	<b>.0</b>
Structural Grade:	<b>0</b>
O&M Grade:	<b>0</b>
Clock Start/From:	
Clock To:	
1st Value:	
2nd Value:	
Value Percent:	<b>5.000</b>
Continuous Index:	
Within 8" of Joint:	<b>NO</b>
Remarks:

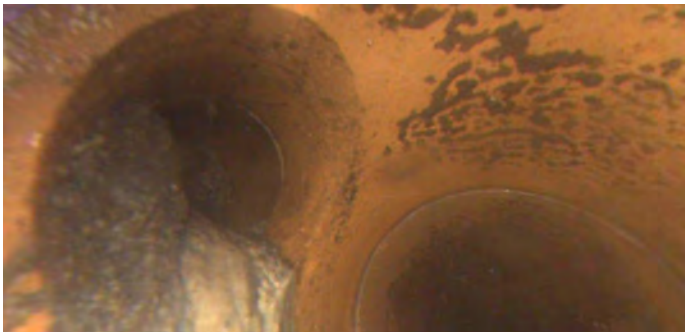
Code:	<b>TFD</b>
Description:	<b>Tap Factory Defective</b>

Distance (ft):	<b>11.3</b>
Structural Grade:	<b>0</b>
O&M Grade:	<b>2</b>
Clock Start/From:	<b>2</b>
Clock To:	
1st Value:	<b>4.000</b>
2nd Value:	
Value Percent:	
Continuous Index:	
Within 8" of Joint:	
Remarks:	<b>dae</b>

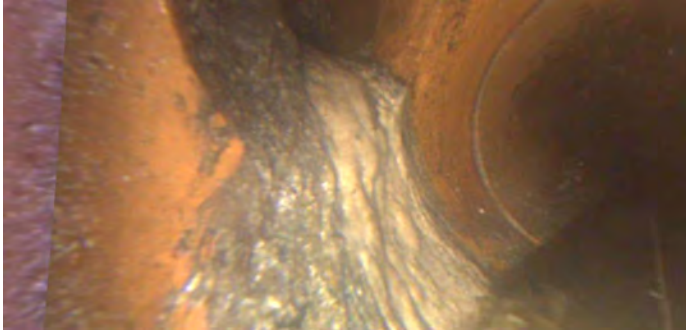
Code: **DAE**  
Description: **Deposits Attached Encrustation**

Distance (ft): **11.3**  
Structural Grade: **0**  
O&M Grade: **2**  
Clock Start/From: **2**  
Clock To: **4**  
1st Value:  
2nd Value:  
Value Percent: **5.000**  
Continuous Index:  
Within 8" of Joint: **NO**  
Remarks:

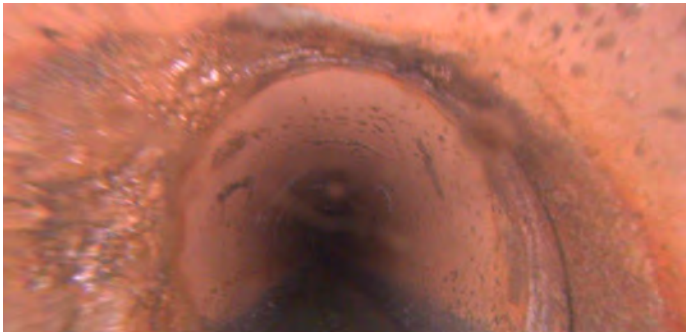
Code: **DAE**  
Description: **Deposits Attached Encrustation**

Distance (ft): **22.2**  
Structural Grade: **0**  
O&M Grade: **2**  
Clock Start/From: **8**  
Clock To: **4**  
1st Value:  
2nd Value:  
Value Percent: **5.000**  
Continuous Index: **S01**  
Within 8" of Joint: **YES**  
Remarks:

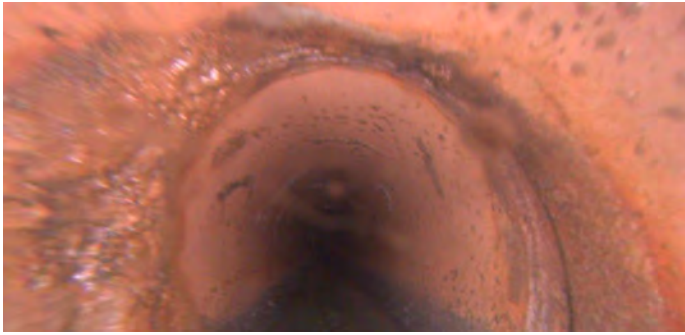
Code: **IW**  
Description: **Infil Weeper**

Distance (ft): **22.2**  
Structural Grade: **0**  
O&M Grade: **2**  
Clock Start/From: **8**  
Clock To: **4**  
1st Value:  
2nd Value:  
Value Percent:  
Continuous Index: **S02**  
Within 8" of Joint: **YES**  
Remarks:

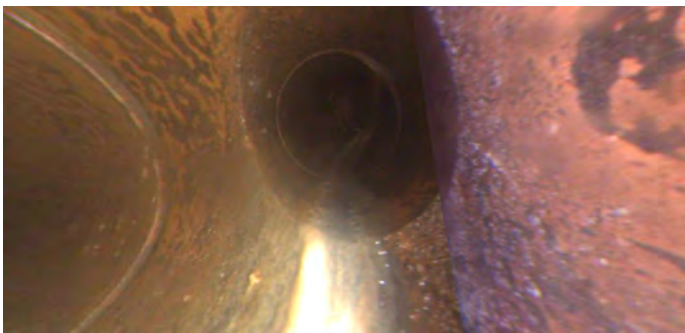
Code: **TFA**  
Description: **Tap Factory Active**

Distance (ft): **33.9**  
Structural Grade: **0**  
O&M Grade: **0**  
Clock Start/From: **2**  
Clock To:  
1st Value: **4.000**  
2nd Value:  
Value Percent:  
Continuous Index:  
Within 8" of Joint:  
Remarks:

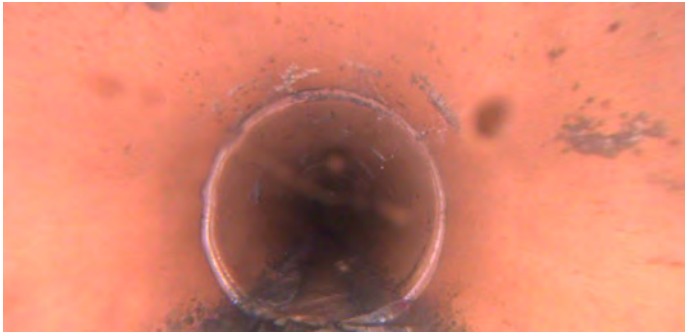
Code: **IW**  
Description: **Infil Weeper**

Distance (ft): **55.0**  
Structural Grade: **0**  
O&M Grade: **2**  
Clock Start/From: **8**  
Clock To: **4**  
1st Value:  
2nd Value:  
Value Percent:  
Continuous Index: **F02**  
Within 8" of Joint: **YES**  
Remarks:

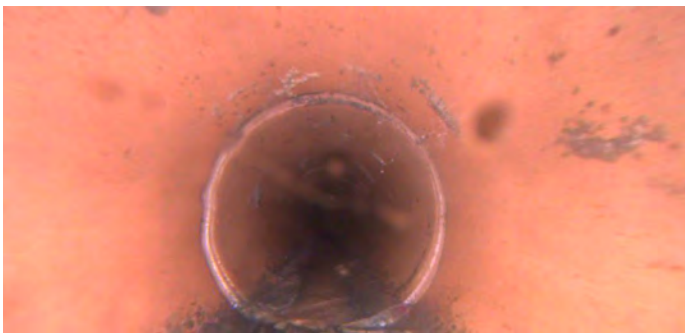
Code: **DAE**  
Description: **Deposits Attached Encrustation**

Distance (ft): **55.0**  
Structural Grade: **0**  
O&M Grade: **2**  
Clock Start/From: **8**  
Clock To: **4**  
1st Value:  
2nd Value:  
Value Percent: **5.000**  
Continuous Index: **F01**  
Within 8" of Joint: **YES**  
Remarks:

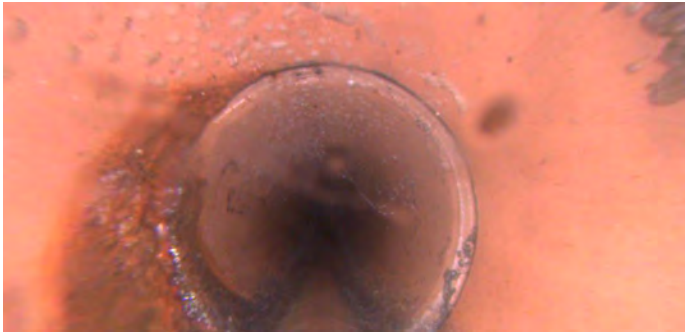
Code: **DAE**  
Description: **Deposits Attached Encrustation**

Distance (ft): **60.3**  
Structural Grade: **0**  
O&M Grade: **2**  
Clock Start/From: **7**  
Clock To: **11**  
1st Value:  
2nd Value:  
Value Percent: **5.000**  
Continuous Index:  
Within 8" of Joint: **YES**  
Remarks:

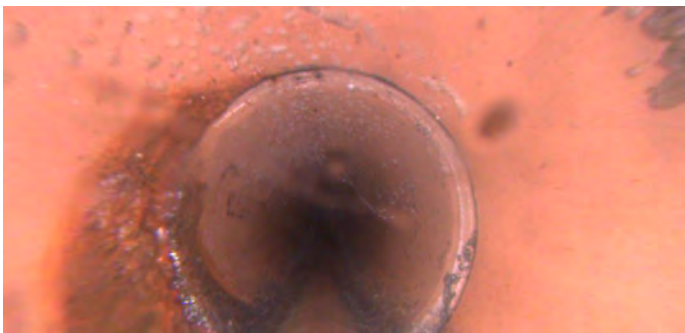
Code: **IW**  
Description: **Infil Weeper**

Distance (ft): **60.3**  
Structural Grade: **0**  
O&M Grade: **2**  
Clock Start/From: **7**  
Clock To: **11**  
1st Value:  
2nd Value:  
Value Percent:  
Continuous Index:  
Within 8" of Joint: **YES**  
Remarks:

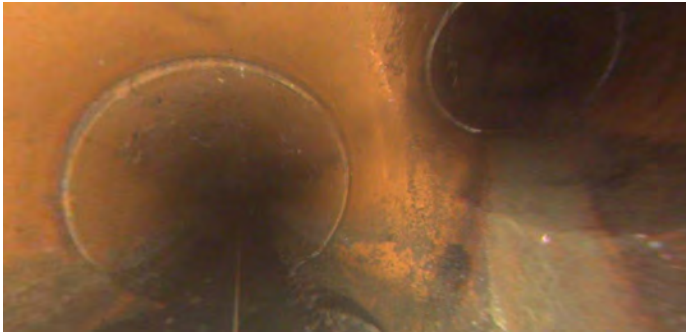
Code: **TFA**  
Description: **Tap Factory Active**

Distance (ft): **82.6**  
Structural Grade: **0**  
O&M Grade: **0**  
Clock Start/From: **9**  
Clock To:  
1st Value: **4.000**  
2nd Value:  
Value Percent:  
Continuous Index:  
Within 8" of Joint:  
Remarks:

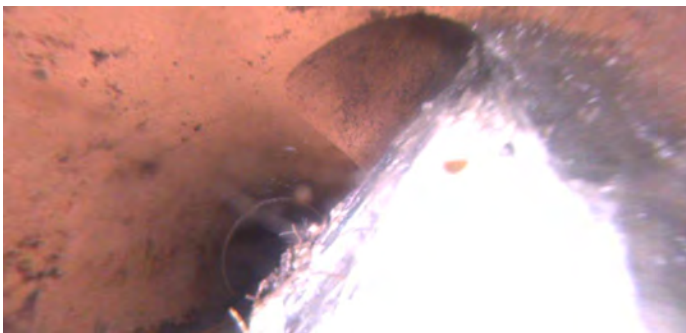
Code: **TFD**  
Description: **Tap Factory Defective**

Distance (ft): **89.0**  
Structural Grade: **0**  
O&M Grade: **2**  
Clock Start/From: **1**  
Clock To:  
1st Value: **4.000**  
2nd Value:  
Value Percent:  
Continuous Index:  
Within 8" of Joint:  
Remarks: **roots**

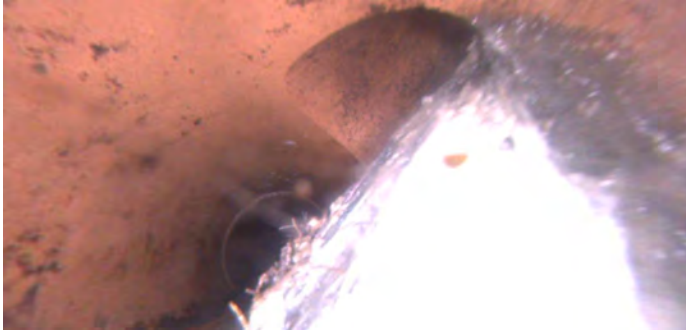
Code: **RML**  
Description: **Roots Medium Lateral**

Distance (ft): **89.0**  
Structural Grade: **0**  
O&M Grade: **3**  
Clock Start/From: **1**  
Clock To: **6**  
1st Value:  
2nd Value:  
Value Percent: **40.000**  
Continuous Index:  
Within 8" of Joint: **NO**  
Remarks:

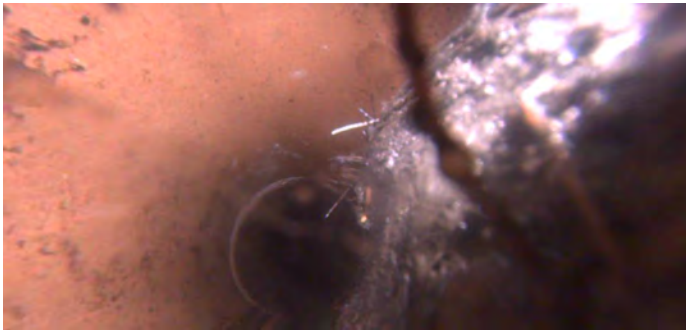
Code: **MSA**  
Description: **Abandoned Survey**

Distance (ft): **89.9**  
Structural Grade: **0**  
O&M Grade: **0**  
Clock Start/From:  
Clock To:  
1st Value:  
2nd Value:  
Value Percent:  
Continuous Index:  
Within 8" of Joint: **NO**  
Remarks: **roots**
