Profile/Photo Observation Report

Date:	04/12/2018	Weather:		Coding:	PACP 6.0
Pipe Length (ft):	276.6	Owner:	NA	Pre Clean:	Not Known
P.O.#:		Surveyor:	Jen Costello	PSR:	P-503-046-045
Customer:		Clean Date:	01/01/1900	Shape:	C

Street:	W 40th ave	Flow Control:	Not Controlled
City:	Hobart, IN	Year Renewed:	
Location:	Other	Tape/Media #:	
Purpose:	Not Known	Dia/Height:	10"
Use:	Sanitary	Material:	VCP
Drain Area:	NA	Lining:	
Category:	NA		
Comment:

Location Details:		Direction of Survey:	Upstream
US MH:	M-503-045	DS MH:	M-503-046
		Total Length Surveyed (ft):	89.9

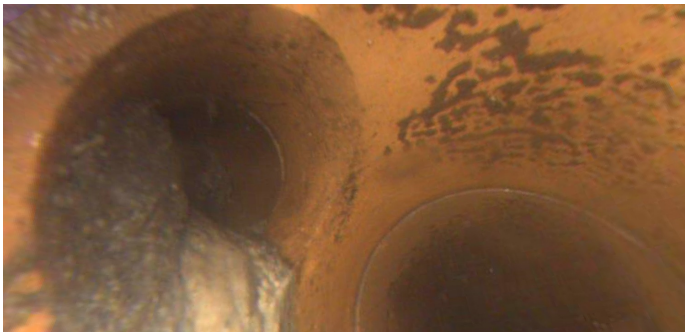
Code:	TFD
Description:	Tap Factory Defective

Distance (ft):	11.3
Structural Grade:	0
O&M Grade:	2
Clock Start/From:	2
Clock To:	
1st Value:	4.000
2nd Value:	
Value Percent:	
Continuous Index:	
Within 8" of Joint:	
Remarks:	dae

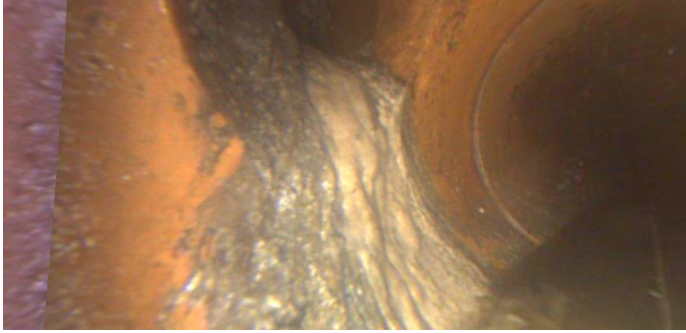
Code: **DAE**
Description: **Deposits Attached Encrustation**

Distance (ft): **11.3**
Structural Grade: **0**
O&M Grade: **2**
Clock Start/From: **2**
Clock To: **4**
1st Value:
2nd Value:
Value Percent: **5.000**
Continuous Index:
Within 8" of Joint: **NO**
Remarks:

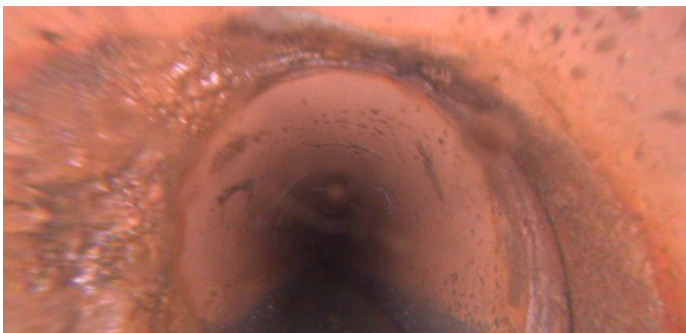
Code: **DAE**
Description: **Deposits Attached Encrustation**

Distance (ft): **22.2**
Structural Grade: **0**
O&M Grade: **2**
Clock Start/From: **8**
Clock To: **4**
1st Value:
2nd Value:
Value Percent: **5.000**
Continuous Index: **S01**
Within 8" of Joint: **YES**
Remarks:

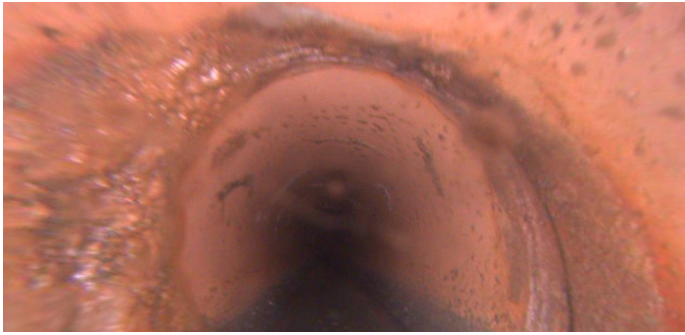
Code: **IW**
Description: **Infil Weeper**

Distance (ft): **22.2**
Structural Grade: **0**
O&M Grade: **2**
Clock Start/From: **8**
Clock To: **4**
1st Value:
2nd Value:
Value Percent:
Continuous Index: **S02**
Within 8" of Joint: **YES**
Remarks:

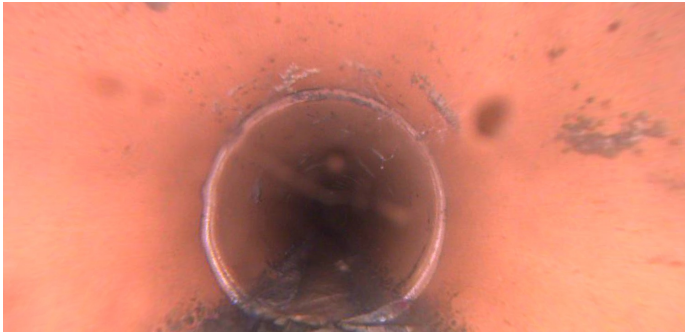
Code: **IW**
Description: **Infil Weeper**

Distance (ft): **55.0**
Structural Grade: **0**
O&M Grade: **2**
Clock Start/From: **8**
Clock To: **4**
1st Value:
2nd Value:
Value Percent:
Continuous Index: **F02**
Within 8" of Joint: **YES**
Remarks:

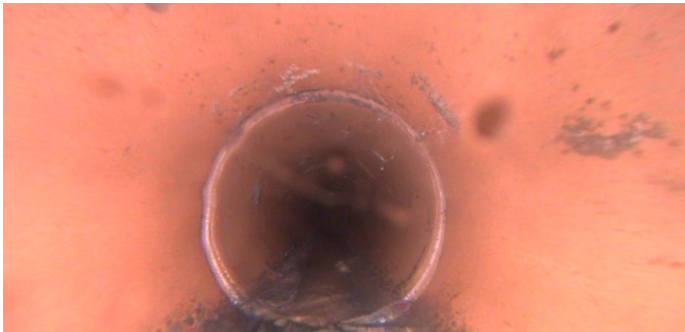
Code: **DAE**
Description: **Deposits Attached Encrustation**

Distance (ft): **55.0**
Structural Grade: **0**
O&M Grade: **2**
Clock Start/From: **8**
Clock To: **4**
1st Value:
2nd Value:
Value Percent: **5.000**
Continuous Index: **F01**
Within 8" of Joint: **YES**
Remarks:

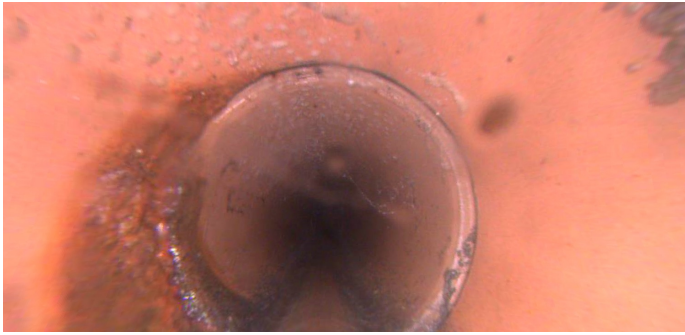
Code: **DAE**
Description: **Deposits Attached Encrustation**

Distance (ft): **60.3**
Structural Grade: **0**
O&M Grade: **2**
Clock Start/From: **7**
Clock To: **11**
1st Value:
2nd Value:
Value Percent: **5.000**
Continuous Index:
Within 8" of Joint: **YES**
Remarks:

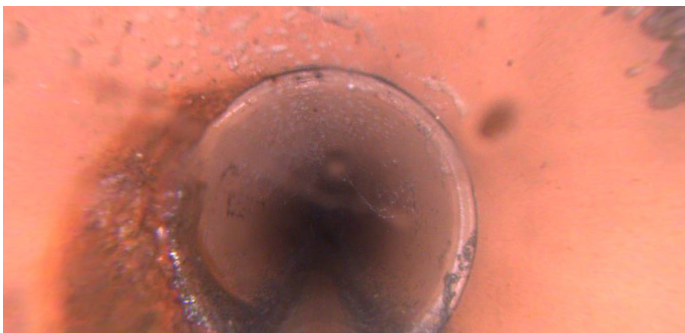
Code: **IW**
Description: **Infil Weeper**

Distance (ft): **60.3**
Structural Grade: **0**
O&M Grade: **2**
Clock Start/From: **7**
Clock To: **11**
1st Value:
2nd Value:
Value Percent:
Continuous Index:
Within 8" of Joint: **YES**
Remarks:

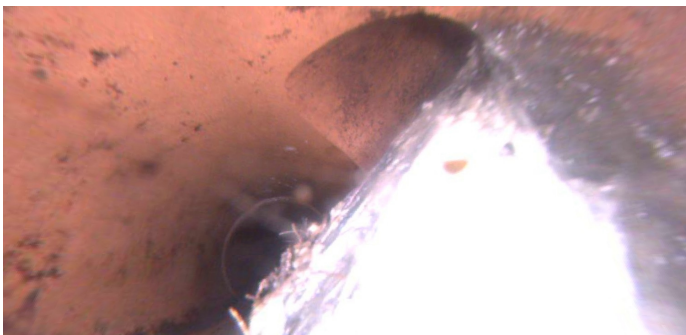
Code: **TFD**
Description: **Tap Factory Defective**

Distance (ft): **89.0**
Structural Grade: **0**
O&M Grade: **2**
Clock Start/From: **1**
Clock To:
1st Value: **4.000**
2nd Value:
Value Percent:
Continuous Index:
Within 8" of Joint:
Remarks: **roots**

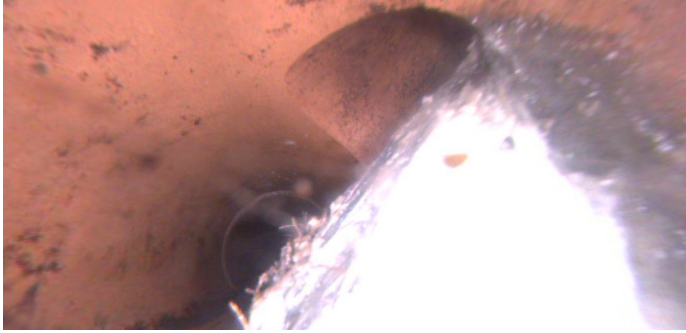
Code: **RML**
Description: **Roots Medium Lateral**

Distance (ft): **89.0**
Structural Grade: **0**
O&M Grade: **3**
Clock Start/From: **1**
Clock To: **6**
1st Value:
2nd Value:
Value Percent: **40.000**
Continuous Index:
Within 8" of Joint: **NO**
Remarks:

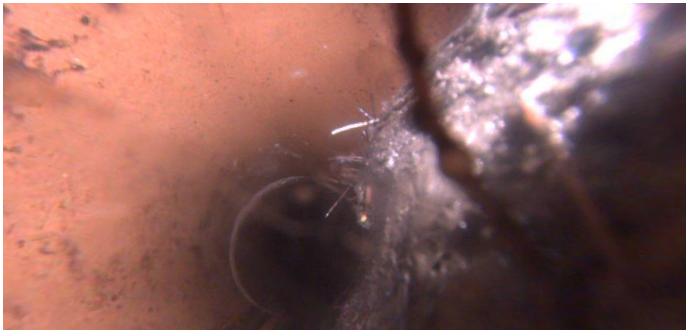
Code: **MSA**
Description: **Abandoned Survey**

Distance (ft): **89.9**
Structural Grade: **0**
O&M Grade: **0**
Clock Start/From:
Clock To:
1st Value:
2nd Value:
Value Percent:
Continuous Index:
Within 8" of Joint: **NO**
Remarks: **roots**
