## Profile/Photo Observation Report

Street:	<b>W 39TH AVE &amp; W 38TH PL</b>	Flow Control:	<b>Not Controlled</b>
City:	<b>Hobart, IN</b>	Year Renewed:	
Location:	<b>Other</b>	Tape/Media #:	
Purpose:	<b>Not Known</b>	Dia/Height:	<b>10"</b>
Use:	<b>Sanitary</b>	Material:	<b>VCP</b>
Drain Area:	<b>NA</b>	Lining:	
Category:	<b>NA</b>		
Comment:

Location Details:		Direction of Survey:	<b>Upstream</b>
US MH:	<b>M-503-046</b>	DS MH:	<b>M-503-047</b>
		Total Length Surveyed (ft):	<b>29.1</b>

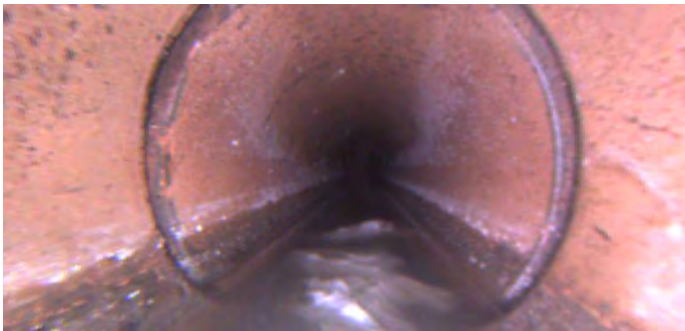
Code: **AMH**  
Description: **Manhole**

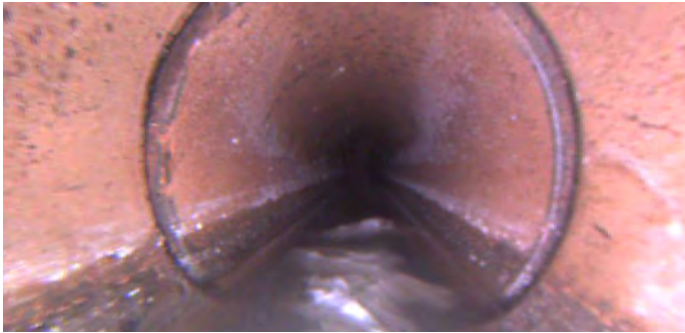
Code:	<b>MWL</b>
Description:	<b>Water Level</b>

Distance (ft):	<b>.0</b>
Structural Grade:	<b>0</b>
O&M Grade:	<b>0</b>
Clock Start/From:	
Clock To:	
1st Value:	
2nd Value:	
Value Percent:	<b>5.000</b>
Continuous Index:	
Within 8" of Joint:	<b>NO</b>
Remarks:

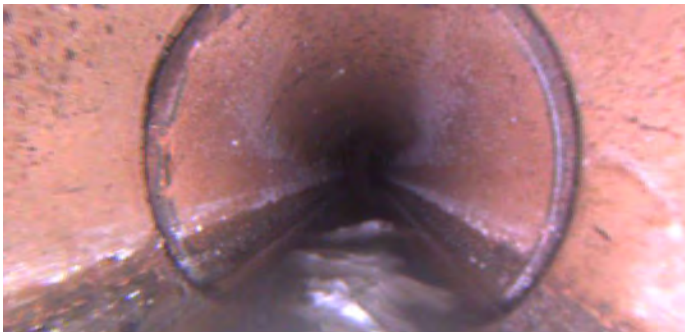
Code:	<b>DSZ</b>
Description:	<b>Deposits Settled Other</b>

Distance (ft):	<b>.0</b>
Structural Grade:	<b>0</b>
O&M Grade:	<b>2</b>
Clock Start/From:	<b>6</b>
Clock To:	
1st Value:	
2nd Value:	
Value Percent:	<b>5.000</b>
Continuous Index:	
Within 8" of Joint:	<b>NO</b>
Remarks:	<b>tissue</b>

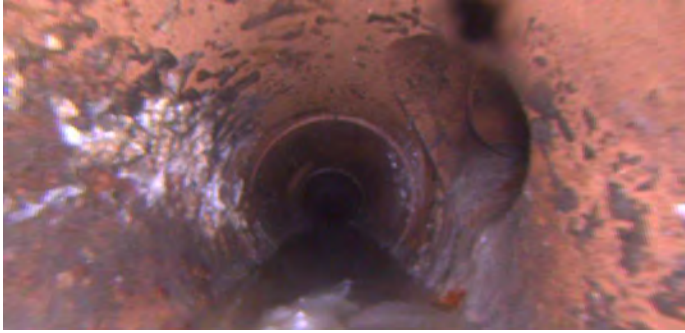
Code: **TF**  
Description: **Tap Factory**

Distance (ft): **7.4**  
Structural Grade: **0**  
O&M Grade: **0**  
Clock Start/From: **2**  
Clock To:  
1st Value: **4.000**  
2nd Value:  
Value Percent:  
Continuous Index:  
Within 8" of Joint: **YES**  
Remarks:

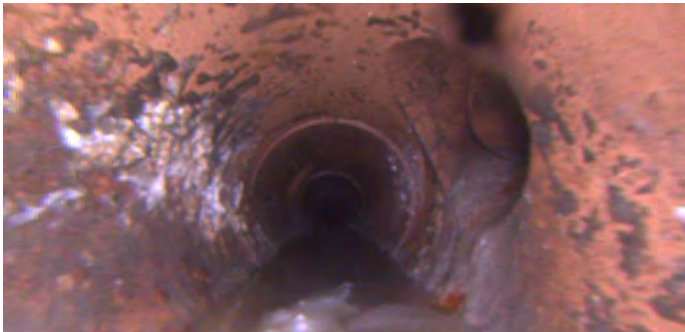
Code: **DAZ**  
Description: **Deposits Attached Other**

Distance (ft): **7.4**  
Structural Grade: **0**  
O&M Grade: **2**  
Clock Start/From: **7**  
Clock To: **10**  
1st Value:  
2nd Value:  
Value Percent: **5.000**  
Continuous Index:  
Within 8" of Joint: **NO**  
Remarks: **tissue**

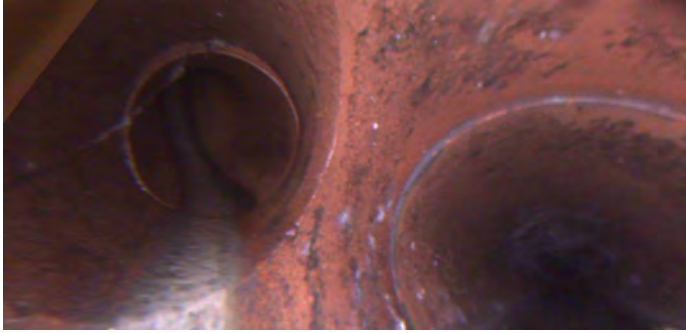
Code: **TF**  
Description: **Tap Factory**

Distance (ft): **9.9**  
Structural Grade: **0**  
O&M Grade: **0**  
Clock Start/From: **10**  
Clock To:  
1st Value: **4.000**  
2nd Value:  
Value Percent:  
Continuous Index:  
Within 8" of Joint: **YES**  
Remarks:

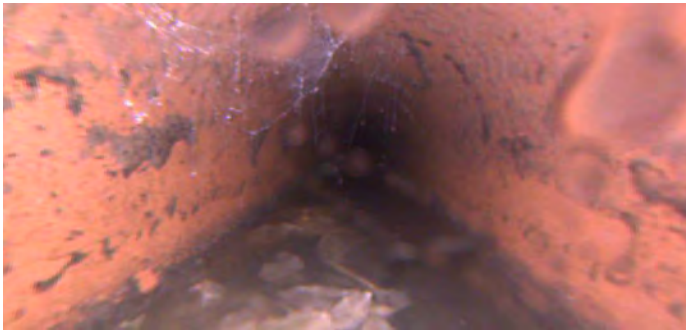
Code: **DSZ**  
Description: **Deposits Settled Other**

Distance (ft): **22.2**  
Structural Grade: **0**  
O&M Grade: **2**  
Clock Start/From: **6**  
Clock To:  
1st Value:  
2nd Value:  
Value Percent: **5.000**  
Continuous Index: **S01**  
Within 8" of Joint: **NO**  
Remarks: **tissue**

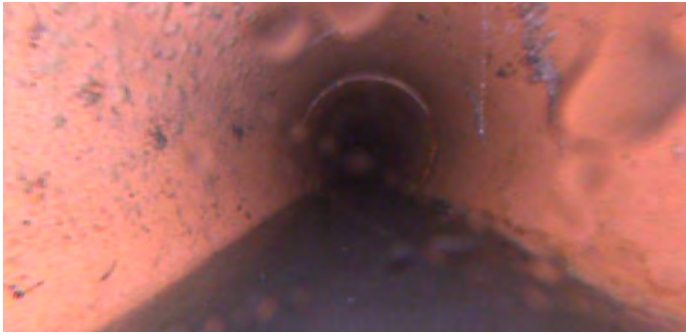
Code: **MSA**  
Description: **Abandoned Survey**

Distance (ft): **29.1**  
Structural Grade: **0**  
O&M Grade: **0**  
Clock Start/From:  
Clock To:  
1st Value:  
2nd Value:  
Value Percent:  
Continuous Index:  
Within 8" of Joint: **NO**  
Remarks: **no blockage**

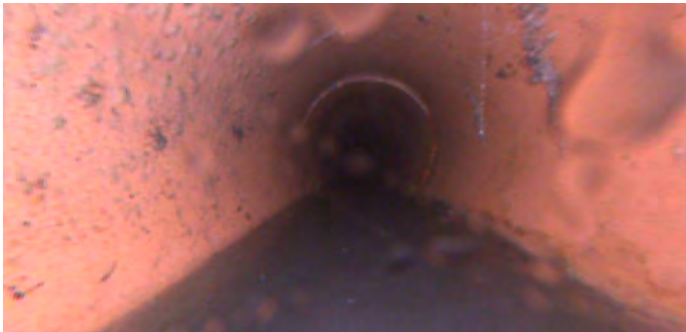
Code: **DSZ**  
Description: **Deposits Settled Other**

Distance (ft): **29.1**  
Structural Grade: **0**  
O&M Grade: **2**  
Clock Start/From: **6**  
Clock To:  
1st Value:  
2nd Value:  
Value Percent: **5.000**  
Continuous Index: **F01**  
Within 8" of Joint: **NO**  
Remarks: **tissue**
