Profile/Photo Observation Report

Street:	W 39TH AVE & W 38TH PL	Flow Control:	Not Controlled
City:	Hobart, IN	Year Renewed:	
Location:	Other	Tape/Media #:	
Purpose:	Not Known	Dia/Height:	10"
Use:	Sanitary	Material:	VCP
Drain Area:	NA	Lining:	
Category:	NA		
Comment:

Location Details:		Direction of Survey:	Downstream
US MH:	M-503-046	DS MH:	M-503-047
		Total Length Surveyed (ft):	196.7

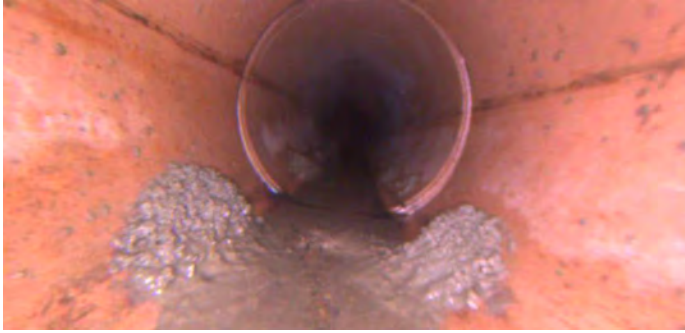
Code: **DSF**
Description: **Deposits Settled Fine**

Distance (ft): **.0**
Structural Grade: **0**
O&M Grade: **2**
Clock Start/From: **5**
Clock To: **7**
1st Value:
2nd Value:
Value Percent: **5.000**
Continuous Index:
Within 8" of Joint: **NO**
Remarks:

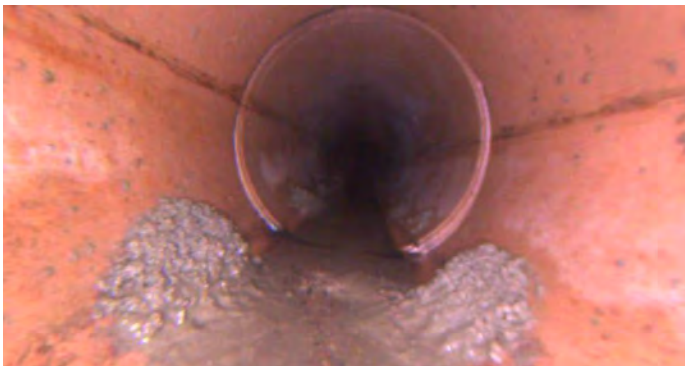
Code: **AMH**
Description: **Manhole**

Distance (ft): **.0**
Structural Grade: **0**
O&M Grade: **0**
Clock Start/From:
Clock To:
1st Value:
2nd Value:
Value Percent:
Continuous Index:
Within 8" of Joint: **NO**
Remarks: **M-503-046**

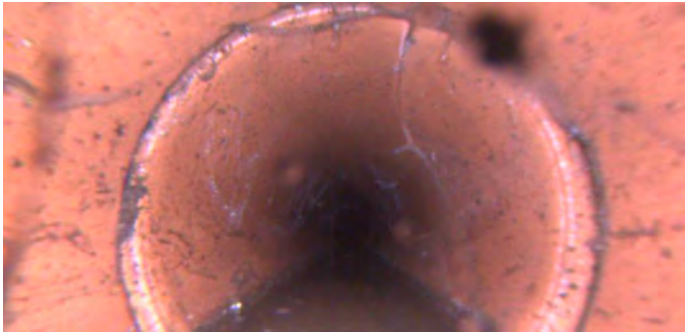
Code: **FS**
Description: **Fracture Spiral**

Distance (ft): **55.2**
Structural Grade: **3**
O&M Grade: **0**
Clock Start/From: **1**
Clock To: **2**
1st Value:
2nd Value:
Value Percent:
Continuous Index:
Within 8" of Joint: **YES**
Remarks:

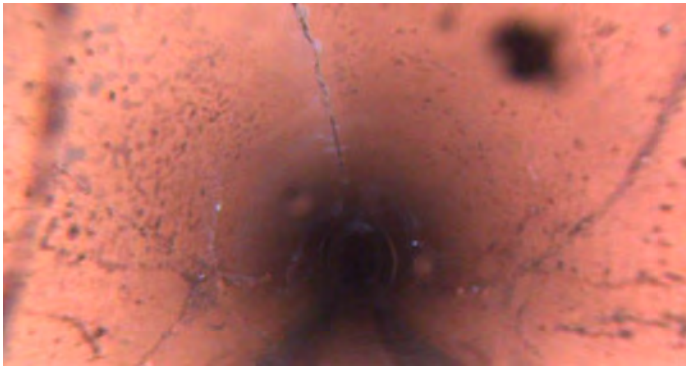
Code: **FM**
Description: **Fracture Multiple**

Distance (ft): **79.7**
Structural Grade: **4**
O&M Grade: **0**
Clock Start/From: **11**
Clock To: **5**
1st Value:
2nd Value:
Value Percent:
Continuous Index:
Within 8" of Joint: **YES**
Remarks:

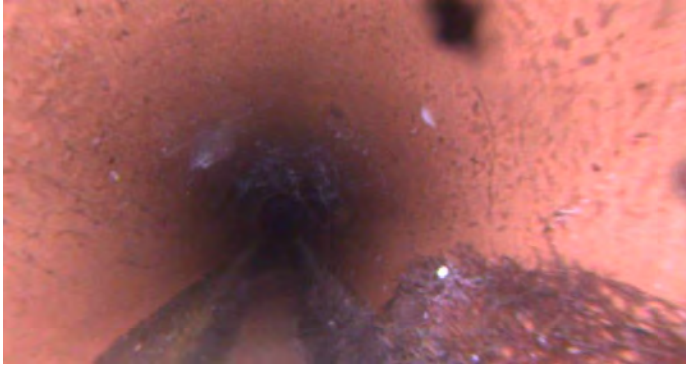
Code: **RFJ**
Description: **Roots Fine Joint**

Distance (ft): **115.0**
Structural Grade: **0**
O&M Grade: **1**
Clock Start/From: **4**
Clock To: **5**
1st Value:
2nd Value:
Value Percent:
Continuous Index:
Within 8" of Joint: **YES**
Remarks:

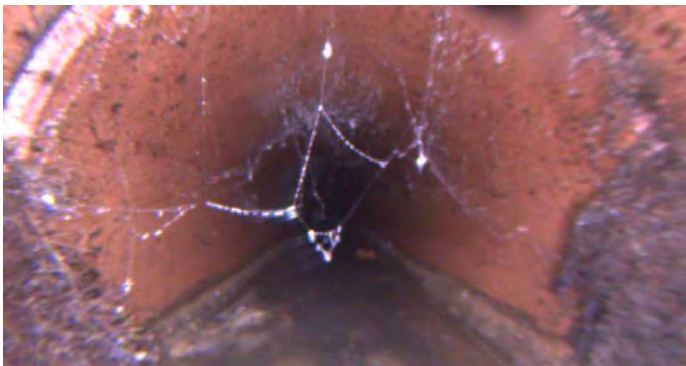
Code: **RMJ**
Description: **Roots Medium Joint**

Distance (ft): **129.5**
Structural Grade: **0**
O&M Grade: **3**
Clock Start/From: **7**
Clock To: **5**
1st Value:
2nd Value:
Value Percent: **5.000**
Continuous Index:
Within 8" of Joint: **YES**
Remarks:

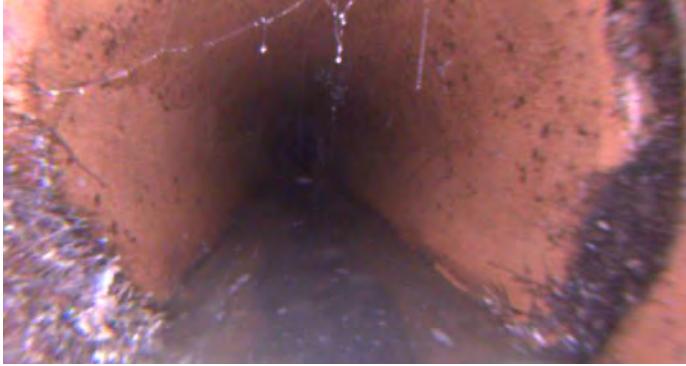
Code: **RMJ**
Description: **Roots Medium Joint**

Distance (ft): **139.5**
Structural Grade: **0**
O&M Grade: **3**
Clock Start/From: **7**
Clock To: **5**
1st Value:
2nd Value:
Value Percent: **5.000**
Continuous Index: **S01**
Within 8" of Joint: **YES**
Remarks:

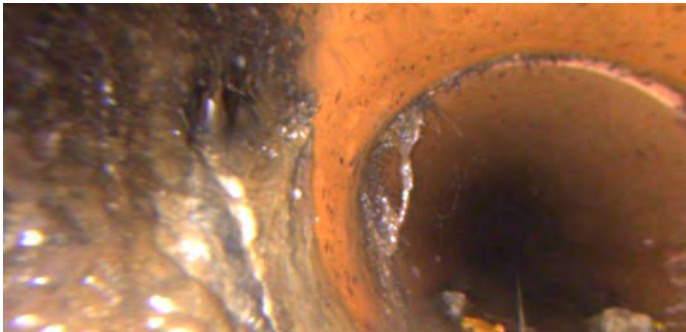
Code: **RFL**
Description: **Roots Fine Lateral**

Distance (ft): **145.8**
Structural Grade: **0**
O&M Grade: **1**
Clock Start/From: **2**
Clock To:
1st Value:
2nd Value:
Value Percent:
Continuous Index:
Within 8" of Joint: **NO**
Remarks: **ROOTS**

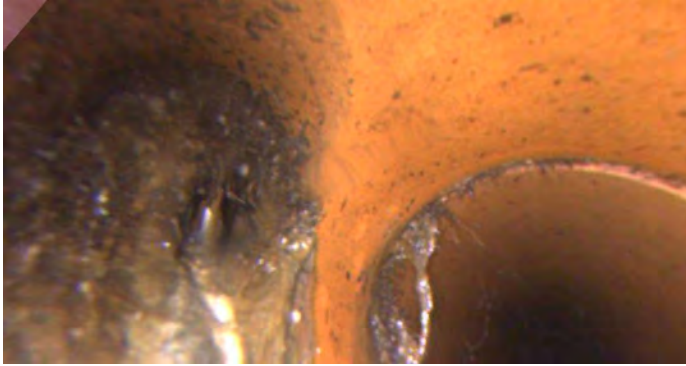
Code: **TFD**
Description: **Tap Factory Defective**

Distance (ft): **145.8**
Structural Grade: **0**
O&M Grade: **2**
Clock Start/From: **2**
Clock To:
1st Value: **4.000**
2nd Value:
Value Percent:
Continuous Index:
Within 8" of Joint:
Remarks: **Roots, Photo taken from rear camera.**

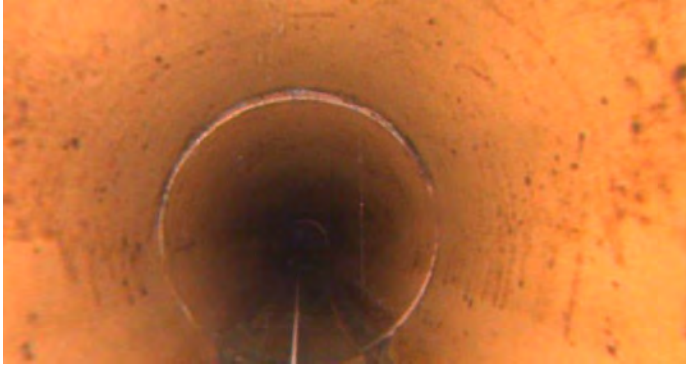
Code:	RMJ
Description:	Roots Medium Joint
Distance (ft):	165.0
Structural Grade:	0
O&M Grade:	3
Clock Start/From:	7
Clock To:	5
1st Value:	
2nd Value:	
Value Percent:	5.000
Continuous Index:	F01
Within 8" of Joint:	YES
Remarks:

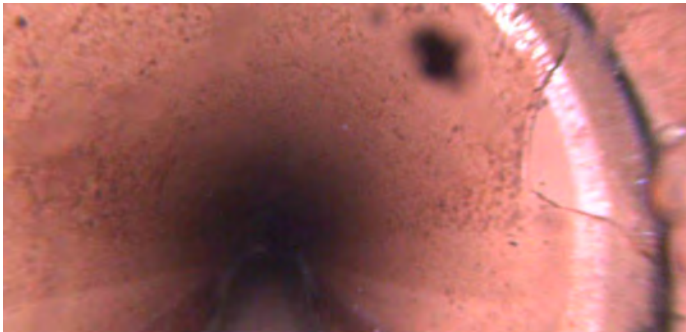
Code:	FS
Description:	Fracture Spiral
Distance (ft):	168.7
Structural Grade:	3
O&M Grade:	0
Clock Start/From:	1
Clock To:	3
1st Value:	
2nd Value:	
Value Percent:	
Continuous Index:	
Within 8" of Joint:	YES
Remarks:

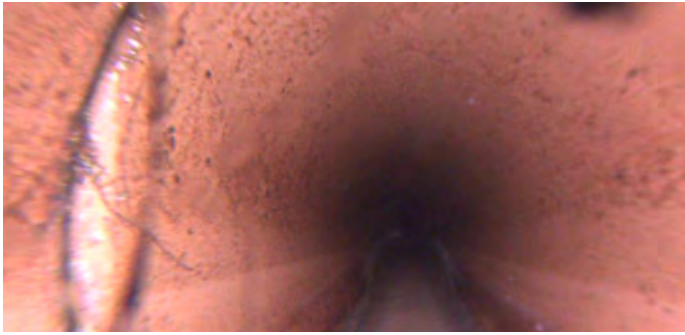
Code: **RFJ**
Description: **Roots Fine Joint**

Distance (ft): **168.7**
Structural Grade: **0**
O&M Grade: **1**
Clock Start/From: **9**
Clock To:
1st Value:
2nd Value:
Value Percent:
Continuous Index:
Within 8" of Joint: **YES**
Remarks:

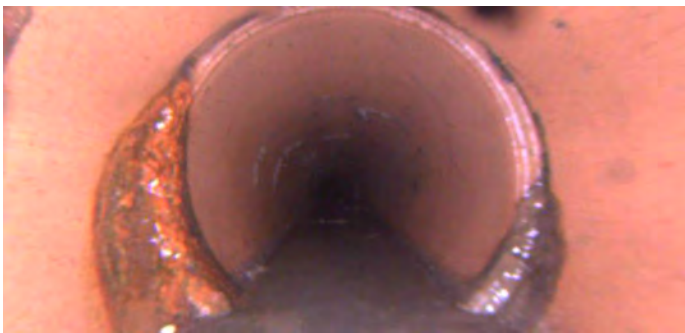
Code: **IW**
Description: **Infil Weeper**

Distance (ft): **188.5**
Structural Grade: **0**
O&M Grade: **2**
Clock Start/From: **8**
Clock To: **4**
1st Value:
2nd Value:
Value Percent:
Continuous Index:
Within 8" of Joint: **YES**
Remarks:

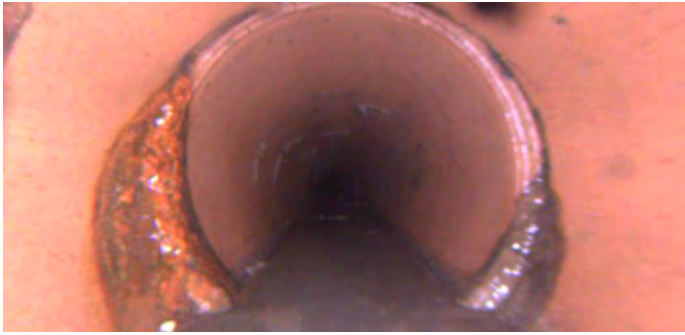
Code: **DAE**
Description: **Deposits Attached Encrustation**

Distance (ft): **188.5**
Structural Grade: **0**
O&M Grade: **2**
Clock Start/From: **8**
Clock To: **4**
1st Value:
2nd Value:
Value Percent: **5.000**
Continuous Index:
Within 8" of Joint: **YES**
Remarks:

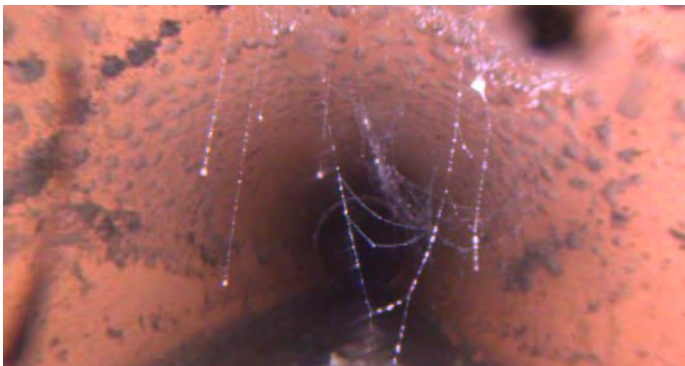
Code: **MSA**
Description: **Abandoned Survey**

Distance (ft): **196.7**
Structural Grade: **0**
O&M Grade: **0**
Clock Start/From:
Clock To:
1st Value:
2nd Value:
Value Percent:
Continuous Index:
Within 8" of Joint: **NO**
Remarks: **Debris under water**
