Profile/Photo Observation Report

Date:	04/10/2018	Weather:		Coding:	PACP 6.0
Pipe Length (ft):	224.0	Owner:	NA	Pre Clean:	Not Known
P.O.#:		Surveyor:	Mark Ruby	PSR:	P-503-047-046
Customer:		Clean Date:	01/01/1900	Shape:	C

Street:	W 40th ave	Flow Control:	Not Controlled
City:	Hobart, IN	Year Renewed:	
Location:	Other	Tape/Media #:	
Purpose:	Not Known	Dia/Height:	10"
Use:	Sanitary	Material:	VCP
Drain Area:	NA	Lining:	
Category:	NA		
Comment:

Location Details:		Direction of Survey:	Downstream
US MH:	M-503-046	DS MH:	M-503-047
		Total Length Surveyed (ft):	196.7

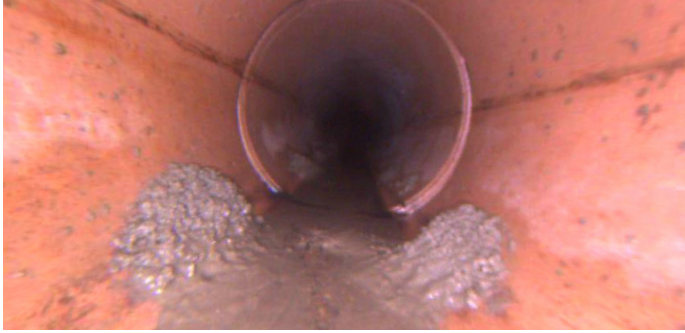
Code: **DSF**
Description: **Deposits Settled Fine**

Distance (ft): **.0**
Structural Grade: **0**
O&M Grade: **2**
Clock Start/From: **5**
Clock To: **7**
1st Value:
2nd Value:
Value Percent: **5.000**
Continuous Index:
Within 8" of Joint: **NO**
Remarks:

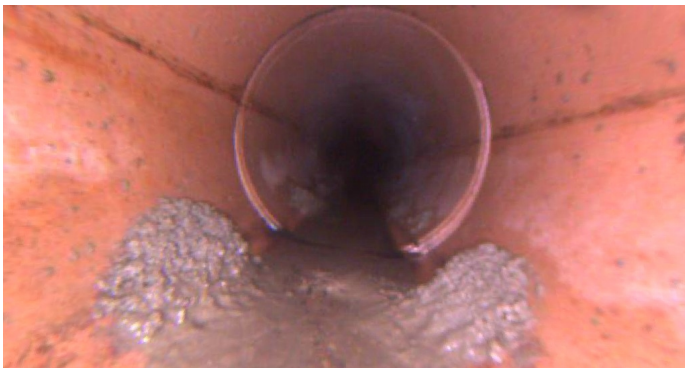
Code: **AMH**
Description: **Manhole**

Distance (ft): **.0**
Structural Grade: **0**
O&M Grade: **0**
Clock Start/From:
Clock To:
1st Value:
2nd Value:
Value Percent:
Continuous Index:
Within 8" of Joint: **NO**
Remarks: **M-503-046**

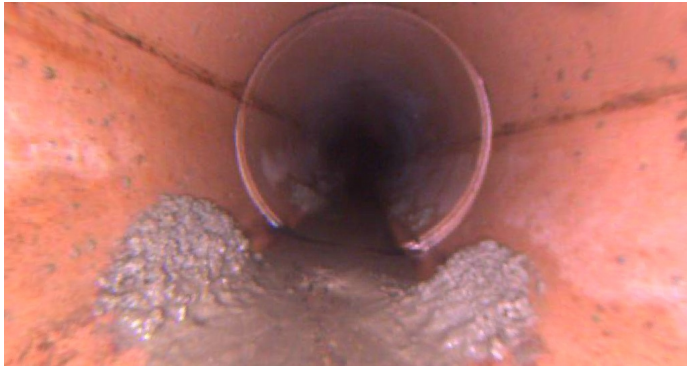
Code: **MWL**
Description: **Water Level**

Distance (ft): **.0**
Structural Grade: **0**
O&M Grade: **0**
Clock Start/From:
Clock To:
1st Value:
2nd Value:
Value Percent: **10.000**
Continuous Index:
Within 8" of Joint: **NO**
Remarks:

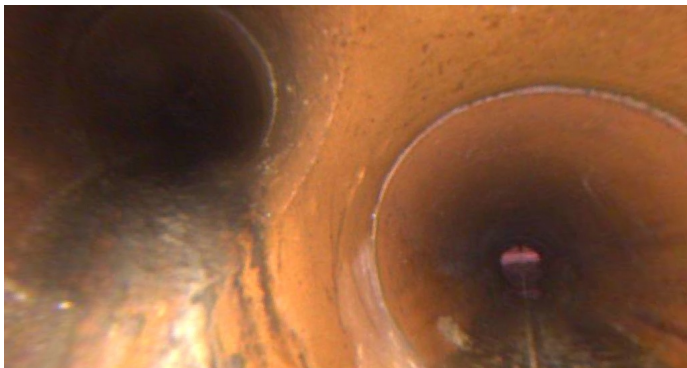
Code: **TF**
Description: **Tap Factory**

Distance (ft): **8.0**
Structural Grade: **0**
O&M Grade: **0**
Clock Start/From: **2**
Clock To:
1st Value: **4.000**
2nd Value:
Value Percent:
Continuous Index:
Within 8" of Joint:
Remarks: **Photo taken from rear camera.**

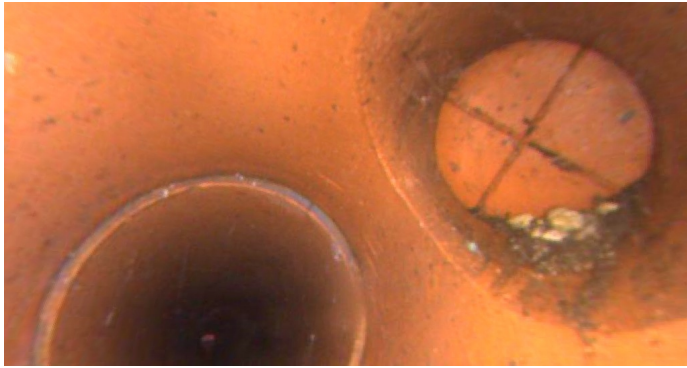
Code: **TFC**
Description: **Tap Factory Capped**

Distance (ft): **25.0**
Structural Grade: **0**
O&M Grade: **0**
Clock Start/From: **10**
Clock To:
1st Value: **4.000**
2nd Value:
Value Percent:
Continuous Index:
Within 8" of Joint:
Remarks: **Photo taken from rear camera.**

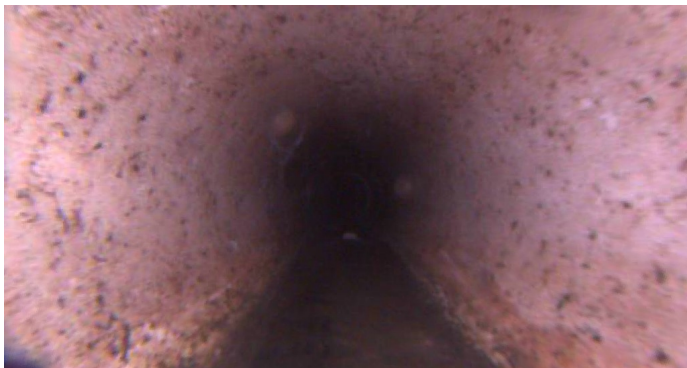
Code: **MMC**
Description: **Material Change**

Distance (ft): **36.0**
Structural Grade: **0**
O&M Grade: **0**
Clock Start/From:
Clock To:
1st Value:
2nd Value:
Value Percent:
Continuous Index:
Within 8" of Joint: **NO**
Remarks: **PVC**

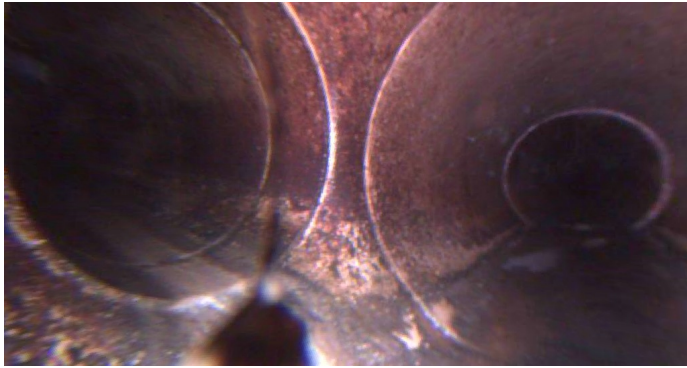
Code: **TF**
Description: **Tap Factory**

Distance (ft): **39.1**
Structural Grade: **0**
O&M Grade: **0**
Clock Start/From: **8**
Clock To:
1st Value: **4.000**
2nd Value:
Value Percent:
Continuous Index:
Within 8" of Joint:
Remarks:

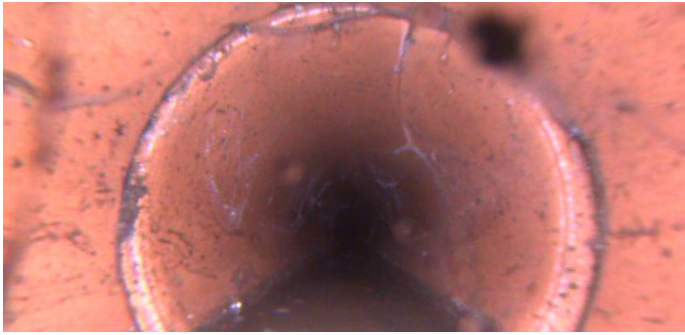
Code: **FS**
Description: **Fracture Spiral**

Distance (ft): **55.2**
Structural Grade: **3**
O&M Grade: **0**
Clock Start/From: **1**
Clock To: **2**
1st Value:
2nd Value:
Value Percent:
Continuous Index:
Within 8" of Joint: **YES**
Remarks:

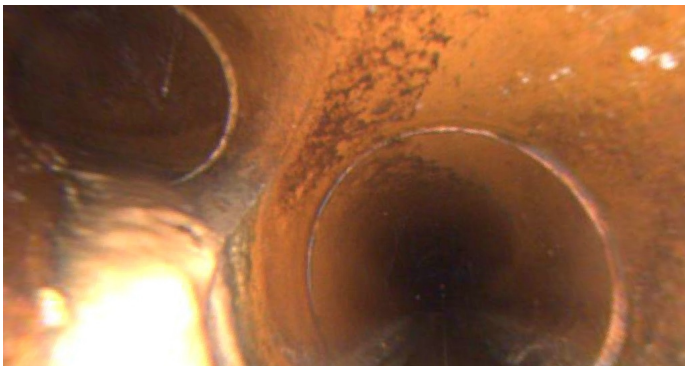
Code: **TF**
Description: **Tap Factory**

Distance (ft): **66.7**
Structural Grade: **0**
O&M Grade: **0**
Clock Start/From: **2**
Clock To:
1st Value: **4.000**
2nd Value:
Value Percent:
Continuous Index:
Within 8" of Joint:
Remarks: **Photo taken from rear camera.**

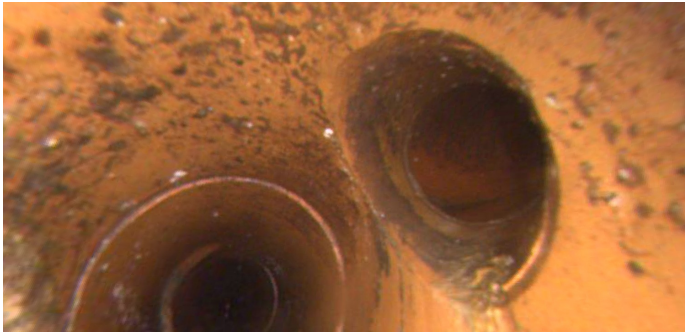
Code: **TF**
Description: **Tap Factory**

Distance (ft): **69.0**
Structural Grade: **0**
O&M Grade: **0**
Clock Start/From: **2**
Clock To:
1st Value: **4.000**
2nd Value:
Value Percent:
Continuous Index:
Within 8" of Joint:
Remarks:

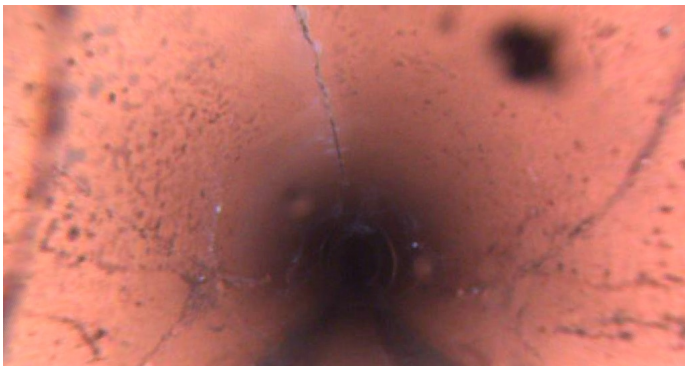
Code: **FM**
Description: **Fracture Multiple**

Distance (ft): **79.7**
Structural Grade: **4**
O&M Grade: **0**
Clock Start/From: **11**
Clock To: **5**
1st Value:
2nd Value:
Value Percent:
Continuous Index:
Within 8" of Joint: **YES**
Remarks:

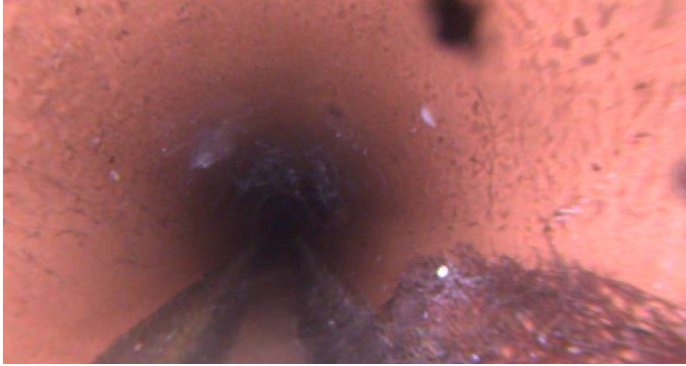
Code: **RFJ**
Description: **Roots Fine Joint**

Distance (ft): **115.0**
Structural Grade: **0**
O&M Grade: **1**
Clock Start/From: **4**
Clock To: **5**
1st Value:
2nd Value:
Value Percent:
Continuous Index:
Within 8" of Joint: **YES**
Remarks:

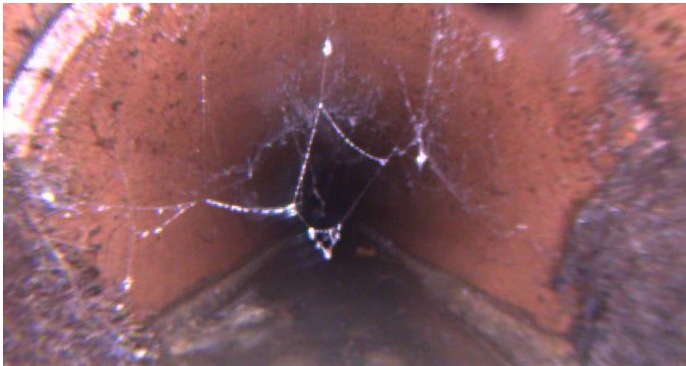
Code: **RMJ**
Description: **Roots Medium Joint**

Distance (ft): **129.5**
Structural Grade: **0**
O&M Grade: **3**
Clock Start/From: **7**
Clock To: **5**
1st Value:
2nd Value:
Value Percent: **5.000**
Continuous Index:
Within 8" of Joint: **YES**
Remarks:

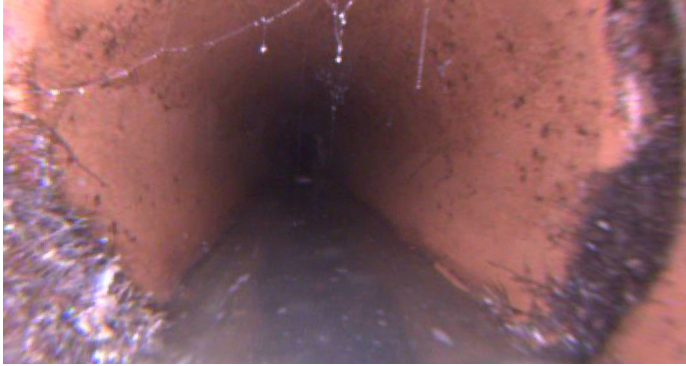
Code: **RMJ**
Description: **Roots Medium Joint**

Distance (ft): **139.5**
Structural Grade: **0**
O&M Grade: **3**
Clock Start/From: **7**
Clock To: **5**
1st Value:
2nd Value:
Value Percent: **5.000**
Continuous Index: **S01**
Within 8" of Joint: **YES**
Remarks:

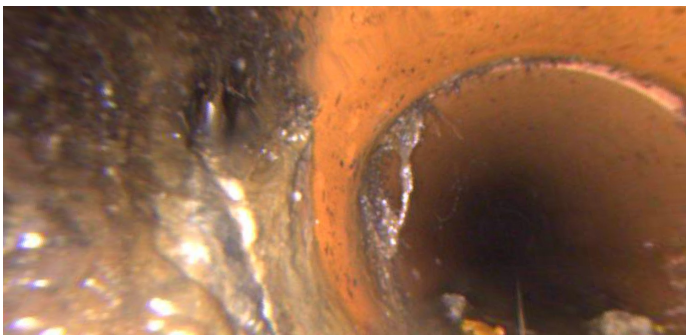
Code: **RFL**
Description: **Roots Fine Lateral**

Distance (ft): **145.8**
Structural Grade: **0**
O&M Grade: **1**
Clock Start/From: **2**
Clock To:
1st Value:
2nd Value:
Value Percent:
Continuous Index:
Within 8" of Joint: **NO**
Remarks: **ROOTS**

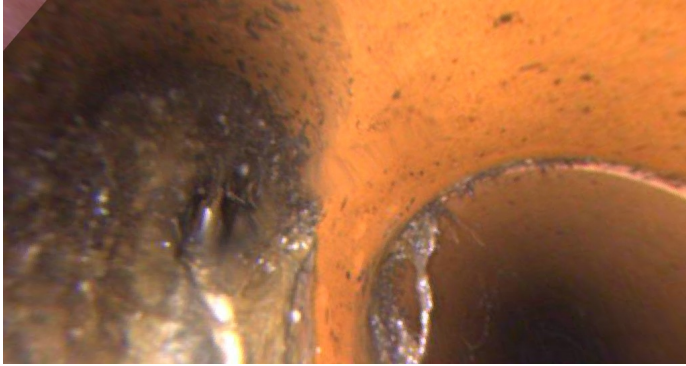
Code:	TFD
Description:	Tap Factory Defective
Distance (ft):	145.8
Structural Grade:	0
O&M Grade:	2
Clock Start/From:	2
Clock To:	
1st Value:	4.000
2nd Value:	
Value Percent:	
Continuous Index:	
Within 8" of Joint:	
Remarks:	Roots, Photo taken from rear camera.

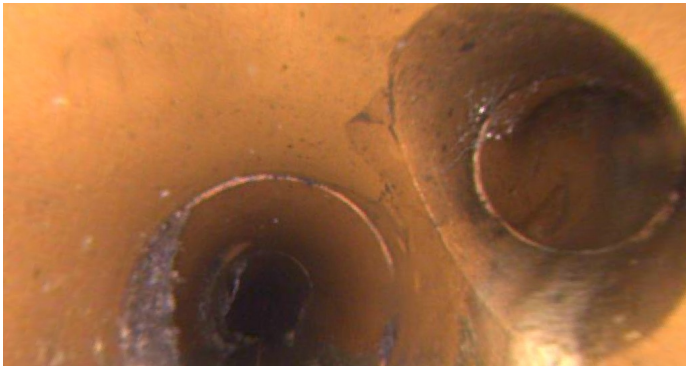
Code:	TF
Description:	Tap Factory
Distance (ft):	148.0
Structural Grade:	0
O&M Grade:	0
Clock Start/From:	10
Clock To:	
1st Value:	4.000
2nd Value:	
Value Percent:	
Continuous Index:	
Within 8" of Joint:	
Remarks:	Photo taken from rear camera.

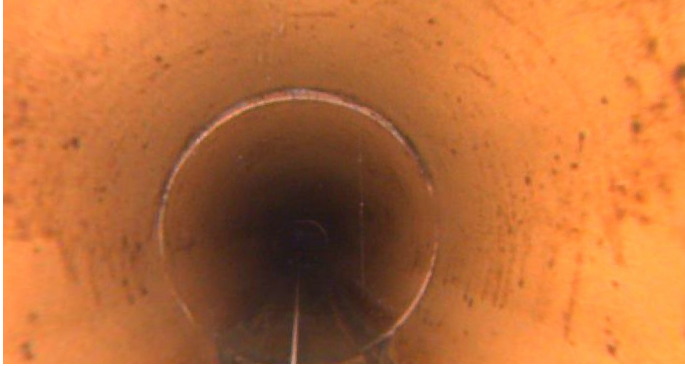
Code: **RMJ**
Description: **Roots Medium Joint**

Distance (ft): **165.0**
Structural Grade: **0**
O&M Grade: **3**
Clock Start/From: **7**
Clock To: **5**
1st Value:
2nd Value:
Value Percent: **5.000**
Continuous Index: **F01**
Within 8" of Joint: **YES**
Remarks:

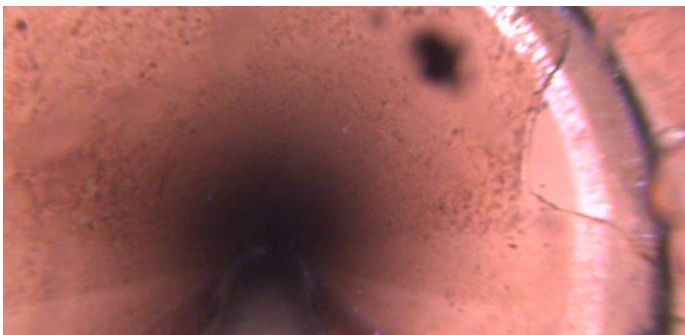
Code: **FS**
Description: **Fracture Spiral**

Distance (ft): **168.7**
Structural Grade: **3**
O&M Grade: **0**
Clock Start/From: **1**
Clock To: **3**
1st Value:
2nd Value:
Value Percent:
Continuous Index:
Within 8" of Joint: **YES**
Remarks:

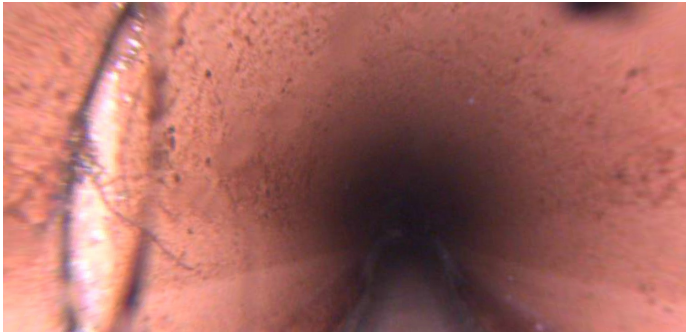
Code: **RFJ**
Description: **Roots Fine Joint**

Distance (ft): **168.7**
Structural Grade: **0**
O&M Grade: **1**
Clock Start/From: **9**
Clock To:
1st Value:
2nd Value:
Value Percent:
Continuous Index:
Within 8" of Joint: **YES**
Remarks:

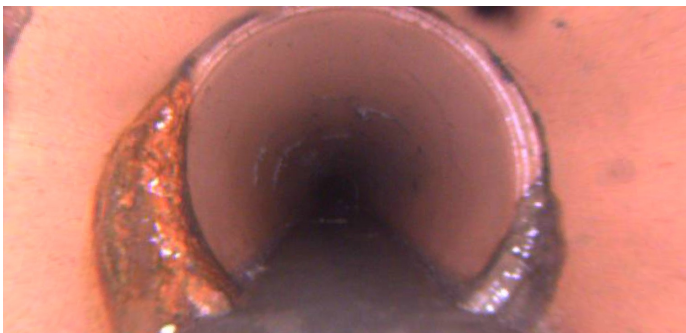
Code: **IW**
Description: **Infil Weeper**

Distance (ft): **188.5**
Structural Grade: **0**
O&M Grade: **2**
Clock Start/From: **8**
Clock To: **4**
1st Value:
2nd Value:
Value Percent:
Continuous Index:
Within 8" of Joint: **YES**
Remarks:

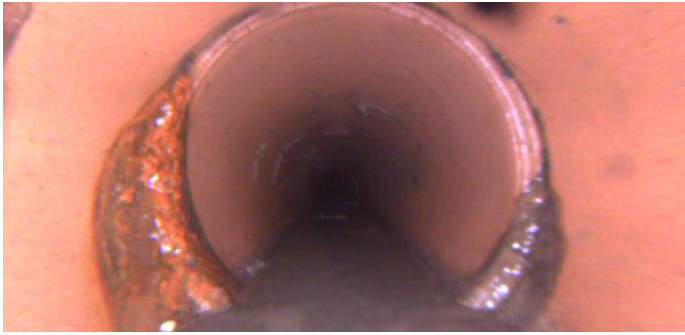
Code: **DAE**
Description: **Deposits Attached Encrustation**

Distance (ft): **188.5**
Structural Grade: **0**
O&M Grade: **2**
Clock Start/From: **8**
Clock To: **4**
1st Value:
2nd Value:
Value Percent: **5.000**
Continuous Index:
Within 8" of Joint: **YES**
Remarks:

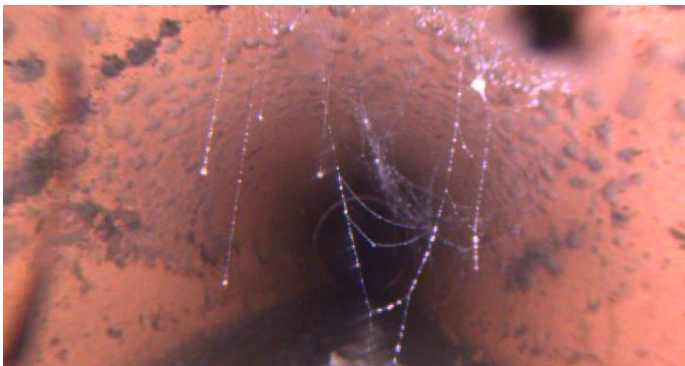
Code: **MSA**
Description: **Abandoned Survey**

Distance (ft): **196.7**
Structural Grade: **0**
O&M Grade: **0**
Clock Start/From:
Clock To:
1st Value:
2nd Value:
Value Percent:
Continuous Index:
Within 8" of Joint: **NO**
Remarks: **Debris under water**
