Profile/Photo Observation Report

Location Details:		Direction of Survey:	Downstream
US MH:	M-503-050	DS MH:	M-503-049
		Total Length Surveyed (ft):	38.3

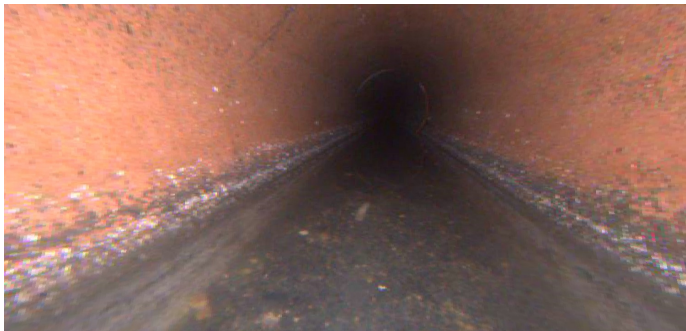
Code: **AMH**
Description: **Manhole**

Distance (ft): **.0**
Structural Grade: **0**
O&M Grade: **0**
Clock Start/From:
Clock To:
1st Value:
2nd Value:
Value Percent:
Continuous Index:
Within 8" of Joint: **NO**
Remarks: **M-503-050**

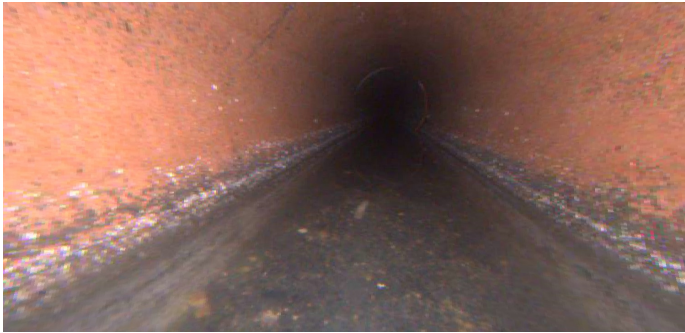
Code:	MWL
Description:	Water Level

Distance (ft):	.0
Structural Grade:	0
O&M Grade:	0
Clock Start/From:	
Clock To:	
1st Value:	
2nd Value:	
Value Percent:	5.000
Continuous Index:	
Within 8" of Joint:	NO
Remarks:

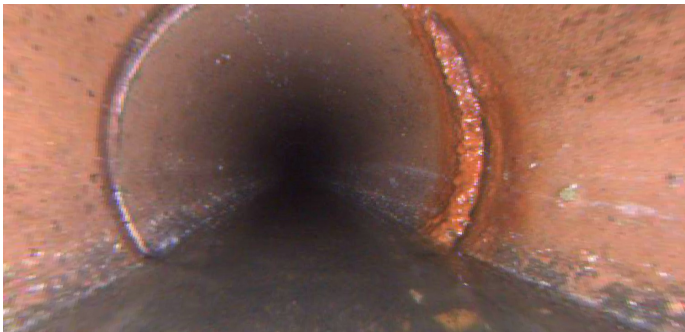
Code:	DAE
Description:	Deposits Attached Encrustation

Distance (ft):	3.8
Structural Grade:	0
O&M Grade:	2
Clock Start/From:	2
Clock To:	5
1st Value:	
2nd Value:	
Value Percent:	5.000
Continuous Index:	
Within 8" of Joint:	YES
Remarks:

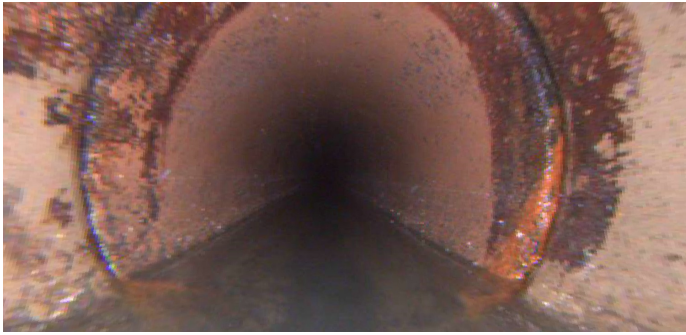
Code: **IS**
Description: **Infil Stain**

Distance (ft): **8.7**
Structural Grade: **0**
O&M Grade: **0**
Clock Start/From: **7**
Clock To: **5**
1st Value:
2nd Value:
Value Percent:
Continuous Index:
Within 8" of Joint: **YES**
Remarks:

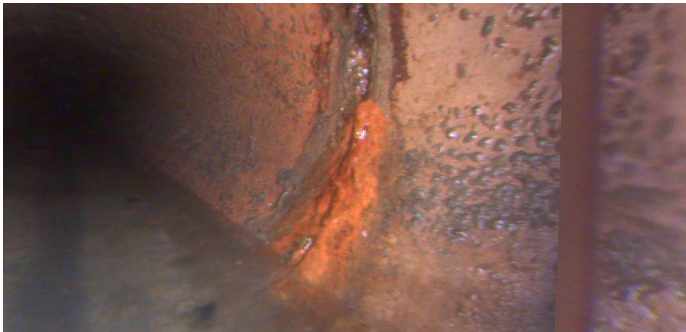
Code: **DAE**
Description: **Deposits Attached Encrustation**

Distance (ft): **18.6**
Structural Grade: **0**
O&M Grade: **2**
Clock Start/From: **3**
Clock To: **5**
1st Value:
2nd Value:
Value Percent: **5.000**
Continuous Index:
Within 8" of Joint: **YES**
Remarks:

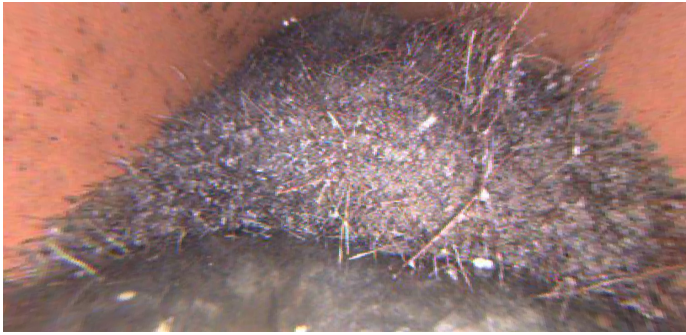
Code: **RBJ**
Description: **Roots Ball Joint**

Distance (ft): **37.5**
Structural Grade: **0**
O&M Grade: **4**
Clock Start/From: **7**
Clock To: **5**
1st Value:
2nd Value:
Value Percent: **100.000**
Continuous Index:
Within 8" of Joint: **YES**
Remarks: **total blockage**

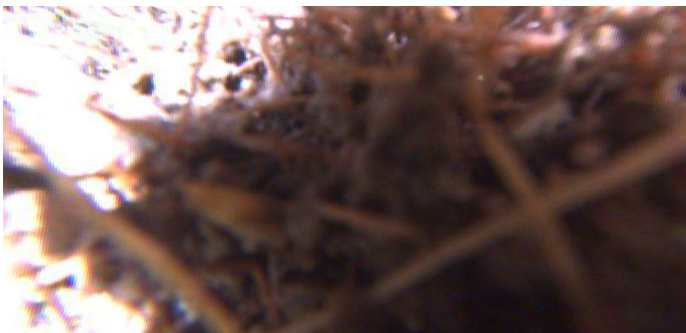
Code: **MSA**
Description: **Abandoned Survey**

Distance (ft): **38.3**
Structural Grade: **0**
O&M Grade: **0**
Clock Start/From:
Clock To:
1st Value:
2nd Value:
Value Percent:
Continuous Index:
Within 8" of Joint: **NO**
Remarks: **rbj**
