Profile/Photo Observation Report

Street:	N COLORADO ST	Flow Control:	Not Controlled
City:	Hobart, IN	Year Renewed:	
Location:	Other	Tape/Media #:	
Purpose:	Not Known	Dia/Height:	10"
Use:	Sanitary	Material:	VCP
Drain Area:	NA	Lining:	
Category:	NA		
Comment:

Location Details:		Direction of Survey:	Upstream
US MH:	M-503-050	DS MH:	M-503-049
		Total Length Surveyed (ft):	69.7

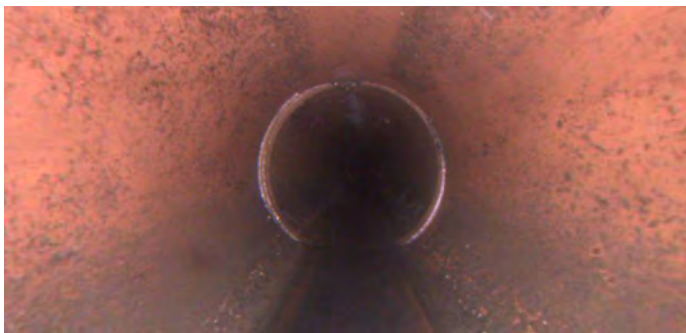
Code: **AMH**
Description: **Manhole**

Distance (ft): **.0**
Structural Grade: **0**
O&M Grade: **0**
Clock Start/From:
Clock To:
1st Value:
2nd Value:
Value Percent:
Continuous Index:
Within 8" of Joint: **NO**
Remarks: **M-503-050**

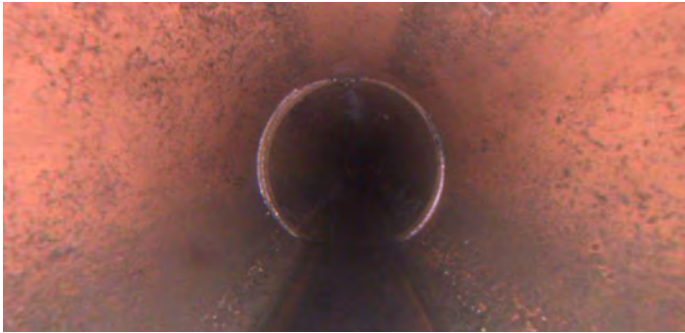
Code:	MWL
Description:	Water Level

Distance (ft):	.0
Structural Grade:	0
O&M Grade:	0
Clock Start/From:	
Clock To:	
1st Value:	
2nd Value:	
Value Percent:	5.000
Continuous Index:	
Within 8" of Joint:	NO
Remarks:

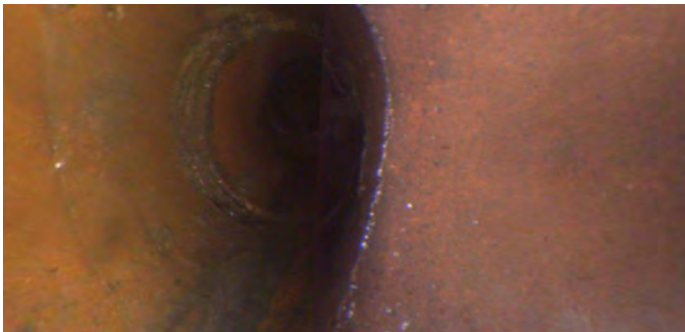
Code:	TF
Description:	Tap Factory

Distance (ft):	13.7
Structural Grade:	0
O&M Grade:	0
Clock Start/From:	9
Clock To:	
1st Value:	4.000
2nd Value:	
Value Percent:	
Continuous Index:	
Within 8" of Joint:	
Remarks:

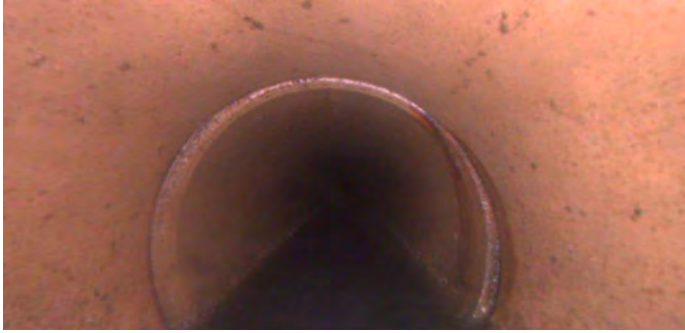
Code: **IW**
Description: **Infil Weeper**

Distance (ft): **24.8**
Structural Grade: **0**
O&M Grade: **2**
Clock Start/From: **1**
Clock To: **4**
1st Value:
2nd Value:
Value Percent:
Continuous Index:
Within 8" of Joint: **YES**
Remarks:

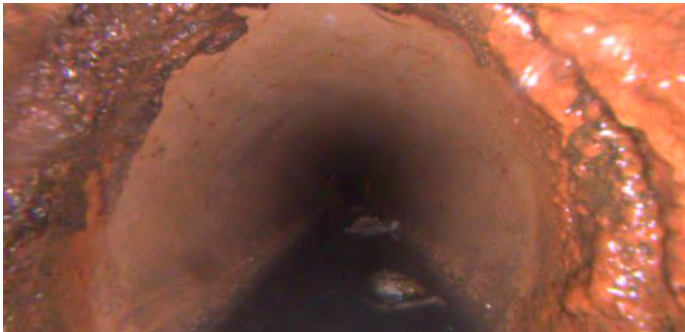
Code: **DAE**
Description: **Deposits Attached Encrustation**

Distance (ft): **30.4**
Structural Grade: **0**
O&M Grade: **2**
Clock Start/From: **8**
Clock To: **4**
1st Value:
2nd Value:
Value Percent: **5.000**
Continuous Index:
Within 8" of Joint: **YES**
Remarks:

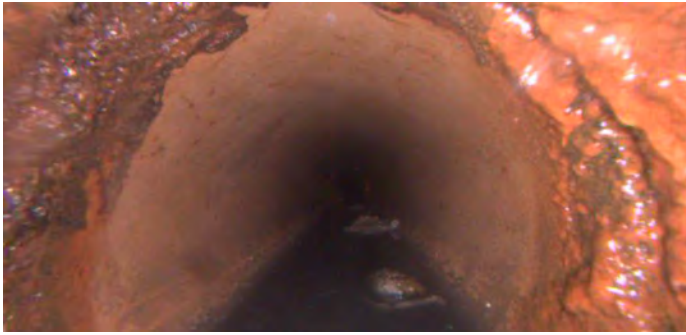
Code: **IW**
Description: **Infil Weeper**

Distance (ft): **30.4**
Structural Grade: **0**
O&M Grade: **2**
Clock Start/From: **8**
Clock To: **4**
1st Value:
2nd Value:
Value Percent:
Continuous Index:
Within 8" of Joint: **YES**
Remarks:

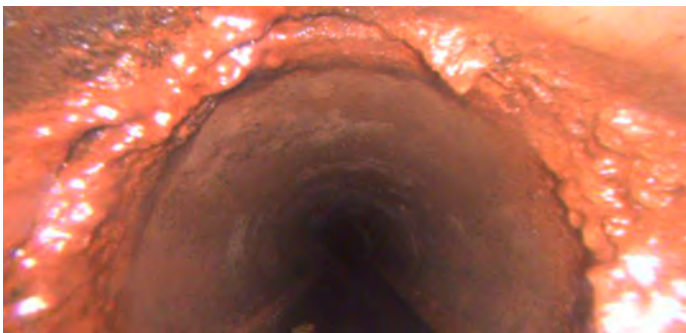
Code: **DAE**
Description: **Deposits Attached Encrustation**

Distance (ft): **35.6**
Structural Grade: **0**
O&M Grade: **2**
Clock Start/From: **8**
Clock To: **4**
1st Value:
2nd Value:
Value Percent: **10.000**
Continuous Index:
Within 8" of Joint: **YES**
Remarks:

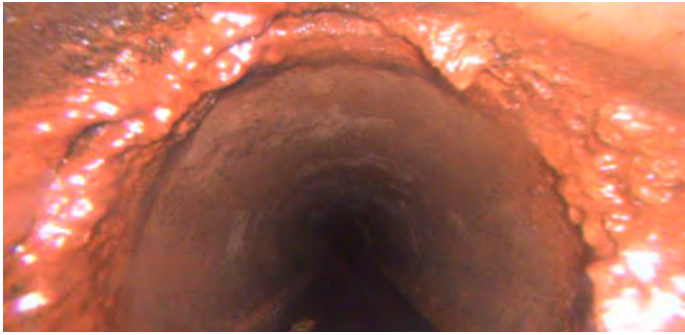
Code: **IW**
Description: **Infil Weeper**

Distance (ft): **35.6**
Structural Grade: **0**
O&M Grade: **2**
Clock Start/From: **8**
Clock To: **4**
1st Value:
2nd Value:
Value Percent:
Continuous Index:
Within 8" of Joint: **YES**
Remarks:

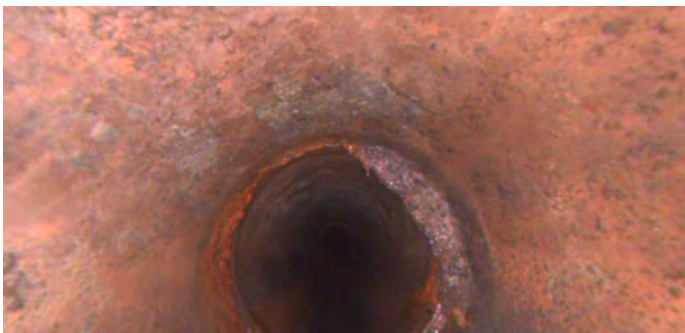
Code: **ID**
Description: **Infil Dripper**

Distance (ft): **40.1**
Structural Grade: **0**
O&M Grade: **3**
Clock Start/From: **12**
Clock To:
1st Value:
2nd Value:
Value Percent:
Continuous Index:
Within 8" of Joint: **YES**
Remarks:

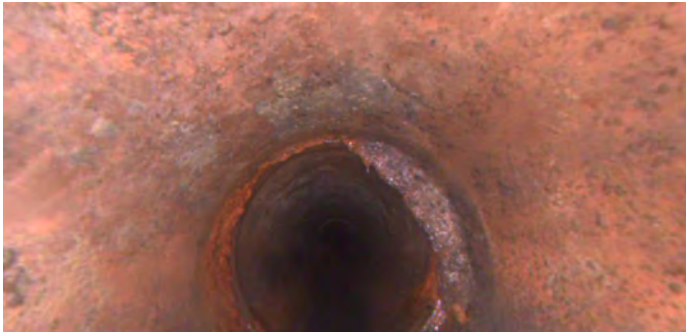
Code: **DAE**
Description: **Deposits Attached Encrustation**

Distance (ft): **40.1**
Structural Grade: **0**
O&M Grade: **2**
Clock Start/From: **8**
Clock To: **4**
1st Value:
2nd Value:
Value Percent: **10.000**
Continuous Index:
Within 8" of Joint: **YES**
Remarks:

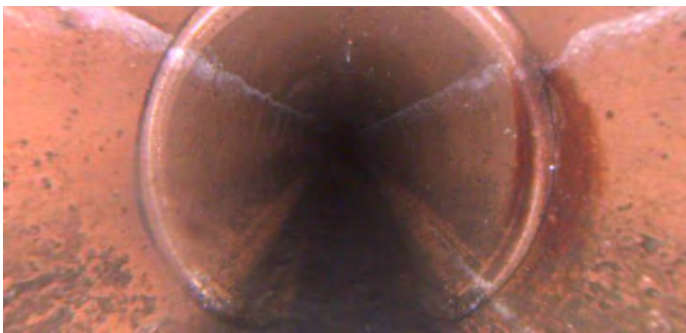
Code: **IS**
Description: **Infil Stain**

Distance (ft): **51.1**
Structural Grade: **0**
O&M Grade: **0**
Clock Start/From: **2**
Clock To: **4**
1st Value:
2nd Value:
Value Percent:
Continuous Index:
Within 8" of Joint: **YES**
Remarks:

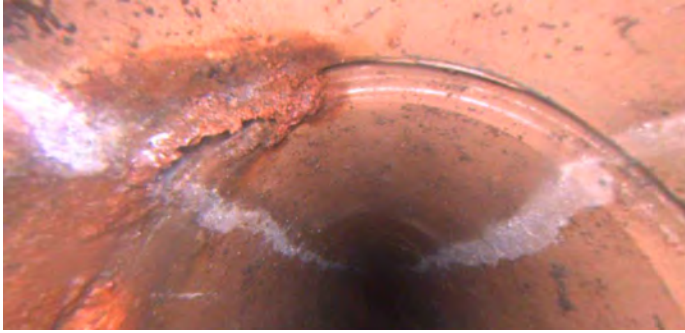
Code: **DAE**
Description: **Deposits Attached Encrustation**

Distance (ft): **56.5**
Structural Grade: **0**
O&M Grade: **2**
Clock Start/From: **8**
Clock To: **11**
1st Value:
2nd Value:
Value Percent: **5.000**
Continuous Index:
Within 8" of Joint: **YES**
Remarks:

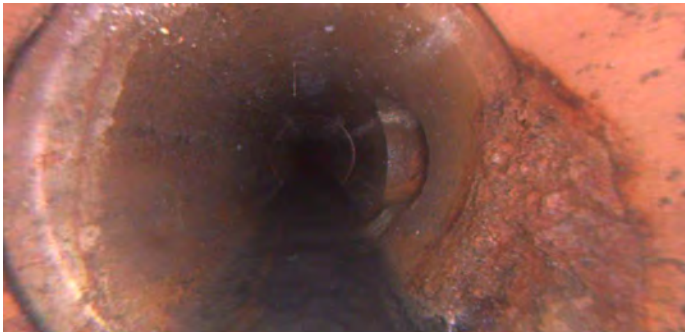
Code: **DAE**
Description: **Deposits Attached Encrustation**

Distance (ft): **61.7**
Structural Grade: **0**
O&M Grade: **2**
Clock Start/From: **2**
Clock To: **4**
1st Value:
2nd Value:
Value Percent: **5.000**
Continuous Index:
Within 8" of Joint: **YES**
Remarks:

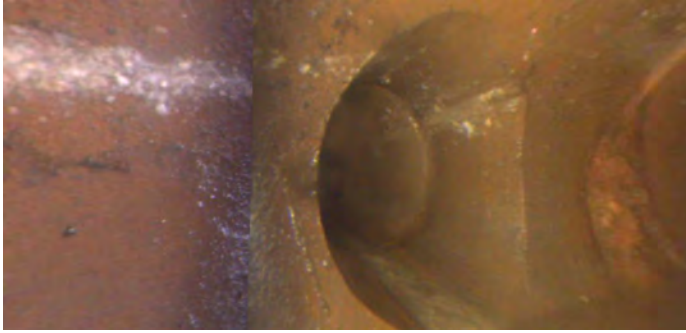
Code: **TF**
Description: **Tap Factory**

Distance (ft): **63.2**
Structural Grade: **0**
O&M Grade: **0**
Clock Start/From: **3**
Clock To:
1st Value: **4.000**
2nd Value:
Value Percent:
Continuous Index:
Within 8" of Joint:
Remarks:

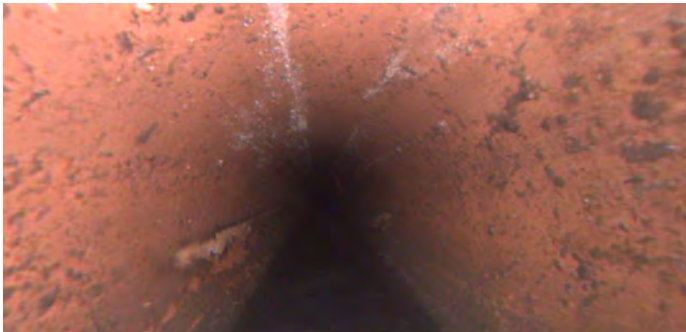
Code: **MSA**
Description: **Abandoned Survey**

Distance (ft): **69.7**
Structural Grade: **0**
O&M Grade: **0**
Clock Start/From:
Clock To:
1st Value:
2nd Value:
Value Percent:
Continuous Index:
Within 8" of Joint: **NO**
Remarks: **debris under water**
