## Profile/Photo Observation Report

Street:	<b>W 40th ave</b>	Flow Control:	<b>Not Controlled</b>
City:	<b>Hobart, IN</b>	Year Renewed:	
Location:	<b>Other</b>	Tape/Media #:	
Purpose:	<b>Not Known</b>	Dia/Height:	<b>10"</b>
Use:	<b>Sanitary</b>	Material:	<b>VCP</b>
Drain Area:	<b>NA</b>	Lining:	
Category:	<b>NA</b>		
Comment:

Location Details:		Direction of Survey:	<b>Downstream</b>
US MH:	<b>M-503-051</b>	DS MH:	<b>M-503-050</b>
		Total Length Surveyed (ft):	<b>117.5</b>

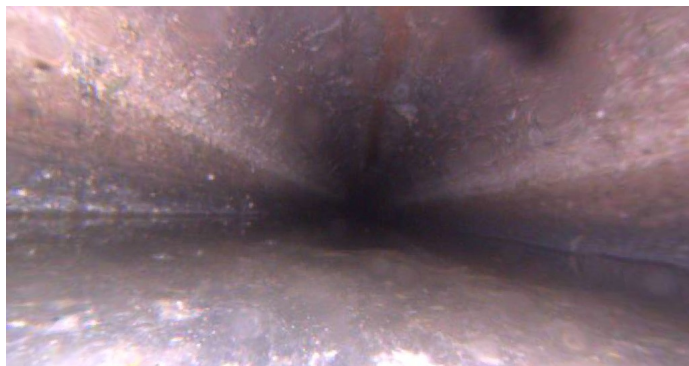
Code: **AMH**  
 Description: **Manhole**

Distance (ft): **.0**  
 Structural Grade: **0**  
 O&M Grade: **0**  
 Clock Start/From:  
 Clock To:  
 1st Value:  
 2nd Value:  
 Value Percent:  
 Continuous Index:  
 Within 8" of Joint: **NO**  
 Remarks: **M-503-051**

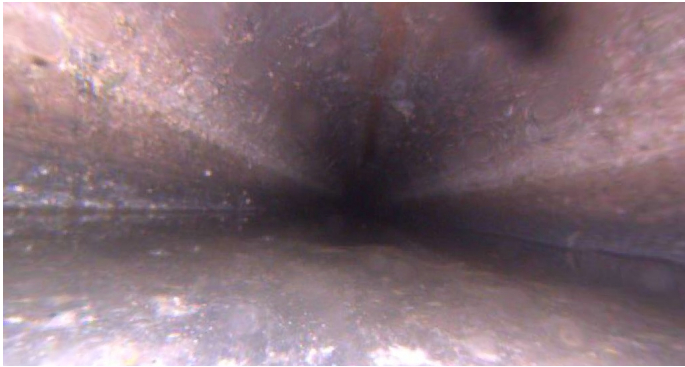
Code:	<b>MWL</b>
Description:	<b>Water Level</b>

Distance (ft):	<b>.0</b>
Structural Grade:	<b>0</b>
O&M Grade:	<b>0</b>
Clock Start/From:	
Clock To:	
1st Value:	
2nd Value:	
Value Percent:	<b>10.000</b>
Continuous Index:	
Within 8" of Joint:	<b>NO</b>
Remarks:

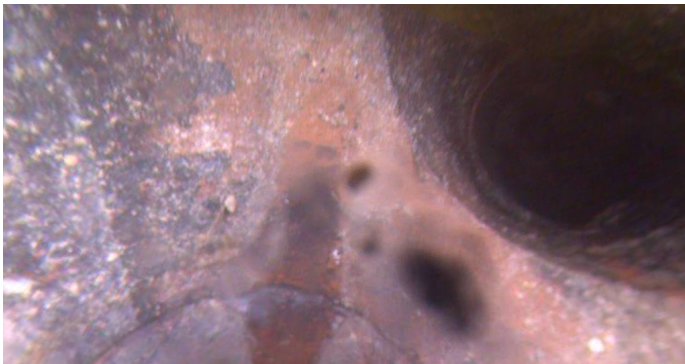
Code:	<b>TF</b>
Description:	<b>Tap Factory</b>

Distance (ft):	<b>15.7</b>
Structural Grade:	<b>0</b>
O&M Grade:	<b>0</b>
Clock Start/From:	<b>2</b>
Clock To:	
1st Value:	<b>4.000</b>
2nd Value:	
Value Percent:	
Continuous Index:	
Within 8" of Joint:	
Remarks:

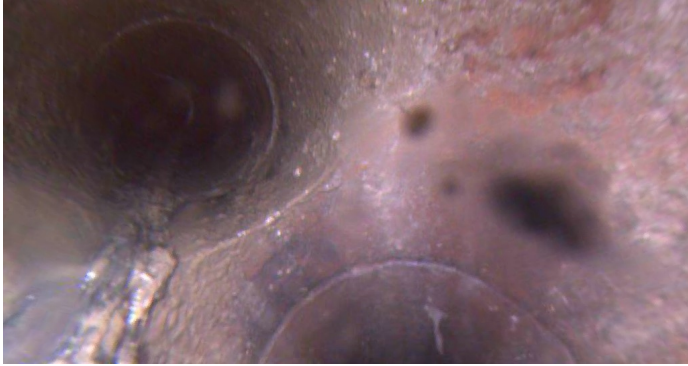
Code: **TF**  
Description: **Tap Factory**

Distance (ft): **27.6**  
Structural Grade: **0**  
O&M Grade: **0**  
Clock Start/From: **10**  
Clock To:  
1st Value: **4.000**  
2nd Value:  
Value Percent:  
Continuous Index:  
Within 8" of Joint:  
Remarks:

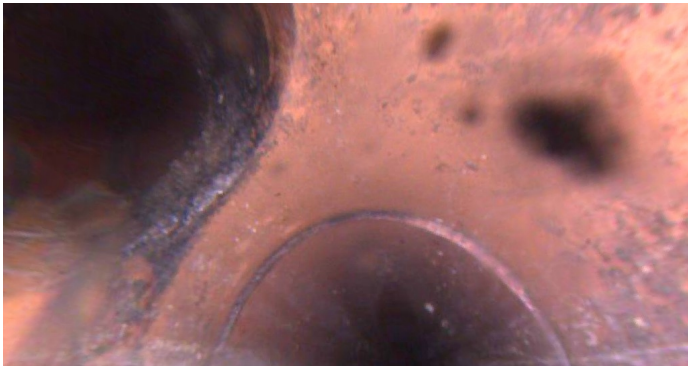
Code: **TF**  
Description: **Tap Factory**

Distance (ft): **74.5**  
Structural Grade: **0**  
O&M Grade: **0**  
Clock Start/From: **10**  
Clock To:  
1st Value: **4.000**  
2nd Value:  
Value Percent:  
Continuous Index:  
Within 8" of Joint:  
Remarks:

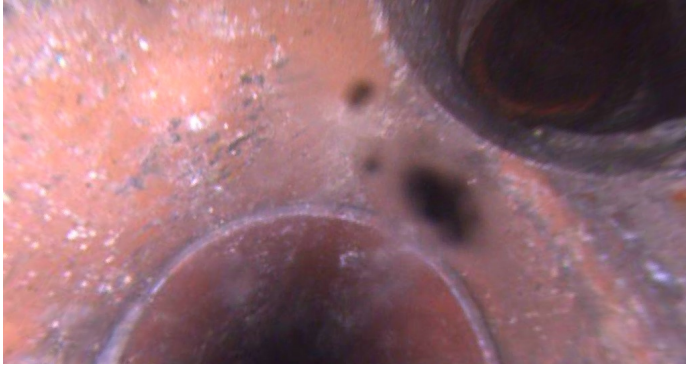
Code: **TF**  
Description: **Tap Factory**

Distance (ft): **91.7**  
Structural Grade: **0**  
O&M Grade: **0**  
Clock Start/From: **2**  
Clock To:  
1st Value: **4.000**  
2nd Value:  
Value Percent:  
Continuous Index:  
Within 8" of Joint:  
Remarks:

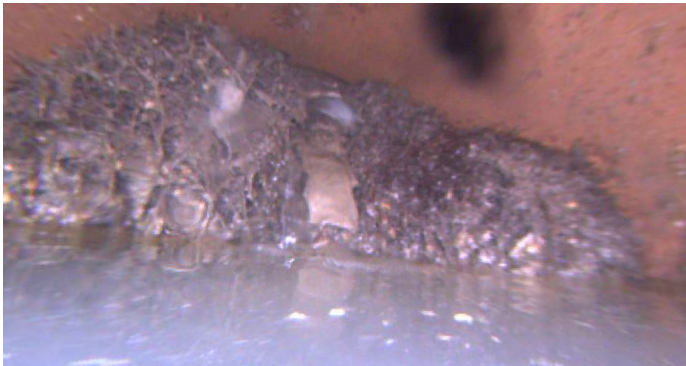
Code: **RBB**  
Description: **Roots Ball Barrel**

Distance (ft): **116.7**  
Structural Grade: **0**  
O&M Grade: **5**  
Clock Start/From: **9**  
Clock To: **4**  
1st Value:  
2nd Value:  
Value Percent: **70.000**  
Continuous Index:  
Within 8" of Joint: **NO**  
Remarks:
