Profile/Photo Observation Report

Date:	04/10/2018	Weather:		Coding:	PACP 6.0
Pipe Length (ft):	280.8	Owner:	NA	Pre Clean:	Not Known
P.O.#:		Surveyor:	Mark Ruby	PSR:	P-503-050-051
Customer:		Clean Date:	01/01/1900	Shape:	C

Street:	W 40th ave	Flow Control:	Not Controlled
City:	Hobart, IN	Year Renewed:	
Location:	Other	Tape/Media #:	
Purpose:	Not Known	Dia/Height:	10"
Use:	Sanitary	Material:	VCP
Drain Area:	NA	Lining:	
Category:	NA		
Comment:

Location Details:		Direction of Survey:	Downstream
US MH:	M-503-051	DS MH:	M-503-050
		Total Length Surveyed (ft):	153.5

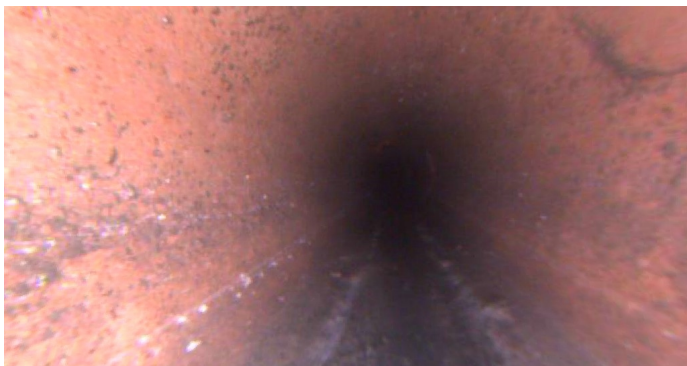
Code: **AMH**
 Description: **Manhole**

Distance (ft): **.0**
 Structural Grade: **0**
 O&M Grade: **0**
 Clock Start/From:
 Clock To:
 1st Value:
 2nd Value:
 Value Percent:
 Continuous Index:
 Within 8" of Joint: **NO**
 Remarks: **M-503-051**

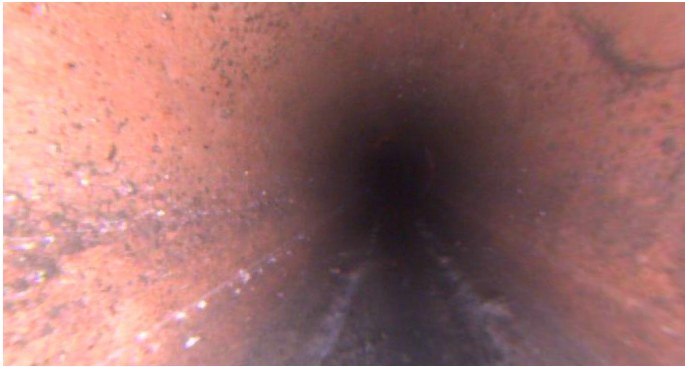
Code:	MWL
Description:	Water Level

Distance (ft):	.0
Structural Grade:	0
O&M Grade:	0
Clock Start/From:	
Clock To:	
1st Value:	
2nd Value:	
Value Percent:	10.000
Continuous Index:	
Within 8" of Joint:	NO
Remarks:

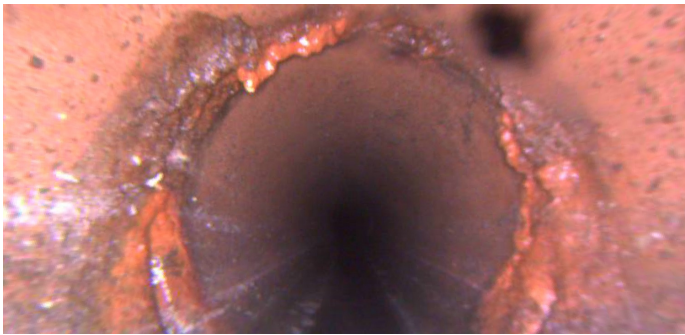
Code:	ID
Description:	Infil Dripper

Distance (ft):	4.1
Structural Grade:	0
O&M Grade:	3
Clock Start/From:	11
Clock To:	
1st Value:	
2nd Value:	
Value Percent:	
Continuous Index:	
Within 8" of Joint:	YES
Remarks:

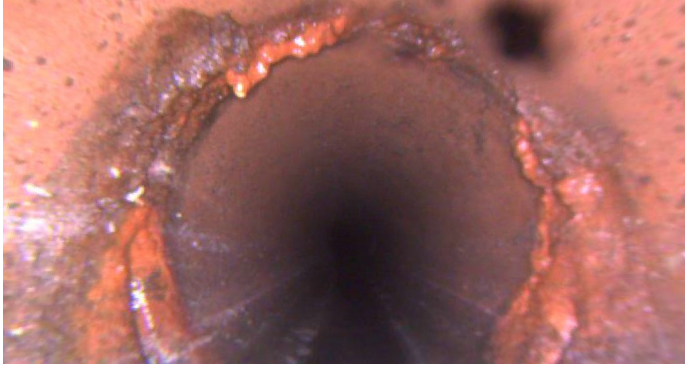
Code: **DAE**
Description: **Deposits Attached Encrustation**

Distance (ft): **4.1**
Structural Grade: **0**
O&M Grade: **2**
Clock Start/From: **7**
Clock To: **5**
1st Value:
2nd Value:
Value Percent: **5.000**
Continuous Index:
Within 8" of Joint: **YES**
Remarks:

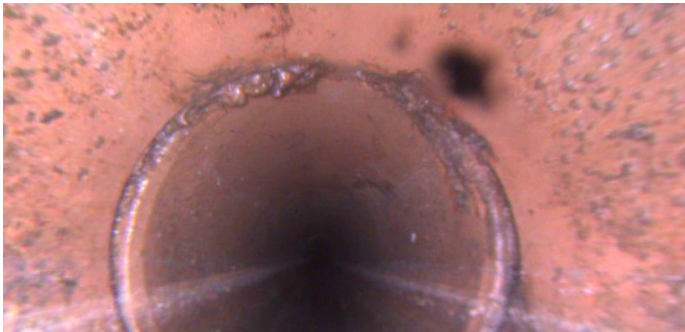
Code: **ID**
Description: **Infil Dripper**

Distance (ft): **28.9**
Structural Grade: **0**
O&M Grade: **3**
Clock Start/From: **12**
Clock To:
1st Value:
2nd Value:
Value Percent:
Continuous Index:
Within 8" of Joint: **YES**
Remarks:

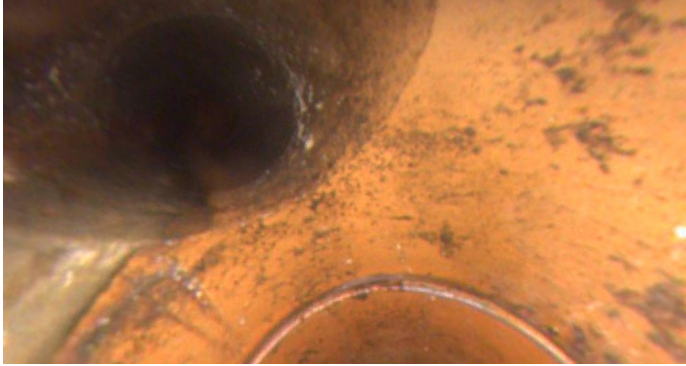
Code: **TF**
Description: **Tap Factory**

Distance (ft): **35.3**
Structural Grade: **0**
O&M Grade: **0**
Clock Start/From: **2**
Clock To:
1st Value: **4.000**
2nd Value:
Value Percent:
Continuous Index:
Within 8" of Joint:
Remarks:

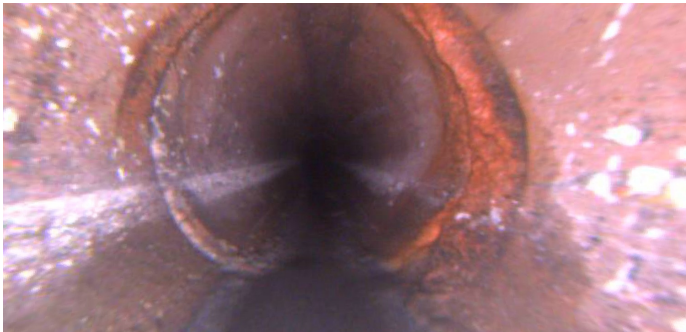
Code: **DAE**
Description: **Deposits Attached Encrustation**

Distance (ft): **35.8**
Structural Grade: **0**
O&M Grade: **2**
Clock Start/From: **8**
Clock To: **4**
1st Value:
2nd Value:
Value Percent: **5.000**
Continuous Index:
Within 8" of Joint: **YES**
Remarks:

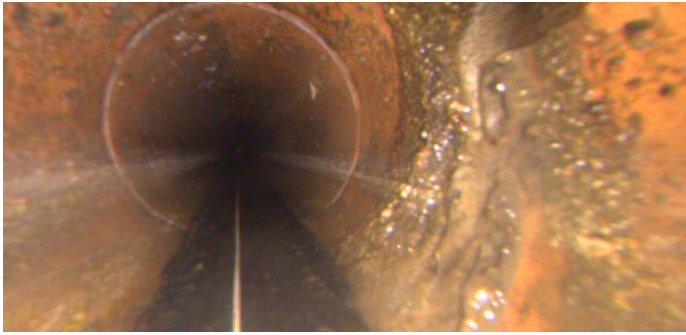
Code: **DAE**
Description: **Deposits Attached Encrustation**

Distance (ft): **47.6**
Structural Grade: **0**
O&M Grade: **2**
Clock Start/From: **8**
Clock To: **10**
1st Value:
2nd Value:
Value Percent: **5.000**
Continuous Index:
Within 8" of Joint: **NO**
Remarks:

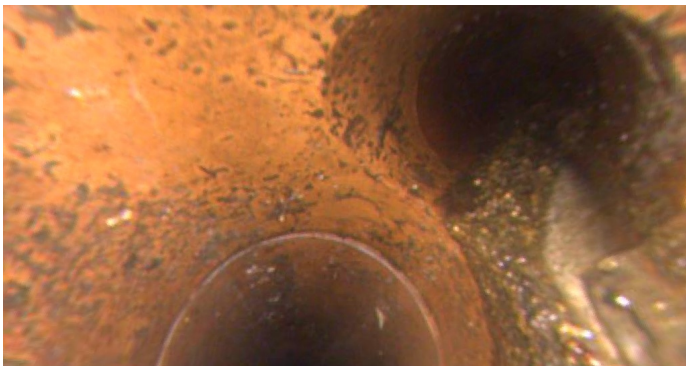
Code: **TF**
Description: **Tap Factory**

Distance (ft): **47.6**
Structural Grade: **0**
O&M Grade: **0**
Clock Start/From: **10**
Clock To:
1st Value: **4.000**
2nd Value:
Value Percent:
Continuous Index:
Within 8" of Joint:
Remarks:

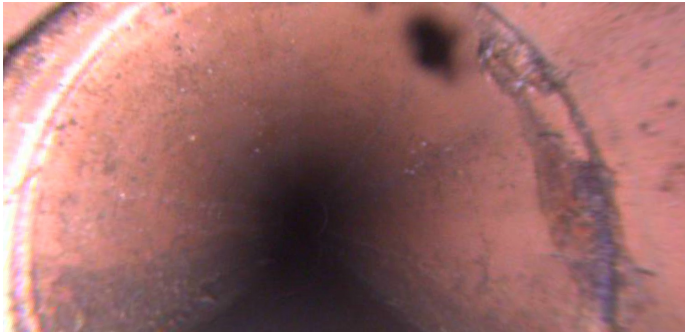
Code: **IS**
Description: **Infil Stain**

Distance (ft): **58.2**
Structural Grade: **0**
O&M Grade: **0**
Clock Start/From: **1**
Clock To: **3**
1st Value:
2nd Value:
Value Percent:
Continuous Index:
Within 8" of Joint: **YES**
Remarks:

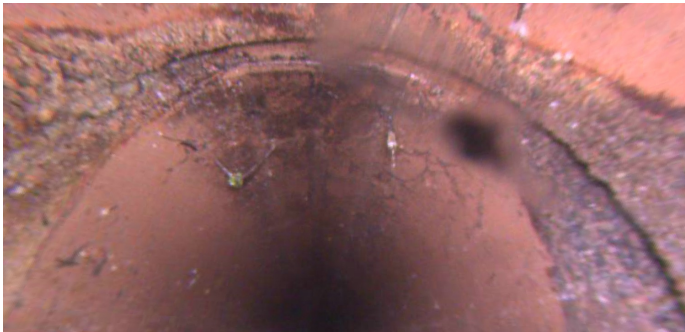
Code: **DAE**
Description: **Deposits Attached Encrustation**

Distance (ft): **83.2**
Structural Grade: **0**
O&M Grade: **2**
Clock Start/From: **8**
Clock To: **4**
1st Value:
2nd Value:
Value Percent: **5.000**
Continuous Index:
Within 8" of Joint: **YES**
Remarks:
