## Profile/Photo Observation Report

Street:	<b>W 40th ave</b>	Flow Control:	<b>Not Controlled</b>
City:	<b>Hobart, IN</b>	Year Renewed:	
Location:	<b>Other</b>	Tape/Media #:	
Purpose:	<b>Not Known</b>	Dia/Height:	<b>10"</b>
Use:	<b>Sanitary</b>	Material:	<b>VCP</b>
Drain Area:	<b>NA</b>	Lining:	
Category:	<b>NA</b>		
Comment:

Location Details:		Direction of Survey:	<b>Downstream</b>
US MH:	<b>M-503-051</b>	DS MH:	<b>M-503-050</b>
		Total Length Surveyed (ft):	<b>118.7</b>

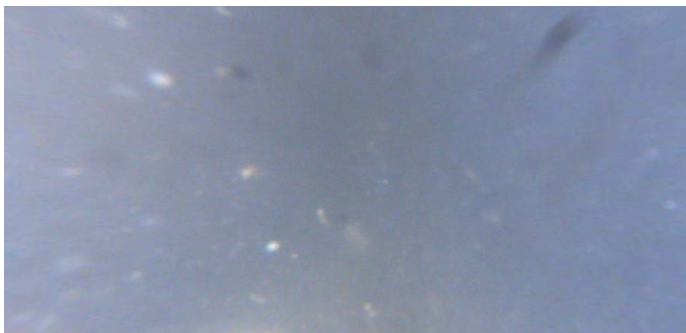
Code: **AMH**  
Description: **Manhole**

Distance (ft): **.0**  
Structural Grade: **0**  
O&M Grade: **0**  
Clock Start/From:  
Clock To:  
1st Value:  
2nd Value:  
Value Percent:  
Continuous Index:  
Within 8" of Joint: **NO**  
Remarks: **M-503-051**

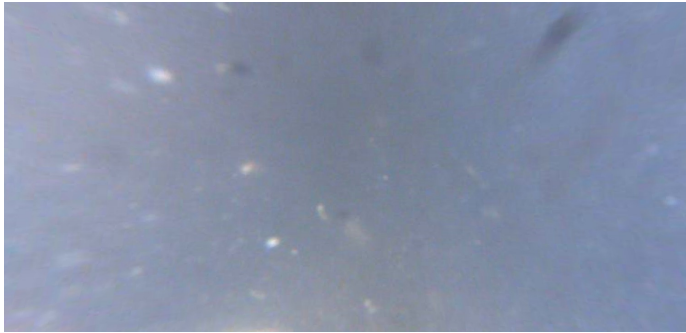
Code:	<b>MWL</b>
Description:	<b>Water Level</b>

Distance (ft):	<b>.0</b>
Structural Grade:	<b>0</b>
O&M Grade:	<b>0</b>
Clock Start/From:	
Clock To:	
1st Value:	
2nd Value:	
Value Percent:	<b>100.000</b>
Continuous Index:	
Within 8" of Joint:	<b>NO</b>
Remarks:

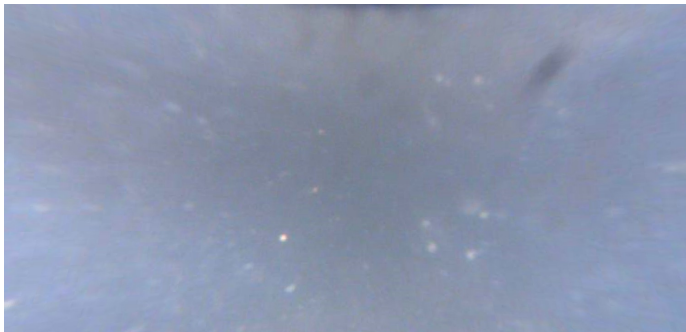
Code:	<b>MCU</b>
Description:	<b>Camera Underwater</b>

Distance (ft):	<b>1.5</b>
Structural Grade:	<b>0</b>
O&M Grade:	<b>4</b>
Clock Start/From:	
Clock To:	
1st Value:	
2nd Value:	
Value Percent:	
Continuous Index:	<b>S01</b>
Within 8" of Joint:	<b>NO</b>
Remarks:

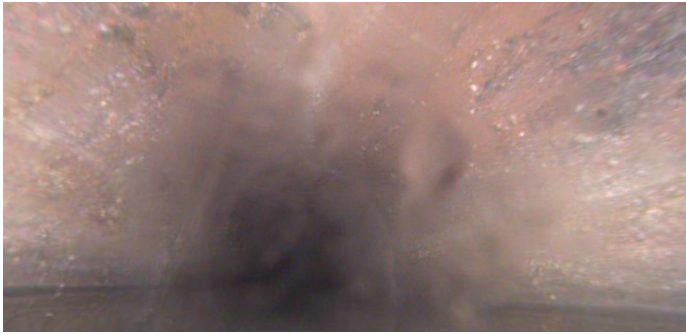
Code: **MCU**  
Description: **Camera Underwater**

Distance (ft): **8.4**  
Structural Grade: **0**  
O&M Grade: **4**  
Clock Start/From:  
Clock To:  
1st Value:  
2nd Value:  
Value Percent:  
Continuous Index: **F01**  
Within 8" of Joint: **NO**  
Remarks:

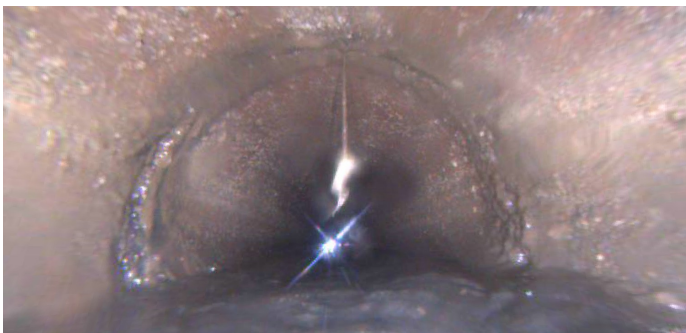
Code: **RFJ**  
Description: **Roots Fine Joint**

Distance (ft): **15.2**  
Structural Grade: **0**  
O&M Grade: **1**  
Clock Start/From: **12**  
Clock To:  
1st Value:  
2nd Value:  
Value Percent:  
Continuous Index:  
Within 8" of Joint: **YES**  
Remarks:

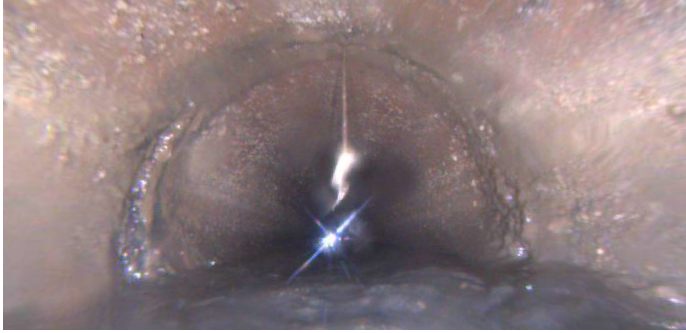
Code: **IW**  
Description: **Infil Weeper**

Distance (ft): **15.2**  
Structural Grade: **0**  
O&M Grade: **2**  
Clock Start/From: **8**  
Clock To: **4**  
1st Value:  
2nd Value:  
Value Percent:  
Continuous Index:  
Within 8" of Joint: **YES**  
Remarks:

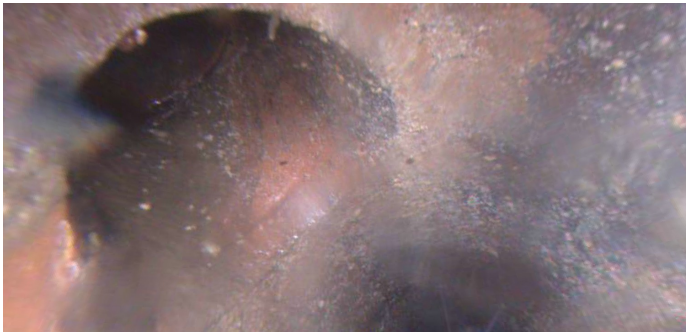
Code: **TFD**  
Description: **Tap Factory Defective**

Distance (ft): **16.2**  
Structural Grade: **0**  
O&M Grade: **2**  
Clock Start/From: **1**  
Clock To:  
1st Value: **4.000**  
2nd Value:  
Value Percent:  
Continuous Index:  
Within 8" of Joint:  
Remarks: **ROOTS**

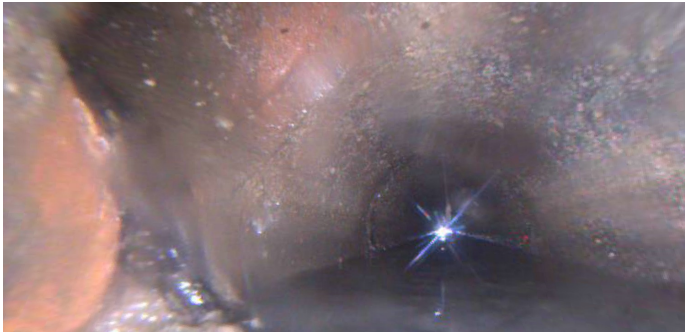
Code: **DAE**  
Description: **Deposits Attached Encrustation**

Distance (ft): **16.2**  
Structural Grade: **0**  
O&M Grade: **2**  
Clock Start/From: **3**  
Clock To: **4**  
1st Value:  
2nd Value:  
Value Percent: **5.000**  
Continuous Index:  
Within 8" of Joint: **NO**  
Remarks:

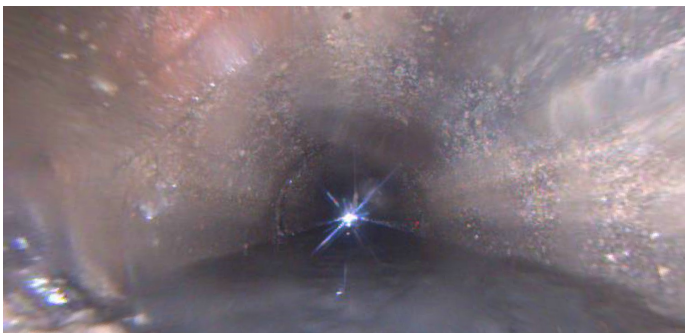
Code: **DAGS**  
Description: **Deposits Attached Grease**

Distance (ft): **16.2**  
Structural Grade: **0**  
O&M Grade: **2**  
Clock Start/From: **8**  
Clock To: **4**  
1st Value:  
2nd Value:  
Value Percent: **5.000**  
Continuous Index: **S02**  
Within 8" of Joint: **NO**  
Remarks:

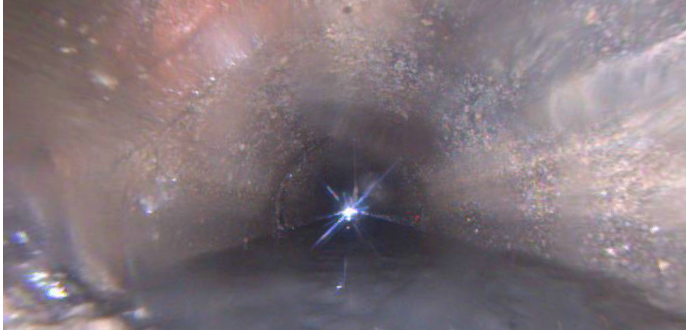
Code: **MGO**  
Description: **General Observation**

Distance (ft): **16.2**  
Structural Grade: **0**  
O&M Grade: **0**  
Clock Start/From:  
Clock To:  
1st Value:  
2nd Value:  
Value Percent:  
Continuous Index:  
Within 8" of Joint: **NO**  
Remarks: **REAR CAMERA**

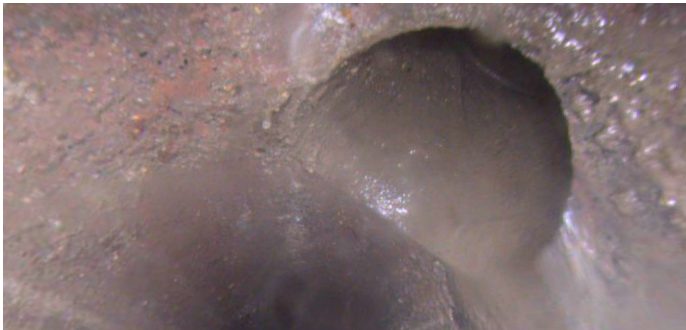
Code: **TF**  
Description: **Tap Factory**

Distance (ft): **28.5**  
Structural Grade: **0**  
O&M Grade: **0**  
Clock Start/From: **11**  
Clock To:  
1st Value: **4.000**  
2nd Value:  
Value Percent:  
Continuous Index:  
Within 8" of Joint:  
Remarks:

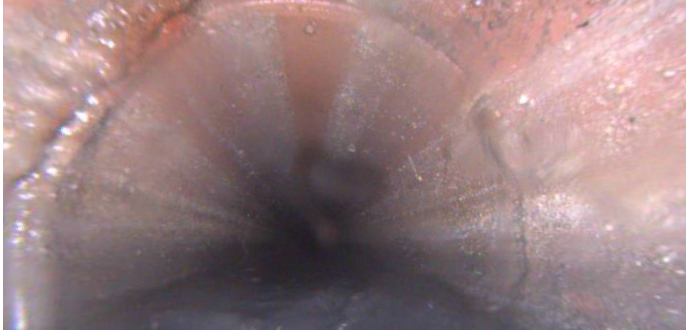
Code: **DAE**  
Description: **Deposits Attached Encrustation**

Distance (ft): **34.4**  
Structural Grade: **0**  
O&M Grade: **2**  
Clock Start/From: **8**  
Clock To: **4**  
1st Value:  
2nd Value:  
Value Percent: **5.000**  
Continuous Index:  
Within 8" of Joint: **YES**  
Remarks:

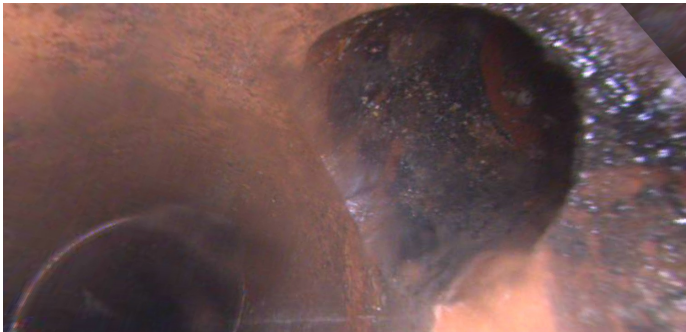
Code: **TF**  
Description: **Tap Factory**

Distance (ft): **76.0**  
Structural Grade: **0**  
O&M Grade: **0**  
Clock Start/From: **10**  
Clock To:  
1st Value: **4.000**  
2nd Value:  
Value Percent:  
Continuous Index:  
Within 8" of Joint:  
Remarks:

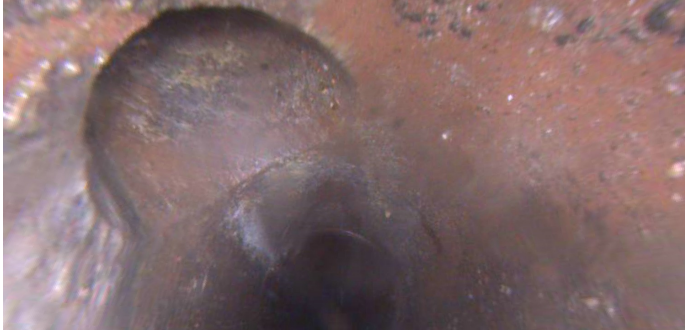
Code: **TF**  
Description: **Tap Factory**

Distance (ft): **93.4**  
Structural Grade: **0**  
O&M Grade: **0**  
Clock Start/From: **11**  
Clock To:  
1st Value: **4.000**  
2nd Value:  
Value Percent:  
Continuous Index:  
Within 8" of Joint:  
Remarks:

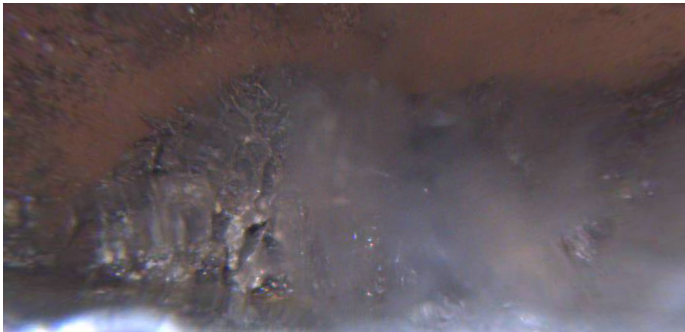
Code: **RBB**  
Description: **Roots Ball Barrel**

Distance (ft): **118.0**  
Structural Grade: **0**  
O&M Grade: **5**  
Clock Start/From: **12**  
Clock To: **12**  
1st Value:  
2nd Value:  
Value Percent: **100.000**  
Continuous Index:  
Within 8" of Joint: **NO**  
Remarks:
