Profile/Photo Observation Report

Date:	04/14/2018	Weather:		Coding:	PACP 6.0
Pipe Length (ft):	280.8	Owner:	NA	Pre Clean:	Not Known
P.O.#:		Surveyor:	Jen Costello	PSR:	P-503-050-051
Customer:		Clean Date:	01/01/1900	Shape:	C

Street:	N COLORADO ST	Flow Control:	Not Controlled
City:	Hobart, IN	Year Renewed:	
Location:	Other	Tape/Media #:	
Purpose:	Not Known	Dia/Height:	10"
Use:	Sanitary	Material:	VCP
Drain Area:	NA	Lining:	
Category:	NA		
Comment:

Location Details:		Direction of Survey:	Upstream
US MH:	M-503-051	DS MH:	M-503-050
		Total Length Surveyed (ft):	157.3

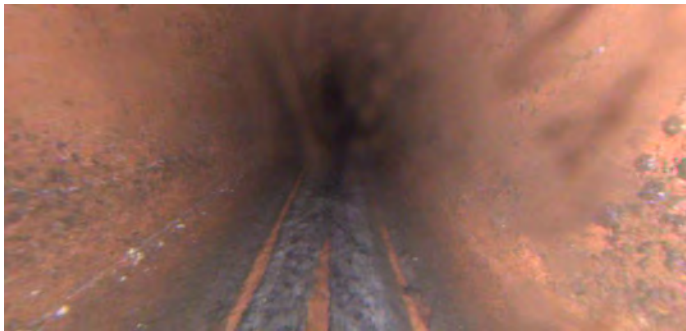
Code: **AMH**
Description: **Manhole**

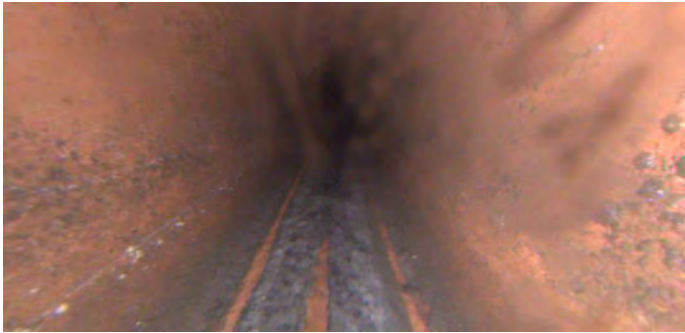
Code:	MWL
Description:	Water Level

Distance (ft):	.0
Structural Grade:	0
O&M Grade:	0
Clock Start/From:	
Clock To:	
1st Value:	
2nd Value:	
Value Percent:	5.000
Continuous Index:	
Within 8" of Joint:	NO
Remarks:

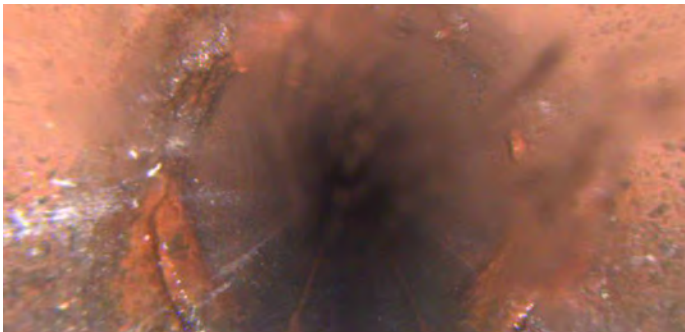
Code:	ID
Description:	Infil Dripper

Distance (ft):	4.1
Structural Grade:	0
O&M Grade:	3
Clock Start/From:	10
Clock To:	2
1st Value:	
2nd Value:	
Value Percent:	
Continuous Index:	
Within 8" of Joint:	YES
Remarks:

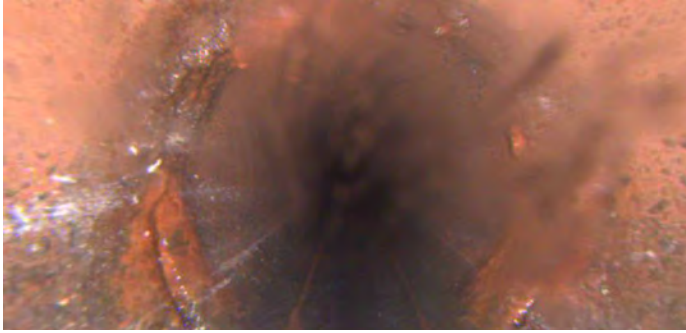
Code: **DAE**
Description: **Deposits Attached Encrustation**

Distance (ft): **4.1**
Structural Grade: **0**
O&M Grade: **2**
Clock Start/From: **8**
Clock To: **4**
1st Value:
2nd Value:
Value Percent: **5.000**
Continuous Index:
Within 8" of Joint: **YES**
Remarks:

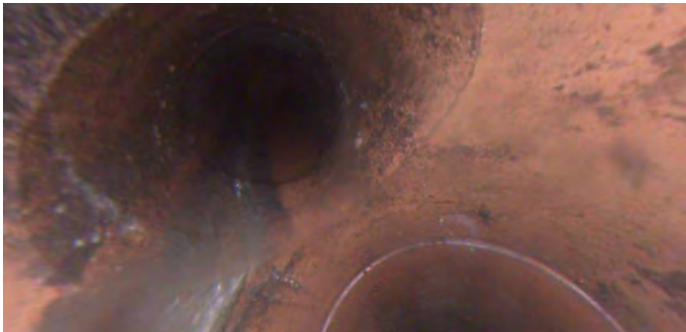
Code: **TF**
Description: **Tap Factory**

Distance (ft): **34.9**
Structural Grade: **0**
O&M Grade: **0**
Clock Start/From: **1**
Clock To:
1st Value: **4.000**
2nd Value:
Value Percent:
Continuous Index:
Within 8" of Joint:
Remarks:

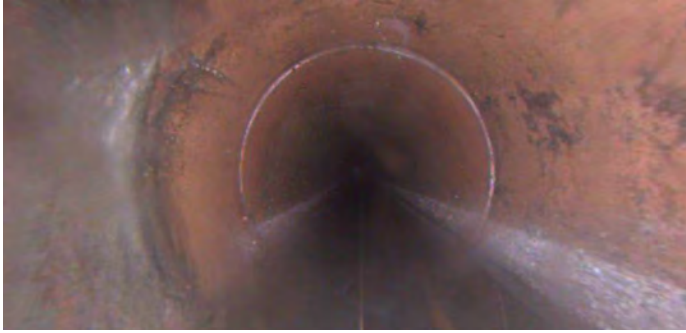
Code: **MGO**
Description: **General Observation**

Distance (ft): **34.9**
Structural Grade: **0**
O&M Grade: **0**
Clock Start/From:
Clock To:
1st Value:
2nd Value:
Value Percent:
Continuous Index:
Within 8" of Joint: **NO**
Remarks: **REAR CAMERA**

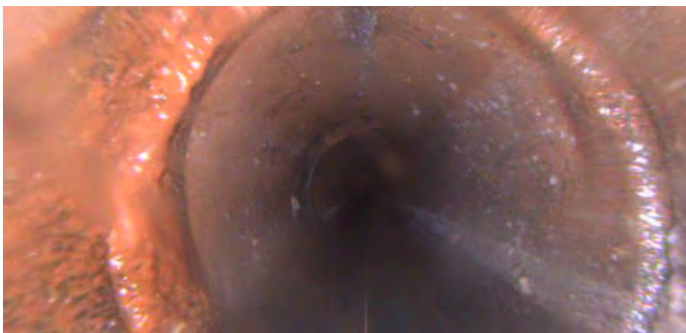
Code: **IW**
Description: **Infil Weeper**

Distance (ft): **36.3**
Structural Grade: **0**
O&M Grade: **2**
Clock Start/From: **8**
Clock To: **4**
1st Value:
2nd Value:
Value Percent:
Continuous Index:
Within 8" of Joint: **YES**
Remarks:

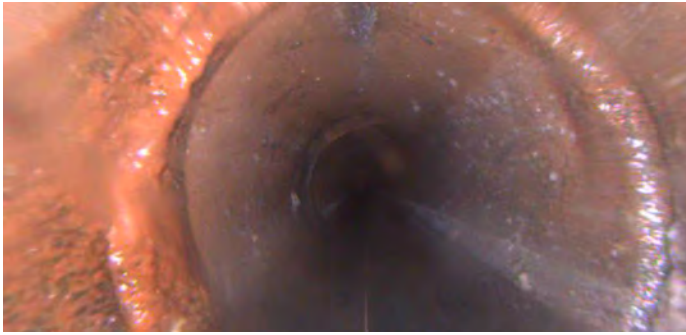
Code: **DAE**
Description: **Deposits Attached Encrustation**

Distance (ft): **36.3**
Structural Grade: **0**
O&M Grade: **2**
Clock Start/From: **8**
Clock To: **4**
1st Value:
2nd Value:
Value Percent: **5.000**
Continuous Index:
Within 8" of Joint: **YES**
Remarks:

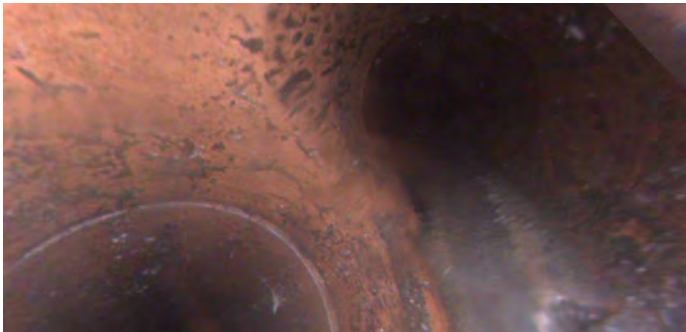
Code: **TFA**
Description: **Tap Factory Active**

Distance (ft): **46.8**
Structural Grade: **0**
O&M Grade: **0**
Clock Start/From: **11**
Clock To:
1st Value: **4.000**
2nd Value:
Value Percent:
Continuous Index:
Within 8" of Joint:
Remarks:

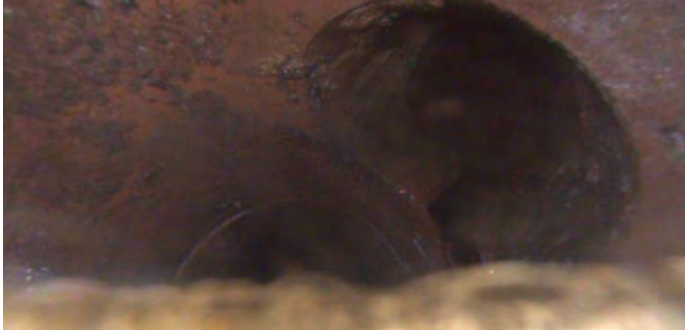
Code: **TFA**
Description: **Tap Factory Active**

Distance (ft): **113.9**
Structural Grade: **0**
O&M Grade: **0**
Clock Start/From: **10**
Clock To:
1st Value: **4.000**
2nd Value:
Value Percent:
Continuous Index:
Within 8" of Joint:
Remarks:

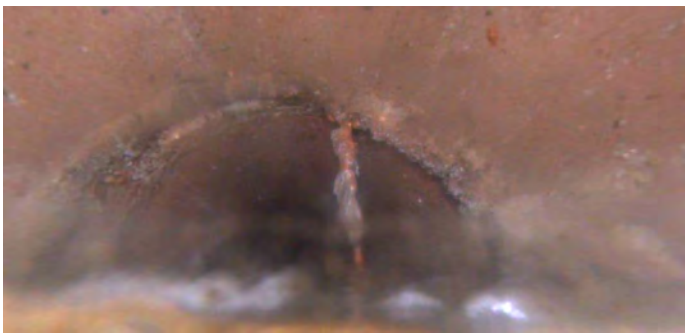
Code: **DAE**
Description: **Deposits Attached Encrustation**

Distance (ft): **120.4**
Structural Grade: **0**
O&M Grade: **2**
Clock Start/From: **8**
Clock To: **4**
1st Value:
2nd Value:
Value Percent: **5.000**
Continuous Index:
Within 8" of Joint: **YES**
Remarks:
