Profile/Photo Observation Report

Date:	04/14/2018	Weather:		Coding:	PACP 6.0
Pipe Length (ft):	280.8	Owner:	NA	Pre Clean:	Not Known
P.O.#:		Surveyor:	Jen Costello	PSR:	P-503-050-051
Customer:		Clean Date:	01/01/1900	Shape:	C

Street:	W 40th ave	Flow Control:	Not Controlled
City:	Hobart, IN	Year Renewed:	
Location:	Other	Tape/Media #:	
Purpose:	Not Known	Dia/Height:	10"
Use:	Sanitary	Material:	VCP
Drain Area:	NA	Lining:	
Category:	NA		
Comment:			
Location Details:		Direction of Survey:	Upstream
US MH:	M-503-051	DS MH:	M-503-050
		Total Length Surveyed (ft):	157.3

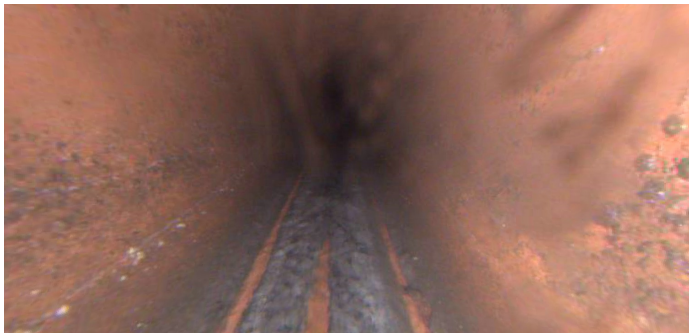
Code: **AMH**
 Description: **Manhole**
 Distance (ft): **.0**
 Structural Grade: **0**
 O&M Grade: **0**
 Clock Start/From:
 Clock To:
 1st Value:
 2nd Value:
 Value Percent:
 Continuous Index:
 Within 8" of Joint: **NO**
 Remarks: **M-503-051**

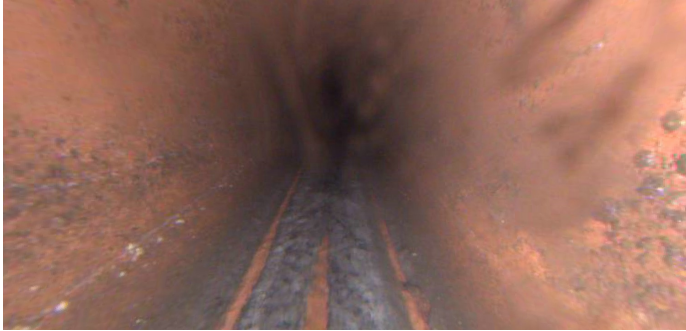
Code: **MWL**
Description: **Water Level**

Distance (ft): **.0**
Structural Grade: **0**
O&M Grade: **0**
Clock Start/From:
Clock To:
1st Value:
2nd Value:
Value Percent: **5.000**
Continuous Index:
Within 8" of Joint: **NO**
Remarks:

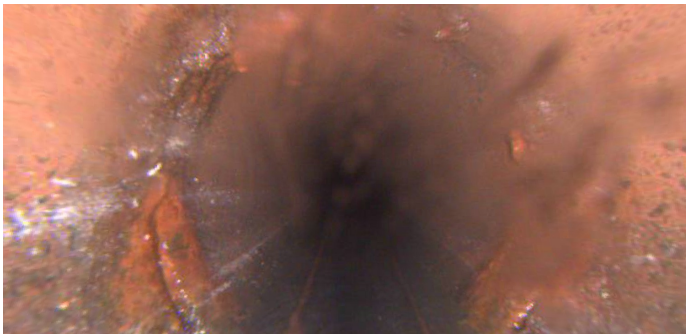
Code: **ID**
Description: **Infil Dripper**

Distance (ft): **4.1**
Structural Grade: **0**
O&M Grade: **3**
Clock Start/From: **10**
Clock To: **2**
1st Value:
2nd Value:
Value Percent:
Continuous Index:
Within 8" of Joint: **YES**
Remarks:

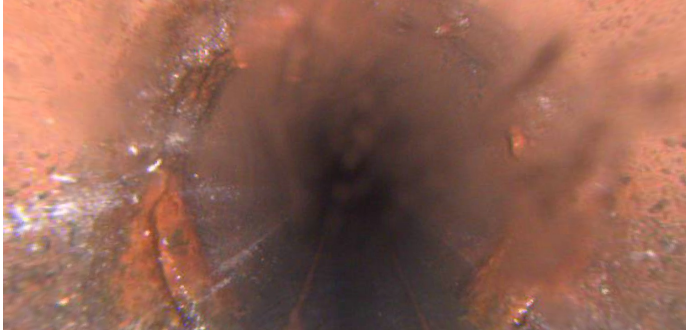
Code: **DAE**
Description: **Deposits Attached Encrustation**

Distance (ft): **4.1**
Structural Grade: **0**
O&M Grade: **2**
Clock Start/From: **8**
Clock To: **4**
1st Value:
2nd Value:
Value Percent: **5.000**
Continuous Index:
Within 8" of Joint: **YES**
Remarks:

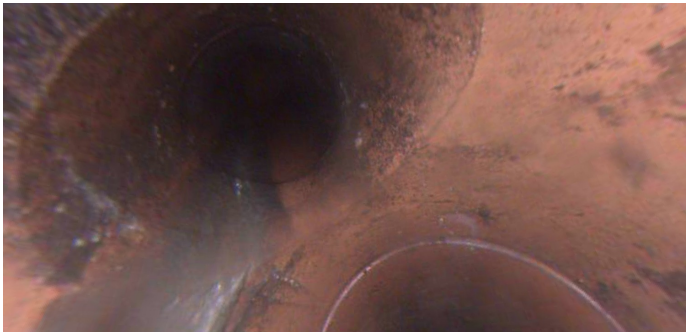
Code: **TF**
Description: **Tap Factory**

Distance (ft): **34.9**
Structural Grade: **0**
O&M Grade: **0**
Clock Start/From: **1**
Clock To:
1st Value: **4.000**
2nd Value:
Value Percent:
Continuous Index:
Within 8" of Joint:
Remarks:

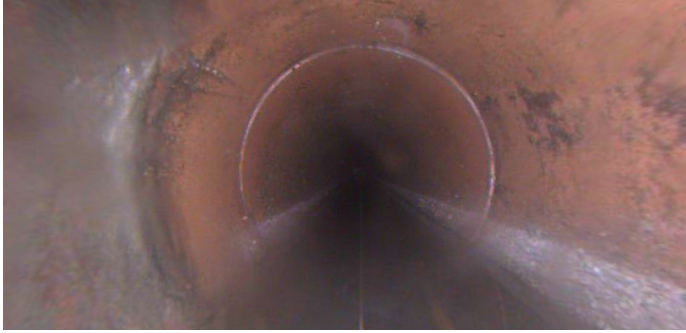
Code: **MGO**
Description: **General Observation**

Distance (ft): **34.9**
Structural Grade: **0**
O&M Grade: **0**
Clock Start/From:
Clock To:
1st Value:
2nd Value:
Value Percent:
Continuous Index:
Within 8" of Joint: **NO**
Remarks: **REAR CAMERA**

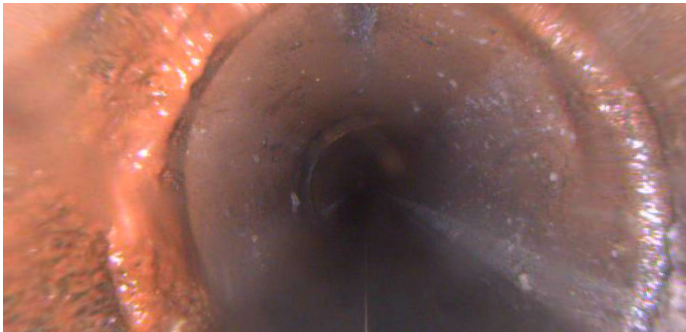
Code: **IW**
Description: **Infil Weeper**

Distance (ft): **36.3**
Structural Grade: **0**
O&M Grade: **2**
Clock Start/From: **8**
Clock To: **4**
1st Value:
2nd Value:
Value Percent:
Continuous Index:
Within 8" of Joint: **YES**
Remarks:

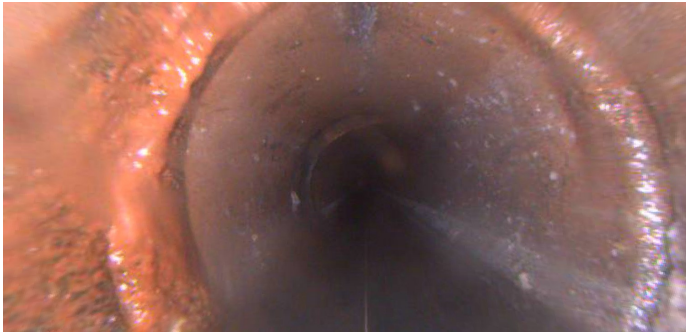
Code: **DAE**
Description: **Deposits Attached Encrustation**

Distance (ft): **36.3**
Structural Grade: **0**
O&M Grade: **2**
Clock Start/From: **8**
Clock To: **4**
1st Value:
2nd Value:
Value Percent: **5.000**
Continuous Index:
Within 8" of Joint: **YES**
Remarks:

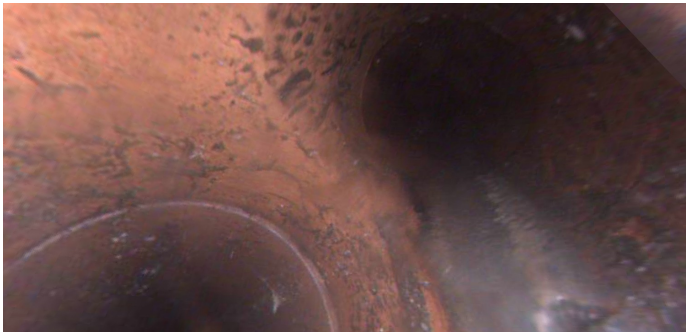
Code: **TFA**
Description: **Tap Factory Active**

Distance (ft): **46.8**
Structural Grade: **0**
O&M Grade: **0**
Clock Start/From: **11**
Clock To:
1st Value: **4.000**
2nd Value:
Value Percent:
Continuous Index:
Within 8" of Joint:
Remarks:

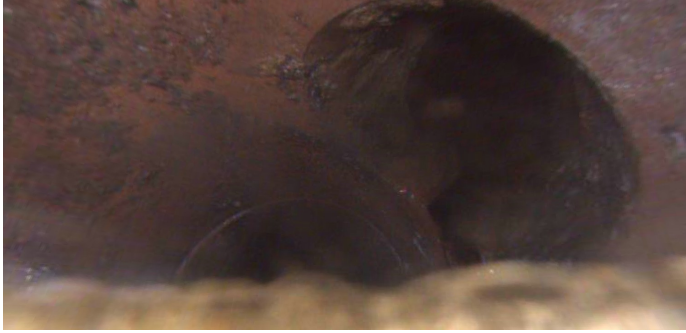
Code: **TFA**
Description: **Tap Factory Active**

Distance (ft): **113.9**
Structural Grade: **0**
O&M Grade: **0**
Clock Start/From: **10**
Clock To:
1st Value: **4.000**
2nd Value:
Value Percent:
Continuous Index:
Within 8" of Joint:
Remarks:

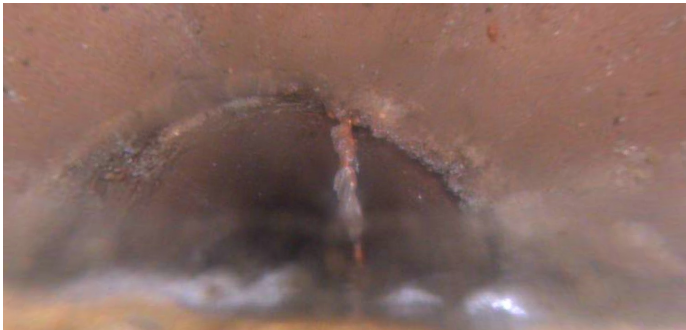
Code: **DAE**
Description: **Deposits Attached Encrustation**

Distance (ft): **120.4**
Structural Grade: **0**
O&M Grade: **2**
Clock Start/From: **8**
Clock To: **4**
1st Value:
2nd Value:
Value Percent: **5.000**
Continuous Index:
Within 8" of Joint: **YES**
Remarks:

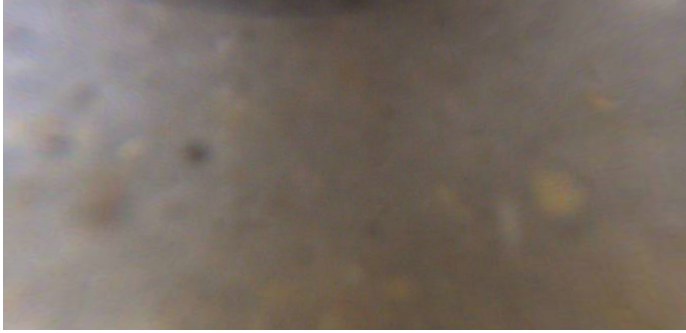
Code: **MWL**
Description: **Water Level**

Distance (ft): **137.3**
Structural Grade: **0**
O&M Grade: **0**
Clock Start/From:
Clock To:
1st Value:
2nd Value:
Value Percent: **100.000**
Continuous Index:
Within 8" of Joint: **NO**
Remarks:

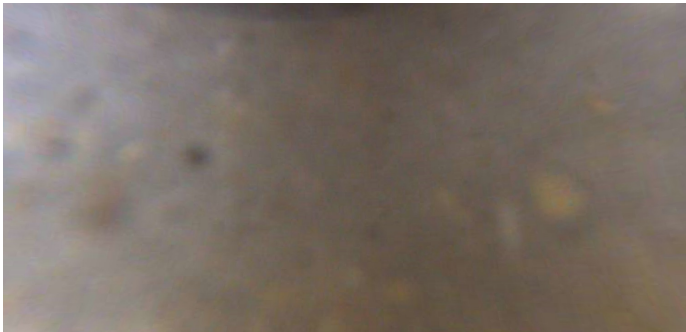
Code: **MCU**
Description: **Camera Underwater**

Distance (ft): **137.3**
Structural Grade: **0**
O&M Grade: **4**
Clock Start/From:
Clock To:
1st Value:
2nd Value:
Value Percent:
Continuous Index: **S01**
Within 8" of Joint: **NO**
Remarks:

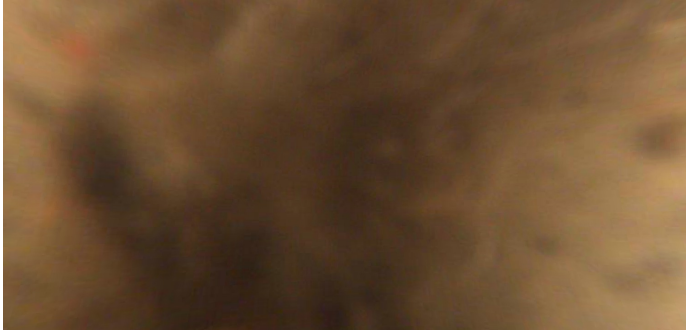
Code: **MCU**
Description: **Camera Underwater**

Distance (ft): **157.3**
Structural Grade: **0**
O&M Grade: **4**
Clock Start/From:
Clock To:
1st Value:
2nd Value:
Value Percent:
Continuous Index: **F01**
Within 8" of Joint: **NO**
Remarks:

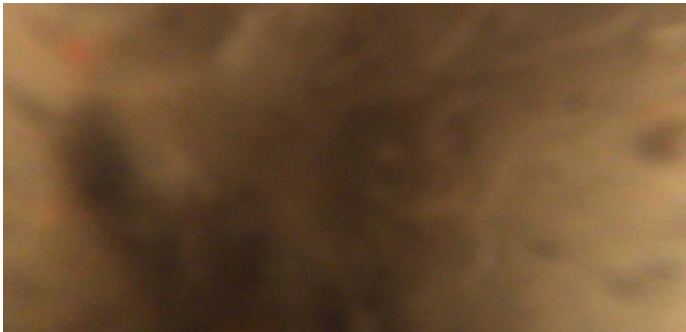
Code: **MSA**
Description: **Abandoned Survey**

Distance (ft): **157.3**
Structural Grade: **0**
O&M Grade: **0**
Clock Start/From:
Clock To:
1st Value:
2nd Value:
Value Percent:
Continuous Index:
Within 8" of Joint: **NO**
Remarks: **MCU**
