Profile/Photo Observation Report

Date:	04/10/2018	Weather:		Coding:	PACP 6.0
Pipe Length (ft):	290.6	Owner:	NA	Pre Clean:	Not Known
P.O.#:		Surveyor:	Jen Costello	PSR:	P-503-051-052
Customer:		Clean Date:	01/01/1900	Shape:	C

Street:	PENNSYLVANIA ST	Flow Control:	Not Controlled
City:	Hobart, IN	Year Renewed:	
Location:	Other	Tape/Media #:	
Purpose:	Not Known	Dia/Height:	10"
Use:	Sanitary	Material:	CP
Drain Area:	NA	Lining:	
Category:	NA		
Comment:

Location Details:		Direction of Survey:	Upstream
US MH:	M-503-052	DS MH:	M-503-051
		Total Length Surveyed (ft):	7.2

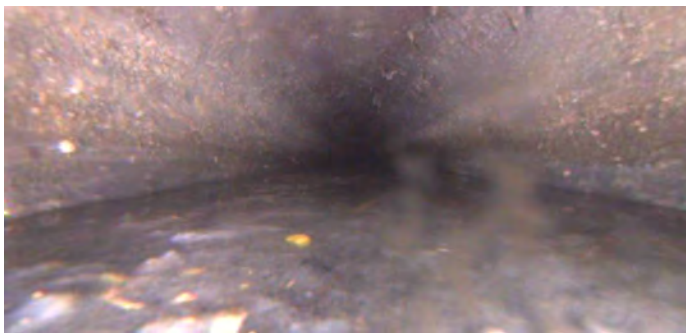
Code: **AMH**
Description: **Manhole**

Distance (ft): **.0**
Structural Grade: **0**
O&M Grade: **0**
Clock Start/From:
Clock To:
1st Value:
2nd Value:
Value Percent:
Continuous Index:
Within 8" of Joint: **NO**
Remarks: **M-503-051**

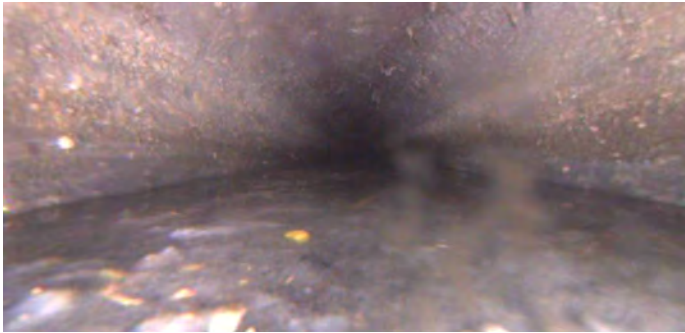
Code:	MWL
Description:	Water Level

Distance (ft):	.0
Structural Grade:	0
O&M Grade:	0
Clock Start/From:	
Clock To:	
1st Value:	
2nd Value:	
Value Percent:	40.000
Continuous Index:	
Within 8" of Joint:	NO
Remarks:

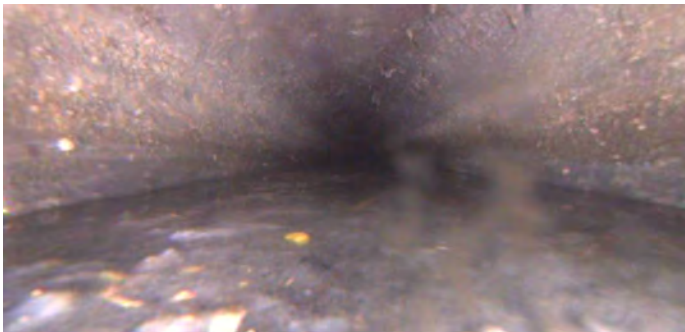
Code:	SAP
Description:	Surface Aggregate Projecting

Distance (ft):	.0
Structural Grade:	3
O&M Grade:	0
Clock Start/From:	8
Clock To:	4
1st Value:	
2nd Value:	
Value Percent:	
Continuous Index:	
Within 8" of Joint:	
Remarks:

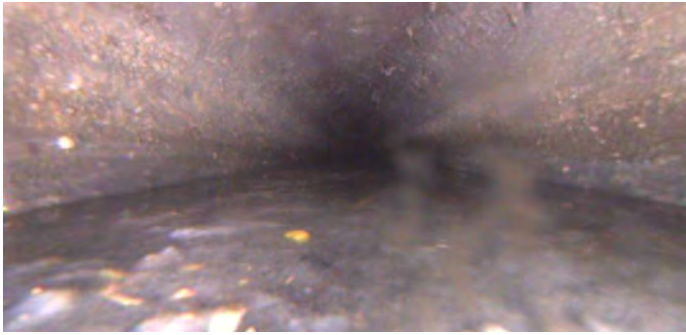
Code: **DAGS**
Description: **Deposits Attached Grease**

Distance (ft): **.0**
Structural Grade: **0**
O&M Grade: **2**
Clock Start/From: **8**
Clock To: **4**
1st Value:
2nd Value:
Value Percent: **5.000**
Continuous Index:
Within 8" of Joint: **NO**
Remarks:

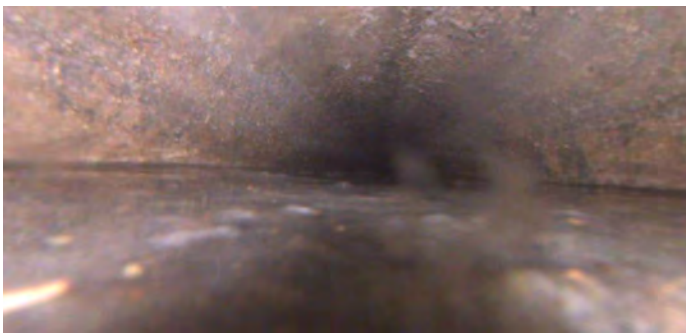
Code: **MSA**
Description: **Abandoned Survey**

Distance (ft): **7.2**
Structural Grade: **0**
O&M Grade: **0**
Clock Start/From:
Clock To:
1st Value:
2nd Value:
Value Percent:
Continuous Index:
Within 8" of Joint: **NO**
Remarks: **debris under water**
