Profile/Photo Observation Report

Street:	W 40th ave	Flow Control:	Not Controlled
City:	Hobart, IN	Year Renewed:	
Location:	Other	Tape/Media #:	
Purpose:	Not Known	Dia/Height:	10"
Use:	Sanitary	Material:	VCP
Drain Area:	NA	Lining:	
Category:	NA		
Comment:

Location Details:		Direction of Survey:	Downstream
US MH:	M-503-052	DS MH:	M-503-051
		Total Length Surveyed (ft):	5.3

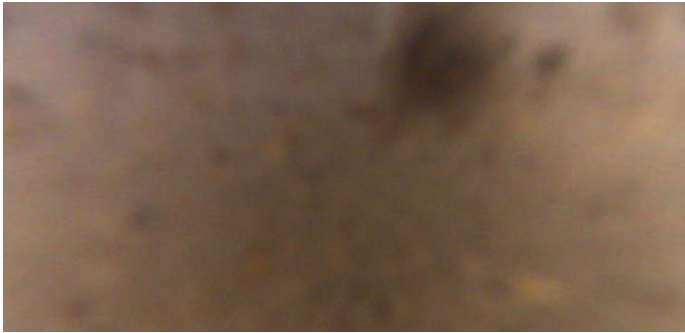
Code:	MWL
Description:	Water Level

Distance (ft):	.0
Structural Grade:	0
O&M Grade:	0
Clock Start/From:	
Clock To:	
1st Value:	
2nd Value:	
Value Percent:	100.000
Continuous Index:	
Within 8" of Joint:	NO
Remarks:

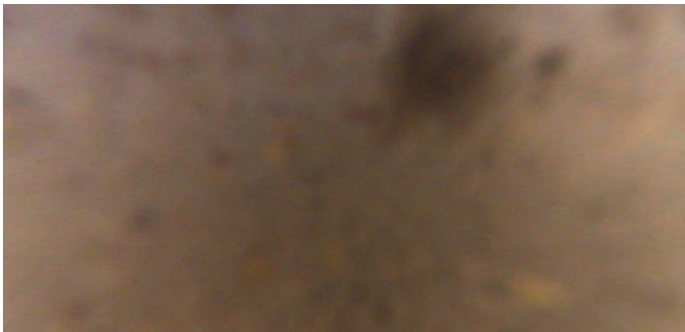
Code:	MCU
Description:	Camera Underwater

Distance (ft):	.0
Structural Grade:	0
O&M Grade:	4
Clock Start/From:	
Clock To:	
1st Value:	
2nd Value:	
Value Percent:	
Continuous Index:	
Within 8" of Joint:	NO
Remarks:
