Profile/Photo Observation Report

Date:	04/14/2018	Weather:		Coding:	PACP 6.0
Pipe Length (ft):	290.6	Owner:	NA	Pre Clean:	Not Known
P.O.#:		Surveyor:	Jen Costello	PSR:	P-503-051-052
Customer:		Clean Date:	01/01/1900	Shape:	C

Street:	PENNSYLVANIA ST	Flow Control:	Not Controlled
City:	Hobart, IN	Year Renewed:	
Location:	Other	Tape/Media #:	
Purpose:	Not Known	Dia/Height:	10"
Use:	Sanitary	Material:	VCP
Drain Area:	NA	Lining:	
Category:	NA		
Comment:

Location Details:		Direction of Survey:	Downstream
US MH:	M-503-052	DS MH:	M-503-051
		Total Length Surveyed (ft):	33.1

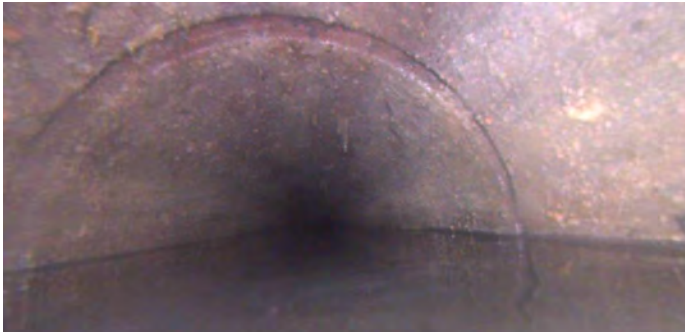
Code:	MWL
Description:	Water Level

Distance (ft):	.0
Structural Grade:	0
O&M Grade:	0
Clock Start/From:	
Clock To:	
1st Value:	
2nd Value:	
Value Percent:	40.000
Continuous Index:	
Within 8" of Joint:	NO
Remarks:

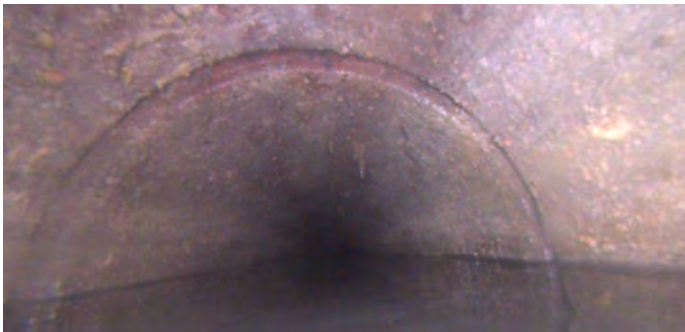
Code:	DAGS
Description:	Deposits Attached Grease

Distance (ft):	.0
Structural Grade:	0
O&M Grade:	2
Clock Start/From:	8
Clock To:	4
1st Value:	
2nd Value:	
Value Percent:	5.000
Continuous Index:	S01
Within 8" of Joint:	NO
Remarks:

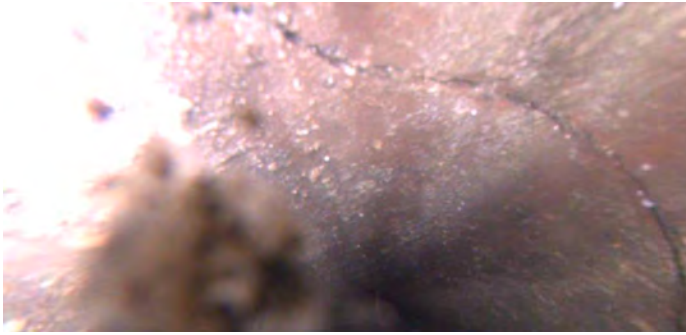
Code: **FC**
Description: **Fracture Circumferential**

Distance (ft): **22.6**
Structural Grade: **2**
O&M Grade: **0**
Clock Start/From: **8**
Clock To: **4**
1st Value:
2nd Value:
Value Percent:
Continuous Index:
Within 8" of Joint:
Remarks:

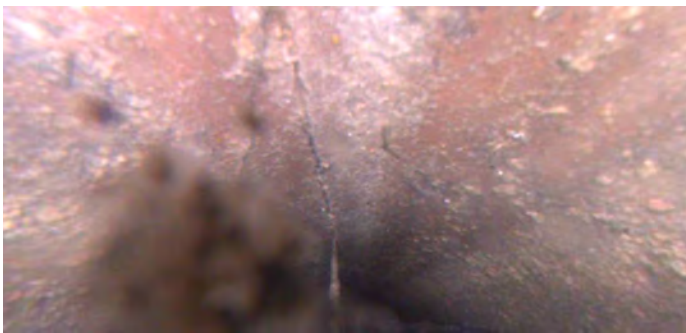
Code: **FL**
Description: **Fracture Longitudinal**

Distance (ft): **24.2**
Structural Grade: **3**
O&M Grade: **0**
Clock Start/From: **12**
Clock To:
1st Value:
2nd Value:
Value Percent:
Continuous Index:
Within 8" of Joint:
Remarks:

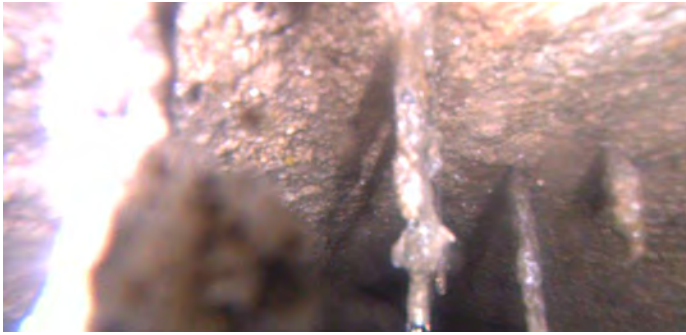
Code: **MSA**
Description: **Abandoned Survey**

Distance (ft): **33.1**
Structural Grade: **0**
O&M Grade: **0**
Clock Start/From:
Clock To:
1st Value:
2nd Value:
Value Percent:
Continuous Index:
Within 8" of Joint: **NO**
Remarks: **dags**

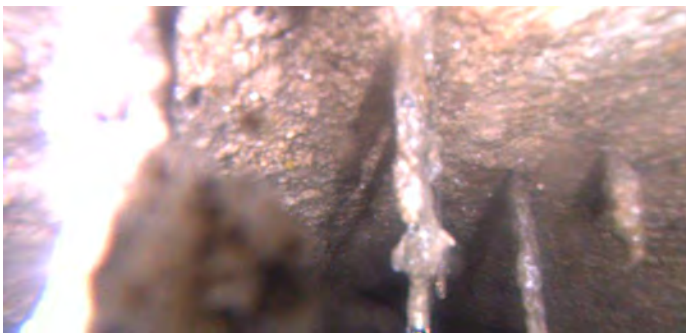
Code: **DAGS**
Description: **Deposits Attached Grease**

Distance (ft): **33.1**
Structural Grade: **0**
O&M Grade: **2**
Clock Start/From: **8**
Clock To: **4**
1st Value:
2nd Value:
Value Percent: **5.000**
Continuous Index: **F01**
Within 8" of Joint: **NO**
Remarks:
