Profile/Photo Observation Report

Date:	09/17/2021	Weather:		Coding:	PACP 7.0
Pipe Length (ft):	291.0	Owner:	City of Hobart	Pre Clean:	Light Cleaning
P.O.#:	YES502259	Surveyor:	S. Bucklin	PSR:	P-503-051-052
Customer:	City of Hobart	Clean Date:	08/25/2021	Shape:	C

Street:	West 38th Place	Flow Control:	Not Controlled
City:	Hobart, IN	Year Renewed:	
Location:	Alley	Tape/Media #:	
Purpose:	Routine Assessment	Dia/Height:	10"
Use:	Sanitary Sewage Pipe	Material:	VCP
Drain Area:		Lining:	None
Category:	NA		
Comment:

Location Details:		Direction of Survey:	Downstream
US MH:	M-503-052	DS MH:	M-503-051
		Total Length Surveyed (ft):	92.0

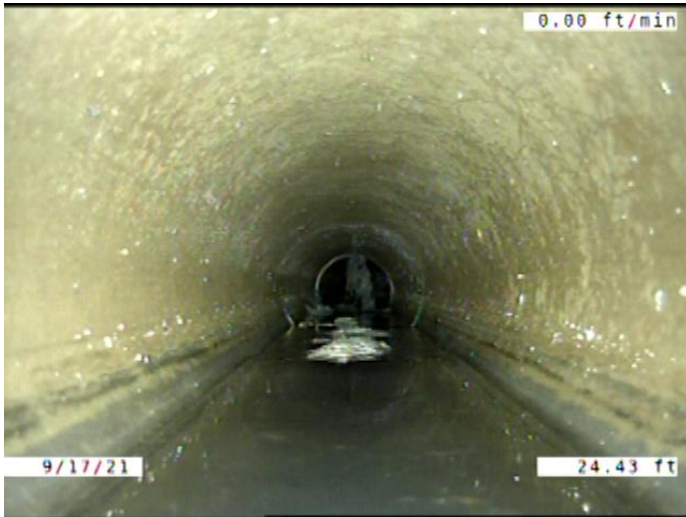
Code: **B**
Description: **Broken**

Distance (ft): **24.4**
Structural Grade: **4**
O&M Grade: **0**
Clock Start/From: **12**
Clock To: **12**
1st Value:
2nd Value:
Value Percent:
Continuous Index: **F02**
Within 8" of Joint: **YES**
Remarks:

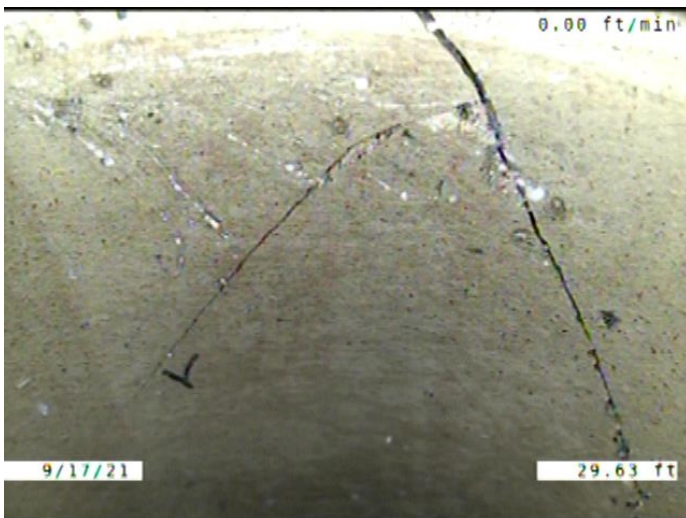
Code: **FM**
Description: **Fracture Multiple**

Distance (ft): **29.6**
Structural Grade: **4**
O&M Grade: **0**
Clock Start/From: **12**
Clock To: **12**
1st Value:
2nd Value:
Value Percent:
Continuous Index: **S03**
Within 8" of Joint: **YES**
Remarks:

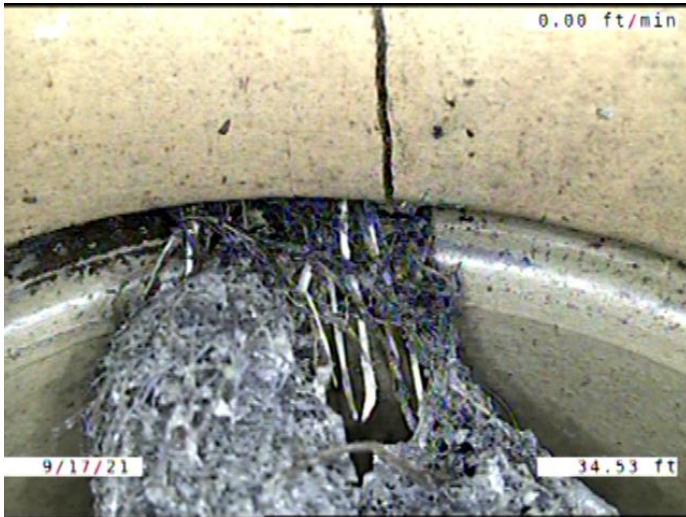
Code: **RMJ**
Description: **Roots Medium Joint**

Distance (ft): **34.5**
Structural Grade: **0**
O&M Grade: **3**
Clock Start/From: **8**
Clock To: **4**
1st Value:
2nd Value:
Value Percent: **5.000**
Continuous Index:
Within 8" of Joint: **YES**
Remarks:

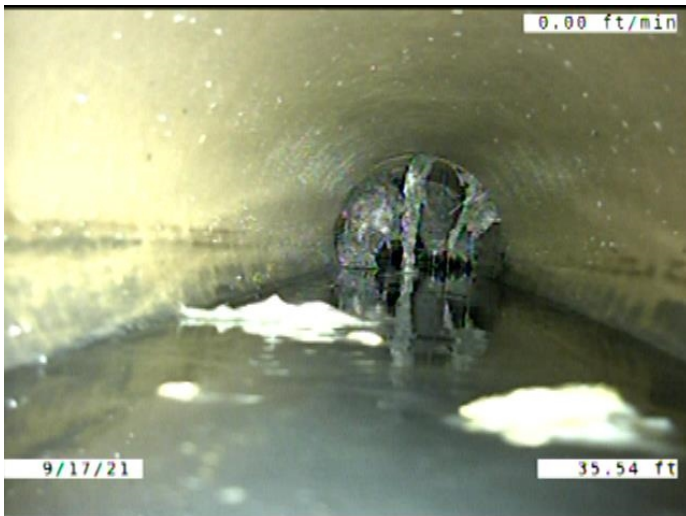
Code: **FM**
Description: **Fracture Multiple**

Distance (ft): **35.5**
Structural Grade: **4**
O&M Grade: **0**
Clock Start/From: **12**
Clock To: **12**
1st Value:
2nd Value:
Value Percent:
Continuous Index: **F03**
Within 8" of Joint: **YES**
Remarks:

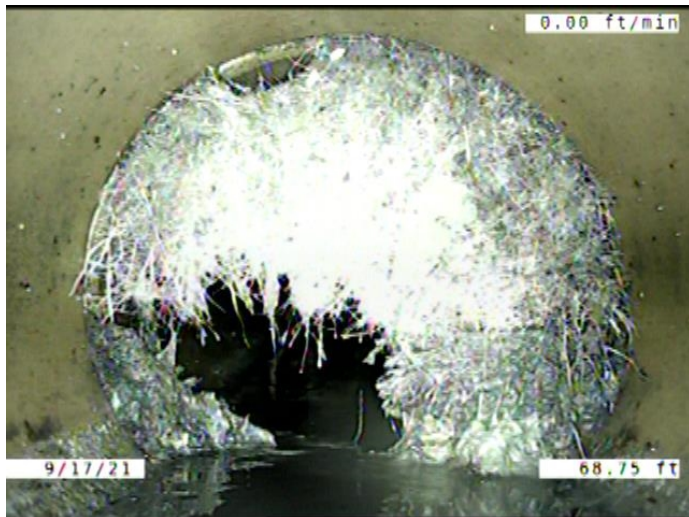
Code: **RBJ**
 Description: **Roots Ball Joint**

Distance (ft): **68.7**
 Structural Grade: **0**
 O&M Grade: **4**
 Clock Start/From: **7**
 Clock To: **5**
 1st Value:
 2nd Value:
 Value Percent: **75.000**
 Continuous Index:
 Within 8" of Joint: **YES**
 Remarks:

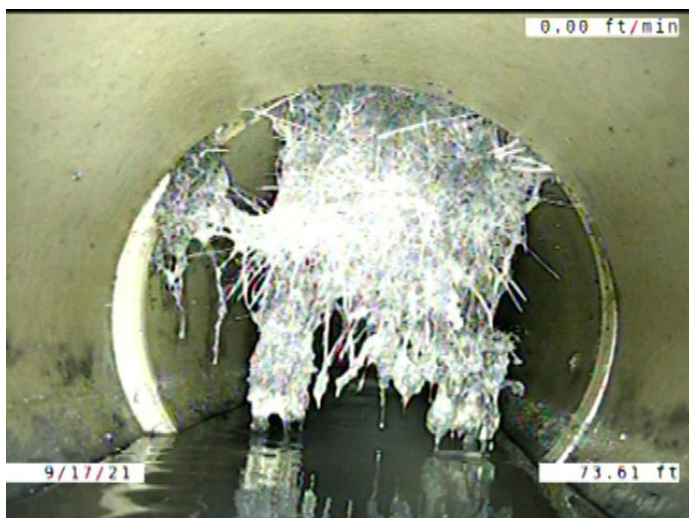
Code: **RMJ**
 Description: **Roots Medium Joint**

Distance (ft): **73.6**
 Structural Grade: **0**
 O&M Grade: **3**
 Clock Start/From: **10**
 Clock To: **2**
 1st Value:
 2nd Value:
 Value Percent: **35.000**
 Continuous Index:
 Within 8" of Joint: **YES**
 Remarks:

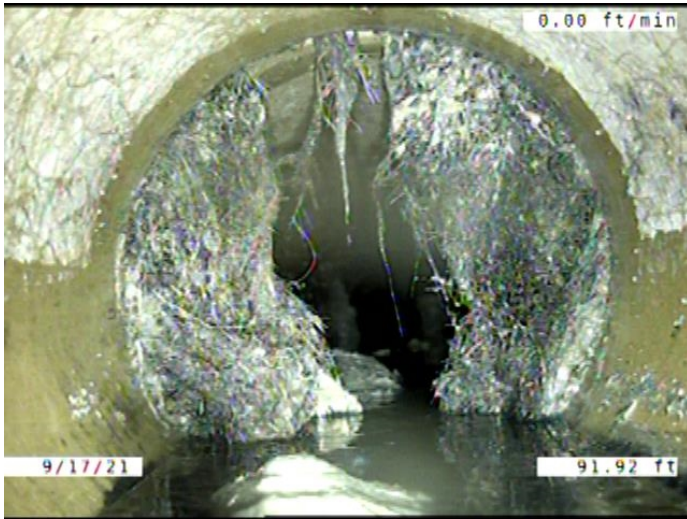
Code: **DSF**
 Description: **Deposits Settled Fine**

Distance (ft): **91.9**
 Structural Grade: **0**
 O&M Grade: **2**
 Clock Start/From: **5**
 Clock To: **7**
 1st Value:
 2nd Value:
 Value Percent: **5.000**
 Continuous Index: **F01**
 Within 8" of Joint: **YES**
 Remarks:

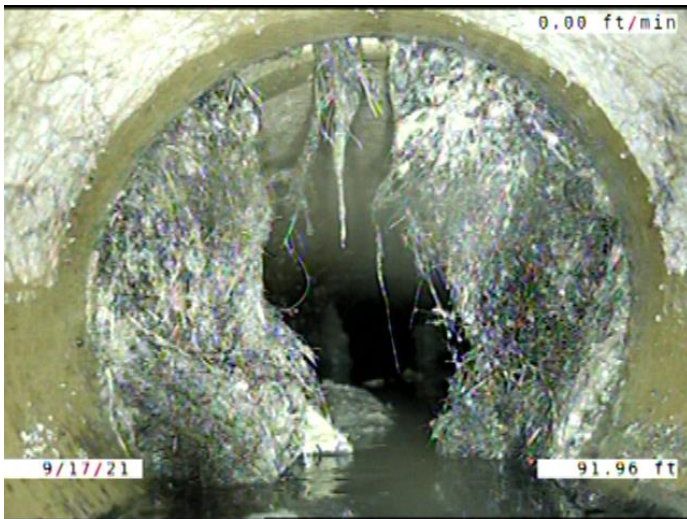
Code: **MSA**
 Description: **Miscellaneous Survey Abandoned**

Distance (ft): **92.0**
 Structural Grade: **0**
 O&M Grade: **0**
 Clock Start/From:
 Clock To:
 1st Value:
 2nd Value:
 Value Percent:
 Continuous Index:
 Within 8" of Joint: **NO**
 Remarks: **CAMERA CANT MAKE IT PAST ROOTS**
