Profile/Photo Observation Report

Date:	09/17/2021	Weather:		Coding:	PACP 7.0
Pipe Length (ft):	291.0	Owner:	City of Hobart	Pre Clean:	Light Cleaning
P.O.#:	YES502259	Surveyor:	S. Bucklin	PSR:	P-503-051-052
Customer:	City of Hobart	Clean Date:	08/25/2021	Shape:	C

Street:	West 38th Place	Flow Control:	Not Controlled
City:	Hobart, IN	Year Renewed:	
Location:	Alley	Tape/Media #:	
Purpose:	Routine Assessment	Dia/Height:	10"
Use:	Sanitary Sewage Pipe	Material:	VCP
Drain Area:		Lining:	None
Category:	NA		
Comment:

Location Details:		Direction of Survey:	Downstream
US MH:	M-503-052	DS MH:	M-503-051
		Total Length Surveyed (ft):	92.0

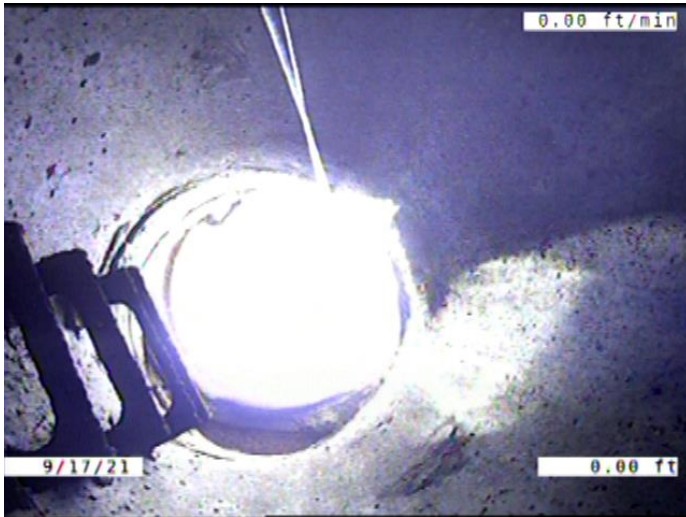
Code: **AMH**
 Description: **Manhole**

Distance (ft): **.0**
 Structural Grade: **0**
 O&M Grade: **0**
 Clock Start/From:
 Clock To:
 1st Value:
 2nd Value:
 Value Percent:
 Continuous Index:
 Within 8" of Joint: **NO**
 Remarks: **M-503-052**

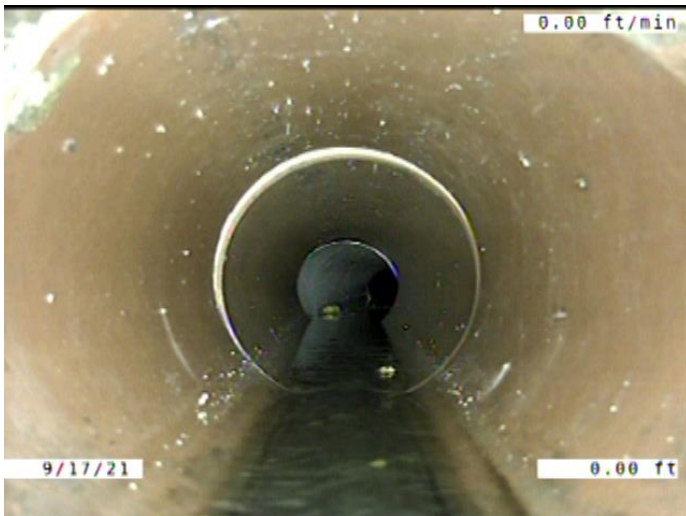
Code: **MWL**
 Description: **Miscellaneous Water Level**

Distance (ft): **.0**
 Structural Grade: **0**
 O&M Grade: **0**
 Clock Start/From:
 Clock To:
 1st Value:
 2nd Value:
 Value Percent: **5.000**
 Continuous Index:
 Within 8" of Joint: **NO**
 Remarks:

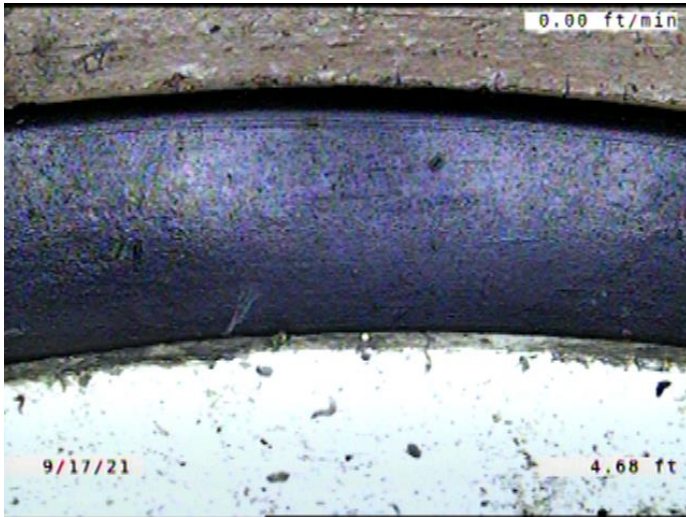
Code: **MMC**
Description: **Miscellaneous Material Change**

Distance (ft): **4.7**
Structural Grade: **0**
O&M Grade: **0**
Clock Start/From:
Clock To:
1st Value:
2nd Value:
Value Percent:
Continuous Index:
Within 8" of Joint: **NO**
Remarks: **VCP TO PVC**

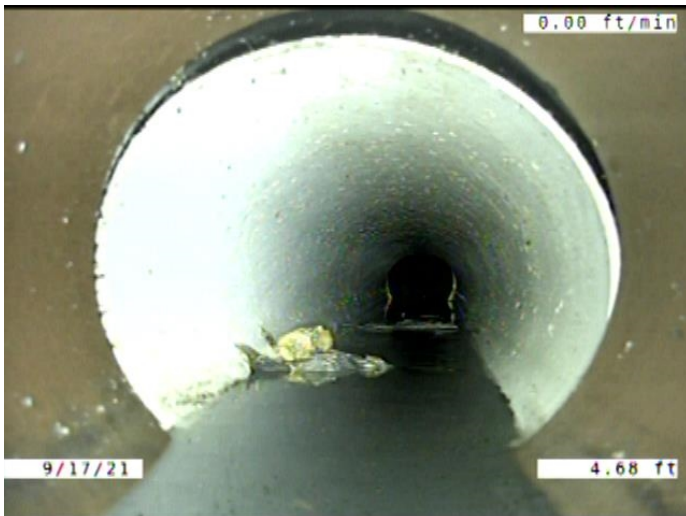
Code: **LR**
Description: **Line Right**

Distance (ft): **4.7**
Structural Grade: **0**
O&M Grade: **1**
Clock Start/From:
Clock To:
1st Value:
2nd Value:
Value Percent: **5.000**
Continuous Index:
Within 8" of Joint: **NO**
Remarks:

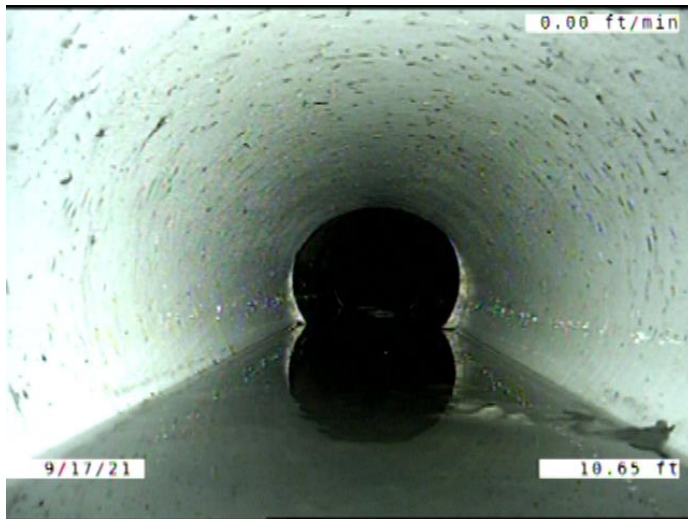
Code: **DSF**
 Description: **Deposits Settled Fine**

Distance (ft): **10.7**
 Structural Grade: **0**
 O&M Grade: **2**
 Clock Start/From: **5**
 Clock To: **7**
 1st Value:
 2nd Value:
 Value Percent: **5.000**
 Continuous Index: **S01**
 Within 8" of Joint: **YES**
 Remarks:

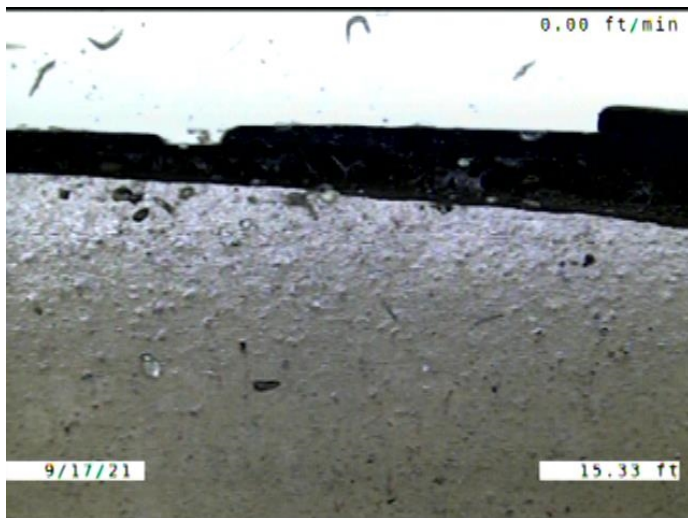
Code: **MMC**
 Description: **Miscellaneous Material Change**

Distance (ft): **15.3**
 Structural Grade: **0**
 O&M Grade: **0**
 Clock Start/From:
 Clock To:
 1st Value:
 2nd Value:
 Value Percent:
 Continuous Index:
 Within 8" of Joint: **NO**
 Remarks: **PVC TO VCP**

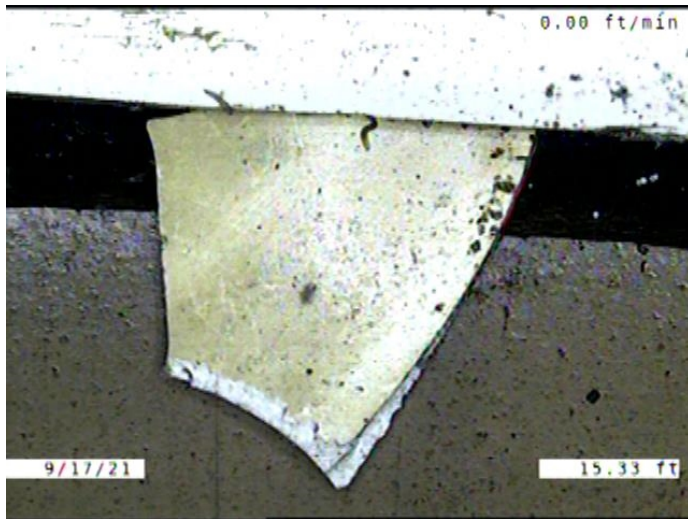
Code: **OBM**
Description: **Obstruction Pipe Material in Invert**

Distance (ft): **15.3**
Structural Grade: **0**
O&M Grade: **2**
Clock Start/From: **12**
Clock To: **1**
1st Value:
2nd Value:
Value Percent: **5.000**
Continuous Index:
Within 8" of Joint: **YES**
Remarks:

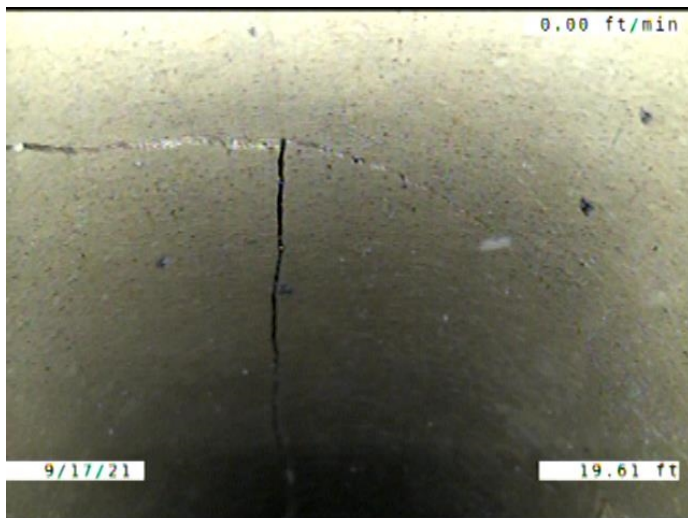
Code: **B**
Description: **Broken**

Distance (ft): **19.6**
Structural Grade: **4**
O&M Grade: **0**
Clock Start/From: **12**
Clock To: **12**
1st Value:
2nd Value:
Value Percent:
Continuous Index: **S02**
Within 8" of Joint: **YES**
Remarks:

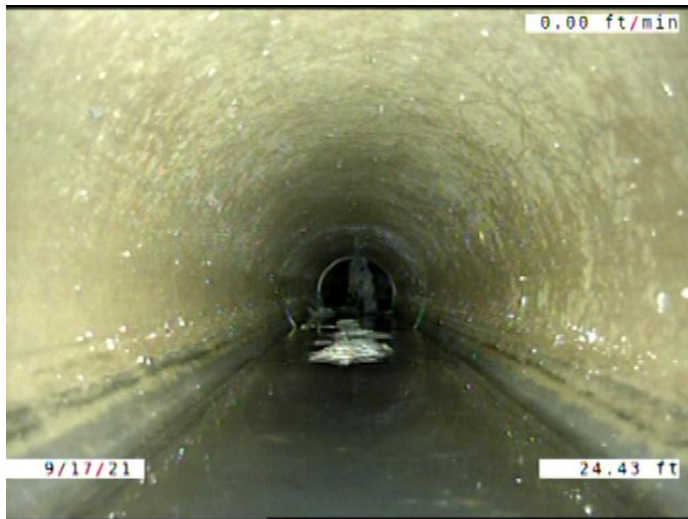
Code: **B**
 Description: **Broken**

Distance (ft): **24.4**
 Structural Grade: **4**
 O&M Grade: **0**
 Clock Start/From: **12**
 Clock To: **12**
 1st Value:
 2nd Value:
 Value Percent:
 Continuous Index: **F02**
 Within 8" of Joint: **YES**
 Remarks:

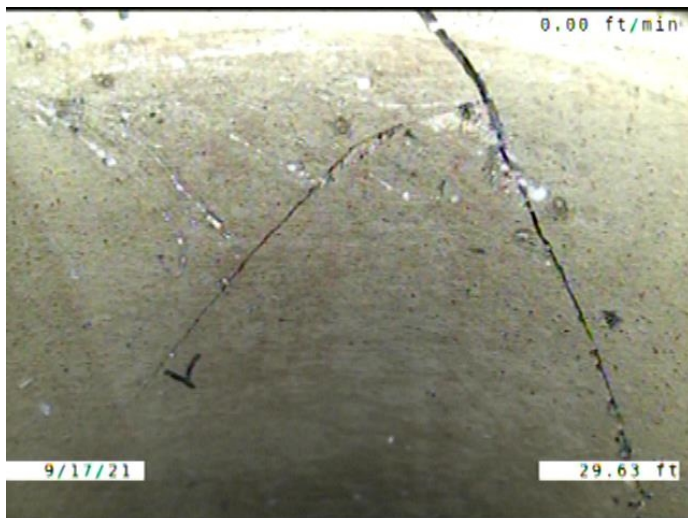
Code: **FM**
 Description: **Fracture Multiple**

Distance (ft): **29.6**
 Structural Grade: **4**
 O&M Grade: **0**
 Clock Start/From: **12**
 Clock To: **12**
 1st Value:
 2nd Value:
 Value Percent:
 Continuous Index: **S03**
 Within 8" of Joint: **YES**
 Remarks:

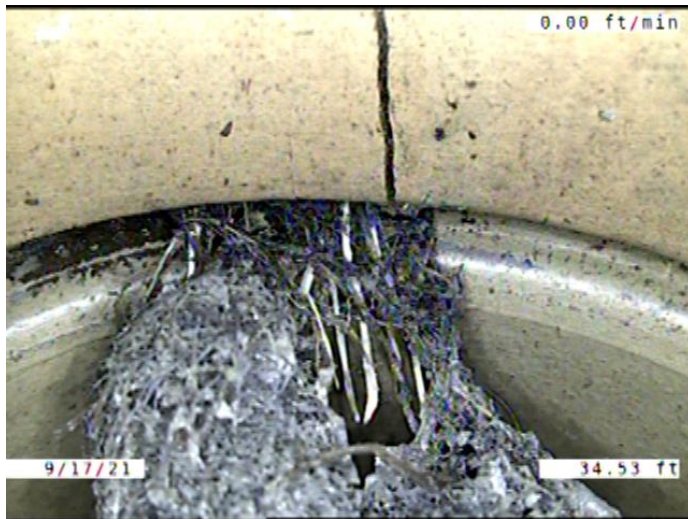
Code: **RMJ**
 Description: **Roots Medium Joint**

Distance (ft): **34.5**
 Structural Grade: **0**
 O&M Grade: **3**
 Clock Start/From: **8**
 Clock To: **4**
 1st Value:
 2nd Value:
 Value Percent: **5.000**
 Continuous Index:
 Within 8" of Joint: **YES**
 Remarks:

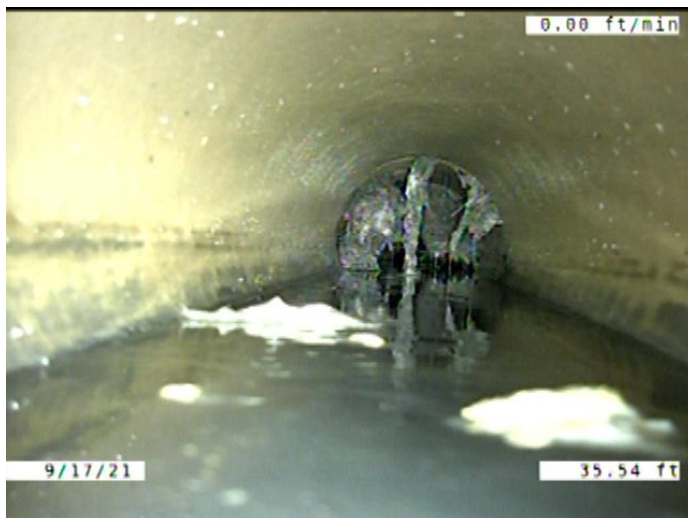
Code: **FM**
 Description: **Fracture Multiple**

Distance (ft): **35.5**
 Structural Grade: **4**
 O&M Grade: **0**
 Clock Start/From: **12**
 Clock To: **12**
 1st Value:
 2nd Value:
 Value Percent:
 Continuous Index: **F03**
 Within 8" of Joint: **YES**
 Remarks:

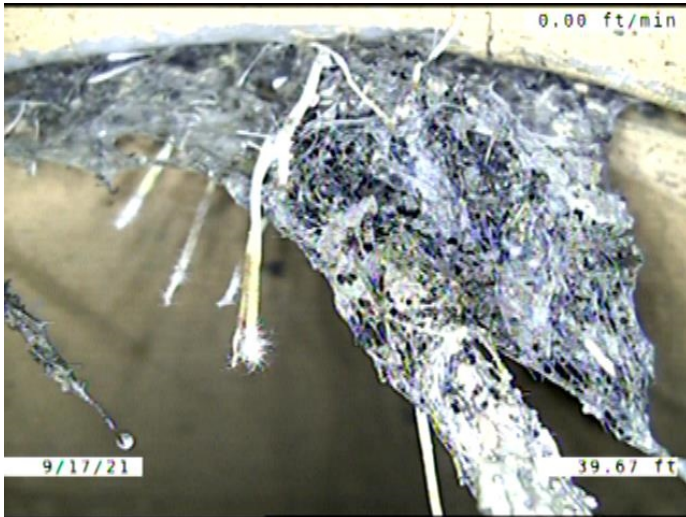
Code: **RMJ**
 Description: **Roots Medium Joint**

Distance (ft): **39.7**
 Structural Grade: **0**
 O&M Grade: **3**
 Clock Start/From: **12**
 Clock To: **2**
 1st Value:
 2nd Value:
 Value Percent: **5.000**
 Continuous Index:
 Within 8" of Joint: **YES**
 Remarks:

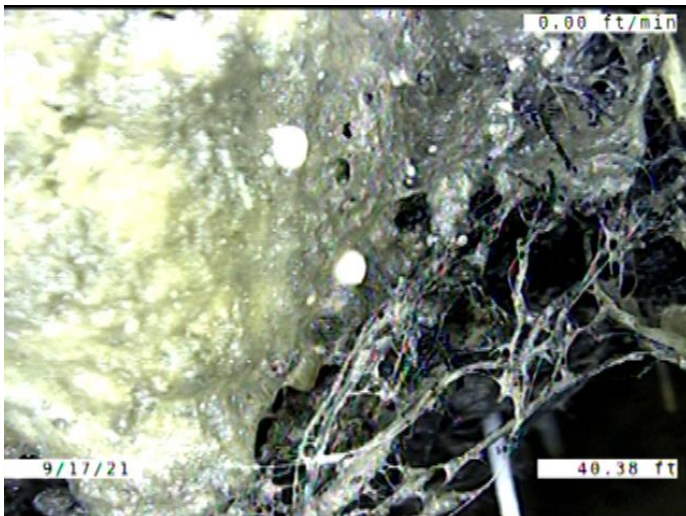
Code: **RML**
 Description: **Roots Medium Lateral**

Distance (ft): **40.4**
 Structural Grade: **0**
 O&M Grade: **3**
 Clock Start/From: **9**
 Clock To: **11**
 1st Value:
 2nd Value:
 Value Percent: **30.000**
 Continuous Index:
 Within 8" of Joint: **NO**
 Remarks:

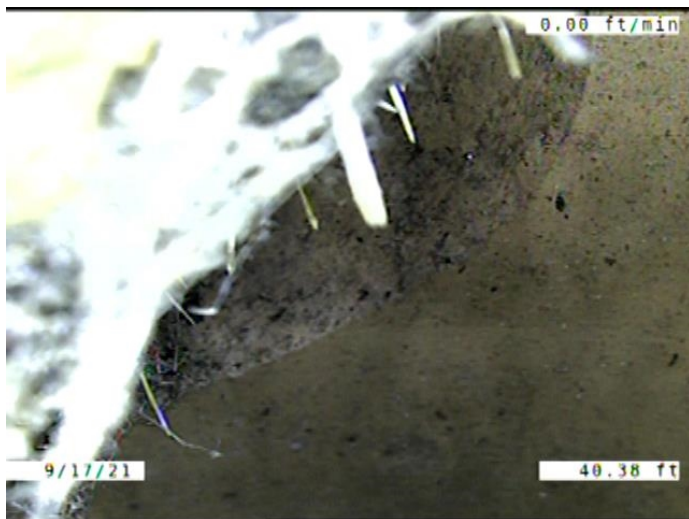
Code: **TFD**
 Description: **Tap Factory Defective**

Distance (ft): **40.4**
 Structural Grade: **0**
 O&M Grade: **3**
 Clock Start/From: **10**
 Clock To:
 1st Value: **4.000**
 2nd Value:
 Value Percent:
 Continuous Index:
 Within 8" of Joint: **YES**
 Remarks: **LOOKS TO BE 100% PLUGGED WITH ROOTS**

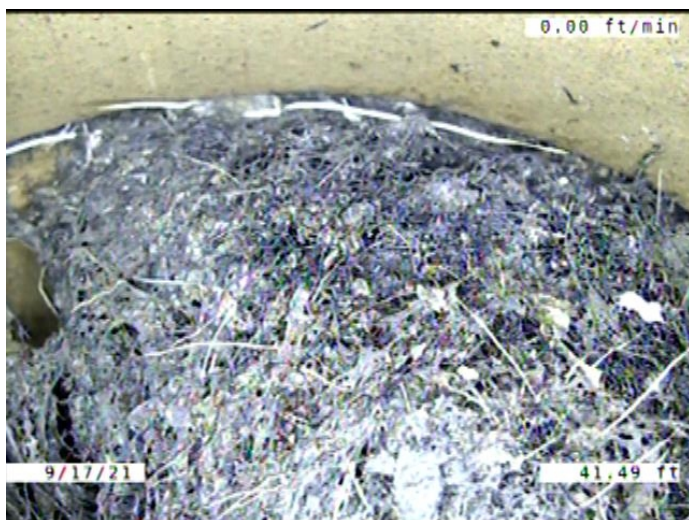
Code: **RMJ**
 Description: **Roots Medium Joint**

Distance (ft): **41.5**
 Structural Grade: **0**
 O&M Grade: **3**
 Clock Start/From: **11**
 Clock To: **4**
 1st Value:
 2nd Value:
 Value Percent: **20.000**
 Continuous Index:
 Within 8" of Joint: **YES**
 Remarks:

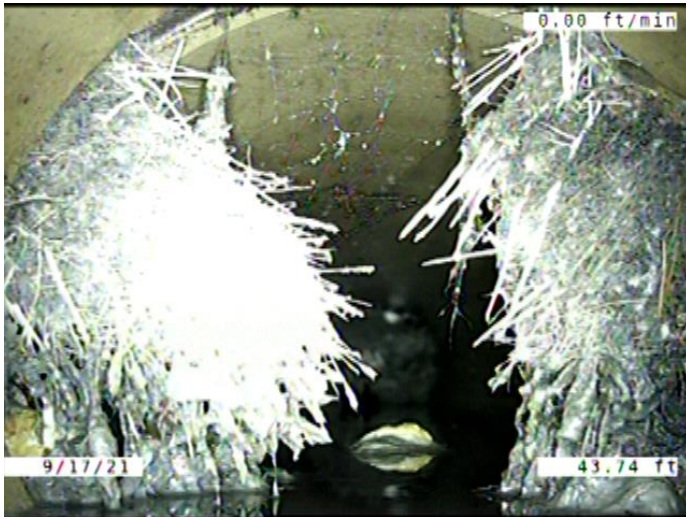
Code: **RMJ**
 Description: **Roots Medium Joint**

Distance (ft): **43.7**
 Structural Grade: **0**
 O&M Grade: **3**
 Clock Start/From: **8**
 Clock To: **5**
 1st Value:
 2nd Value:
 Value Percent: **50.000**
 Continuous Index:
 Within 8" of Joint: **YES**
 Remarks:

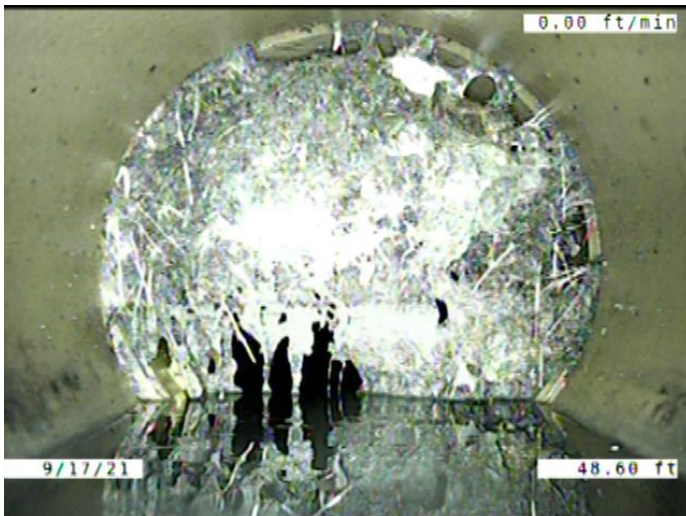
Code: **RBJ**
 Description: **Roots Ball Joint**

Distance (ft): **48.6**
 Structural Grade: **0**
 O&M Grade: **4**
 Clock Start/From: **8**
 Clock To: **4**
 1st Value:
 2nd Value:
 Value Percent: **85.000**
 Continuous Index:
 Within 8" of Joint: **YES**
 Remarks:

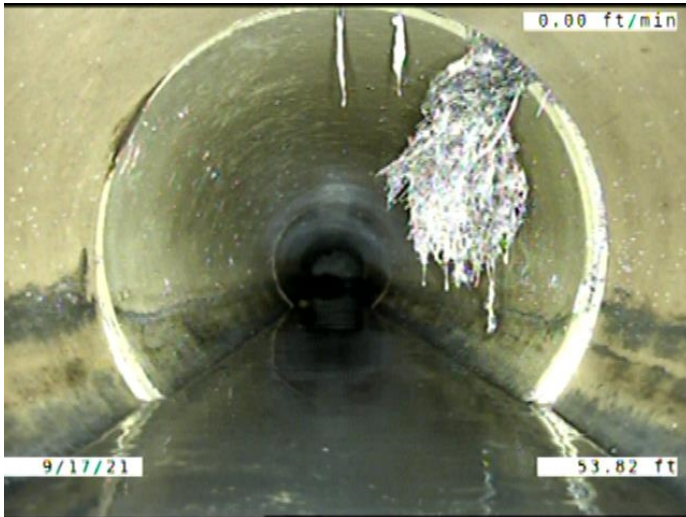
Code: **RMJ**
 Description: **Roots Medium Joint**

Distance (ft): **53.8**
 Structural Grade: **0**
 O&M Grade: **3**
 Clock Start/From: **11**
 Clock To: **2**
 1st Value:
 2nd Value:
 Value Percent: **5.000**
 Continuous Index:
 Within 8" of Joint: **YES**
 Remarks:

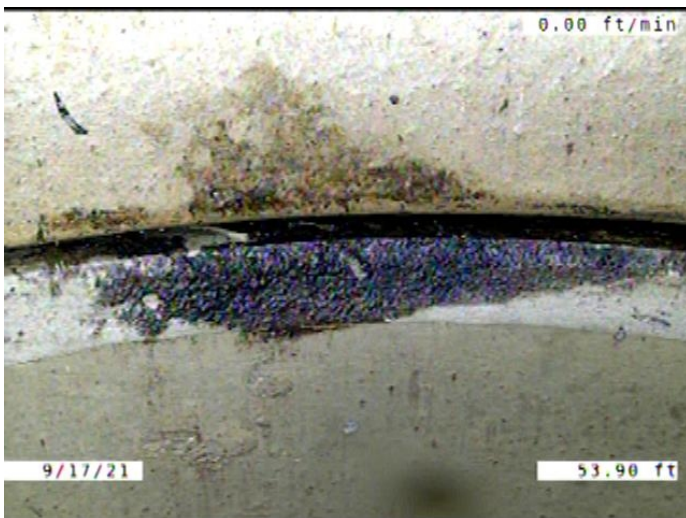
Code: **ISJ**
 Description: **Infiltration Stain Joint**

Distance (ft): **53.9**
 Structural Grade: **0**
 O&M Grade: **1**
 Clock Start/From: **10**
 Clock To: **11**
 1st Value:
 2nd Value:
 Value Percent:
 Continuous Index:
 Within 8" of Joint: **YES**
 Remarks:

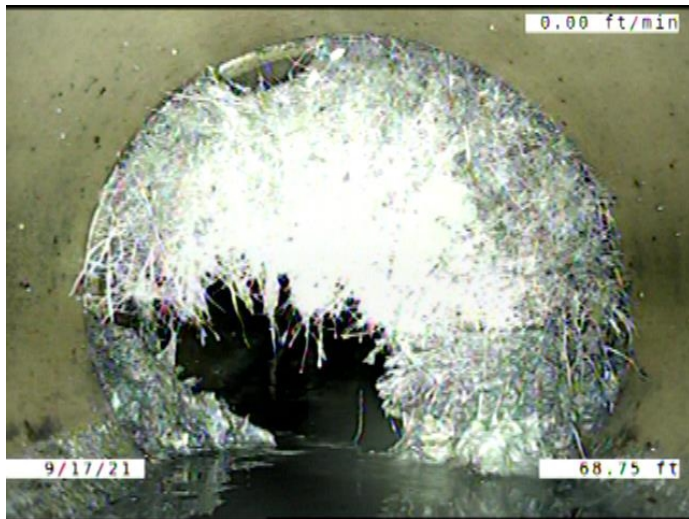
Code: **RBJ**
 Description: **Roots Ball Joint**

Distance (ft): **68.7**
 Structural Grade: **0**
 O&M Grade: **4**
 Clock Start/From: **7**
 Clock To: **5**
 1st Value:
 2nd Value:
 Value Percent: **75.000**
 Continuous Index:
 Within 8" of Joint: **YES**
 Remarks:

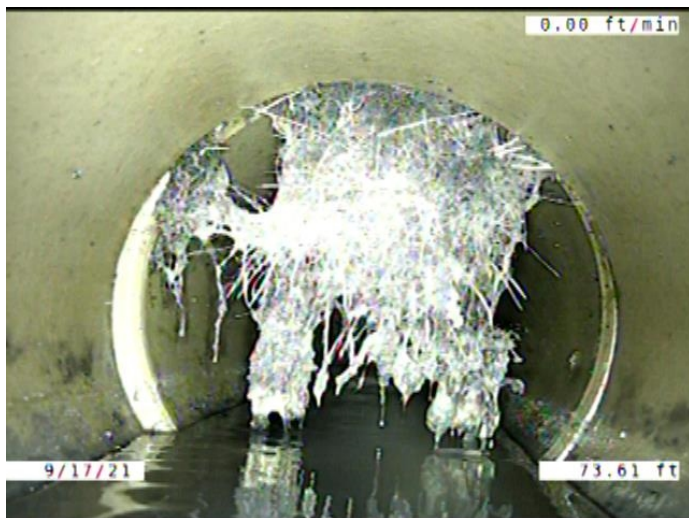
Code: **RMJ**
 Description: **Roots Medium Joint**

Distance (ft): **73.6**
 Structural Grade: **0**
 O&M Grade: **3**
 Clock Start/From: **10**
 Clock To: **2**
 1st Value:
 2nd Value:
 Value Percent: **35.000**
 Continuous Index:
 Within 8" of Joint: **YES**
 Remarks:

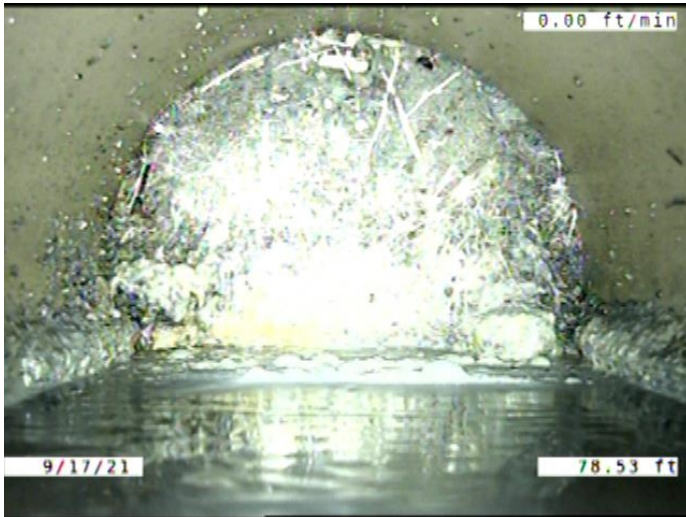
Code: **RBJ**
Description: **Roots Ball Joint**

Distance (ft): **78.5**
Structural Grade: **0**
O&M Grade: **4**
Clock Start/From: **8**
Clock To: **4**
1st Value:
2nd Value:
Value Percent: **80.000**
Continuous Index:
Within 8" of Joint: **YES**
Remarks:

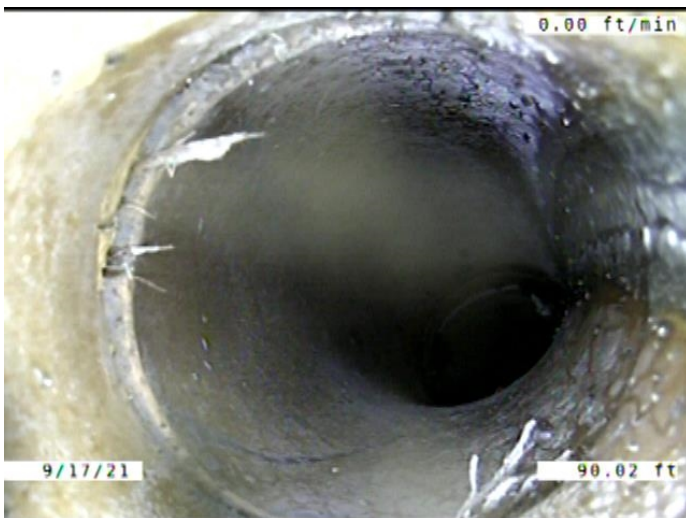
Code: **TF**
Description: **Tap Factory**

Distance (ft): **90.0**
Structural Grade: **0**
O&M Grade: **0**
Clock Start/From: **1**
Clock To:
1st Value: **5.000**
2nd Value:
Value Percent:
Continuous Index:
Within 8" of Joint: **YES**
Remarks: **ROOTS GROWING OUT OF THE JOINTS**

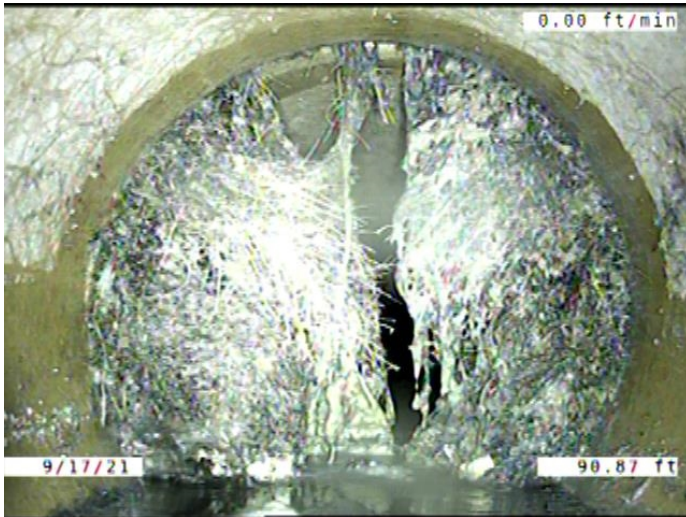
Code: **RBJ**
 Description: **Roots Ball Joint**

Distance (ft): **90.9**
 Structural Grade: **0**
 O&M Grade: **4**
 Clock Start/From: **7**
 Clock To: **5**
 1st Value:
 2nd Value:
 Value Percent: **90.000**
 Continuous Index:
 Within 8" of Joint: **YES**
 Remarks:

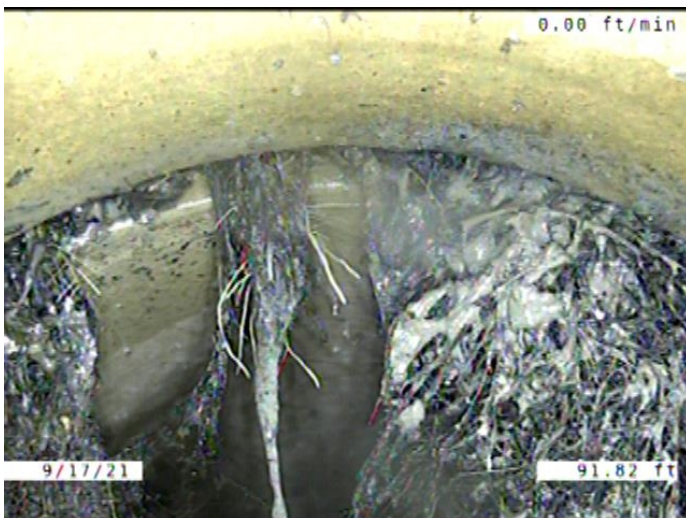
Code: **IRJ**
 Description: **Infiltration Runner Joint**

Distance (ft): **91.8**
 Structural Grade: **0**
 O&M Grade: **4**
 Clock Start/From: **11**
 Clock To: **3**
 1st Value:
 2nd Value:
 Value Percent:
 Continuous Index:
 Within 8" of Joint: **YES**
 Remarks:

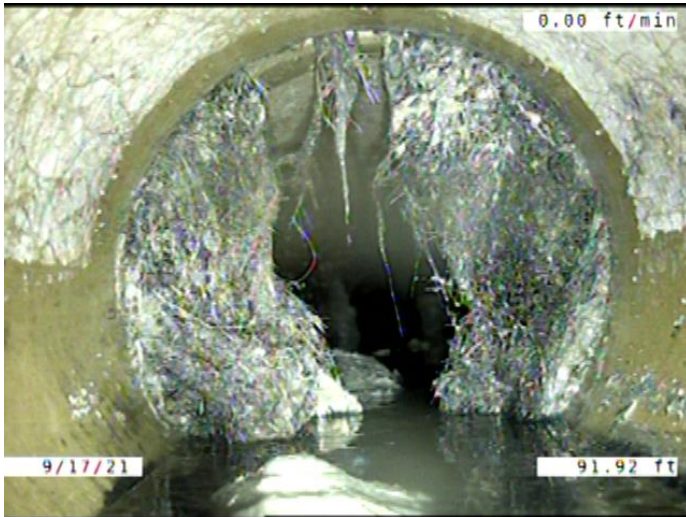
Code: **DSF**
 Description: **Deposits Settled Fine**

Distance (ft): **91.9**
 Structural Grade: **0**
 O&M Grade: **2**
 Clock Start/From: **5**
 Clock To: **7**
 1st Value:
 2nd Value:
 Value Percent: **5.000**
 Continuous Index: **F01**
 Within 8" of Joint: **YES**
 Remarks:

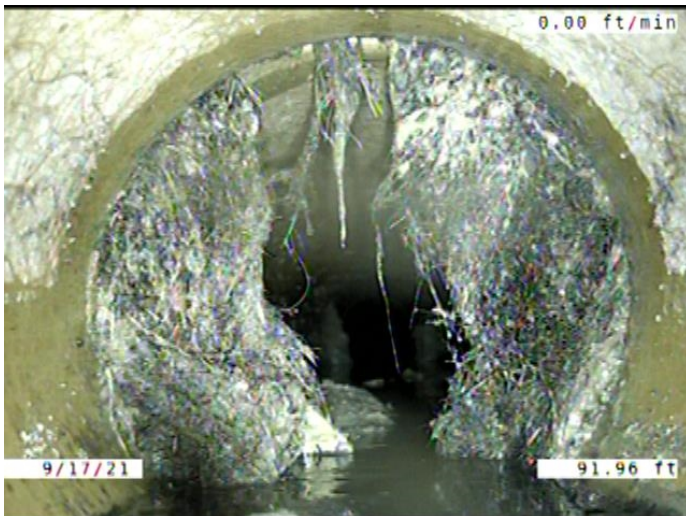
Code: **MSA**
 Description: **Miscellaneous Survey Abandoned**

Distance (ft): **92.0**
 Structural Grade: **0**
 O&M Grade: **0**
 Clock Start/From:
 Clock To:
 1st Value:
 2nd Value:
 Value Percent:
 Continuous Index:
 Within 8" of Joint: **NO**
 Remarks: **CAMERA CANT MAKE IT PAST ROOTS**
