Profile/Photo Observation Report

Date:	10/18/2021	Weather:		Coding:	PACP 6.0
Pipe Length (ft):		Owner:	Hobart, IN	Pre Clean:	Not Known
P.O.#:	879_1	Surveyor:	M. Pielacha	PSR:	P-503-052-053
Customer:	Hobart, IN	Clean Date:		Shape:	C

Street:	Off 38th Place	Flow Control:	
City:	Hobart, IN	Year Renewed:	
Location:	Yard	Tape/Media #:	879
Purpose:	Routine Assessment	Dia/Height:	10"
Use:	Sanitary	Material:	VCP
Drain Area:		Lining:	
Category:	NA		
Comment:

Location Details:		Direction of Survey:	Downstream
US MH:	M-503-53	DS MH:	M-503-52
		Total Length Surveyed (ft):	212.5

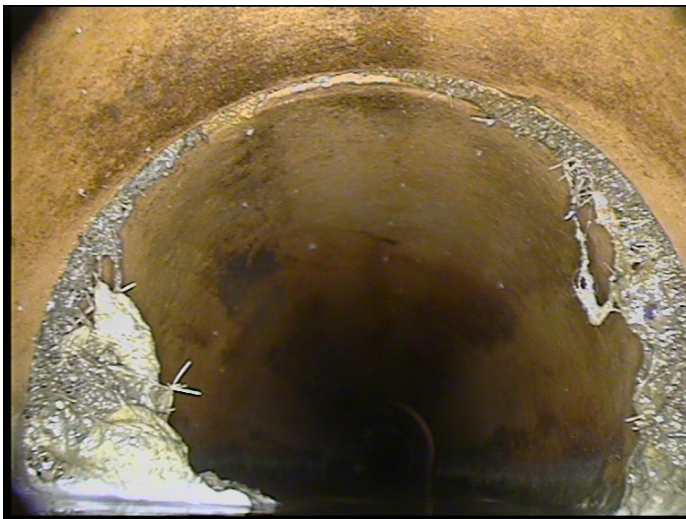
Code: **RMJ**
Description: **Roots Medium Joint**

Distance (ft): **10.6**
Structural Grade: **0**
O&M Grade: **3**
Clock Start/From: **8**
Clock To: **4**
1st Value:
2nd Value:
Value Percent: **5.000**
Continuous Index:
Within 8" of Joint: **YES**
Remarks:

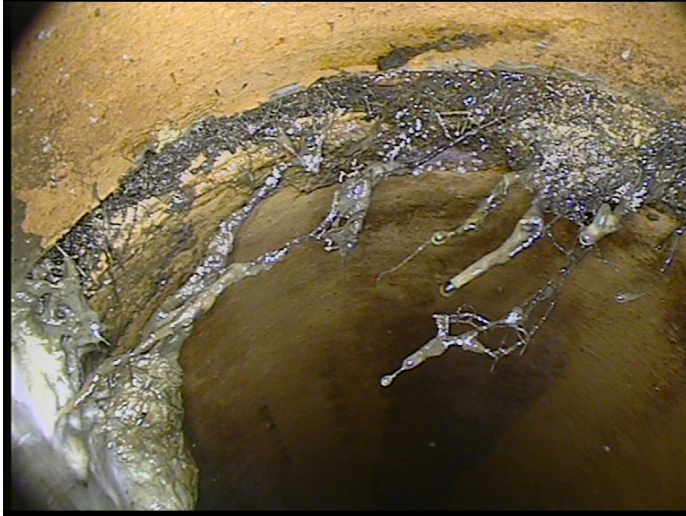
Code:	RFJ
Description:	Roots Fine Joint
Distance (ft):	20.8
Structural Grade:	0
O&M Grade:	1
Clock Start/From:	8
Clock To:	12
1st Value:	
2nd Value:	
Value Percent:	
Continuous Index:	S01
Within 8" of Joint:	YES
Remarks:

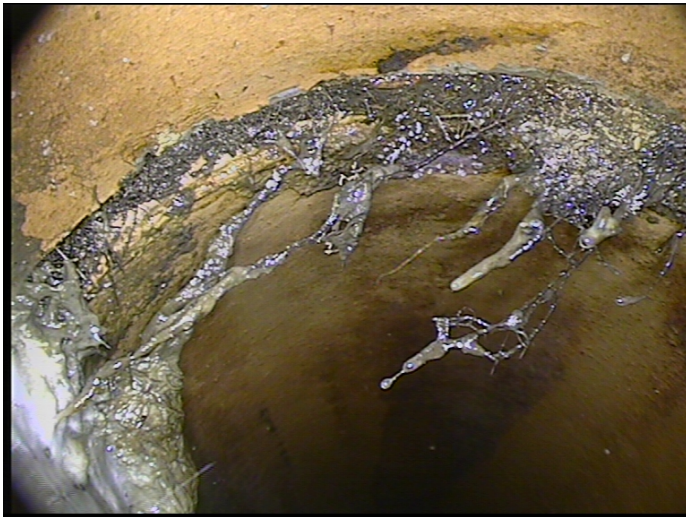
Code:	ID
Description:	Infil Drinker
Distance (ft):	20.8
Structural Grade:	0
O&M Grade:	3
Clock Start/From:	11
Clock To:	
1st Value:	
2nd Value:	
Value Percent:	
Continuous Index:	
Within 8" of Joint:	YES
Remarks:

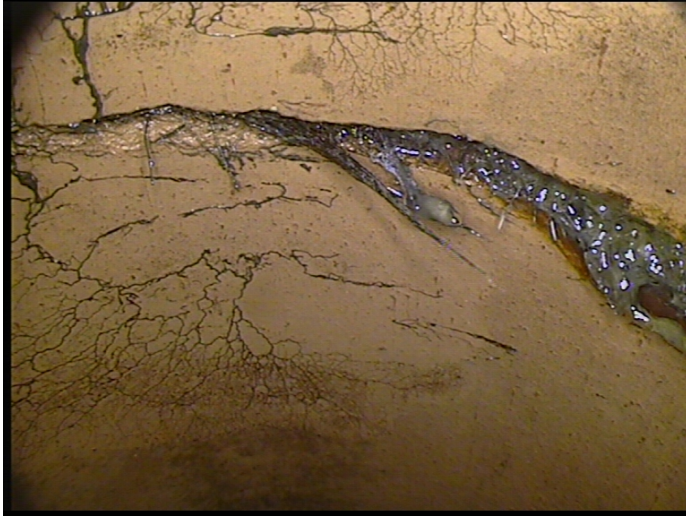
Code:	ID
Description:	Infil Dripper
Distance (ft):	33.0
Structural Grade:	0
O&M Grade:	3
Clock Start/From:	1
Clock To:	
1st Value:	
2nd Value:	
Value Percent:	
Continuous Index:	
Within 8" of Joint:	YES
Remarks:

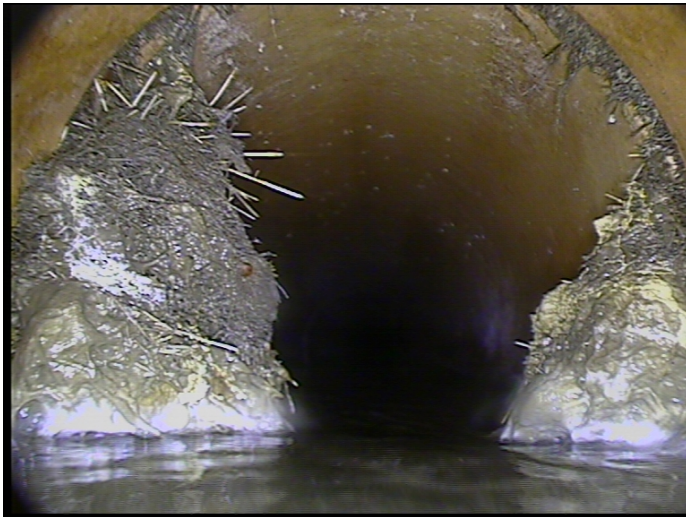
Code:	RFJ
Description:	Roots Fine Joint
Distance (ft):	62.3
Structural Grade:	0
O&M Grade:	1
Clock Start/From:	8
Clock To:	12
1st Value:	
2nd Value:	
Value Percent:	
Continuous Index:	F01
Within 8" of Joint:	YES
Remarks:

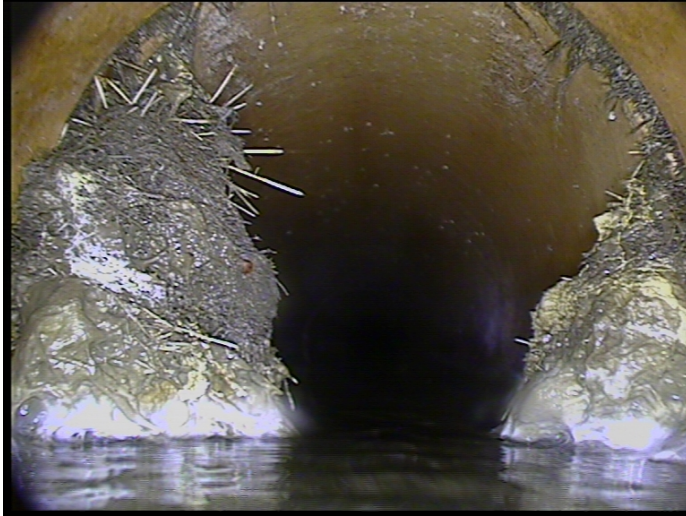
Code:	RMJ
Description:	Roots Medium Joint
Distance (ft):	62.3
Structural Grade:	0
O&M Grade:	3
Clock Start/From:	8
Clock To:	4
1st Value:	
2nd Value:	
Value Percent:	15.000
Continuous Index:	
Within 8" of Joint:	YES
Remarks:

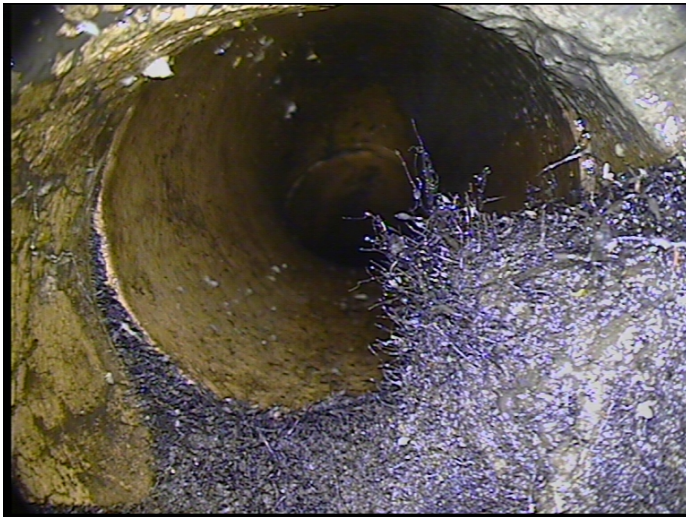
Code:	TFD
Description:	Tap Factory Defective
Distance (ft):	126.3
Structural Grade:	0
O&M Grade:	2
Clock Start/From:	2
Clock To:	
1st Value:	4.000
2nd Value:	
Value Percent:	
Continuous Index:	
Within 8" of Joint:	NO
Remarks:	roots

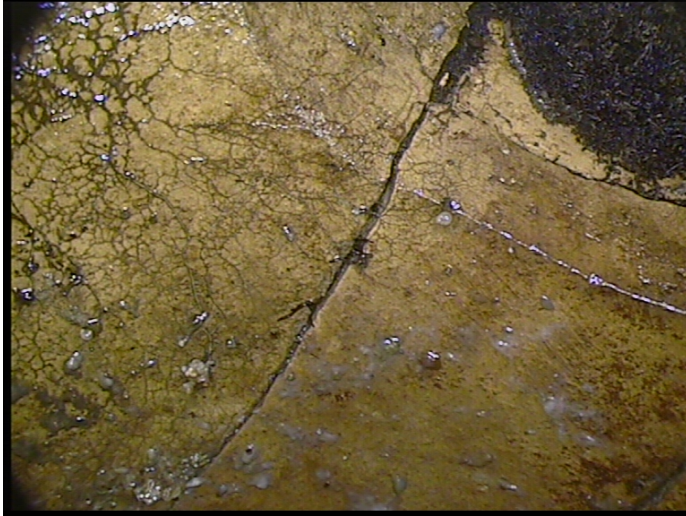
Code: **CL**
Description: **Crack Longitudinal**

Distance (ft): **126.3**
Structural Grade: **2**
O&M Grade: **0**
Clock Start/From: **1**
Clock To:
1st Value:
2nd Value:
Value Percent:
Continuous Index:
Within 8" of Joint: **YES**
Remarks:

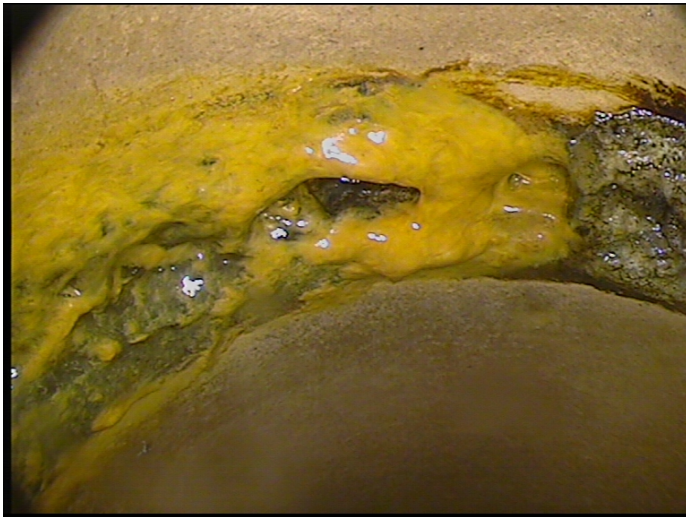
Code: **ID**
Description: **Infil Dripper**

Distance (ft): **196.6**
Structural Grade: **0**
O&M Grade: **3**
Clock Start/From: **11**
Clock To:
1st Value:
2nd Value:
Value Percent:
Continuous Index:
Within 8" of Joint: **YES**
Remarks:

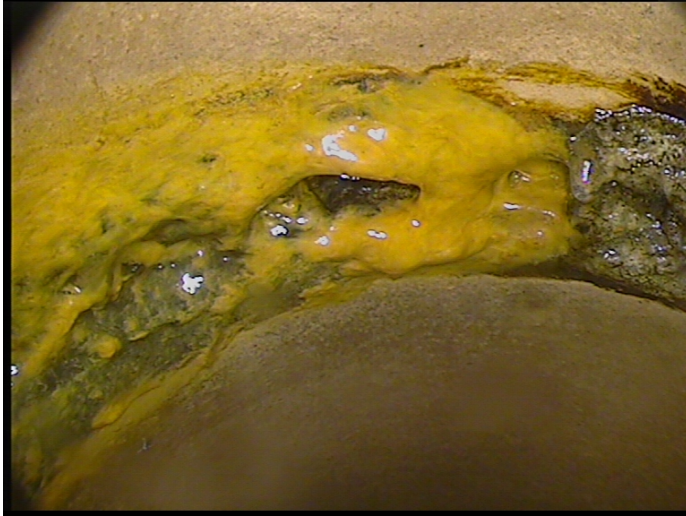
Code:	DAE
Description:	Deposits Attached Encrustation
Distance (ft):	196.6
Structural Grade:	0
O&M Grade:	2
Clock Start/From:	8
Clock To:	12
1st Value:	
2nd Value:	
Value Percent:	5.000
Continuous Index:	
Within 8" of Joint:	YES
Remarks:
