Profile/Photo Observation Report

Date:	09/17/2021	Weather:		Coding:	PACP 7.0
Pipe Length (ft):	203.0	Owner:	City of Hobart	Pre Clean:	Light Cleaning
P.O.#:	YES502259	Surveyor:	S. Bucklin	PSR:	P-503-053-054
Customer:	City of Hobart	Clean Date:	08/24/2021	Shape:	C

Street:	North Guyer Street	Flow Control:	Not Controlled
City:	Hobart, IN	Year Renewed:	
Location:	Easement/Right of Way	Tape/Media #:	
Purpose:	Routine Assessment	Dia/Height:	10"
Use:	Sanitary Sewage Pipe	Material:	VCP
Drain Area:		Lining:	None
Category:	NA		
Comment:

Location Details:		Direction of Survey:	Upstream
US MH:	M-503-053	DS MH:	M-503-054
		Total Length Surveyed (ft):	145.2

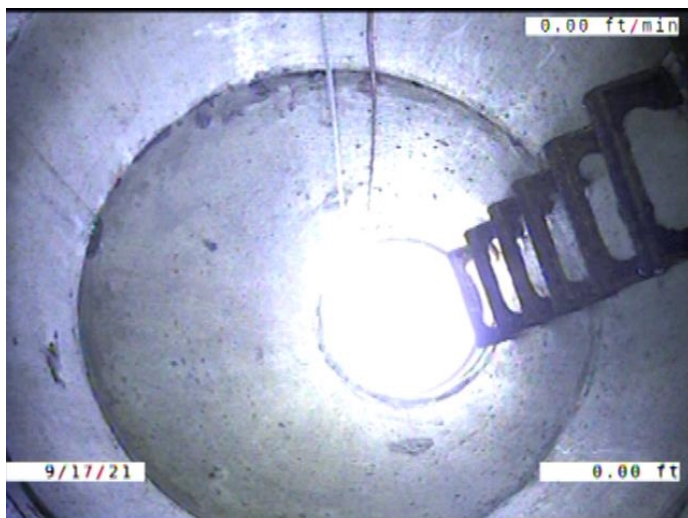
Code: **AMH**
Description: **Manhole**

Distance (ft): **.0**
Structural Grade: **0**
O&M Grade: **0**
Clock Start/From:
Clock To:
1st Value:
2nd Value:
Value Percent:
Continuous Index:
Within 8" of Joint: **NO**
Remarks: **M-503-054**

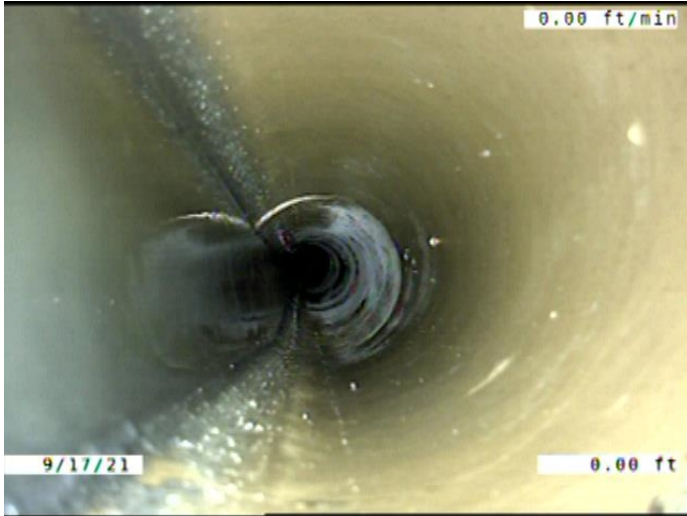
Code: **MWL**
Description: **Miscellaneous Water Level**

Distance (ft): **.0**
Structural Grade: **0**
O&M Grade: **0**
Clock Start/From:
Clock To:
1st Value:
2nd Value:
Value Percent: **5.000**
Continuous Index:
Within 8" of Joint: **NO**
Remarks:

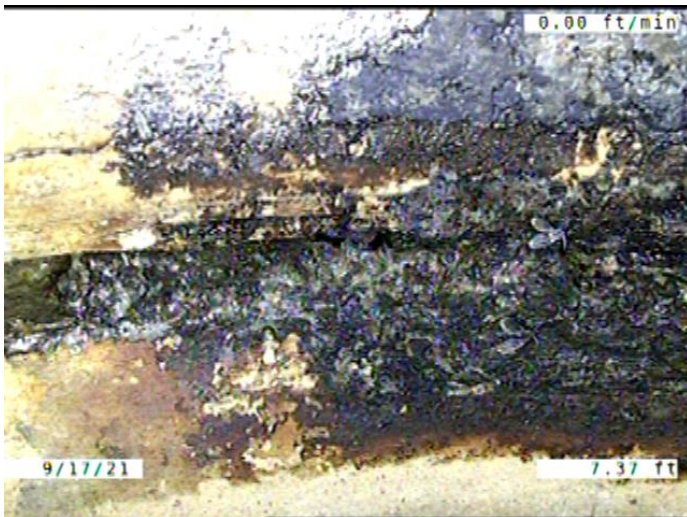
Code: **DAE**
Description: **Deposits Attached Encrustation**

Distance (ft): **7.4**
Structural Grade: **0**
O&M Grade: **2**
Clock Start/From: **8**
Clock To: **4**
1st Value:
2nd Value:
Value Percent: **5.000**
Continuous Index:
Within 8" of Joint: **YES**
Remarks:

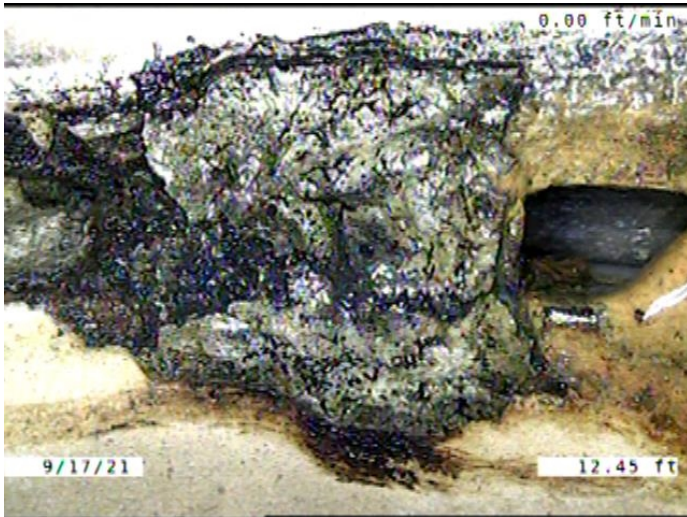
Code: **DAE**
 Description: **Deposits Attached Encrustation**

Distance (ft): **12.4**
 Structural Grade: **0**
 O&M Grade: **2**
 Clock Start/From: **8**
 Clock To: **4**
 1st Value:
 2nd Value:
 Value Percent: **5.000**
 Continuous Index: **S01**
 Within 8" of Joint: **YES**
 Remarks:

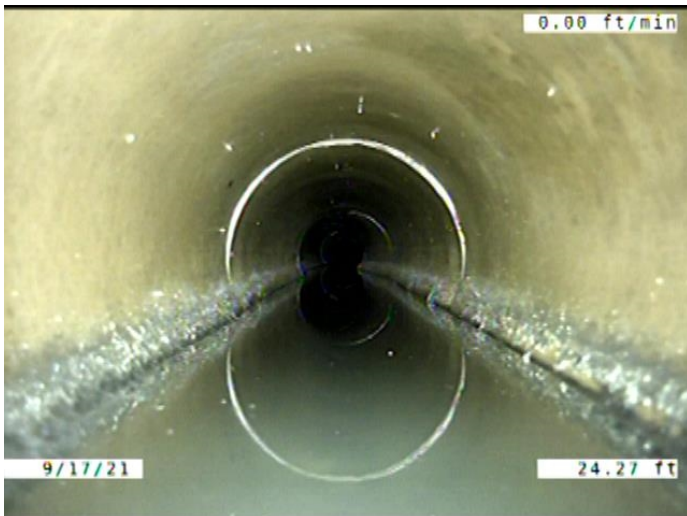
Code: **MWLS**
 Description: **Miscellaneous Water Level Sag**

Distance (ft): **24.3**
 Structural Grade: **2**
 O&M Grade: **0**
 Clock Start/From:
 Clock To:
 1st Value:
 2nd Value:
 Value Percent: **10.000**
 Continuous Index: **S02**
 Within 8" of Joint: **NO**
 Remarks:

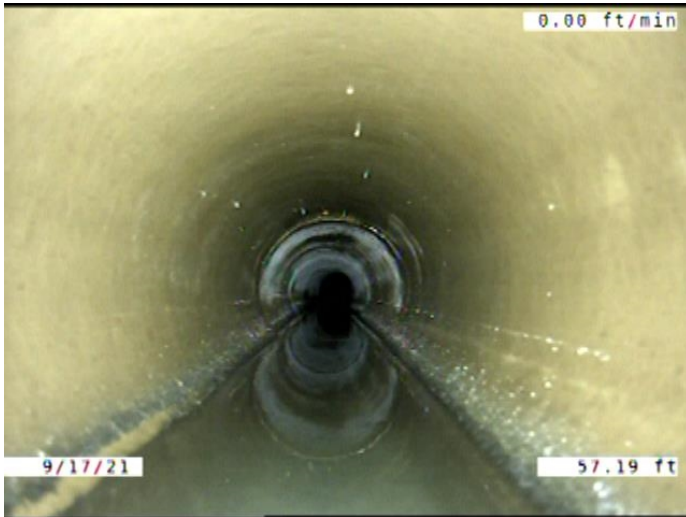
Code: **MWLS**
 Description: **Miscellaneous Water Level Sag**

Distance (ft): **57.2**
 Structural Grade: **2**
 O&M Grade: **0**
 Clock Start/From:
 Clock To:
 1st Value:
 2nd Value:
 Value Percent: **10.000**
 Continuous Index: **F02**
 Within 8" of Joint: **NO**
 Remarks:

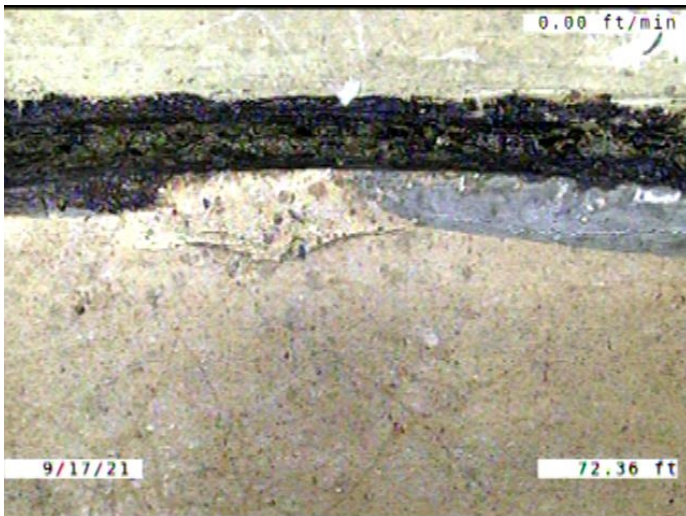
Code: **SSS**
 Description: **Surface Damage Surface Spalling**

Distance (ft): **72.4**
 Structural Grade: **2**
 O&M Grade: **0**
 Clock Start/From: **12**
 Clock To:
 1st Value:
 2nd Value:
 Value Percent:
 Continuous Index:
 Within 8" of Joint: **YES**
 Remarks:

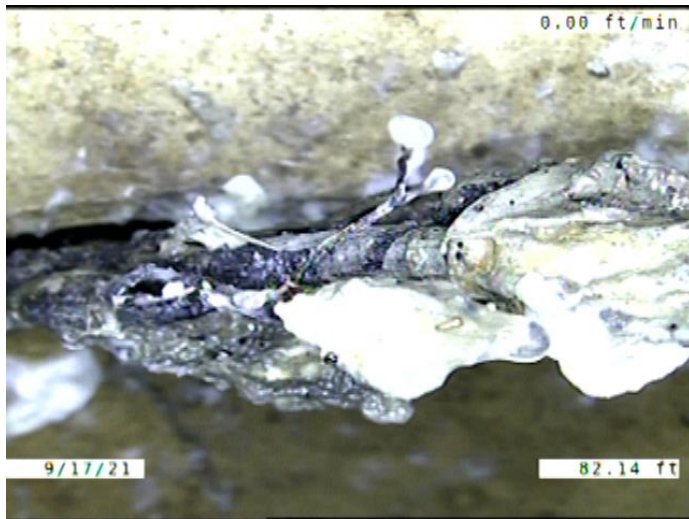
Code: **RMJ**
 Description: **Roots Medium Joint**

Distance (ft): **82.1**
 Structural Grade: **0**
 O&M Grade: **3**
 Clock Start/From: **9**
 Clock To: **3**
 1st Value:
 2nd Value:
 Value Percent: **5.000**
 Continuous Index:
 Within 8" of Joint: **YES**
 Remarks:

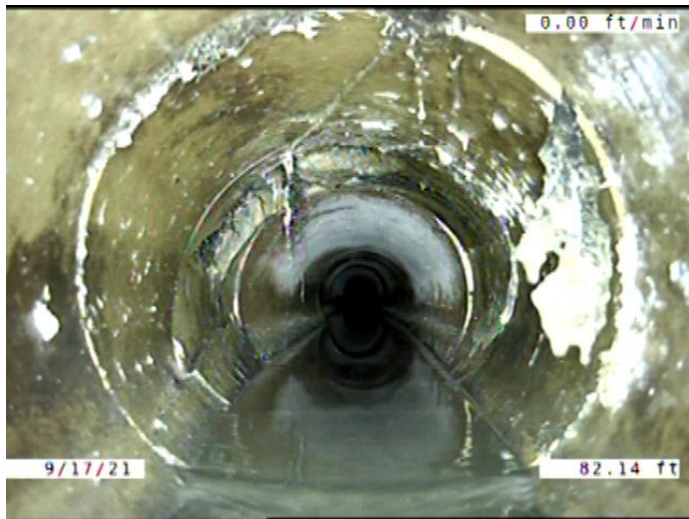
Code: **FM**
 Description: **Fracture Multiple**

Distance (ft): **82.1**
 Structural Grade: **4**
 O&M Grade: **0**
 Clock Start/From: **12**
 Clock To: **12**
 1st Value:
 2nd Value:
 Value Percent:
 Continuous Index:
 Within 8" of Joint: **YES**
 Remarks:

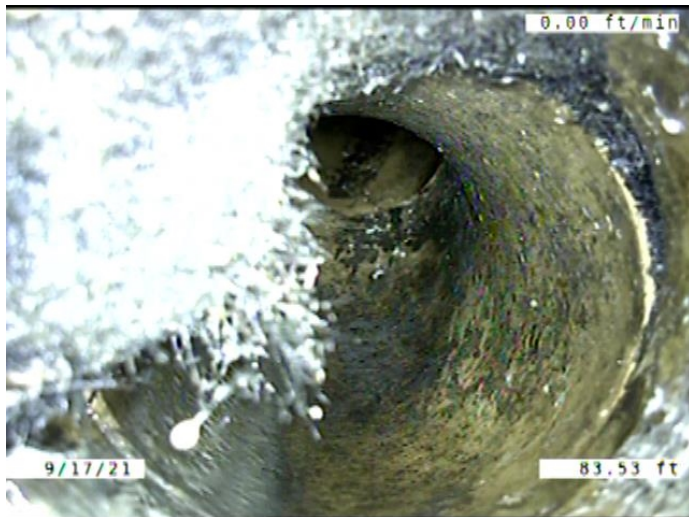
Code: **TFD**
 Description: **Tap Factory Defective**

Distance (ft): **83.5**
 Structural Grade: **0**
 O&M Grade: **3**
 Clock Start/From: **11**
 Clock To:
 1st Value: **4.000**
 2nd Value:
 Value Percent:
 Continuous Index:
 Within 8" of Joint: **YES**
 Remarks: **Defective**

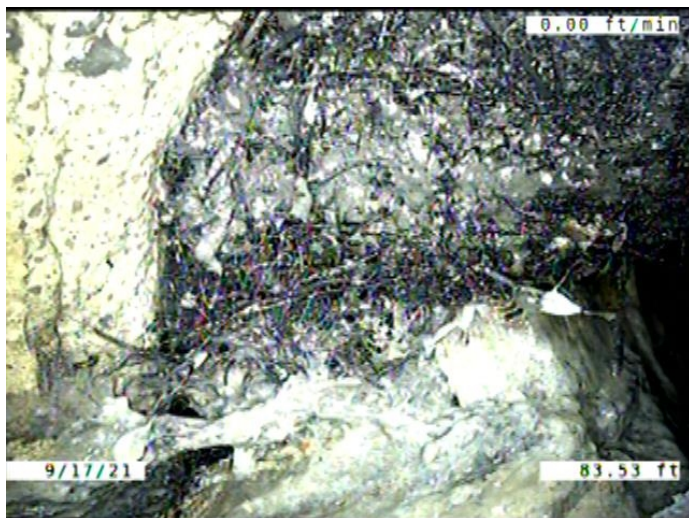
Code: **RFL**
 Description: **Roots Fine Lateral**

Distance (ft): **83.5**
 Structural Grade: **0**
 O&M Grade: **1**
 Clock Start/From: **10**
 Clock To: **12**
 1st Value:
 2nd Value:
 Value Percent:
 Continuous Index:
 Within 8" of Joint: **NO**
 Remarks:

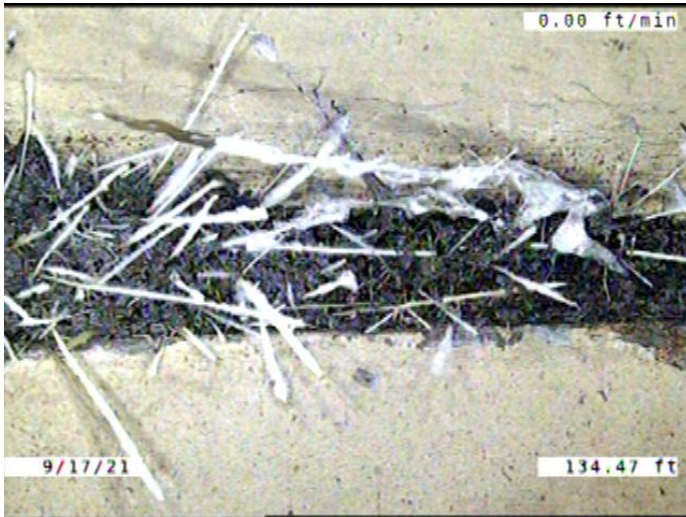
Code: **RFJ**
Description: **Roots Fine Joint**

Distance (ft): **134.5**
Structural Grade: **0**
O&M Grade: **1**
Clock Start/From: **9**
Clock To: **3**
1st Value:
2nd Value:
Value Percent:
Continuous Index:
Within 8" of Joint: **YES**
Remarks:

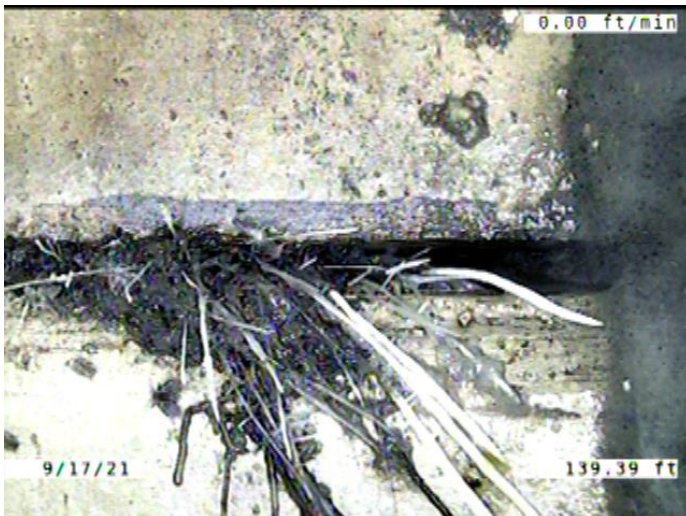
Code: **RFJ**
Description: **Roots Fine Joint**

Distance (ft): **139.4**
Structural Grade: **0**
O&M Grade: **1**
Clock Start/From: **8**
Clock To: **4**
1st Value:
2nd Value:
Value Percent:
Continuous Index:
Within 8" of Joint: **YES**
Remarks:

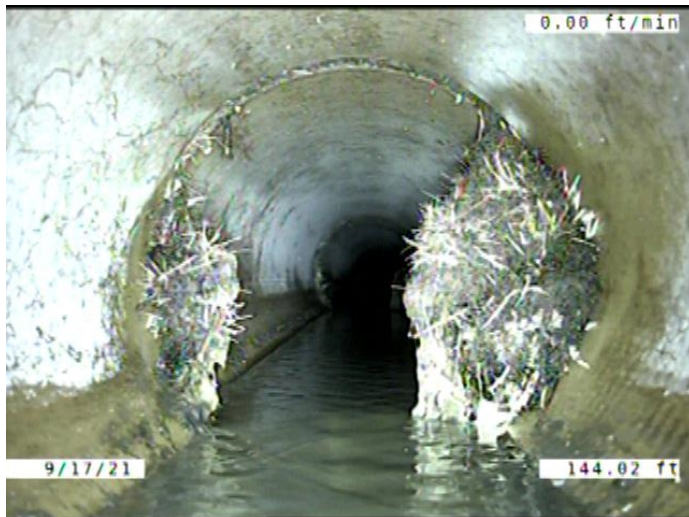
Code: **RMJ**
 Description: **Roots Medium Joint**

Distance (ft): **144.0**
 Structural Grade: **0**
 O&M Grade: **3**
 Clock Start/From: **7**
 Clock To: **5**
 1st Value:
 2nd Value:
 Value Percent: **20.000**
 Continuous Index:
 Within 8" of Joint: **YES**
 Remarks:

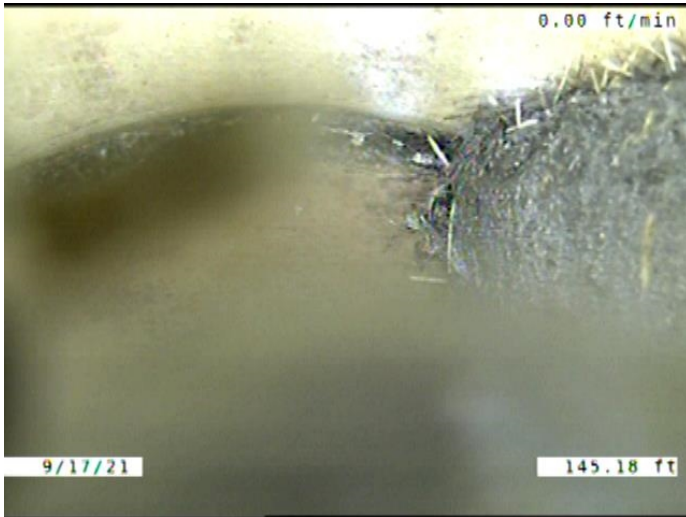
Code:	MSA
Description:	Miscellaneous Survey Abandoned
Distance (ft):	145.2
Structural Grade:	0
O&M Grade:	0
Clock Start/From:	
Clock To:	
1st Value:	
2nd Value:	
Value Percent:	
Continuous Index:	
Within 8" of Joint:	NO
Remarks:	CAMERA CANT MAKE IT PAST ROOTS
